# SPECIAL PROVISIONS

## EXISTING PAINT SURVEY

CUY-480-6.47/VAR PAINT

**Subject: Lead Paint Testing of the CUY 00010 08690 Bridge (SFN #1801325/PID 22131) Lorain Road over the Cuyahoga Valley, Cuyahoga County, Ohio 44111 (L&A 17-0529)**

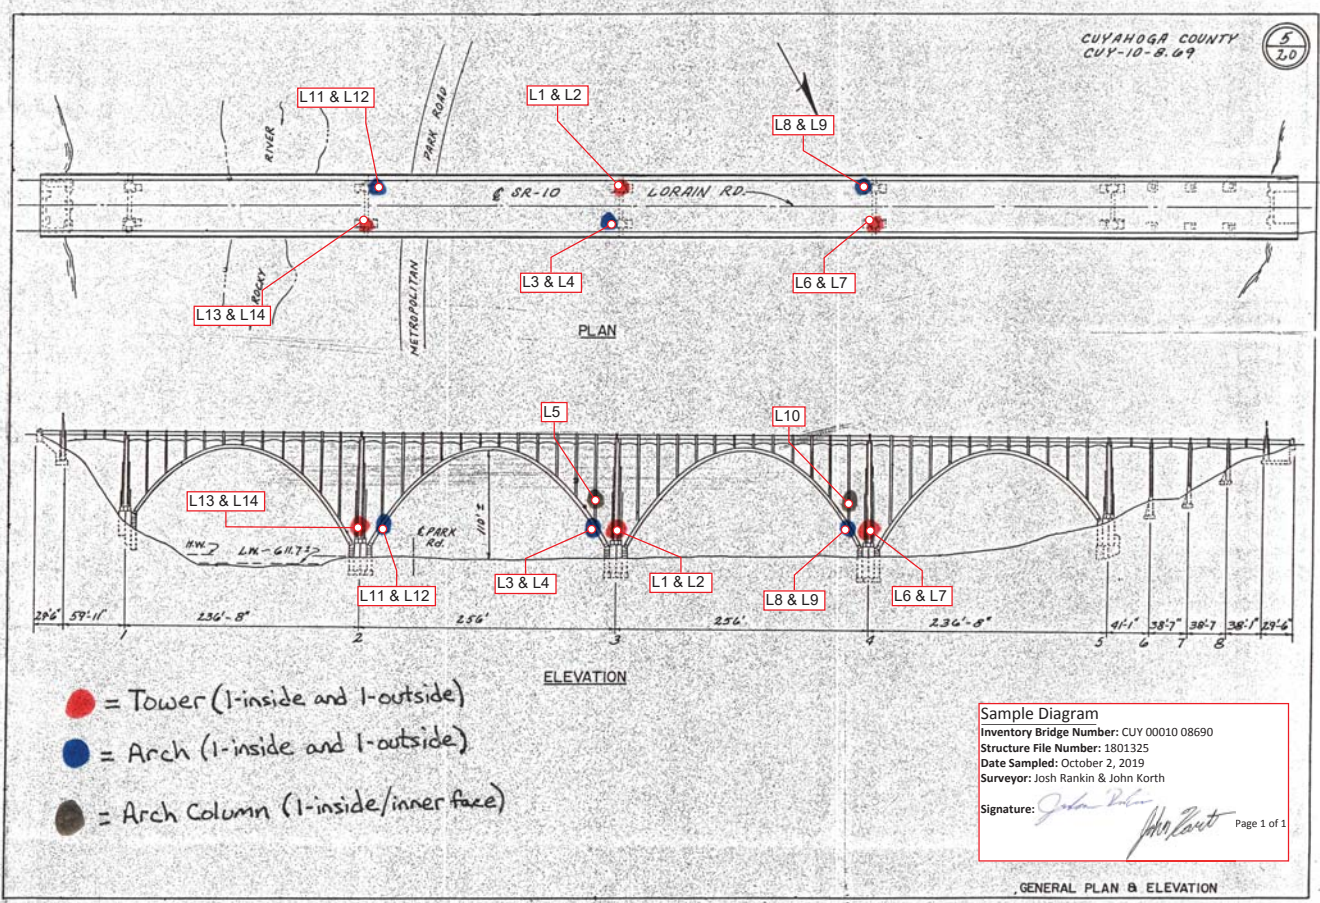
**APPENDIX A  
BULK SAMPLE DIAGRAM**

The survey consisted of the collection of fourteen samples of existing paint on the Lorain Road Bridge. Eight of the sample locations were located on the inside of the towers and arches. The other 6 sampling locations were on the exterior of the towers and arches. A diagram of the bridge, lead based paint sampling locations can be found in **Appendix A**.

Sample #	Sample Description and Location	Lead %
L-1	South Side Central, Tower - Outside	0.035
L-2	South Side Central, Tower - Inside	0.063
<b>L-3</b>	<b>North Side Central, Arch - Outside</b>	<b>0.64</b>
<b>L-4</b>	<b>North Side Central, Arch - Inside</b>	<b>35</b>
L-5	South Side Central, Arch Column	0.022
L-6	North Side, West End, Tower - Outside	<0.0086
L-7	North Side, West End, Tower - Inside	<0.0080
L-8	South Side, West End, Arch- Outside	0.043

Sample #	Sample Description and Location	Lead %
<b>L-9</b>	<b>South Side, West End, Arch - Inside</b>	<b>30</b>
L-10	North Side, West End, Arch Column	0.013
<b>L-11</b>	<b>South Side, East End, Arch - Outside</b>	<b>0.76</b>
<b>L-12</b>	<b>South Side, East End, Arch - Inside</b>	<b>34</b>
L-13	North Side, East End, Tower - Outside	0.043
L-14	North Side, East End Tower - Inside	0.025

It is the position of OSHA CFR 1926.62 Lead in Construction Standard that any lead content in paint is a potential issue to be addressed by air monitoring. It is recommended that contractors that impact components with lead base paint exceeding 0.5% lead by weight or 1.0 mg/cm<sup>2</sup>, perform personal air sampling on their employees to ensure they are not being exposed to lead above the Action Level (AL) and Permissible Exposure Limit (PEL). Five samples of the paint on the bridge were found to be LBP containing a lead concentration that exceeds 0.5% lead by weight.

It is important to note that almost all paints will contain some lead when analyzed. It is recommended that all contractors that impact painted building materials perform personal air monitoring on their employees to ensure that they are not being exposed to lead above the AL or PEL, or maintain a negative exposure assessment.
