**FINAL REPORT
SUBGRADE EXPLORATION REPORT
FRA-270-32.92
FRANKLIN COUNTY, OHIO
PID#: 113663**

NEAS PROJECT 22-0063

May 12, 2023

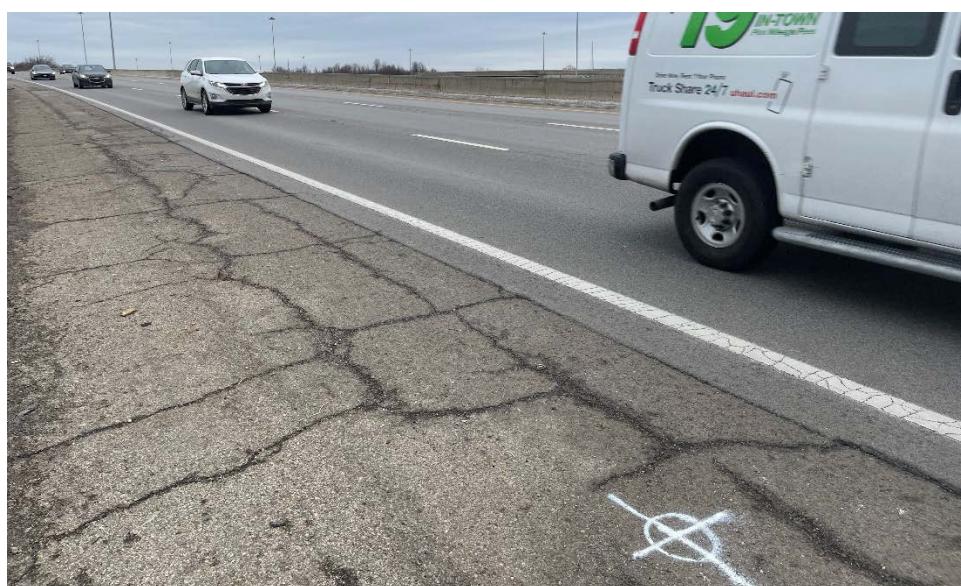
In general, the pavement condition along this section of IR-270 SB was observed to be good with some signs of surface wear. Moderate severity longitudinal cracking was observed along this section as well as crack sealing deficiencies. The shoulders in this section were in noticeably worse condition than the rest of the roadway. Moderate severity transverse and longitudinal cracking was observed along the shoulder as well as edge cracking and crack sealing deficiencies (Photograph 1). The roadway in this section starts on an embankment above the surrounding land to the north with slopes of roughly 2H:1V (2 ft Horizontal to 1 ft Vertical). The roadway then transitions to be level with the surrounding land near the SB exit ramp to Easton Way. The roadway drains to drainage ditches on the outside shoulder of the roadway as well as a culvert near where the exit ramp curves off from IR-270 (Photograph 2). Some erosion control in the form of riprap was observed near the culvert. The area was lightly vegetated for the most part with some standing water observed near the drainage ditch. The flexible pipe culvert itself appeared to be in good condition with only minor warping at the outlet (Photograph 3). The area appeared to be stable with no signs of geotechnical instability.

Photograph 1: Overall Pavement Condition of IR-270 SB Exit Ramp to Easton Way

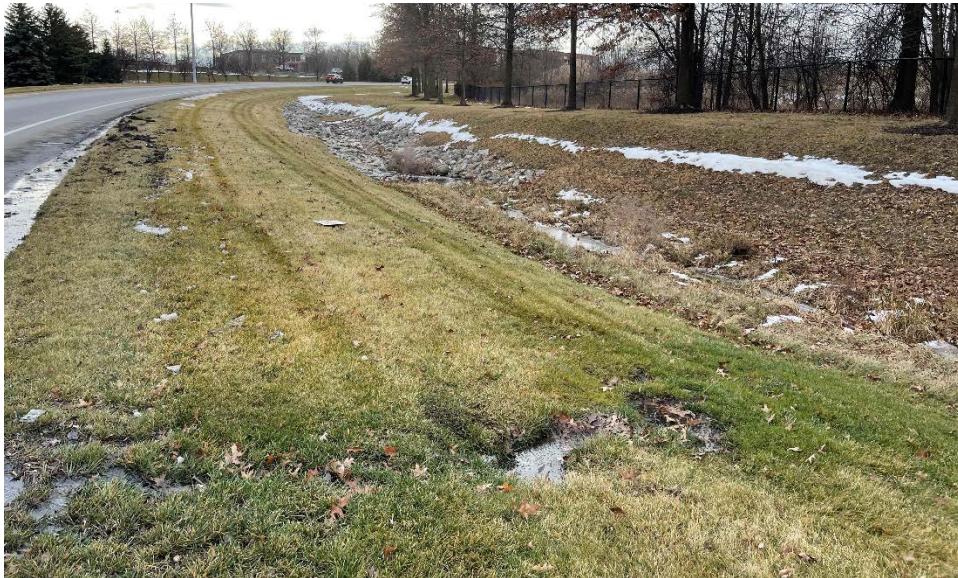
Photograph 2: Erosion Protection near Culvert and Signs of Standing Water

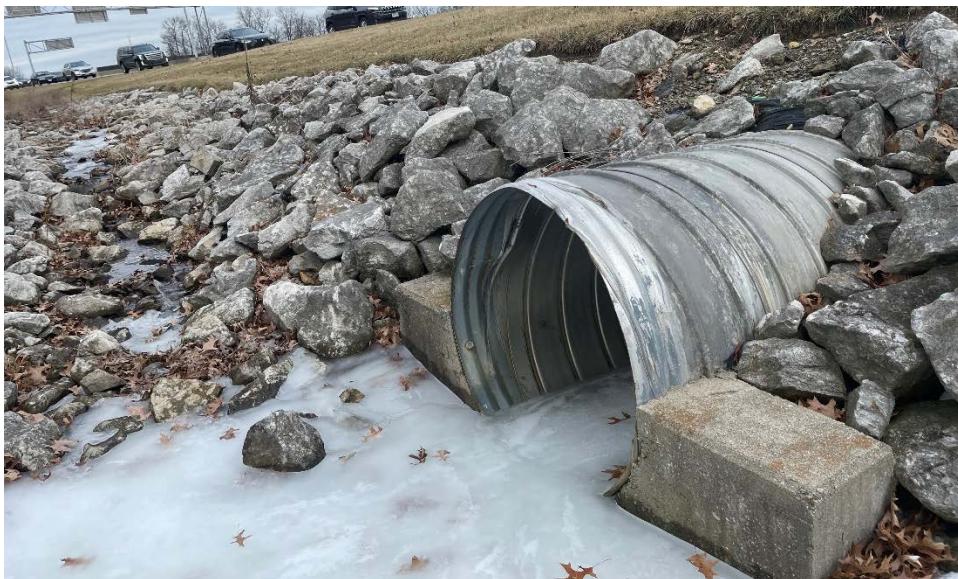
Photograph 3: Flexible Pipe Culvert

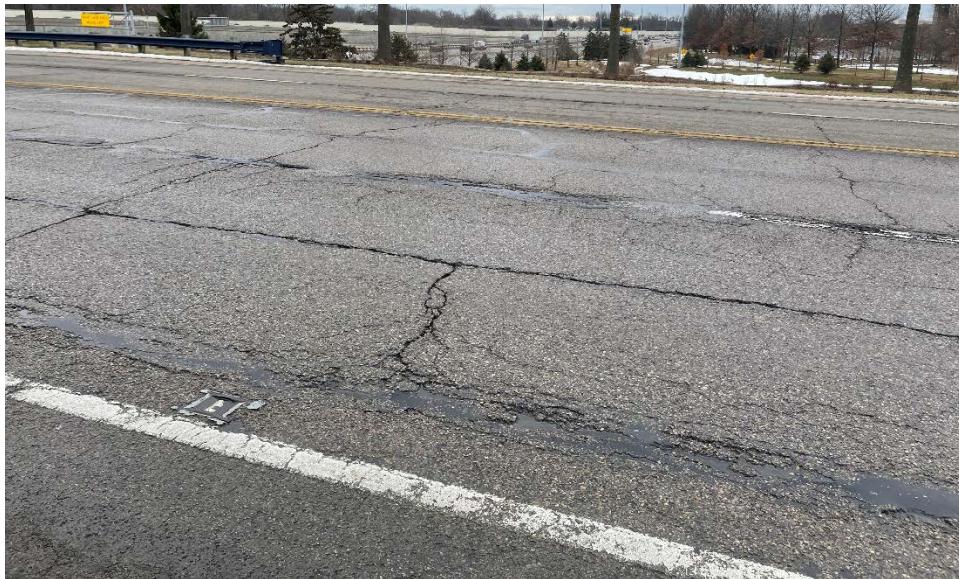
The pavement condition along the project section of Easton Way was observed to be poor with signs of surface wear. High severity longitudinal and transverse cracking was observed along this section as well as potholing, patching, map cracking and crack sealing deficiencies (Photograph 4). The roadway in this section is situated near the grade of the surrounding land starting from the west, and then transitions to an embankment above the surrounding land as it approaches IR-270. A retaining wall was observed beside Easton Way for the portion on an embankment. The retaining wall was observed to be in good condition with minor pop-outs, cracking, and efflorescence (Photograph 5). The roadway gently rises from west to east. The roadway drains to drainage ditches on the outside shoulders of the roadway. The area is lightly vegetated for the most part with standing water observed on the northern shoulder of Easton Way

Photograph 4: Overall Pavement Condition of Easton Way

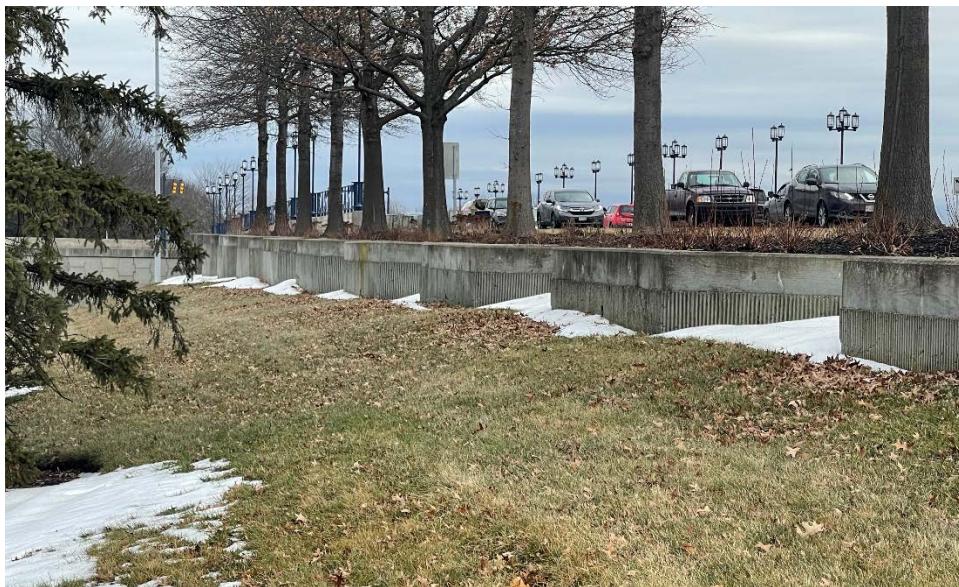
Photograph 5: Retaining Walls Near Eastern Portion of Easton Way

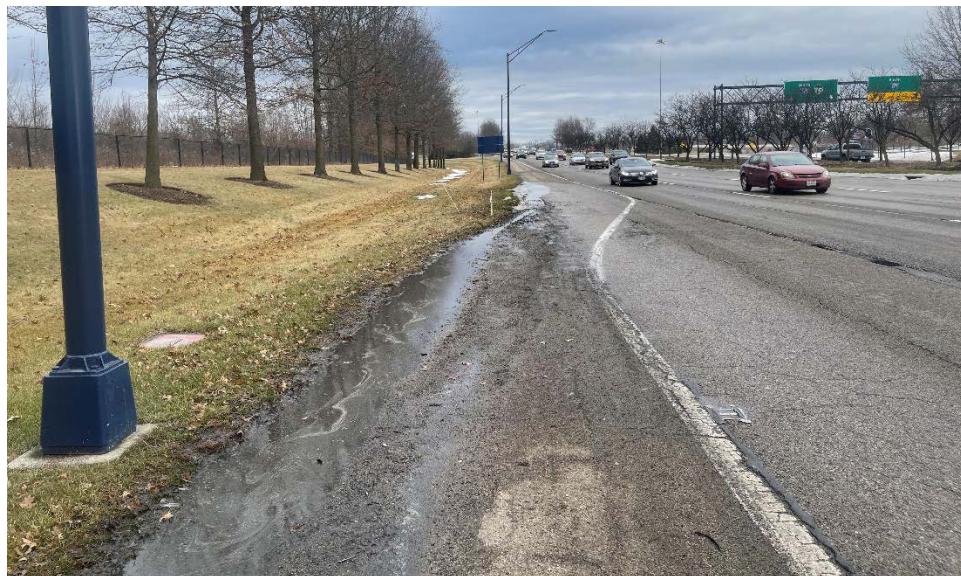
(Photograph 6). Signs of standing water such as cattails were also observed in the area encompassed by Easton Way and the IR-270 SB exit ramp to Easton Way.

Photograph 6: Standing water at Edge of Easton Way

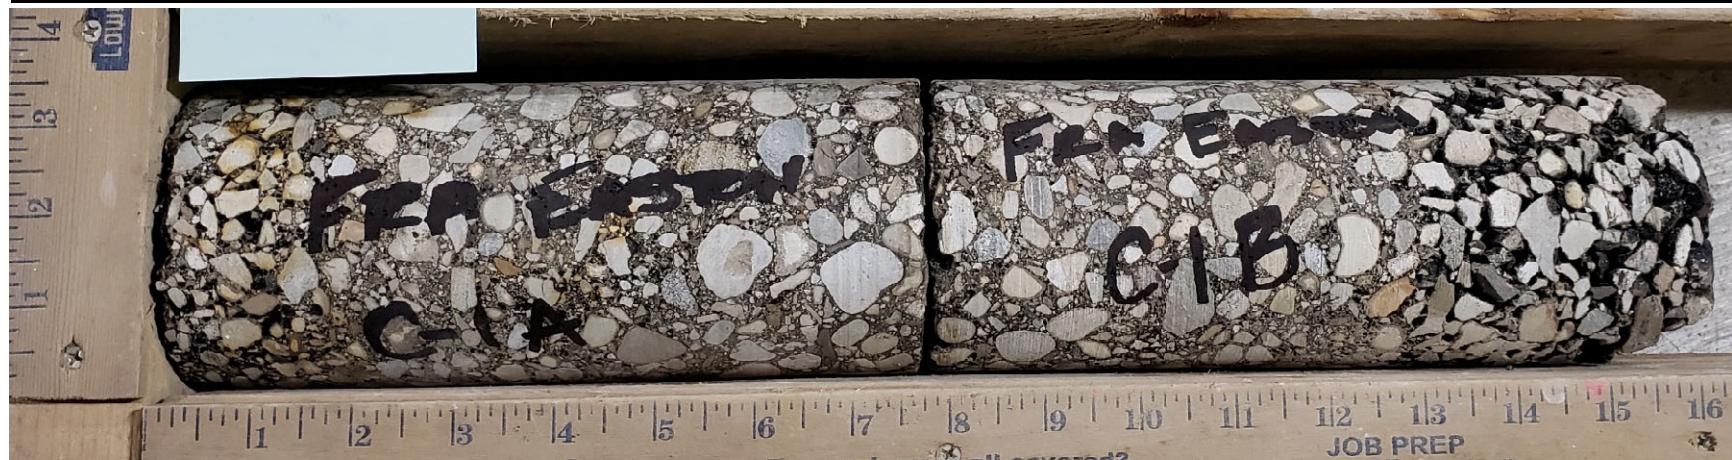
Core Photo: P.C.-1

Core Information				
Core Diameter (in):		3.75		
Core Total Length (in):		16.75		
Layers	Core Composition & Thickness (in)			Remarks/ Condition
	Asphalt	Concrete	Brick	
1	1.25			Good
2	6.25			Good
3	5.5			Good
4	3.75			Good
Rebar Encountered	N/A

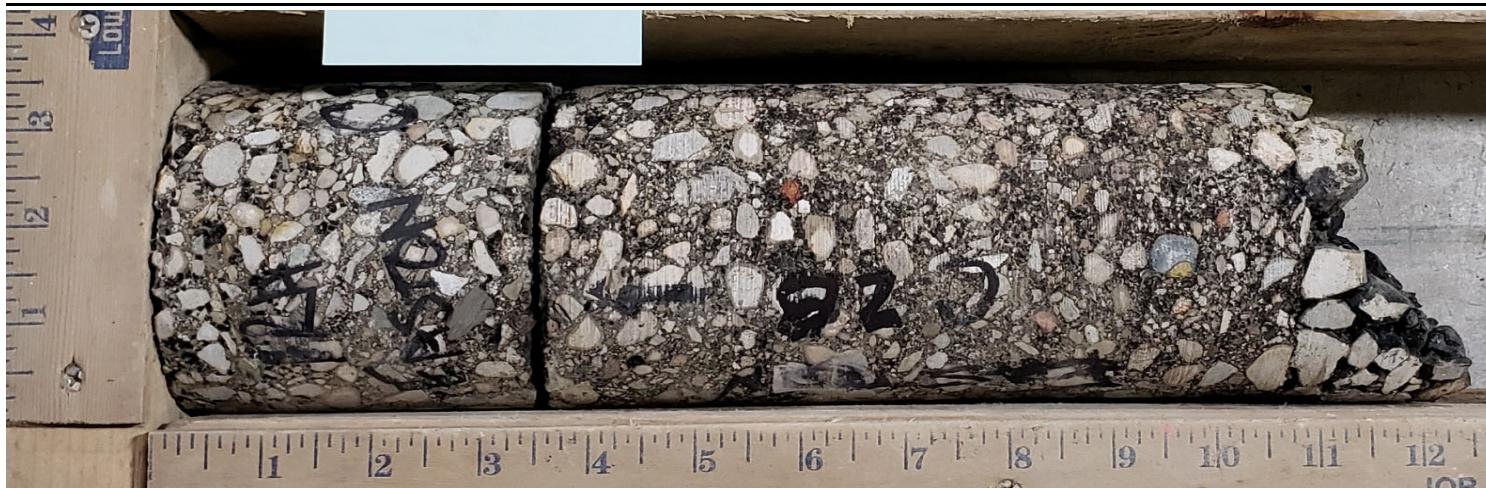
Core Photo: P.C.-2

Core Information				
Core Diameter (in):		3.75		
Core Total Length (in):		13		
Layers	Core Composition & Thickness (in)			Remarks/ Condition
	Asphalt	Concrete	Brick	
1	1.25			Good
2	2.25			Good
3	7.5			Good
4	2			Good
Rebar Encountered	N/A
