**DATA REPORT  
FRA-270-3060 FIRE DAMAGE  
PID 124598  
FRANKLIN COUNTY, OHIO**

NEAS presents our MSE wall panel core report for the FRA-270-3060 project in Franklin County, Ohio. The intent of this project is to collect information regarding the extent of fire damage to MSE wall 12 at the intersection of I270 and SR161.

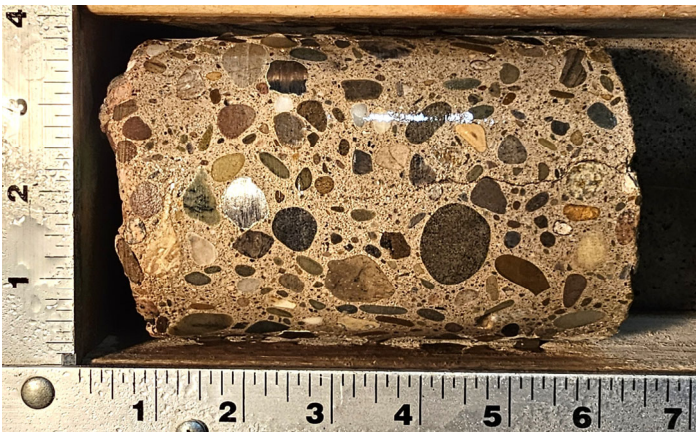
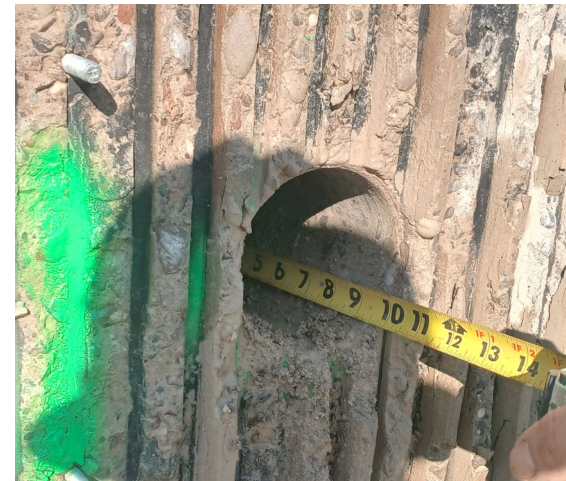
## Core Photo: X-001-0-25

| Sample ID | Diameter of Core (in) | Length of Core (in) | Rebar Encountered | Known Defects in Core |
|---|---|---|---|---|
| X-001-0-25 | 4.00 | 6.25 | #4 rebar @ 2.0" and 2.5" depths | 3.0" fracture along axis, propagating from interior. Moderately friable surface (exterior 1.0"-1.5") |

| Core Identification | X-001-0-25 | X-002-0-25 | X-003-0-25 | X-004-0-25 |
|---|---|---|---|---|
| Any Defects in core: | V. Fracture | None | None | None |

| Core Information | | | | |
|---|---|---|---|---|
| 1 | | 6.25 | | Fractured |
| Rebar<br>Encountered | #4 rebar @ 2.0" and 2.5" depth | | | |

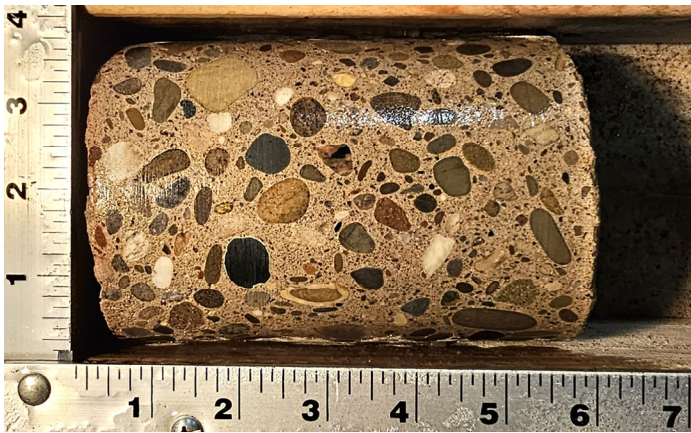
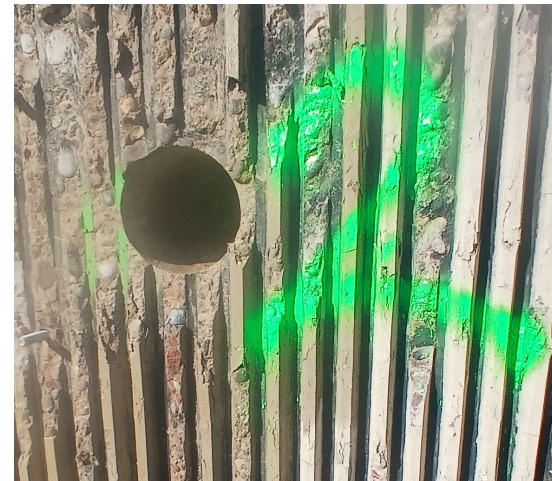
## Core Photo: X-002-0-25

| Sample ID | Diameter of Core (in) | Length of Core (in) | Rebar Encountered | Known Defects in Core |
|---|---|---|---|---|
| X-002-0-25 | 4.00 | 6.00 | #4 rebar @ 2.0" depth | Moderately friable surface (exterior 1.0"-1.5") |

| Core Information | | | | |
|---|---|---|---|---|
| 1 | | 6 | | Good |
| Rebar<br>Encountered | #4 rebar @ 2.0" depth | | | |

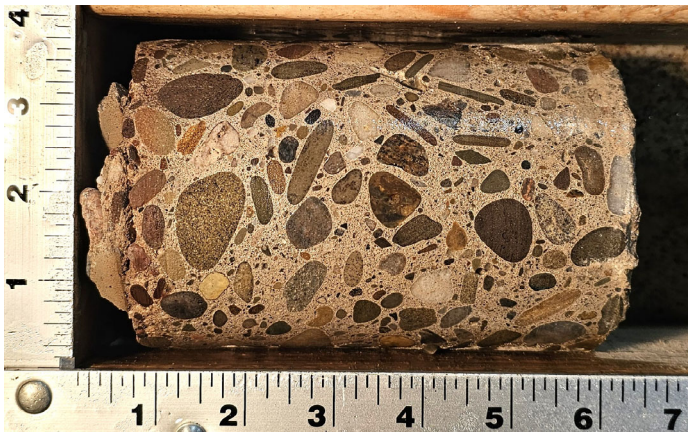
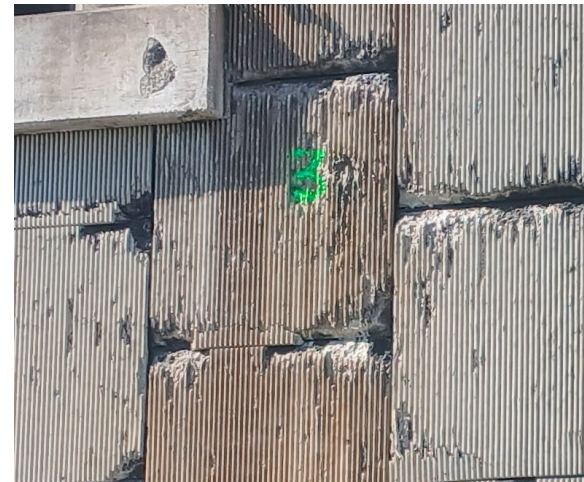
### Core Photo: X-003-0-25

| Sample ID | Diameter of Core (in) | Length of Core (in) | Rebar Encountered | Known Defects in Core |
|---|---|---|---|---|
| X-003-0-25 | 4.00 | 6.25 | Not Encountered | Moderately friable surface (exterior 1.0"-1.5") |

| Core Information | | | | |
|---|---|---|---|---|
| 1 | | 6.25 | | Good |
| Rebar<br>Encountered | N/E | | | |

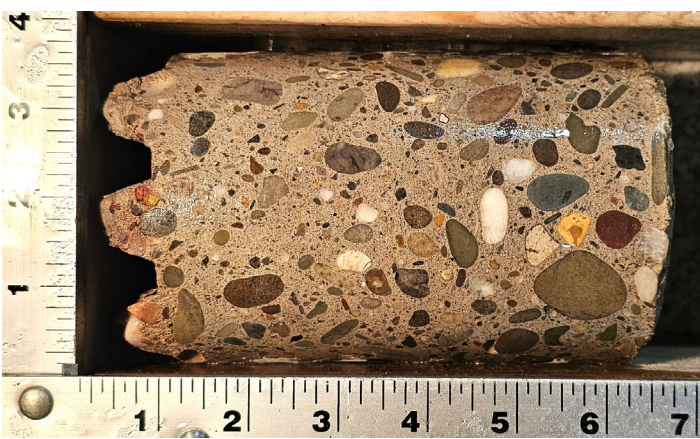
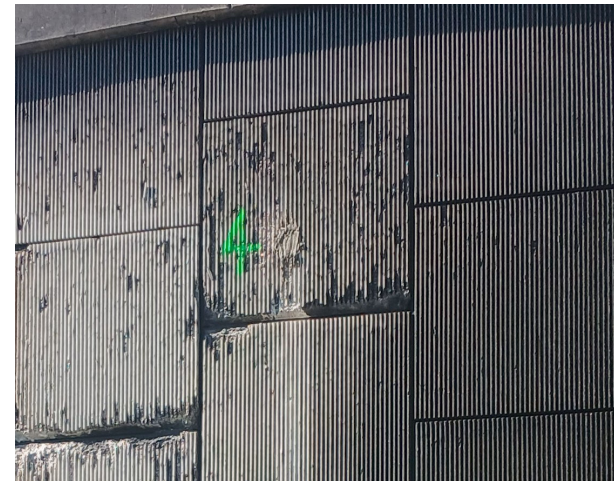
## Core Photo: X-004-0-25

| Sample ID | Diameter of Core (in) | Length of Core (in) | Rebar Encountered | Known Defects in Core |
|---|---|---|---|---|
| X-004-0-25 | 4.00 | 6.50 | Not Encountered | Slightly friable surface (1.0") |

| Core Information | | | | |
|---|---|---|---|---|
| 1 | | 6.5 | | Good |
| Rebar<br>Encountered | N/E | | | |
