PAVEMENT DATA REPORT

GEA-006-3.51 (PID 110950)
SR-6 and SR-44, CHARDON, OHIO

SME Project Number: 092062.16
APRIL 12, 2024

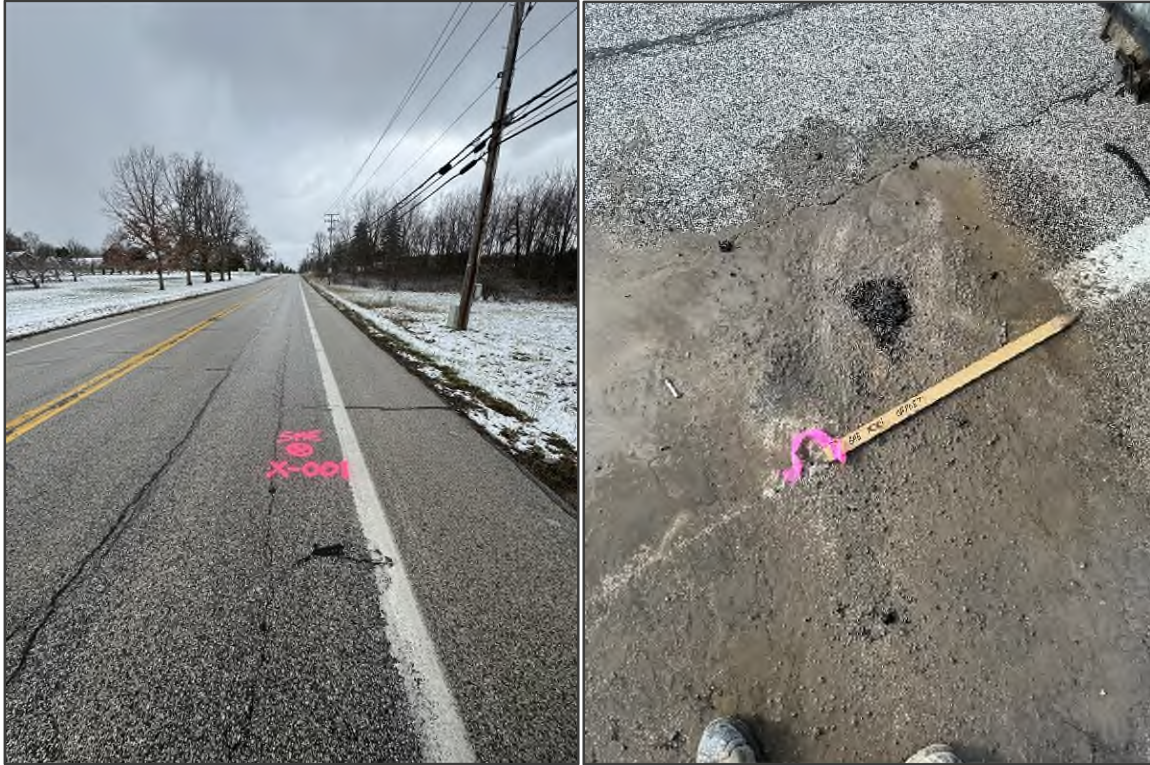
FIGURE NOS. 1 & 2: Before and after photographs of X-001-0-24.

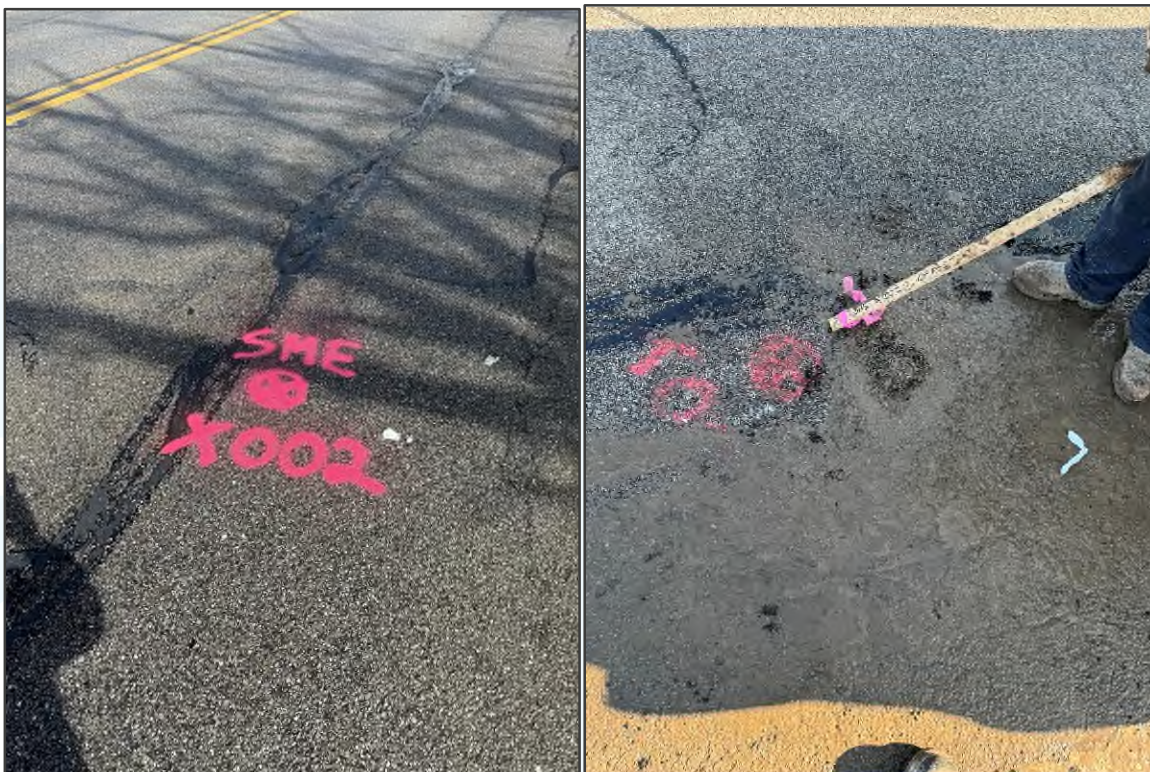
FIGURE NOS. 3 & 4: Before and after photographs of X-002-0-24.

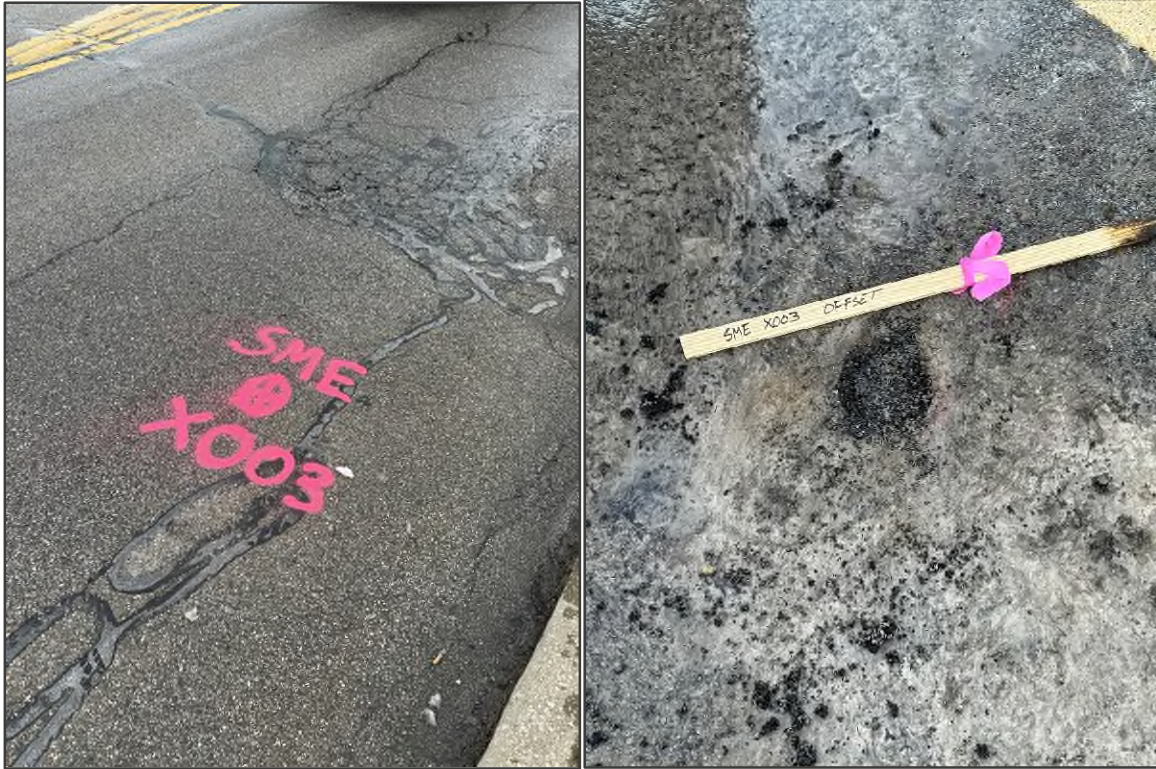
FIGURE NOS. 5 & 6: Before and after photographs of X-003-0-24.

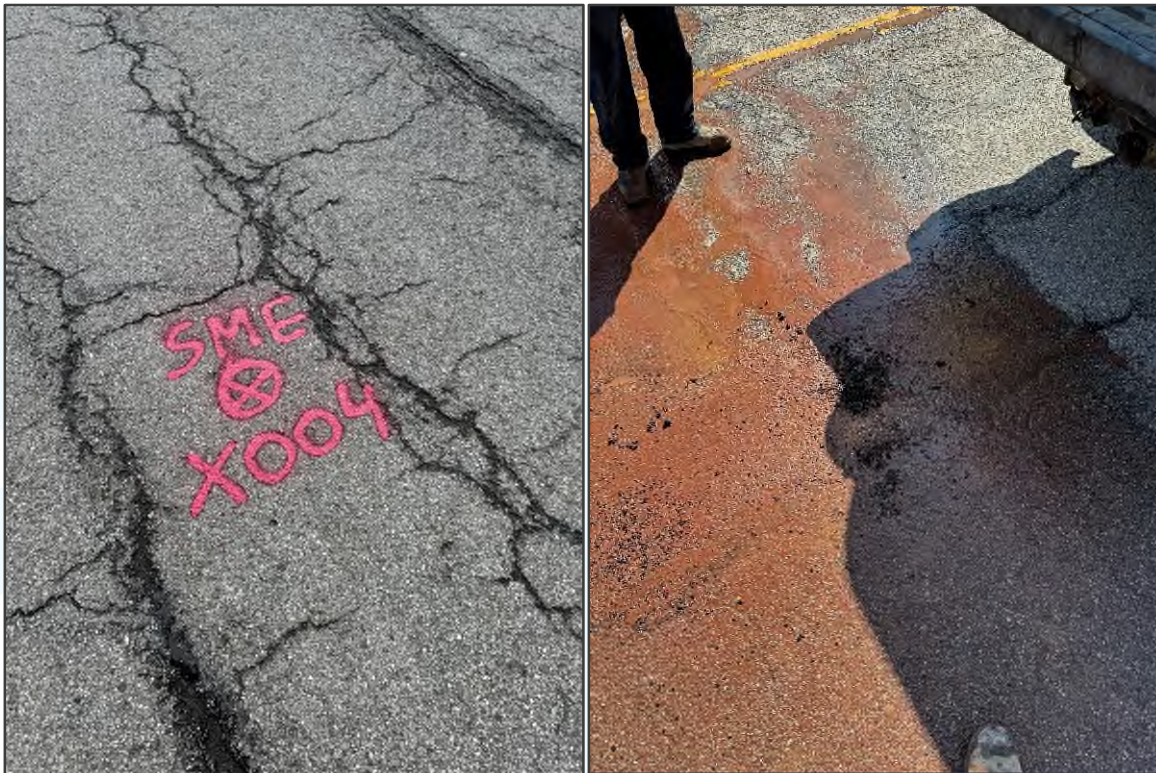
FIGURE NOS. 7 & 8: Before and after photographs of X-004-0-24.

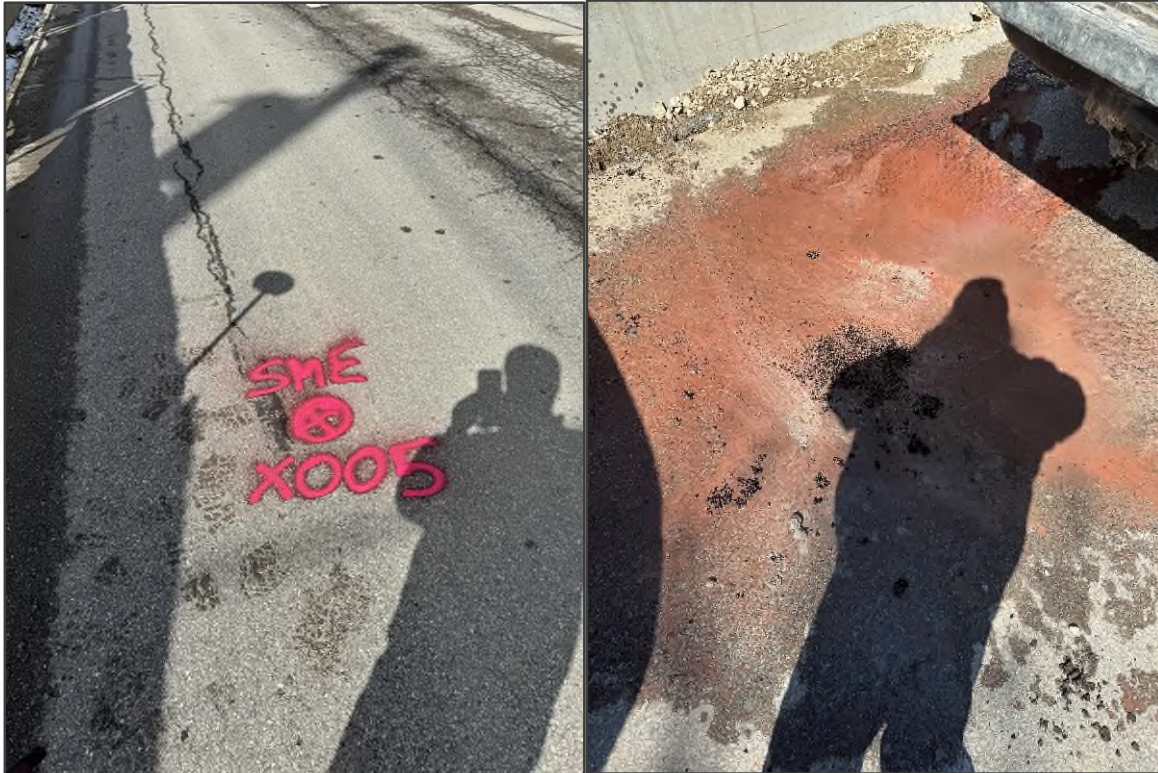
FIGURE NOS. 9 & 10: Before and after photographs of X-005-0-24.

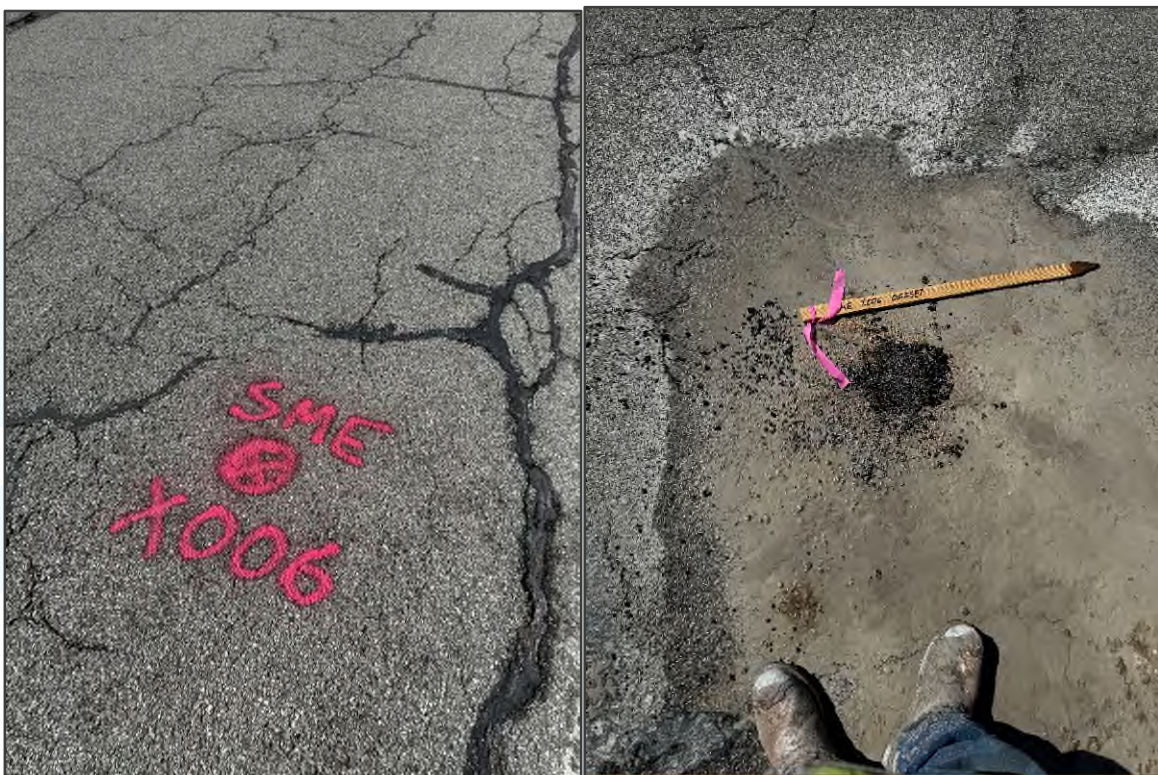
FIGURE NOS. 11 & 12: Before and after photographs of X-006-0-24.

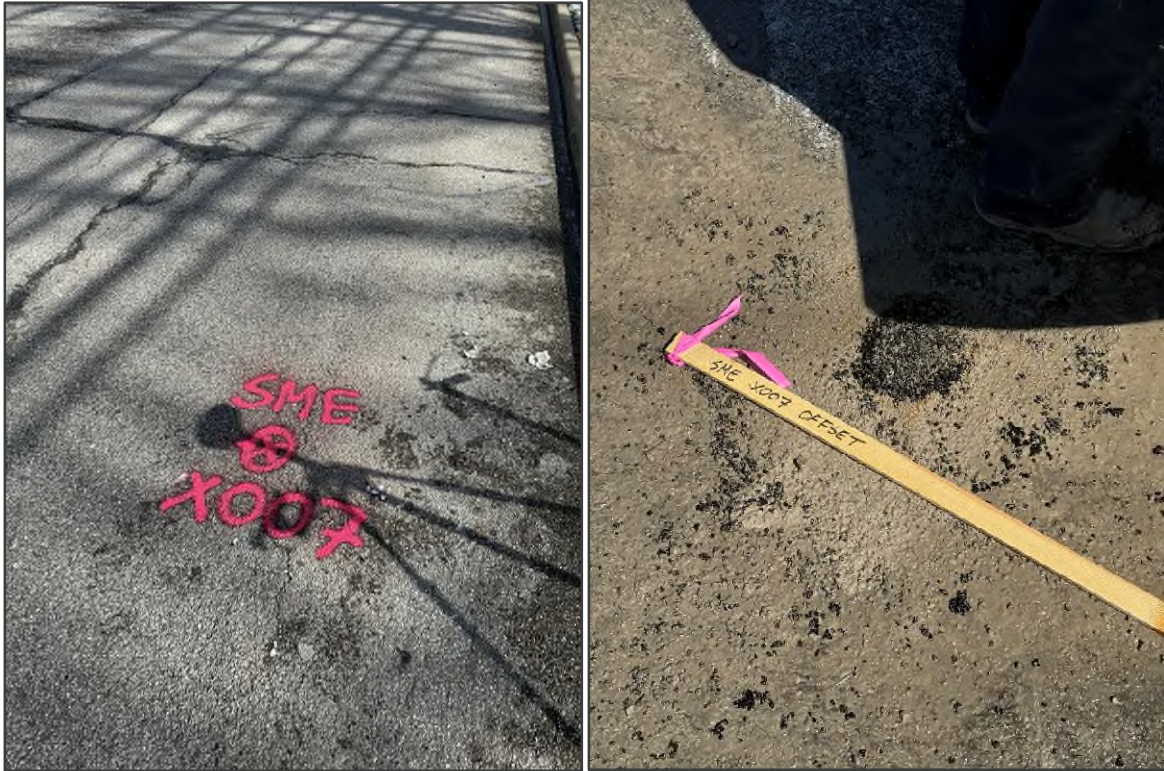
FIGURE NOS. 13 & 14: Before and after photographs of X-007-0-24.

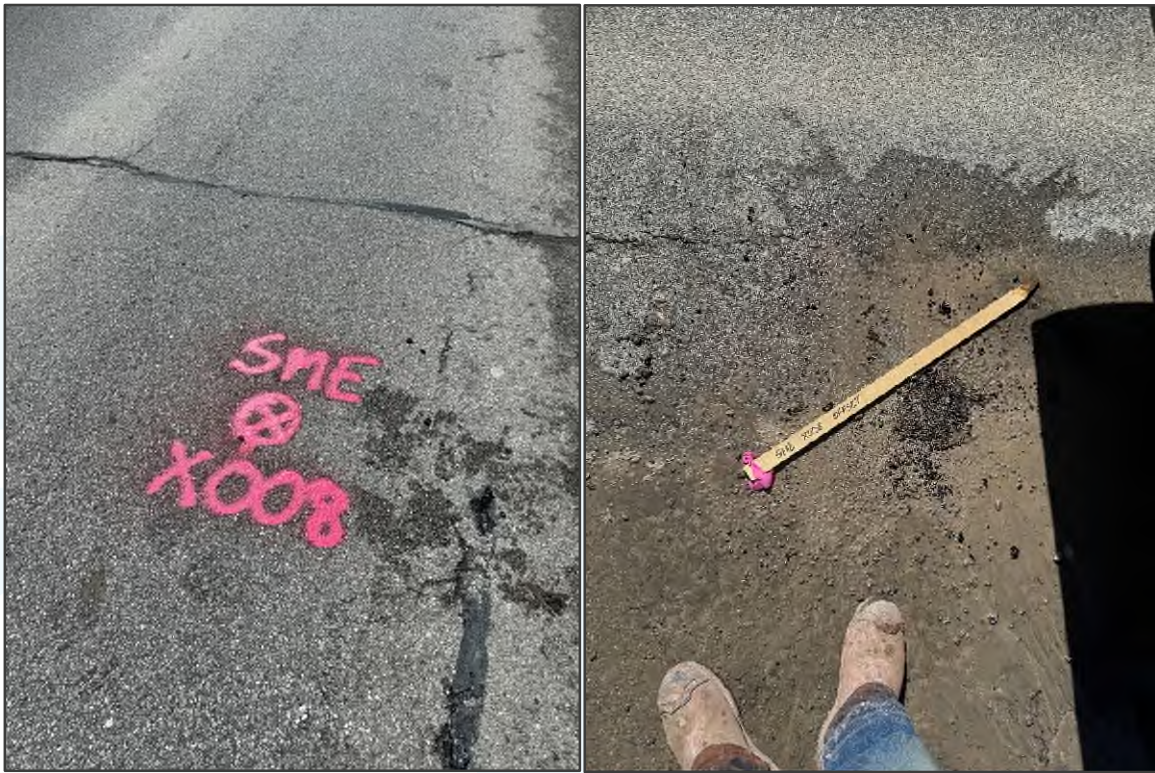
FIGURE NOS. 15 & 16: Before and after photographs of X-008-0-24.

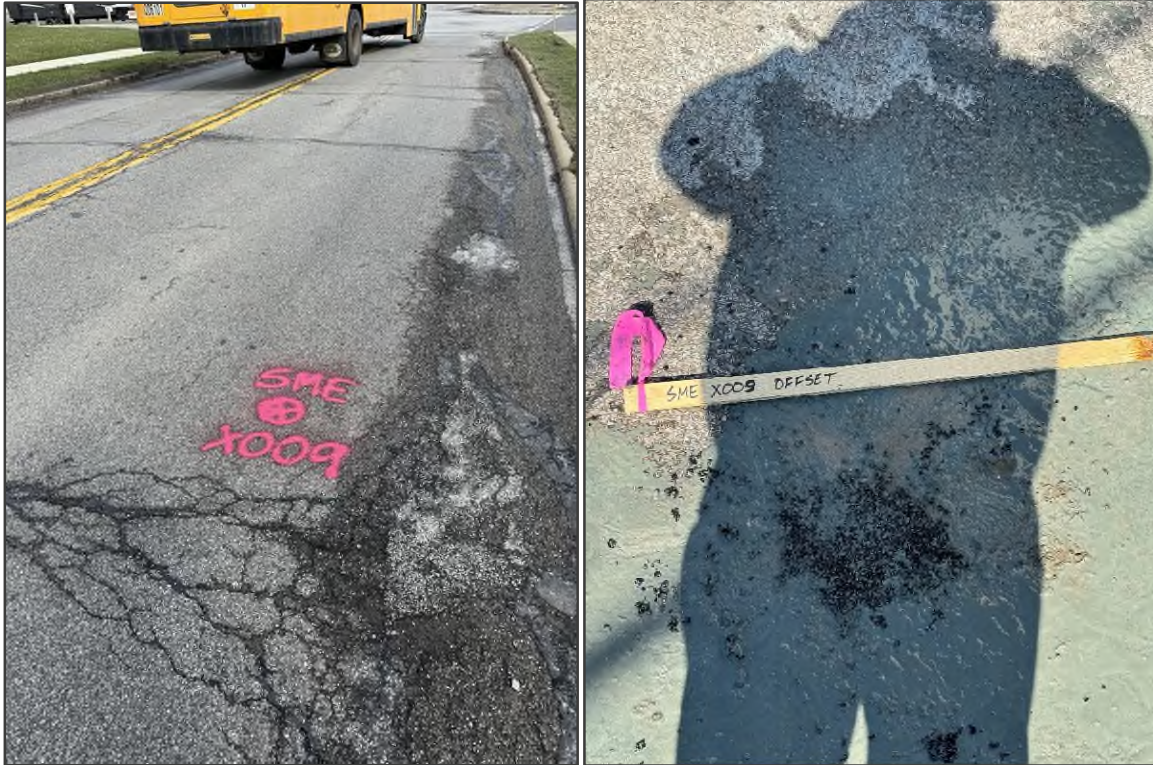
FIGURE NOS. 17 & 18: Before and after photographs of X-009-0-24.

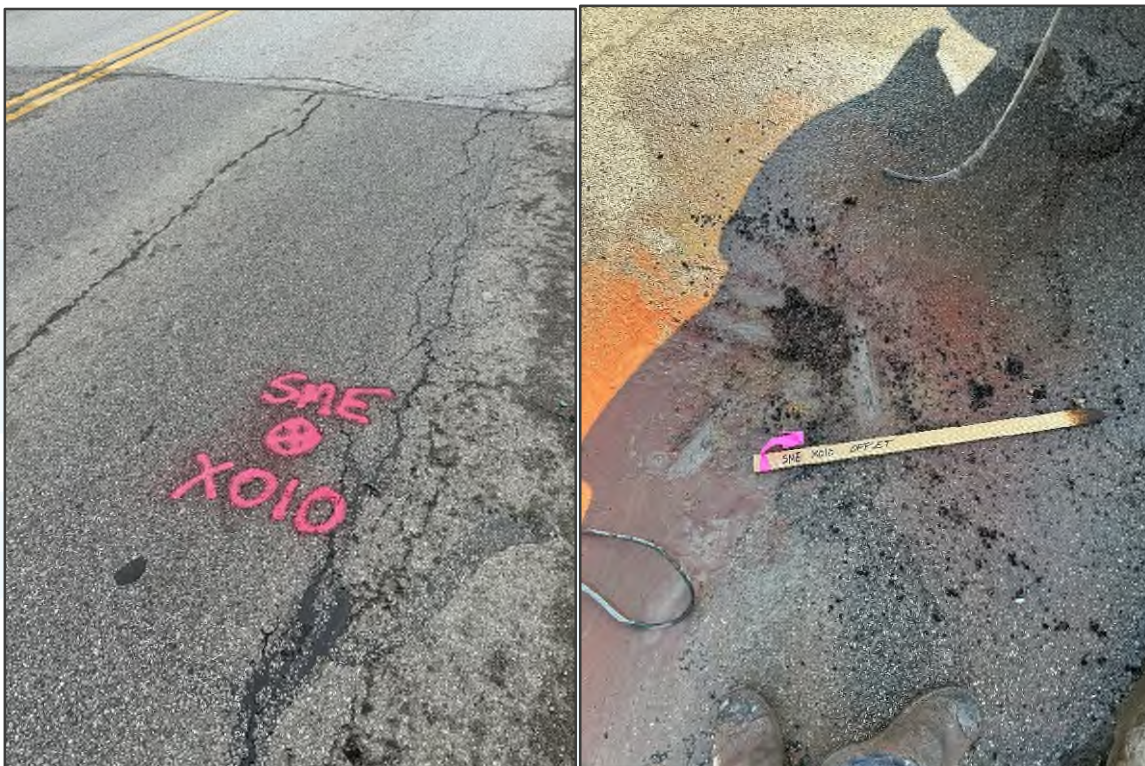
FIGURE NOS. 19 & 20: Before and after photographs of X-010-0-24.

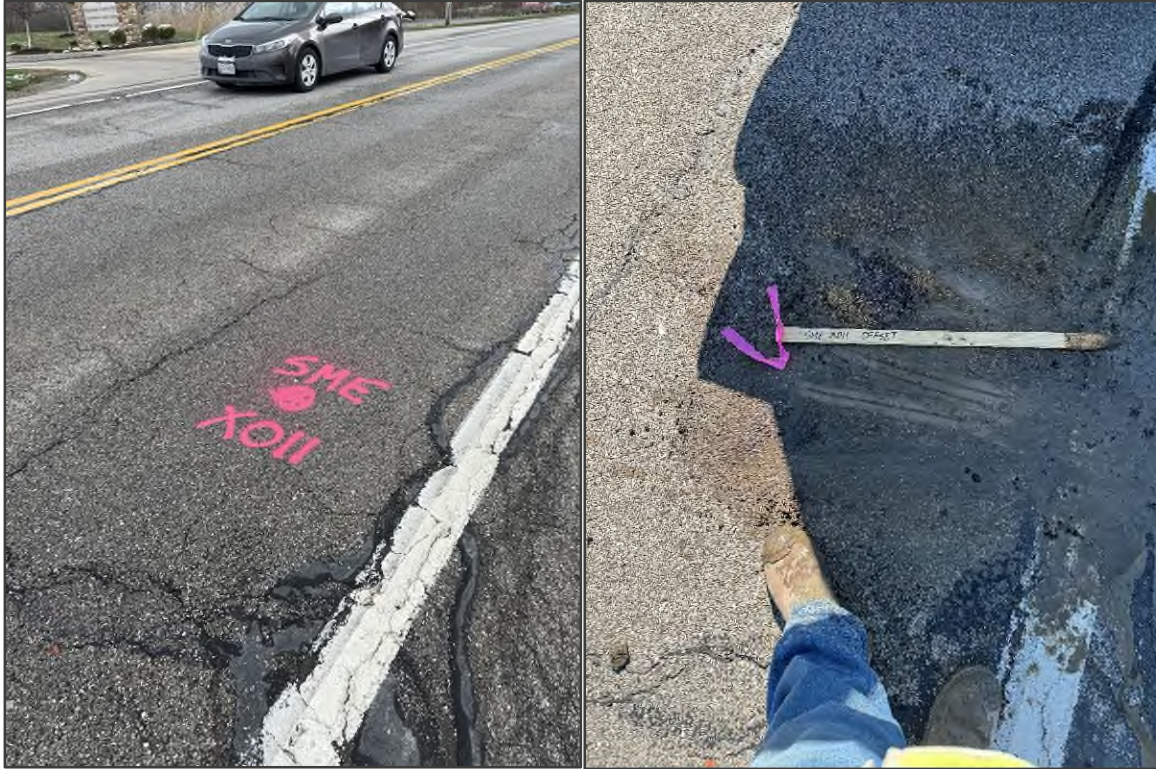
FIGURE NOS. 21 & 22: Before and after photographs of X-011-0-24.

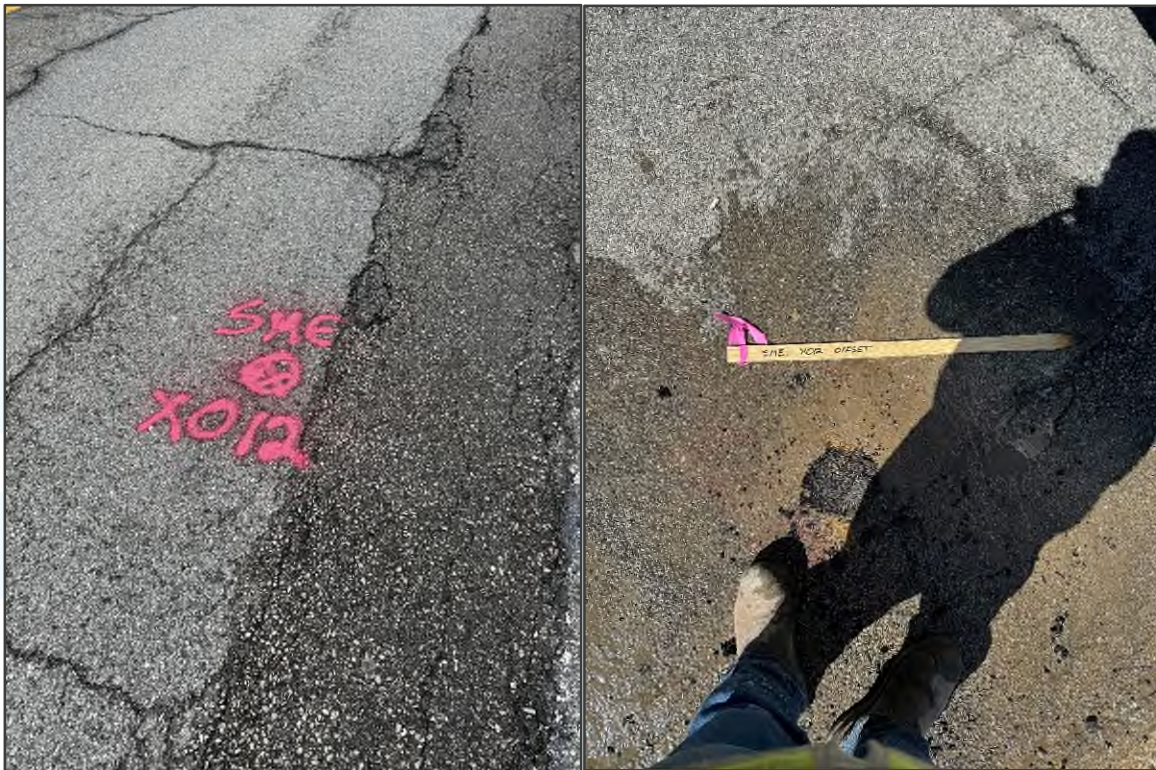
FIGURE NOS. 23 & 24: Before and after photographs of X-012-0-24.

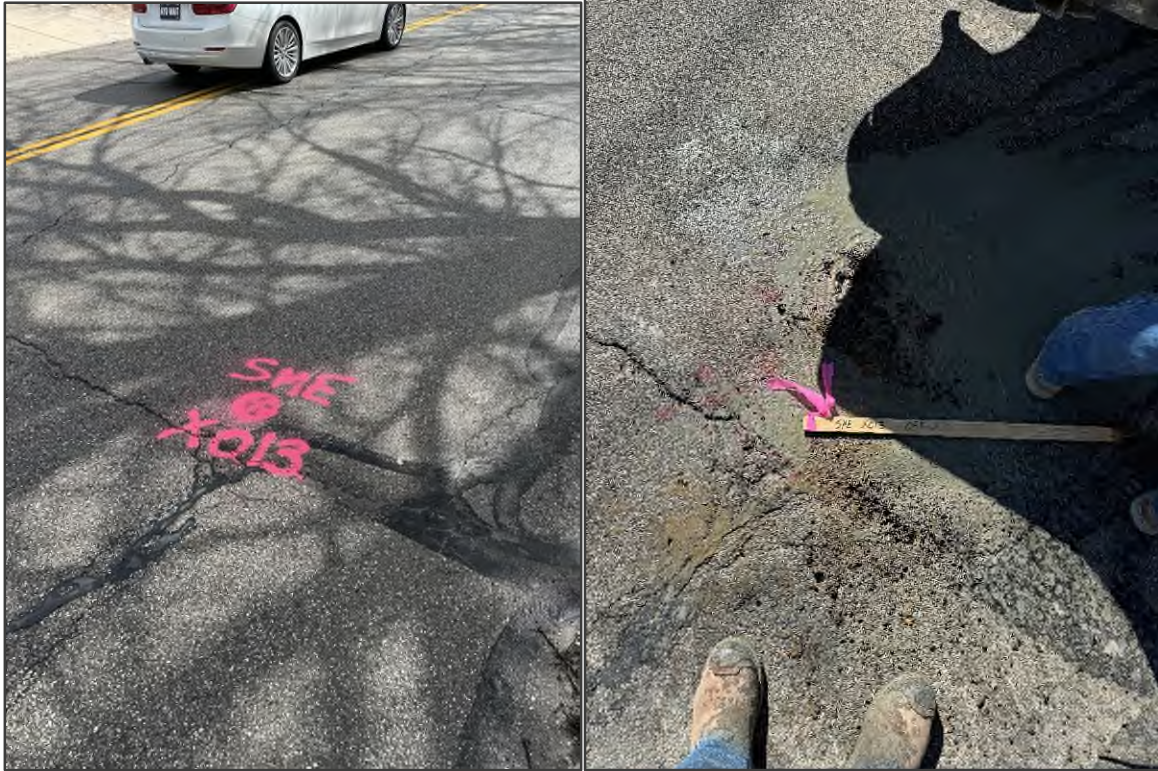
FIGURE NOS. 25 & 26: Before and after photographs of X-013-0-24.

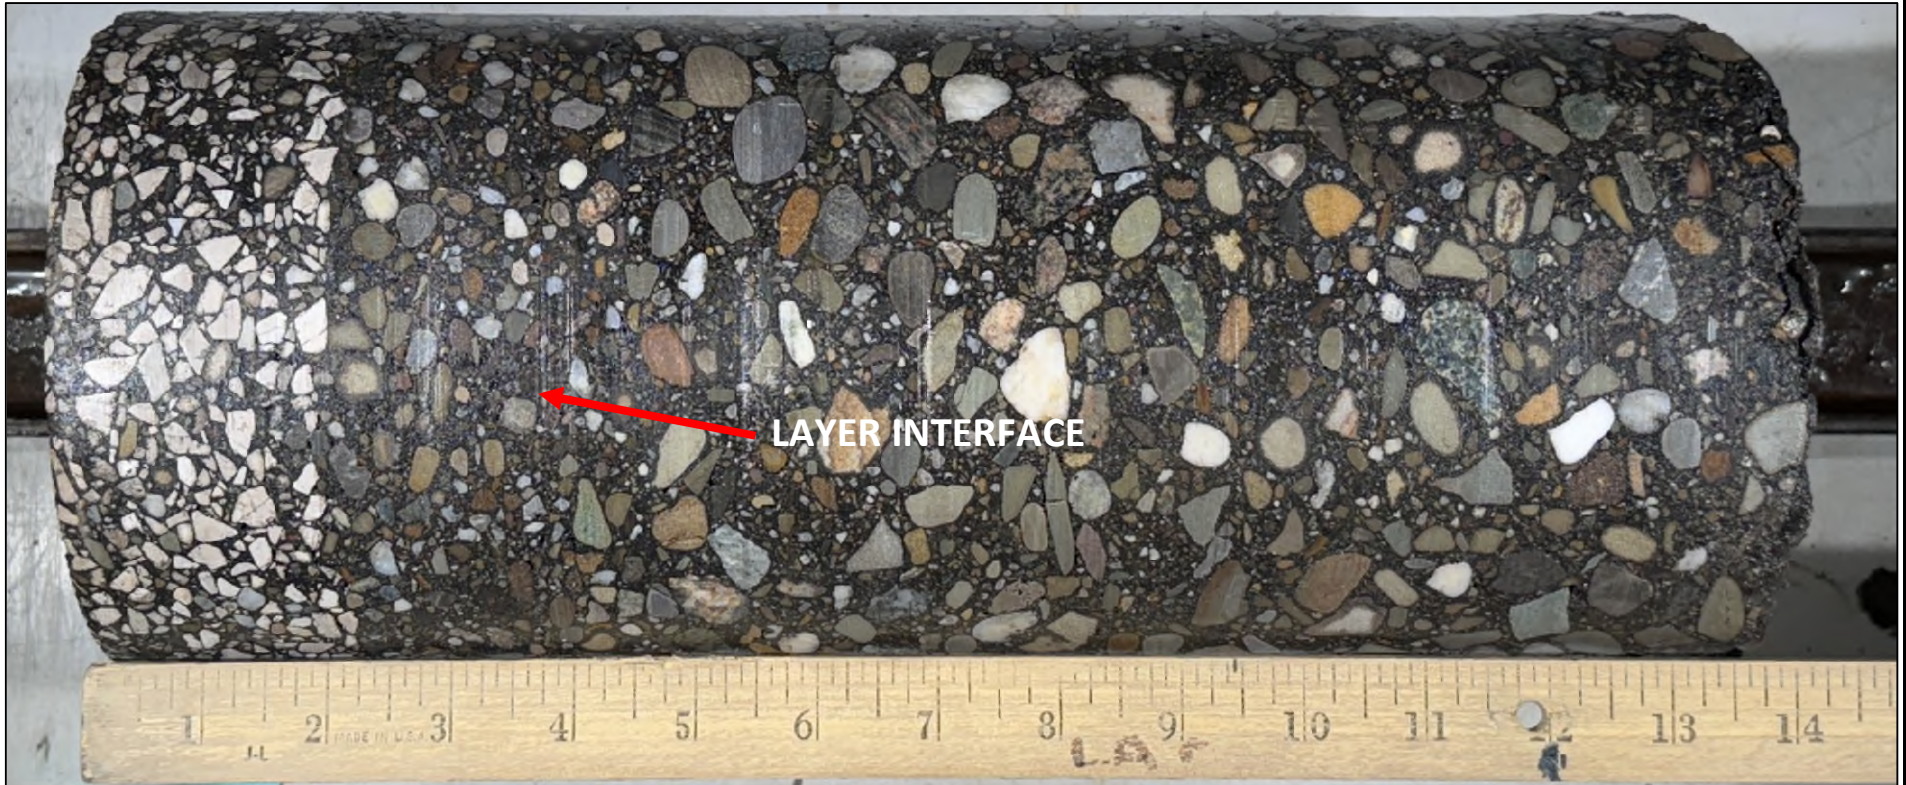
X-001-0-24

Layer Thickness, in.	Description	Comments
2.25	ASPHALT: Surface Course	- 13.75 inches of pavement total - Asphalt sections observed to be intact
1.75	ASPHALT: Surface Course	
9.75	ASPHALT: Intermediate Course	
11.5	AGGREGATE BASE: Recycled Concrete, Limestone, and Slag

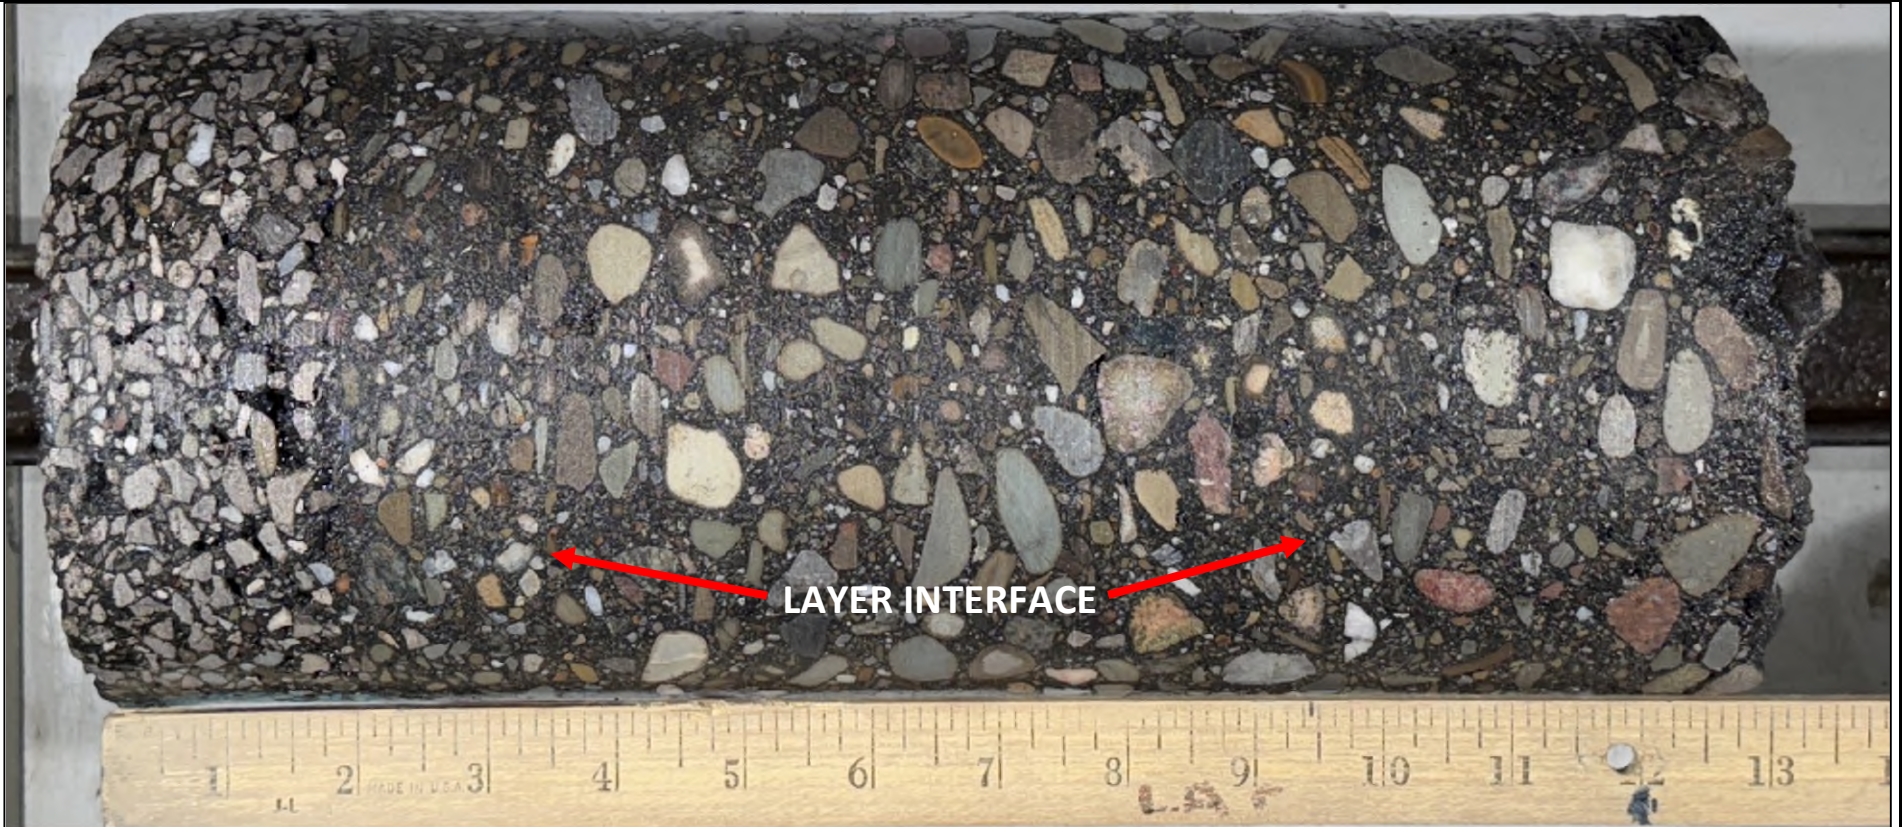
X-002-0-24

Layer Thickness, in.	Description	Comments
2	ASPHALT: Surface Course	- 13 inches of pavement total - Asphalt sections observed to be intact
1.5	ASPHALT: Intermediate Course	
6	ASPHALT: Intermediate Course	
3.5	ASPHALT: Intermediate Course	
8.5	AGGREGATE BASE: Recycled Slag and Limestone

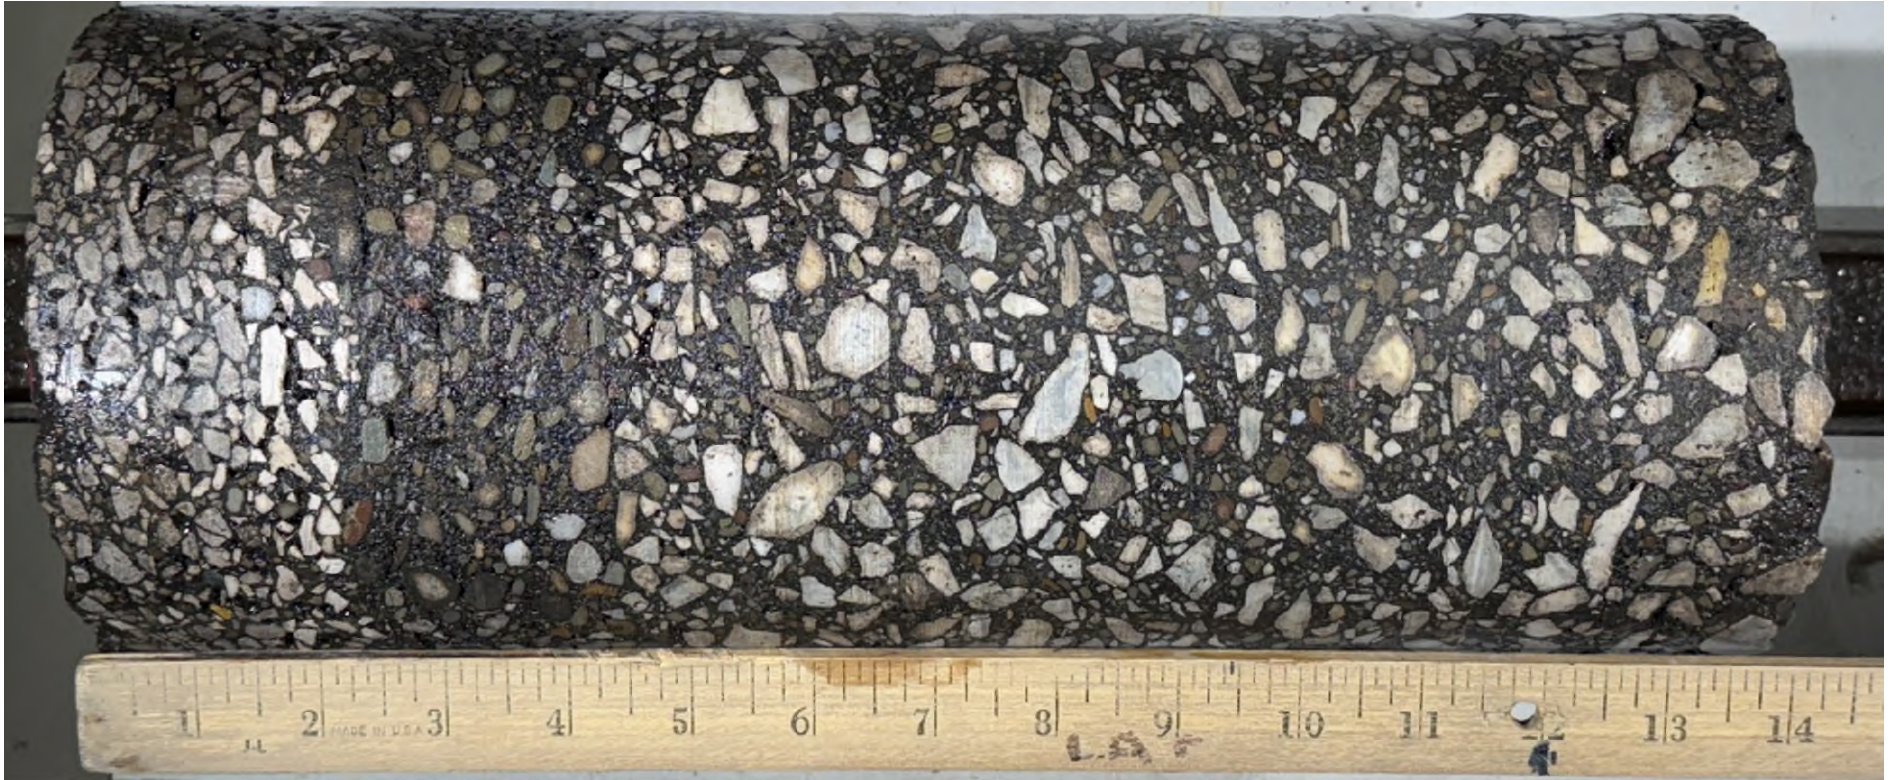
X-003-0-24

Layer Thickness, in.	Description	Comments
2.5	ASPHALT: Surface Course	- 14 inches of pavement total - Asphalt sections observed to be intact
2	ASPHALT: Surface Course	
9.5	ASPHALT: Intermediate Course	
--	NO AGGREGATE BASE ENCOUNTERED

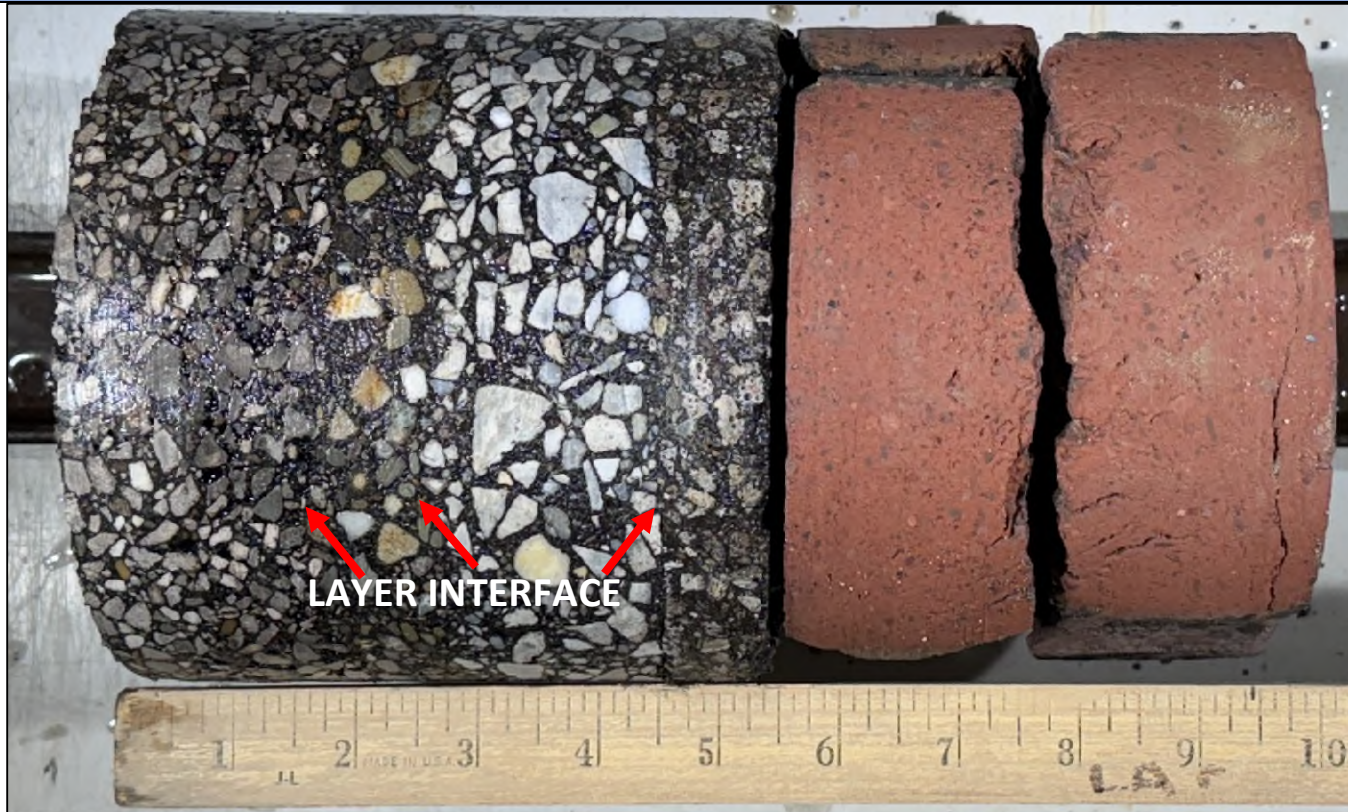
X-004-0-24

Layer Thickness, in.	Description	Comments
2.5	ASPHALT: Surface Course	- 9.75 inches of pavement total - Asphalt sections observed to be intact - Delaminated from brick layer
1	ASPHALT: Surface Course	
1.5	ASPHALT: Intermediate Course	
0.5	ASPHALT: Surface Course	
4.25	RED BRICK	- Transverse break through center - Brick separated from mortar
--	NO AGGREGATE BASE ENCOUNTERED

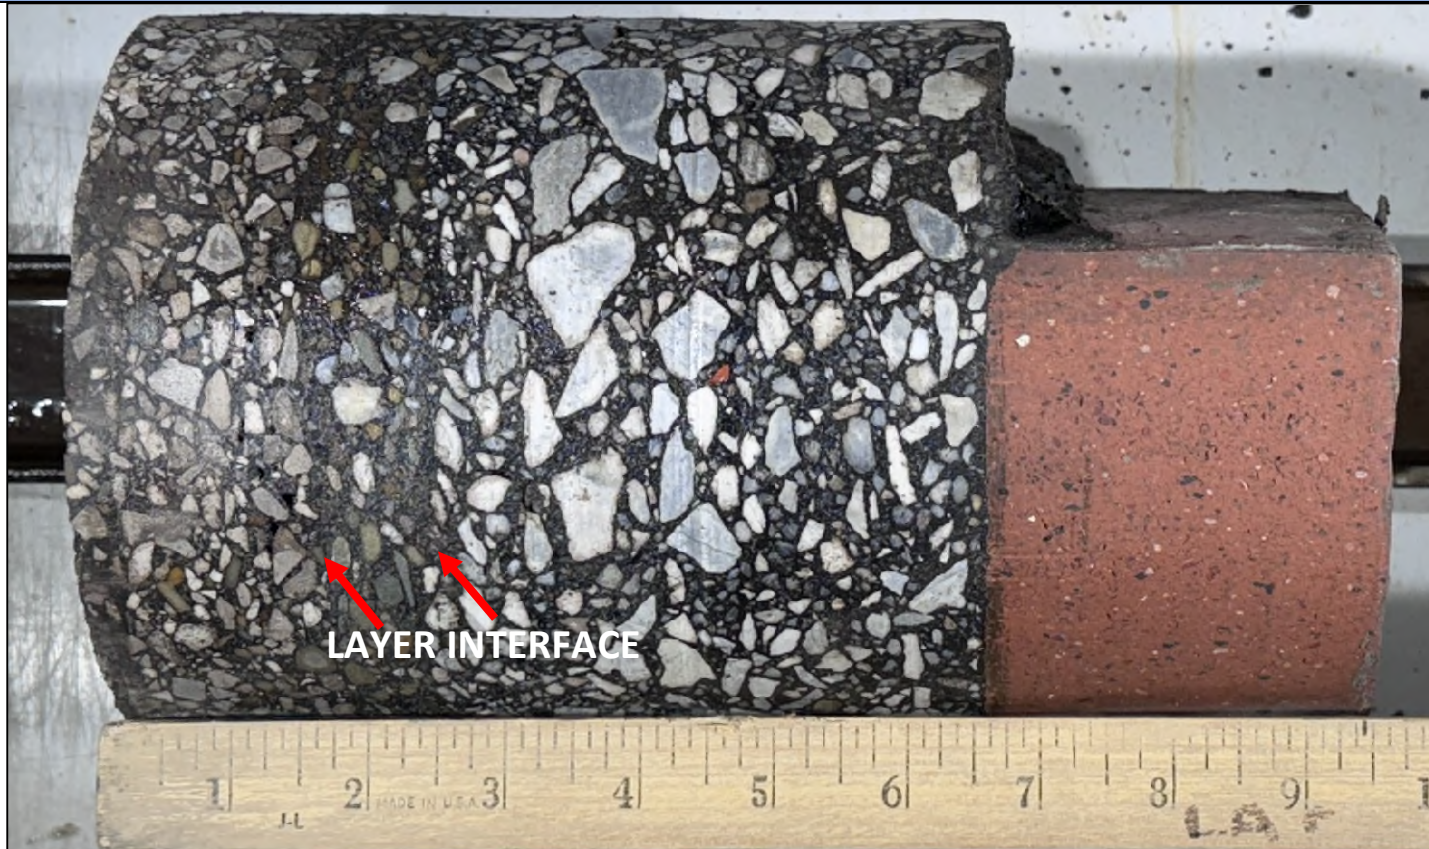
X-005-0-24

Layer Thickness, in.	Description	Comments
2	ASPHALT: Surface Course	- 9.5 inches of pavement total - Asphalt sections observed to be intact
0.5	ASPHALT: Surface Course	
4	ASPHALT: Intermediate Course	
3	RED BRICK	- Brick separated from mortar
3.5	AGGREGATE BASE: Solidified Slag

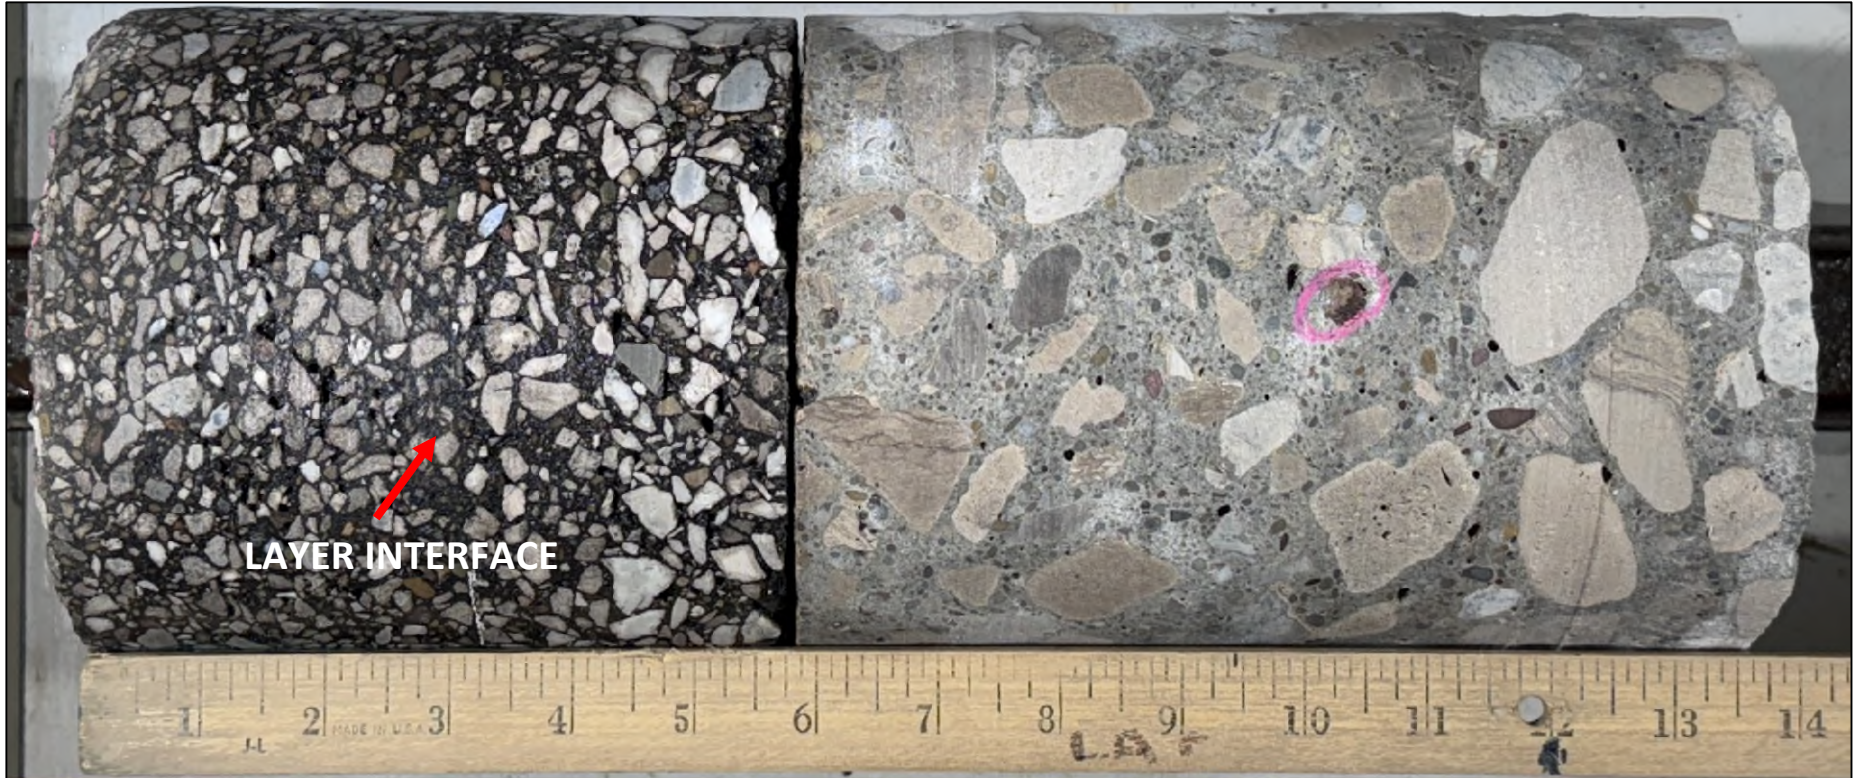
X-006-0-24

Layer Thickness, in.	Description	Comments
3.5	ASPHALT: Surface Course	- 13.75 inches of pavement total - Asphalt sections observed to be intact - Delaminated from concrete layer
1	ASPHALT: Surface Course	
1.25	ASPHALT: Intermediate Course	
8	REINFORCED CONCRETE	- Concrete section observed to be intact - ≈0.25-inch diameter reinforcing steel observed about 4.25 inches below top of concrete (circled)
--	NO AGGREGATE BASE ENCOUNTERED

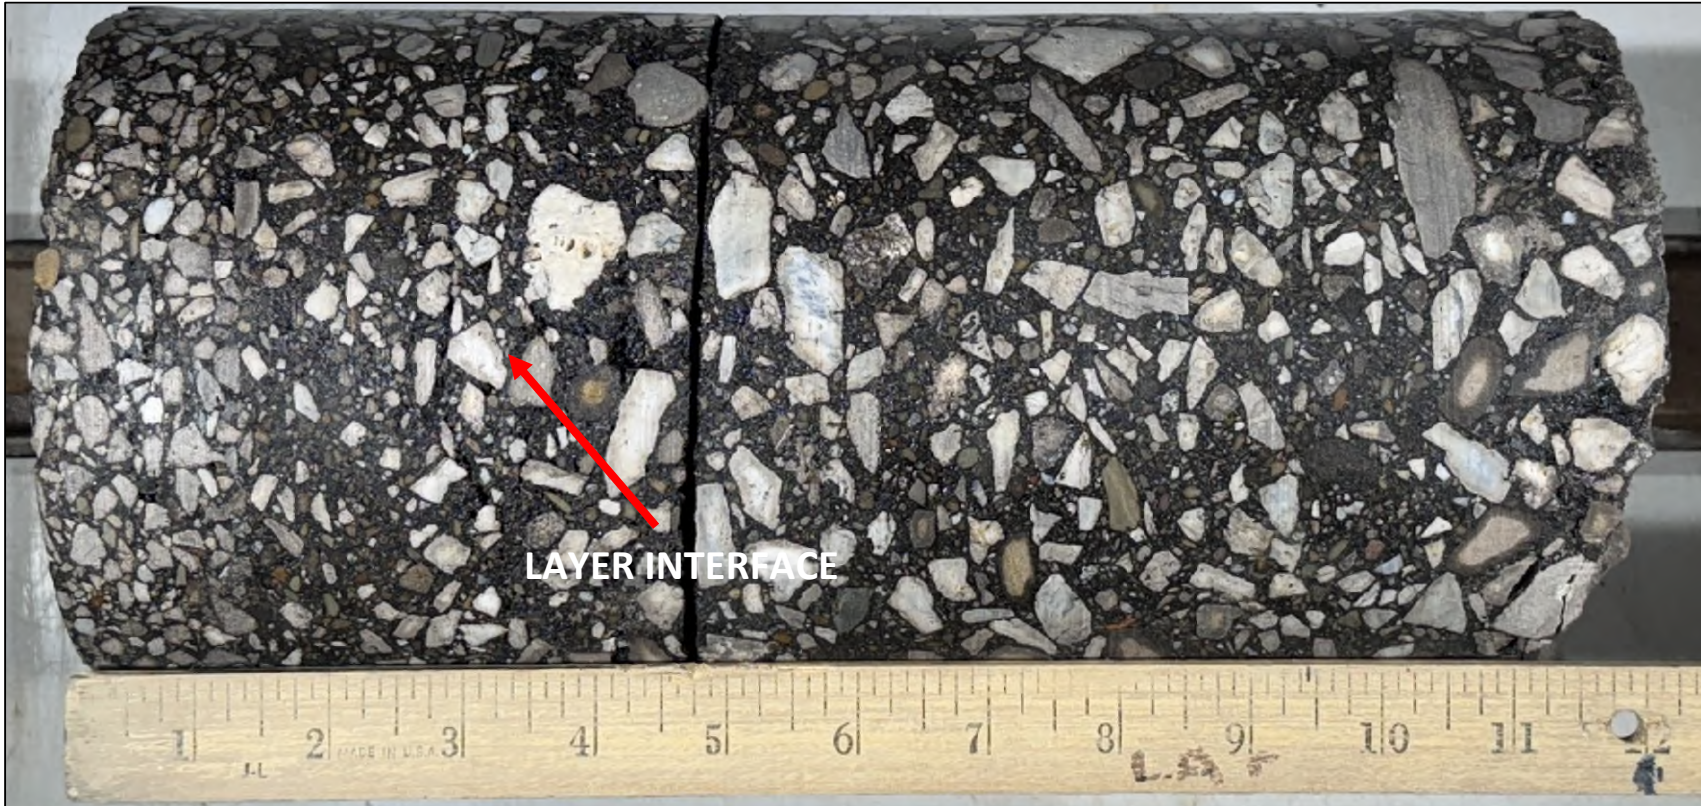
X-007-0-24

Layer Thickness, in.	Description	Comments
1.5	ASPHALT: Surface Course	- 12 inches of pavement total - Asphalt sections observed to be intact - Delaminated in intermediate layer at 4.75 inches
2	ASPHALT: Surface Course	
8.5	ASPHALT: Intermediate Course	
8	AGGREGATE BASE: Crushed Limestone
