PAVEMENT DATA REPORT

GEA-006-3.51 (PID 110950)
SR-6 and SR-44, CHARDON, OHIO

SME Project Number: 092062.16
APRIL 12, 2024

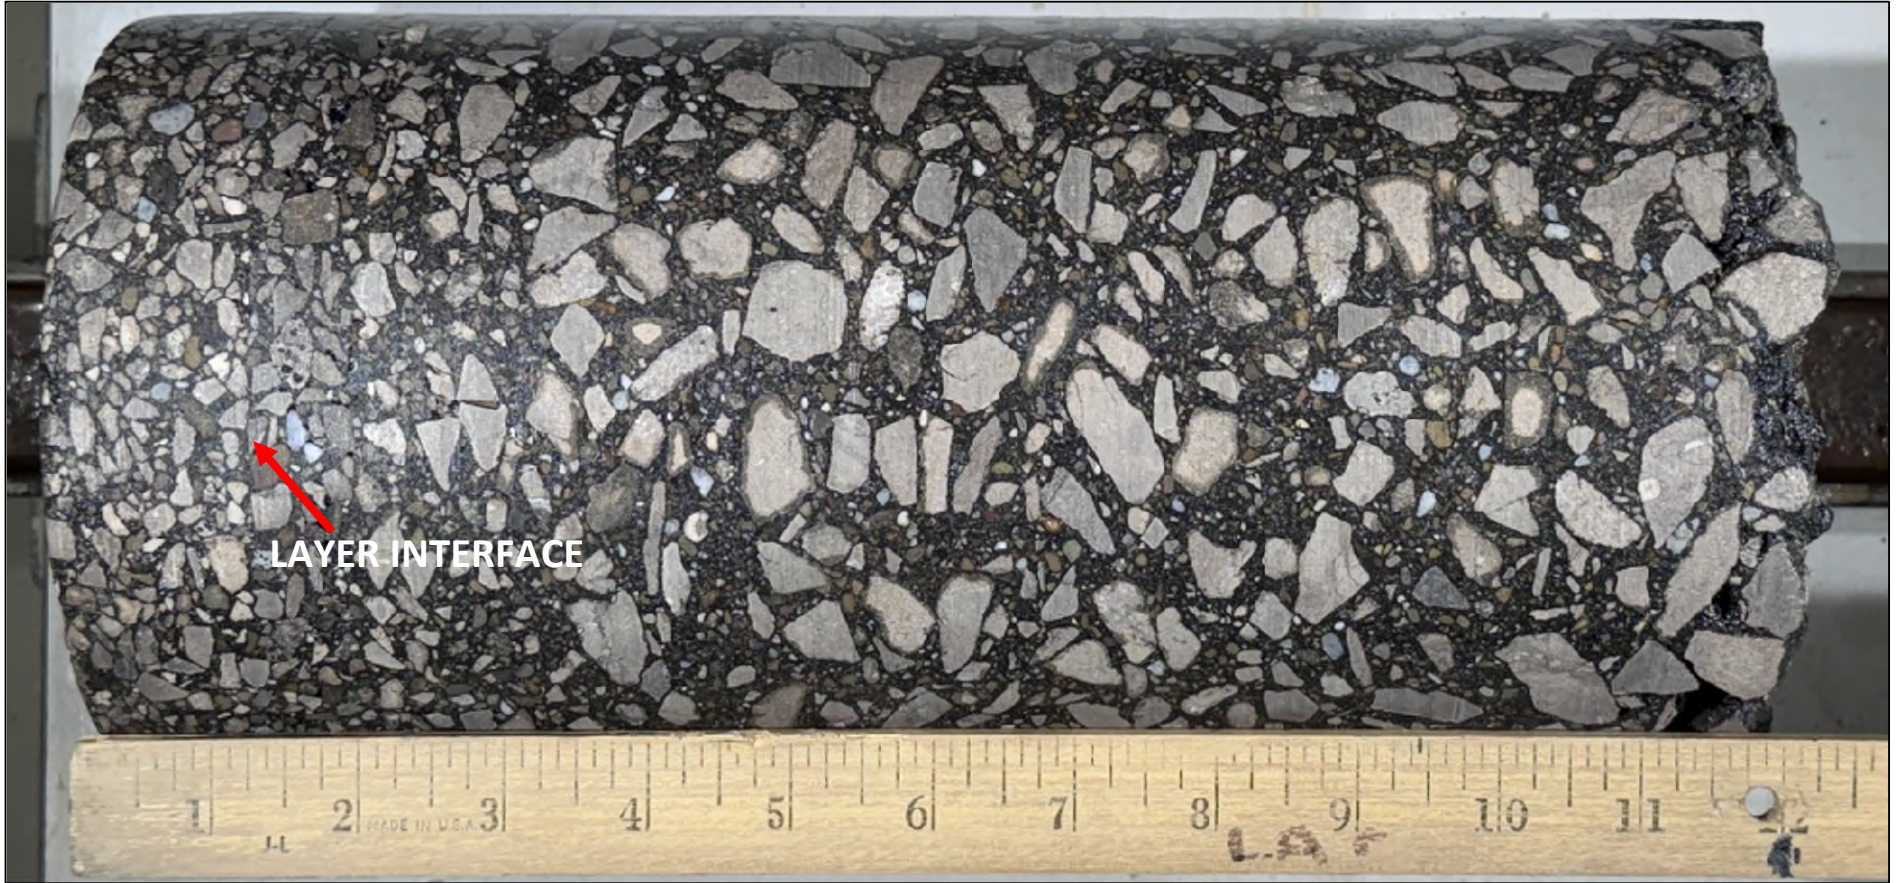
X-008-0-24

Layer Thickness, in.	Description	Comments
1.5	ASPHALT: Surface Course	- 12 inches of pavement total - Asphalt sections observed to be intact
2	ASPHALT: Surface Course	
8.5	ASPHALT: Intermediate Course	
9	AGGREGATE BASE: Crushed Limestone

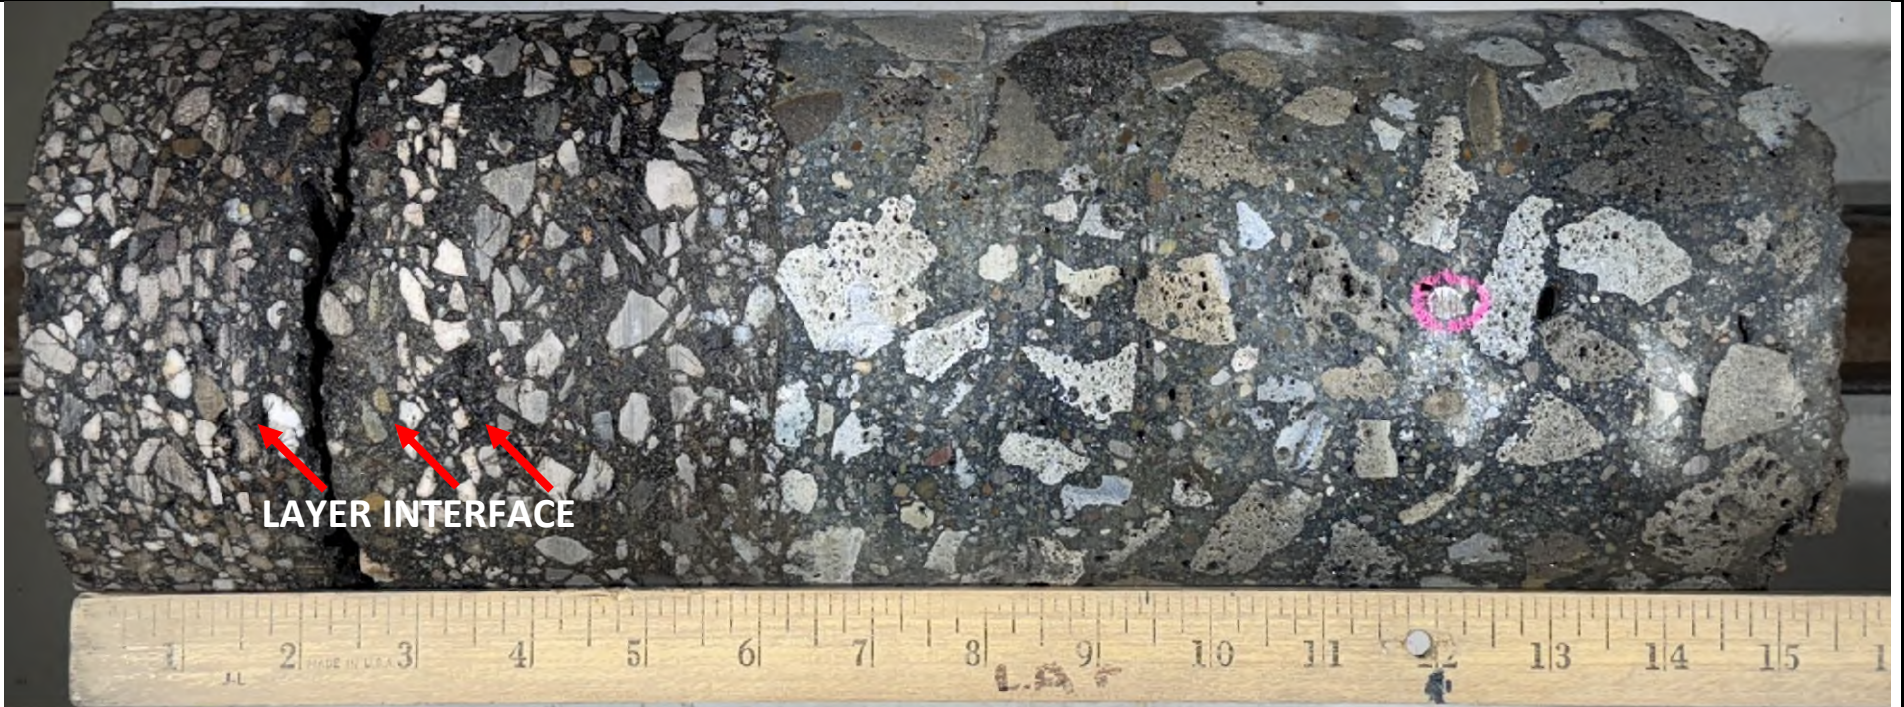
X-009-0-24

Layer Thickness, in.	Description	Comments
2	ASPHALT: Surface Course	- 15 inches of pavement total
1	ASPHALT: Surface Course	- Transverse break through core at 2.5 inches
1	ASPHALT: Surface Course	
2.25	ASPHALT: Intermediate Course	
8.75	REINFORCED CONCRETE	- Concrete section observed to be intact - ≈0.25-inch diameter reinforcing steel observed about 5.5 inches below top of concrete (circled)
--	NO AGGREGATE BASE ENCOUNTERED

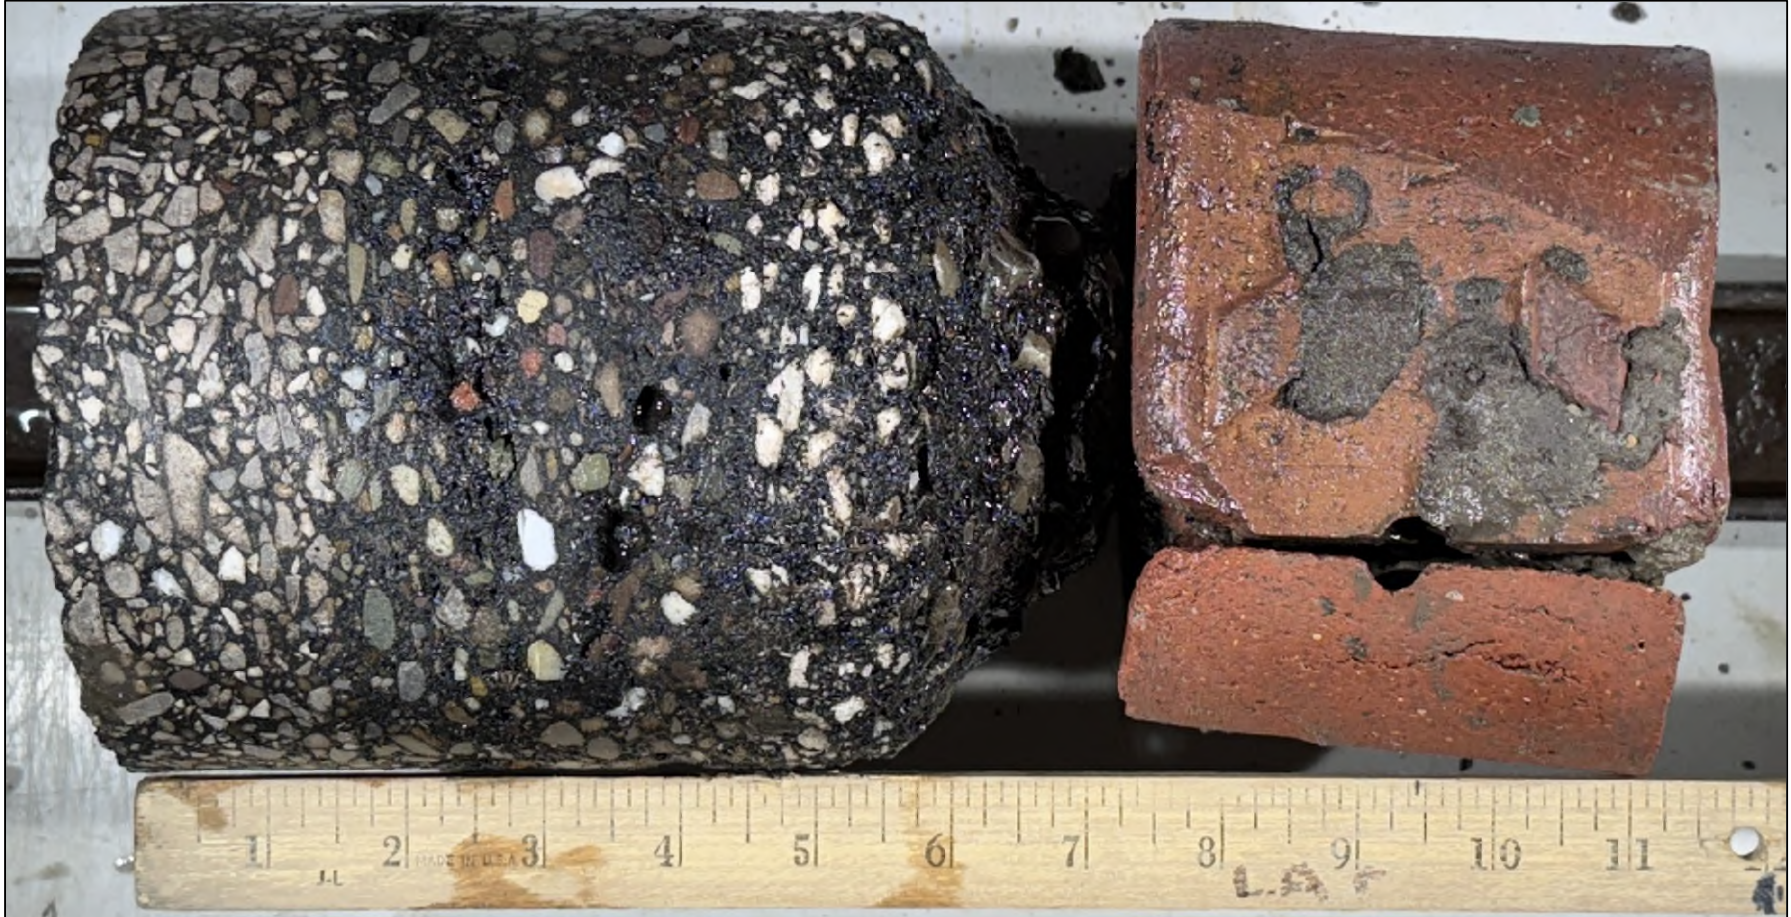
X-010-0-24

Layer Thickness, in.	Description	Comments
1.75	ASPHALT: Surface Course	- 11.5 inches of pavement total
3	ASPHALT: Surface Course	
2.5	ASPHALT: Intermediate Course	- Deterioration around perimeter of core from 5.75 inches to top of brick layer
4.25	RED BRICK	- Brick separated from mortar
--	NO AGGREGATE BASE ENCOUNTERED

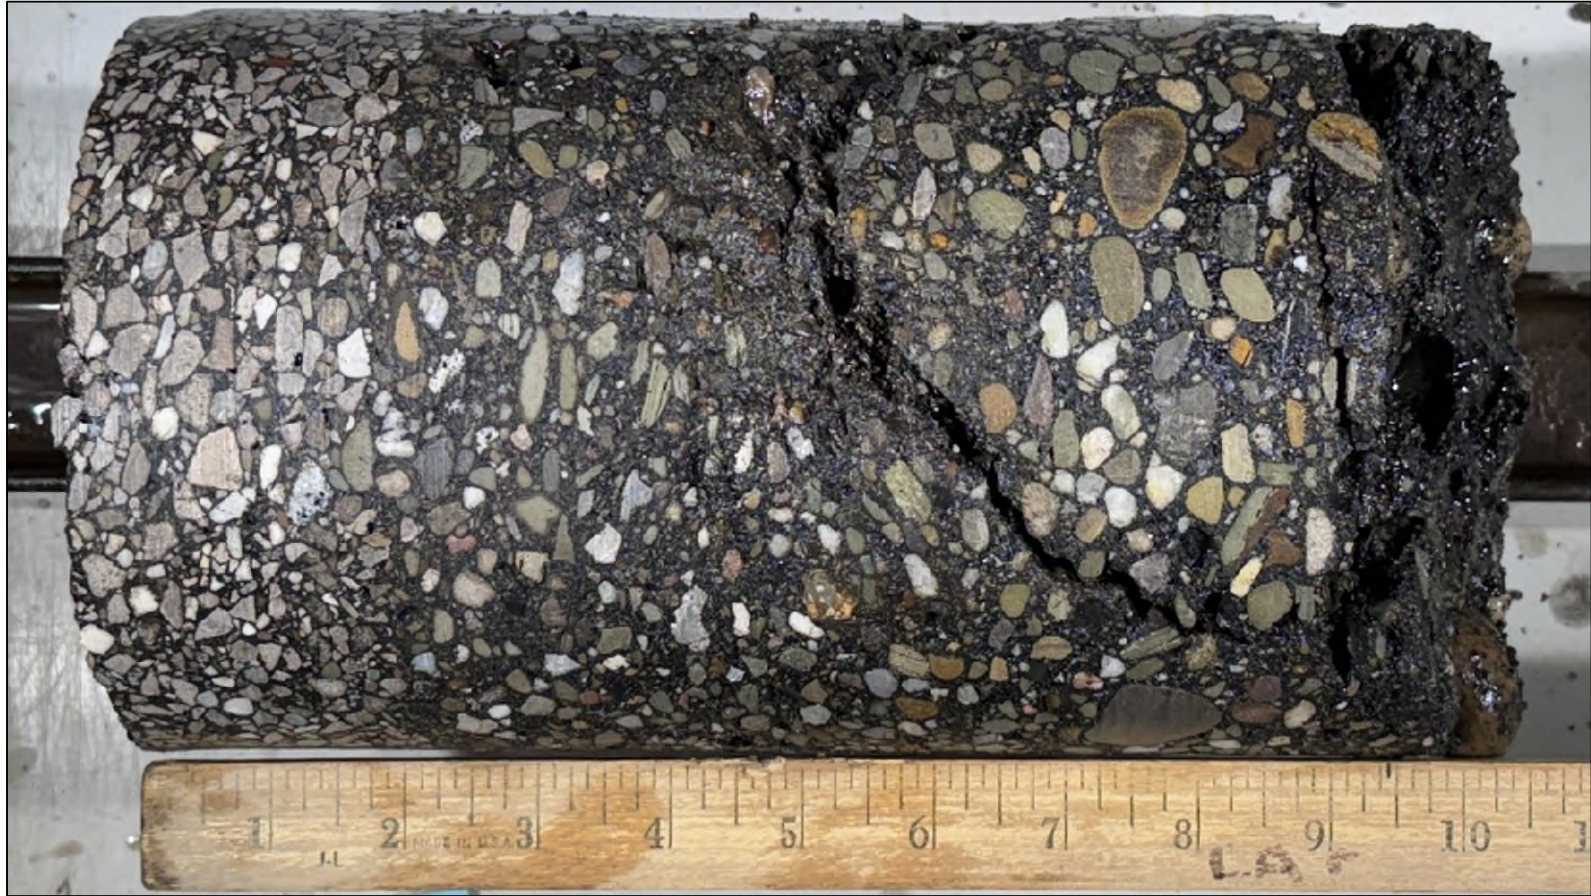
X-011-0-24

Layer Thickness, in.	Description	Comments
2.25	ASPHALT: Surface Course	- 10.5 inches of pavement total
8.25	ASPHALT: Intermediate Course	- Approx. 1-inch thick broken portion on one side of core (shown) - Deterioration around perimeter of core from 9.5 to 10.5 inches
9	AGGREGATE BASE: Recycled Slag and Limestone

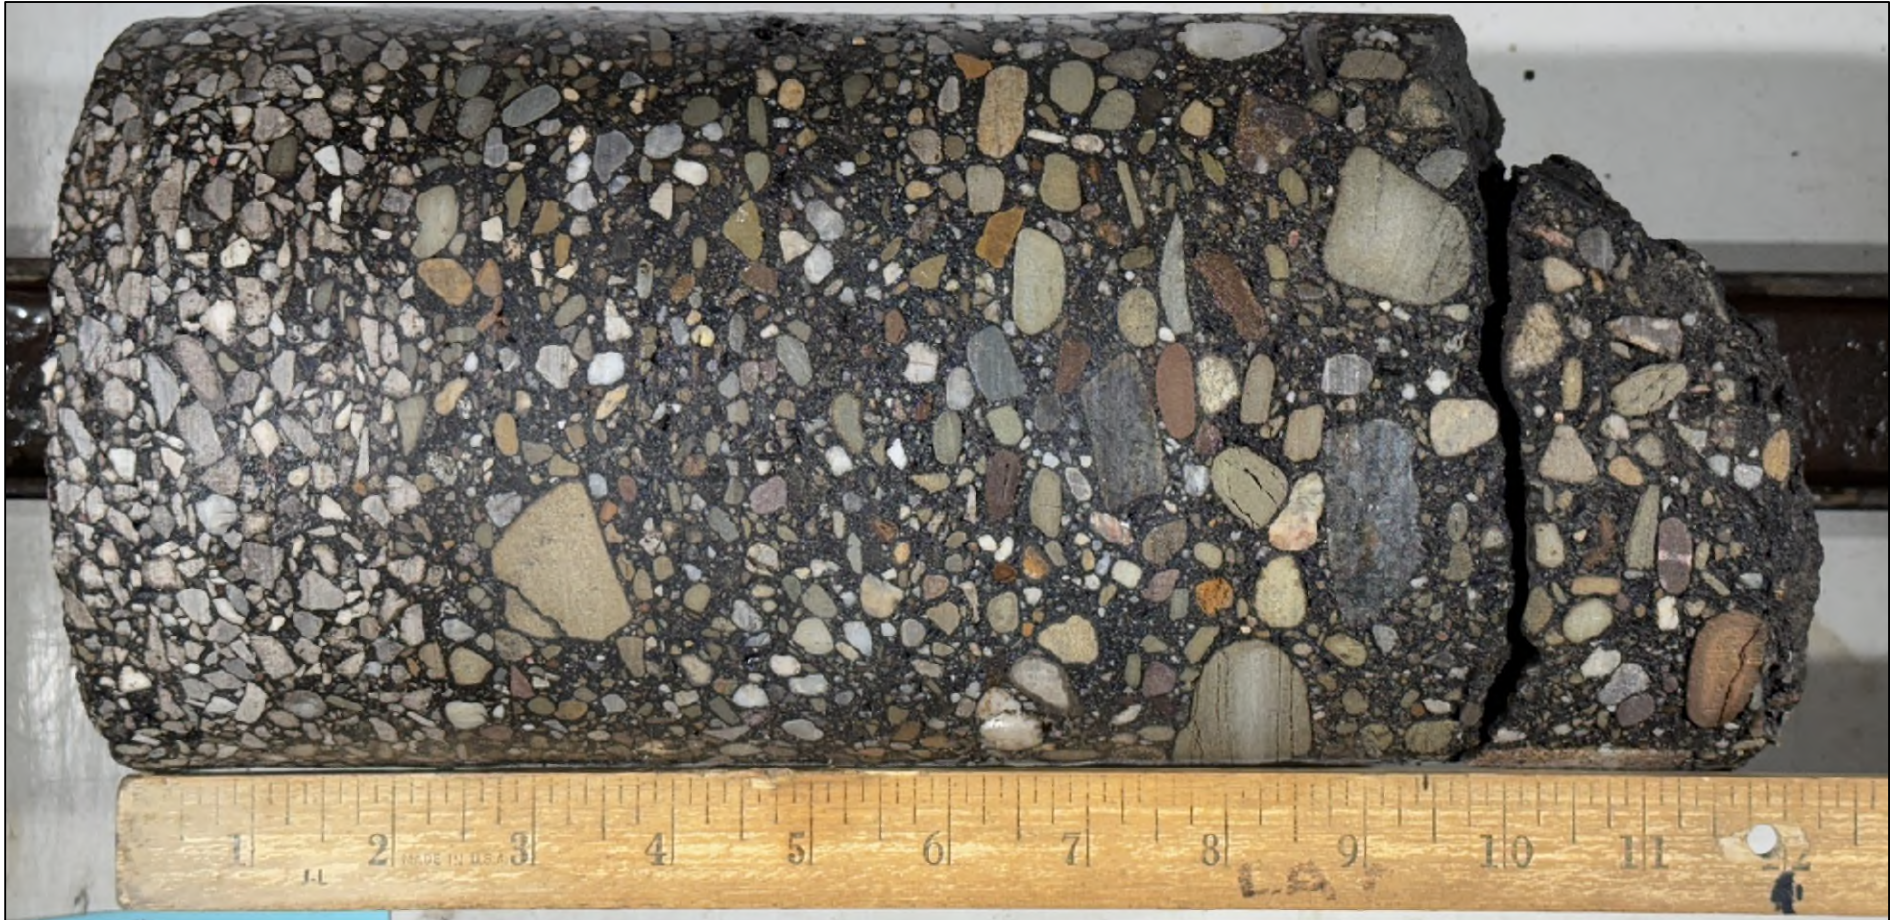
X-012-0-24

Layer Thickness, in.	Description	Comments
2.5	ASPHALT: Surface Course	- 12 inches of pavement total
9.5	ASPHALT: Intermediate Course	- Broken portion from 9.75 to 12 inches
7	AGGREGATE BASE: Recycled Slag and Limestone

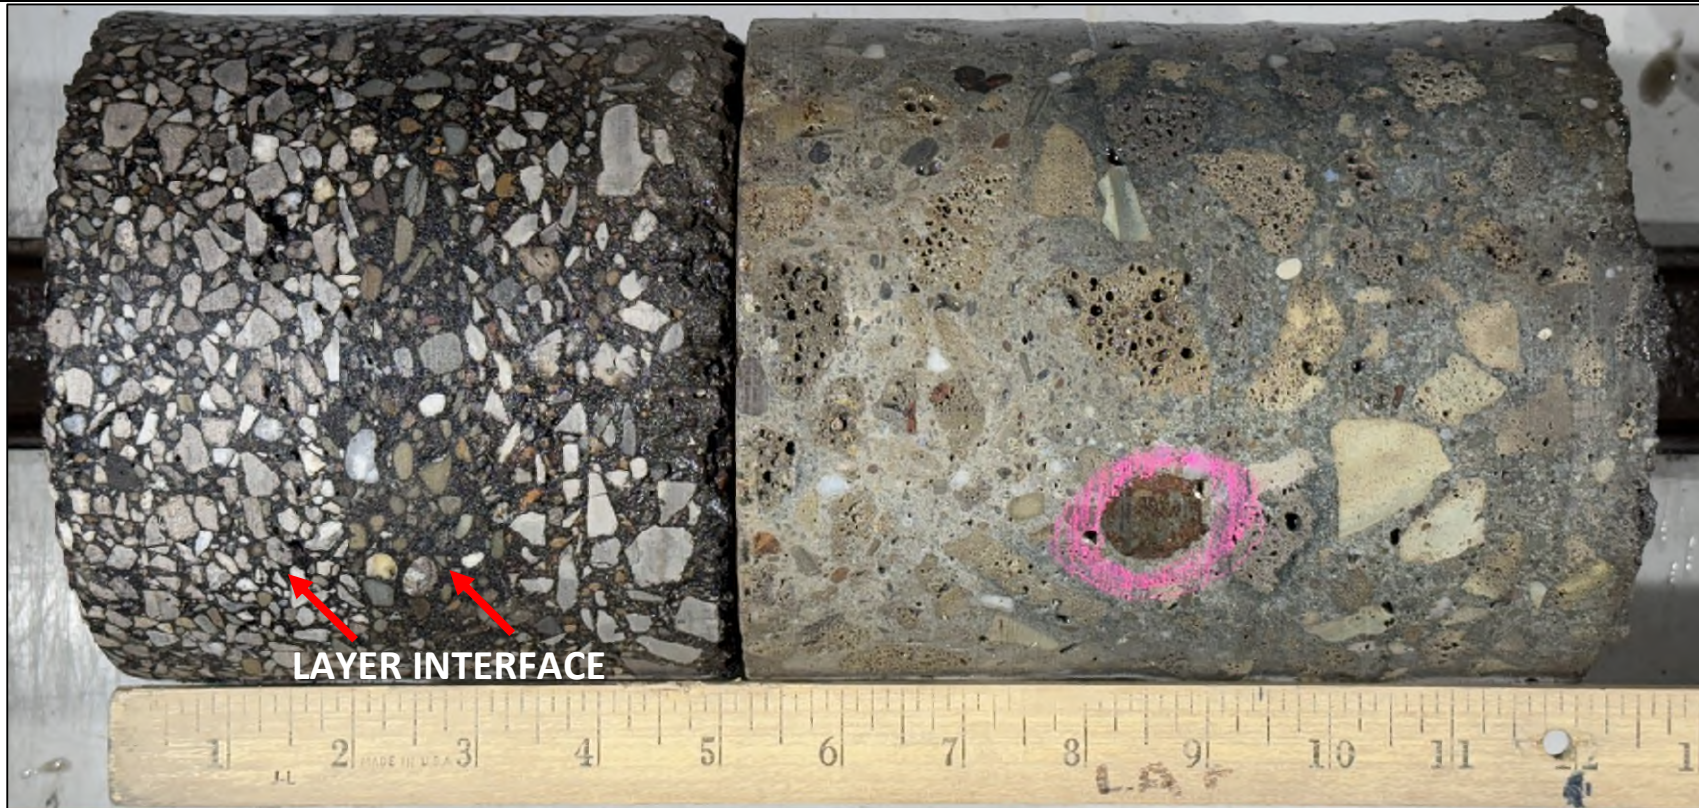
X-013-0-24

Layer Thickness, in.	Description	Comments
2	ASPHALT: Surface Course	- 12 inches of pavement total - Asphalt section observed to be intact
1	ASPHALT: Surface Course	- Delaminated from concrete layer
2	ASPHALT: Intermediate Course	
7	REINFORCED CONCRETE	- Concrete layer observed to be intact - ≈0.75-inch diameter reinforcing steel observed about 3 inches below top of concrete (circled)
--	NO AGGREGATE BASE ENCOUNTERED
