STRUCTURE NOTES - 3  
BRIDGE No: HAM-71-6.75 & HAM-71-7.31  
EDMONSON RD. & ROBERTSON AVE. OVER I-71

STRUCTURE QUANTITIES  
 BRIDGE No.: HAM-71-6.75 & HAM-71-7.31  
 EDMONSON RD. & ROBERTSON AVE. OVER I-71

GENERAL PLAN  
 BRIDGE No: HAM-71-7.31  
 ROBERTSON AVE. OVER I-71

PHASE CONSTRUCTION  
 BRIDGE No: HAM-71-7.31  
 ROBERTSON AVE. OVER I-71

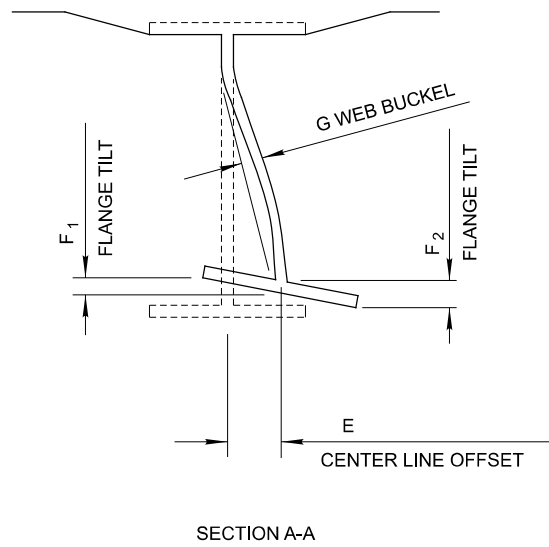
SECTION A-A  
 NEGATIVE E VALUES ARE BENT LEFT  
 NEGATIVE F VALUES ARE BENT DOWN  
 NEGATIVE G VALUES ARE BENT LEFT

| DAMAGE AREA No. | MEMBER LINE No. A | PIER OR ABUT. | B | C | D | E | F <sub>1</sub> | F <sub>2</sub> | G | H | J | K | L |
|---|---|---|---|---|---|---|---|---|---|---|---|---|---|
| D.A. #1 | B7 | PIER 2 | 50.13' | 50.88' | 51.63' | 0 | -1" | 1" | 0 | | | | |

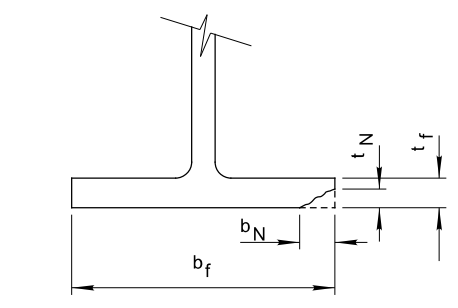
SECTION A-A  
SEE NOTE 1 THROUGH 4  
FLANGE NOT SHOWN WITH BEND FOR CLARITY

| DAMAGE AREA No. | MEMBER LINE No. A | PIER OR ABUT. | B | C | D | E | F <sub>1</sub> | F <sub>2</sub> | G | H | J | K | L |
|---|---|---|---|---|---|---|---|---|---|---|---|---|---|
| 1 | BEAM 6 | PIER 1 | 40.3' | 41.6' | 42.9' | — | -0.5" | +0.5" | — | | | | |

1. DETERMINE IF IMPACT NOTCH IS CRACKED USING MAGNETIC PARTICLE INSPECTION
2. IF CRACK DOES NOT EXTEND THROUGH THE FLANGE. DETERMINE DEPTH OF CRACK BY GRINDING
3. IF NOTCH OR PARTIAL DEPTH CRACK CAN BE REMOVED BY GRINDING ACCORDING TO SUPPLEMENTAL SPECIFICATION 849, REPAIR DAMAGED MEMBERS. PERFORM GRINDING ACCORDING TO SUPPLEMENTAL SPECIFICATION 849 AND AS ILLUSTRATED IN DETAIL FC2-2
4. IF NOTCH OR PARTIAL DEPTH CRACK MUST BE REPAIRED BY WELDING ACCORDING TO SUPPLEMENTAL SPECIFICATION 849 REPAIRING DAMAGED MEMBERS, AS ILLUSTRATED IN DETAIL FC2-3. PERFORM COMPLETE PENETRATION WELDING ACCORDING TO C&MS 513.21 BY ATTACHING RUN OFF TABS AND GRIND ALL WELDED SURFACES SMOOTH ACCORDING TO ANSI B46.1 OF 250 MIL
5. PERFORM NDT TESTING ACCORDING TO C&MS 513.25A. MAGNETIC PARTICLE TESTING WILL BE ACCEPTED IN LIEU OF RADIOGRAPHIC TESTING.

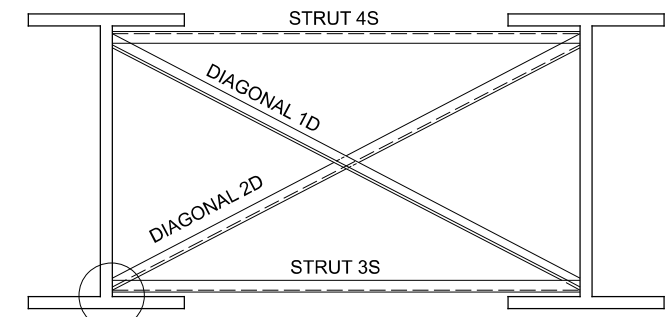
SECTION B-B  
SECONDARY MEMBER BAY No. M

MAIN AND SECONDARY MEMBER DAMAGE IS NOT SHOWN. FOR CLARITY SEE SECTION A-A

REMOVE ACCORDING TO ITEM 202-PORCTIONS OF SECONDARY MEMBERS REMOVED, AS PER PLAN. REPLACE BY MATCHING EXISTING DETAIL. SEE GSD-1-96 FOR ADDITIONAL CLARIFICATION.
