Point No.: 1011
Crew: AJZ KMW
Date: 10/8/25
Location: JAC - TR35

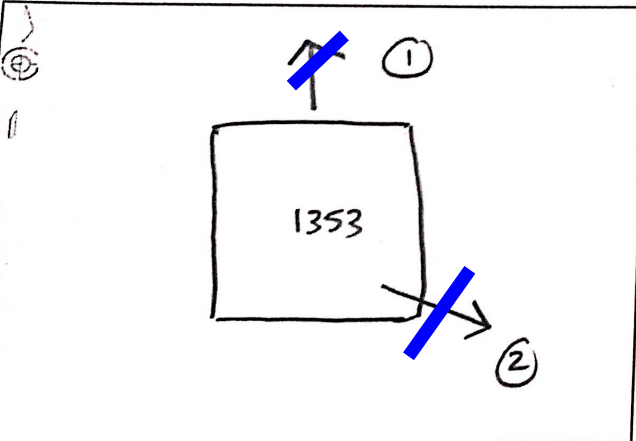
Pipe And Flow Direction:

PIPE ② IS EXTRA OVERFLOW
TO CBS #
IN SOUTHERLY MEDIAN
WATER VISIBLY FLOWING NORTH
OUT OF ①

Type:	<input checked="" type="checkbox"/> Sanitary		<input checked="" type="checkbox"/> Storm	<input type="checkbox"/> Electric	<input type="checkbox"/> Water	<input type="checkbox"/> (Other)	
Index	①	②	3	4	5	6	
Magnetic Azimuth	327°	110°					
Pipe Diameter	27"	6"					
Material	RCP	PVC					
From Invert	3.60'	2.75'					
To Sump							
Notes	TO 1321	TO 1393

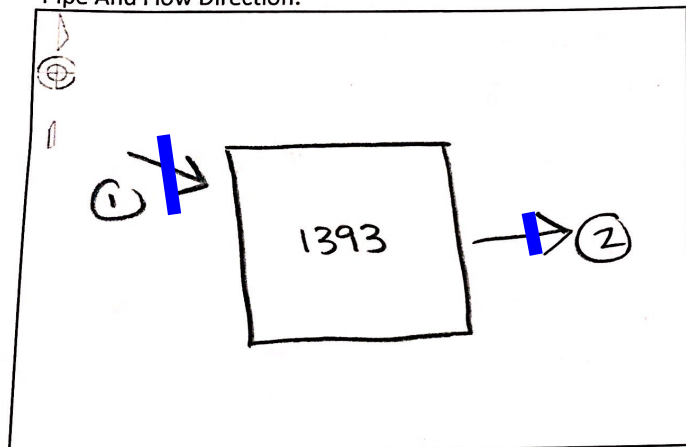
Pipe And Flow Direction:

Pipe Index	①	②	3	4	5	6
Magnetic Azimuth	290°	55°				
Diameter	6"	18"				
Material	PVC	RCP				
Depth To Invert	2.05'	2.95'				
Depth To Sump						
Comments	FROM 1353	OUTFLOW EAST OF 35
