# C-01 CORE LOG

**Project:** PIC-23-17.37, PID 112877      **Date:** 6/29/2022  
**Location:** Pickaway County, Ohio      **Core Type / Alignment:** Pavement / Vertical  
**Client:** Stantec Consulting Services, Inc.      **Coring Crew:** PGI - Jason Kash  
**Core Barrel Size (O.D.):** 4.00"      **Hole Patched w/:** Cold Patch Asphalt

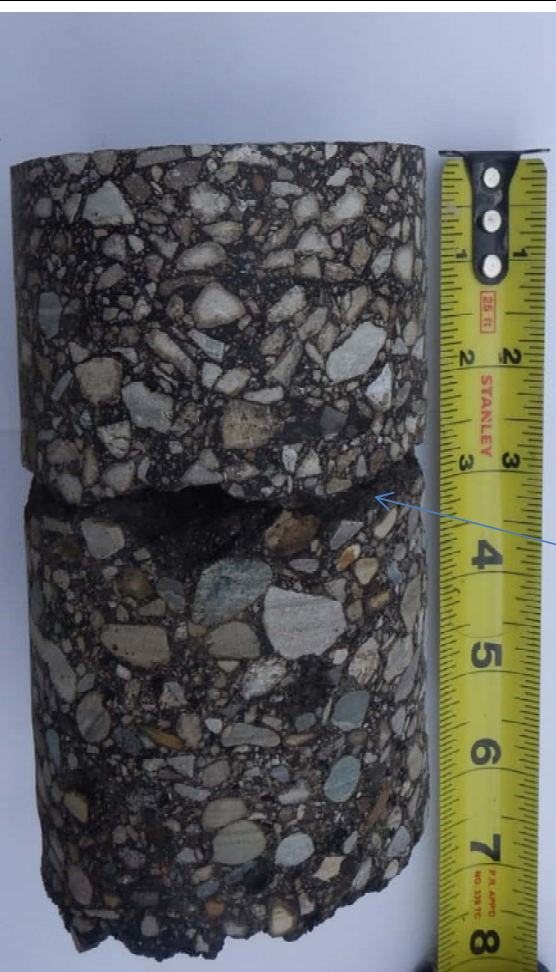
<p><b>Note:</b> Due to the angle at which the photographs were taken, the description to the right of the above core may appear to be slightly above or below the actual feature being described.  <b>FACE OF THE CORE IS AT ZERO</b></p>
	<p>ASPHALT PAVEMENT TO FULL DEPTH</p> <p>ASPHALT PAVEMENT DEPTH FROM 0.0 - 5.75"</p> <p>PAVEMENT CORE DIAMETER = 3.75"</p> <p>JOINT CRACKS WERE OBSERVED ON THE PAVEMENT SURFACE IN THE VICINITY OF THE CORE LOCATION. ASPHALT PAVEMENT APPEARS TO BE IN FAIR CONDITION.</p> <p>MECHANICAL BREAK</p> <p>PAVEMENT HOLE DEPTH = 5.75"</p>

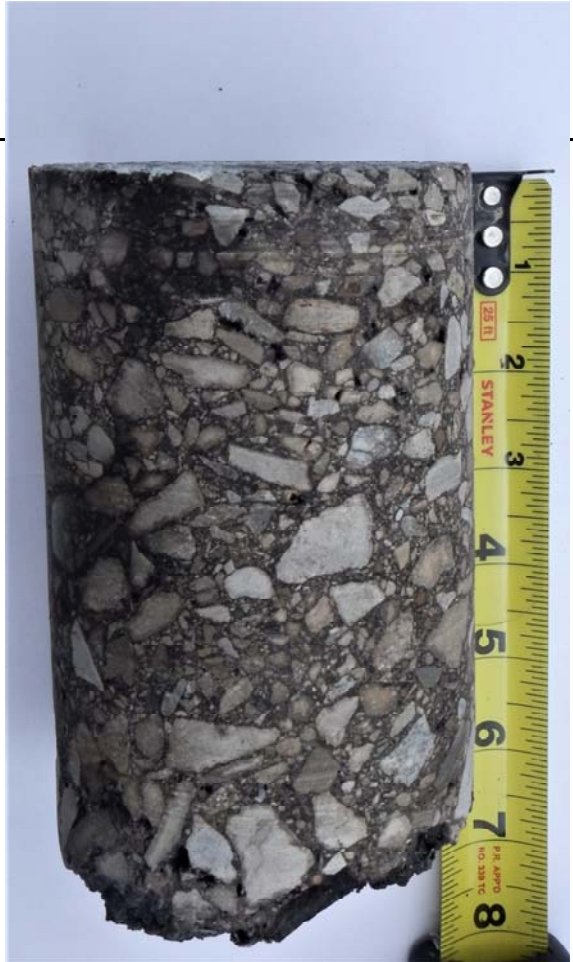
# C-02 CORE LOG

<p><b>Note:</b> Due to the angle at which the photographs were taken, the description to the right of the above core may appear to be slightly above or below the actual feature being described.</p> <p>FACE OF THE CORE IS AT ZERO</p> <p>ASPHALT PAVEMENT TO FULL DEPTH</p> <p>ASPHALT PAVEMENT DEPTH FROM 0.0" - 7.5"</p> <p>PAVEMENT CORE DIAMETER = 3.75"</p> <p>JOINT, LONGITUDINAL, AND LATERAL CRACKS WERE OBSERVED ON THE PAVEMENT SURFACE IN THE VICINITY OF THE CORE LOCATION..</p> <p>ASPHALT PAVEMENT APPEARS TO BE IN FAIR TO POOR CONDITION.</p> <p>PAVEMENT HOLE DEPTH = 7.5"</p>

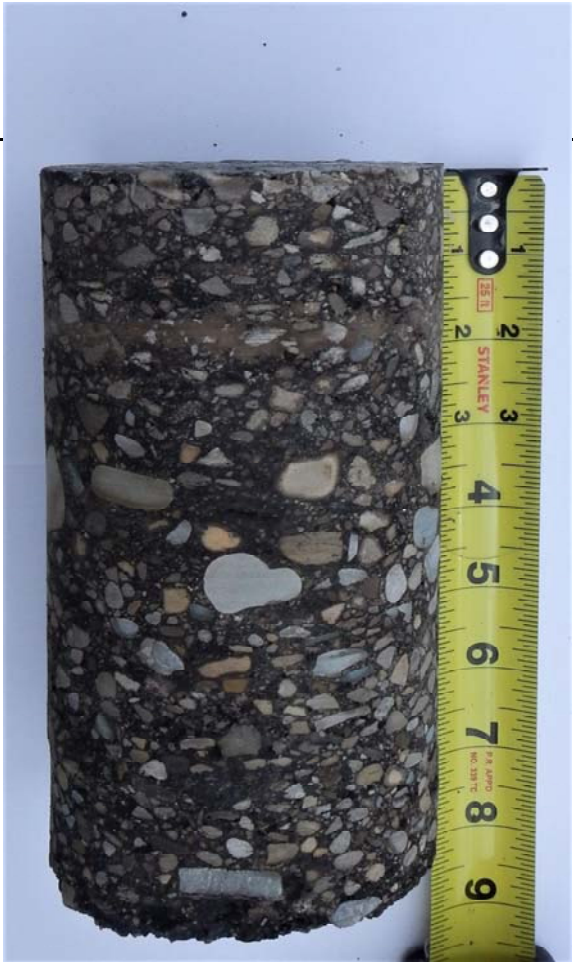
# C-03 CORE LOG

<p><b>Note:</b> Due to the angle at which the photographs were taken, the description to the right of the above core may appear to be slightly above or below the actual feature being described.</p> <p>FACE OF THE CORE IS AT ZERO          ASPHALT PAVEMENT TO FULL DEPTH</p> <p>ASPHALT PAVEMENT DEPTH FROM 0.0" - 7.75"</p> <p>PAVEMENT CORE DIAMETER = 3.75"</p> <p>JOINT AND WHEEL RUTTING CRACKS WERE OBSERVED ON THE PAVEMENT SURFACE IN THE VICINITY OF THE CC LOCATION.          ASPHALT PAVEMENT APPEARS TO BE IN FAIR CONDITION.</p> <p>PAVEMENT HOLE DEPTH = 7.75"</p>

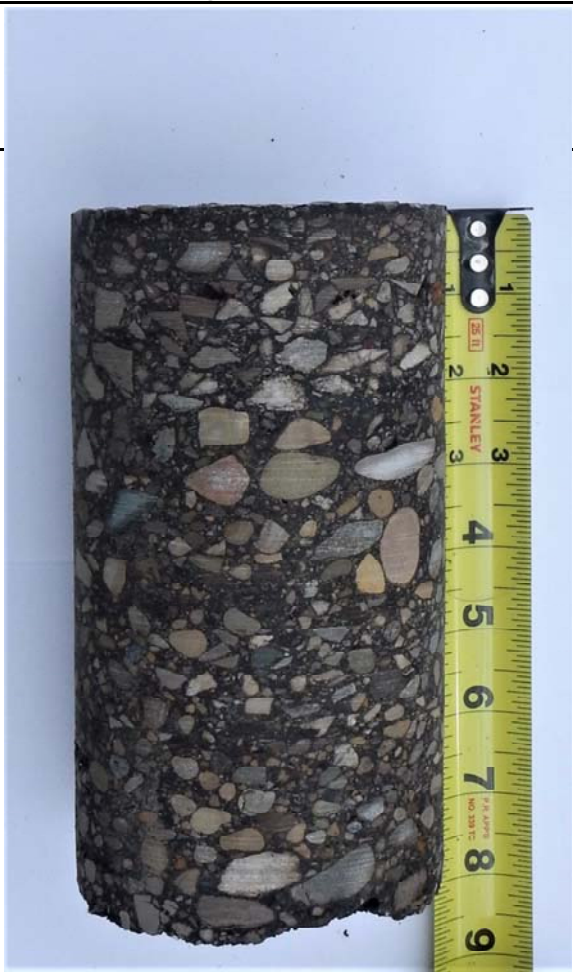
# C-04 CORE LOG

<p><b>Note:</b> Due to the angle at which the photographs were taken, the description to the right of the above core may appear to be slightly above or below the actual feature being described.</p> <p>FACE OF THE CORE IS AT ZERO</p> <p>ASPHALT PAVEMENT TO FULL DEPTH</p> <p>ASPHALT PAVEMENT DEPTH FROM 0.0" - 7.25"</p> <p>PAVEMENT CORE DIAMETER = 3.75"</p> <p>JOINT, ALLIGATOR, LONGITUDINAL, AND LATERAL CRACKS WERE OBSERVED ON THE PAVEMENT SURFACE IN THE VICINITY OF THE CORE LOCATION..</p> <p>ASPHALT PAVEMENT APPEARS TO BE IN FAIR TO POOR CONDITION.</p> <p>PAVEMENT HOLE DEPTH = 7.25"</p>

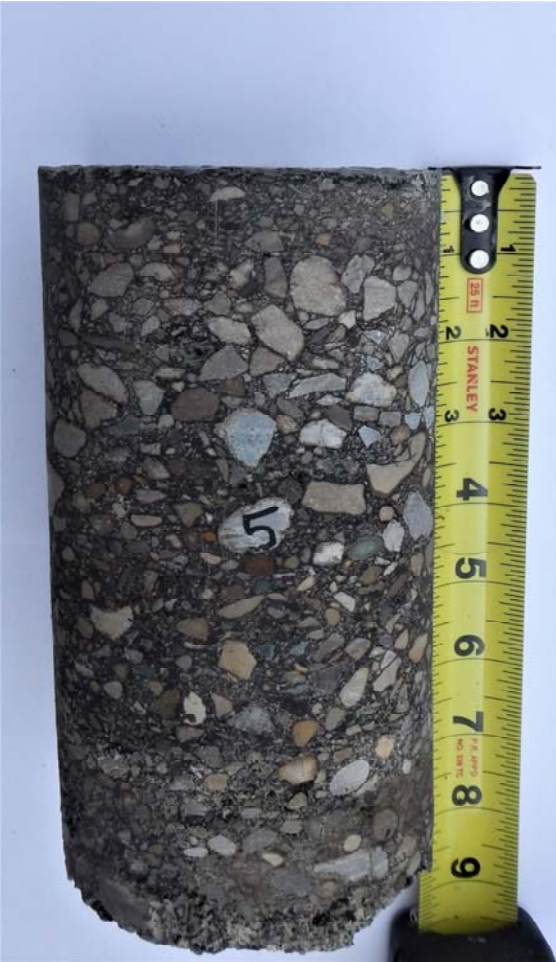
# C-05 CORE LOG

<p><b>Note:</b> Due to the angle at which the photographs were taken, the description to the right of the above core may appear to be slightly above or below the actual feature being described.</p> <p>FACE OF THE CORE IS AT ZERO          ASPHALT PAVEMENT TO FULL DEPTH</p> <p>ASPHALT PAVEMENT DEPTH FROM 0.0" - 7.5"</p> <p>PAVEMENT CORE DIAMETER = 3.75"</p> <p>JOINT, ALLIGATOR, LONGITUDINAL, AND LATERAL CRACKS WERE OBSERVED ON THE PAVEMENT SURFACE IN THE VICINITY OF THE CORE LOCATION..</p> <p>ASPHALT PAVEMENT APPEARS TO BE IN FAIR TO POOR CONDITION.</p> <p>PAVEMENT HOLE DEPTH = 7.5"</p>

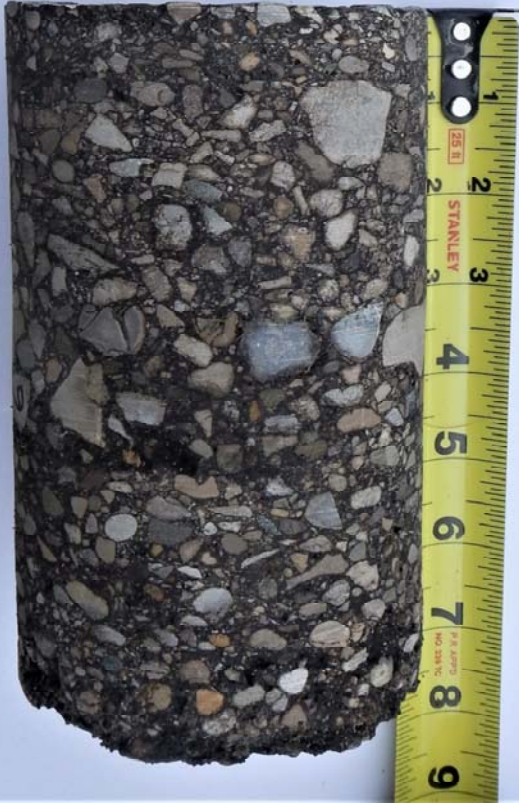
# C-06 CORE LOG

<p><b>Note:</b> Due to the angle at which the photographs were taken, the description to the right of the above core may appear to be slightly above or below the actual feature being described.</p> <p>FACE OF THE CORE IS AT ZERO</p> <p>ASPHALT PAVEMENT TO FULL DEPTH</p> <p>ASPHALT PAVEMENT DEPTH FROM 0.0" - 7.0"</p> <p>PAVEMENT CORE DIAMETER = 3.75"</p> <p>JOINT, LONGITUDINAL, AND LATERAL CRACKS WERE OBSERVED ON THE PAVEMENT SURFACE IN THE VICINITY OF THE CORE LOCATION..</p> <p>ASPHALT PAVEMENT APPEARS TO BE IN FAIR TO POOR CONDITION.</p> <p>PAVEMENT HOLE DEPTH = 7.0"</p>

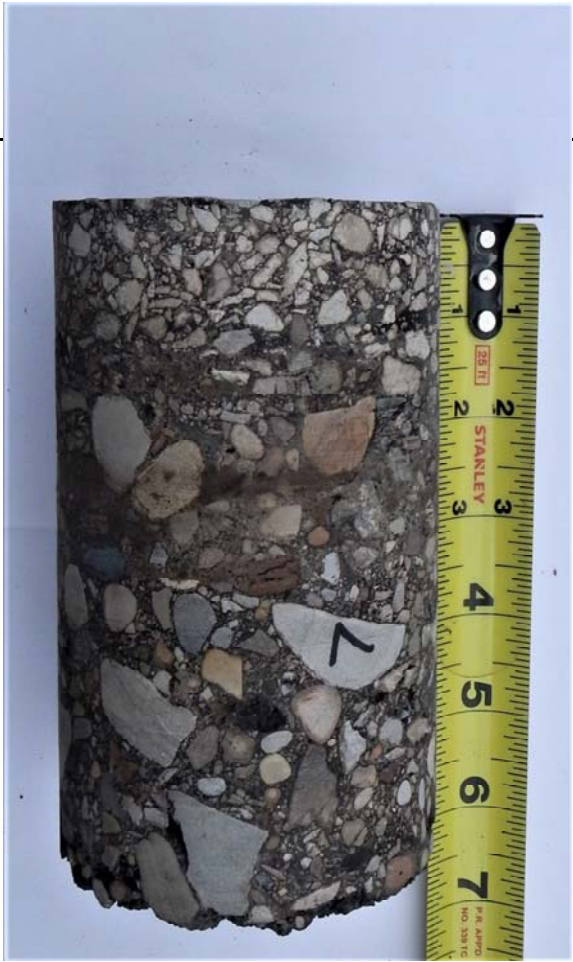
# C-07 CORE LOG

<p><b>Note:</b> Due to the angle at which the photographs were taken, the description to the right of the above core may appear to be slightly above or below the actual feature being described.</p> <p>FACE OF THE CORE IS AT ZERO</p> <p>ASPHALT PAVEMENT TO FULL DEPTH</p> <p>ASPHALT PAVEMENT DEPTH FROM 0.0" - 5.75"</p> <p>PAVEMENT CORE DIAMETER = 3.75"</p> <p>JOINT AND LONGITUDINAL CRACKS WERE OBSERVED ON THE PAVEMENT SURFACE IN THE VICINITY OF THE CORE LOCATION..</p> <p>ASPHALT PAVEMENT APPEARS TO BE IN FAIR CONDITION.</p> <p>PAVEMENT HOLE DEPTH = 5.75"</p>

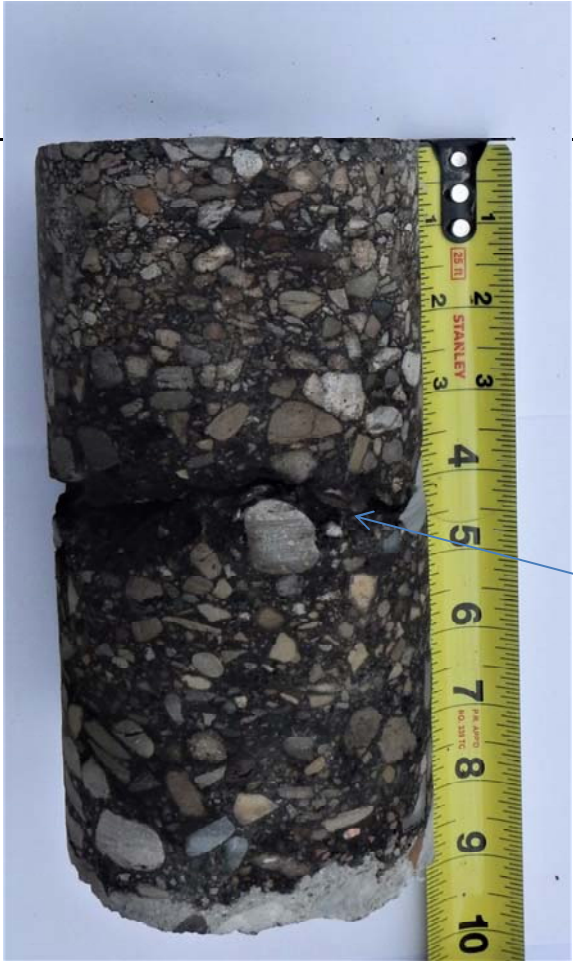
# C-08 CORE LOG

<p><b>Note:</b> Due to the angle at which the photographs were taken, the description to the right of the above core may appear to be slightly above or below the actual feature being described.</p> <p>FACE OF THE CORE IS AT ZERO</p> <p>ASPHALT PAVEMENT TO FULL DEPTH</p> <p>ASPHALT PAVEMENT DEPTH FROM 0.0" - 8.0"</p> <p>PAVEMENT CORE DIAMETER = 3.75"</p> <p>ASPHALT PAVEMENT APPEARS TO BE IN FAIR TO POOR CONDITION.</p> <p>MECHANICAL BREAK</p> <p>PAVEMENT HOLE DEPTH = 8.0"</p>
	<p><b>Core Location</b></p>

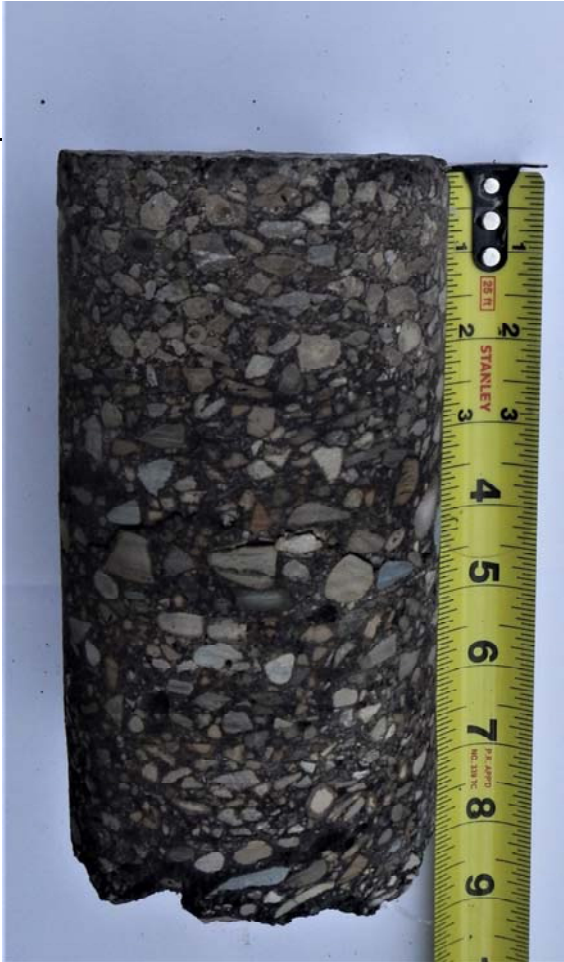
# C-09 CORE LOG

<p><b>Note:</b> Due to the angle at which the photographs were taken, the description to the right of the above core may appear to be slightly above or below the actual feature being described.</p> <p>FACE OF THE CORE IS AT ZERO</p> <p>ASPHALT PAVEMENT TO FULL DEPTH</p> <p>ASPHALT PAVEMENT DEPTH FROM 0.0" - 7.5"</p> <p>PAVEMENT CORE DIAMETER = 3.75"</p> <p>JOINT CRACKS WERE OBSERVED ON THE PAVEMENT SURFACE IN THE VICINITY OF THE CORE LOCATION.</p> <p>ASPHALT PAVEMENT APPEARS TO BE IN GOOD CONDITION.</p> <p>PAVEMENT HOLE DEPTH = 7.5"</p>

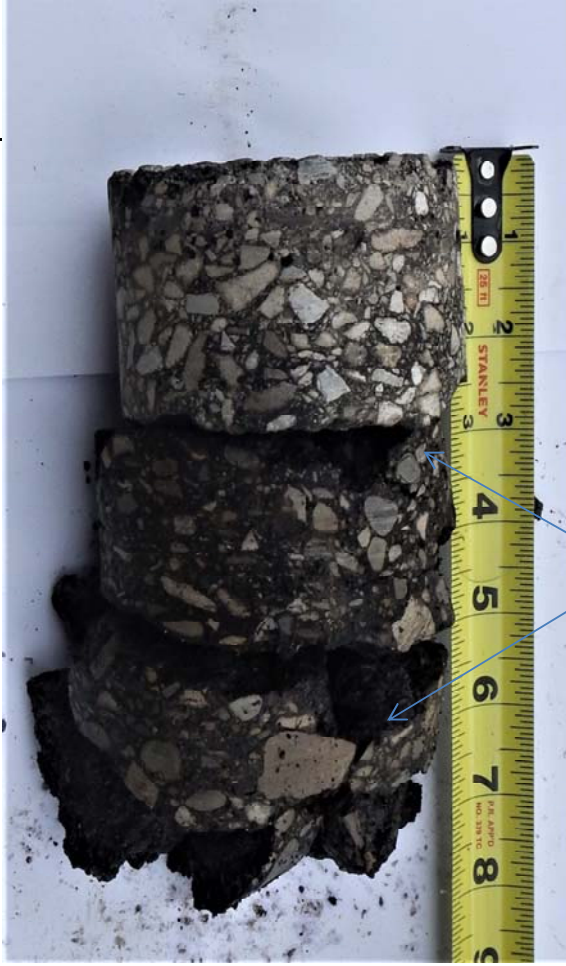
# C-10 CORE LOG

<p><b>Note:</b> Due to the angle at which the photographs were taken, the description to the right of the above core may appear to be slightly above or below the actual feature being described.</p> <p>FACE OF THE CORE IS AT ZERO</p> <p>ASPHALT PAVEMENT TO FULL DEPTH</p> <p>ASPHALT PAVEMENT DEPTH FROM 0.0" - 7.0"</p> <p>PAVEMENT CORE DIAMETER = 3.75"</p> <p>JOINT, WHEEL RUTTING, ALLIGATOR, LONGITUDINAL, AND LATERAL CRACKS WERE OBSERVED ON THE PAVEMENT SURFACE IN THE VICINITY OF THE CORE LOC. ASPHALT PAVEMENT APPEARS TO BE IN FAIR TO POOR CONDITION.</p> <p>MECHANICAL BREAK</p> <p>PAVEMENT HOLE DEPTH = 7.0"</p>
	<p><b>Core Location</b></p>
	<p><b>Wider Prospective</b>                      <b>Close Up</b></p>

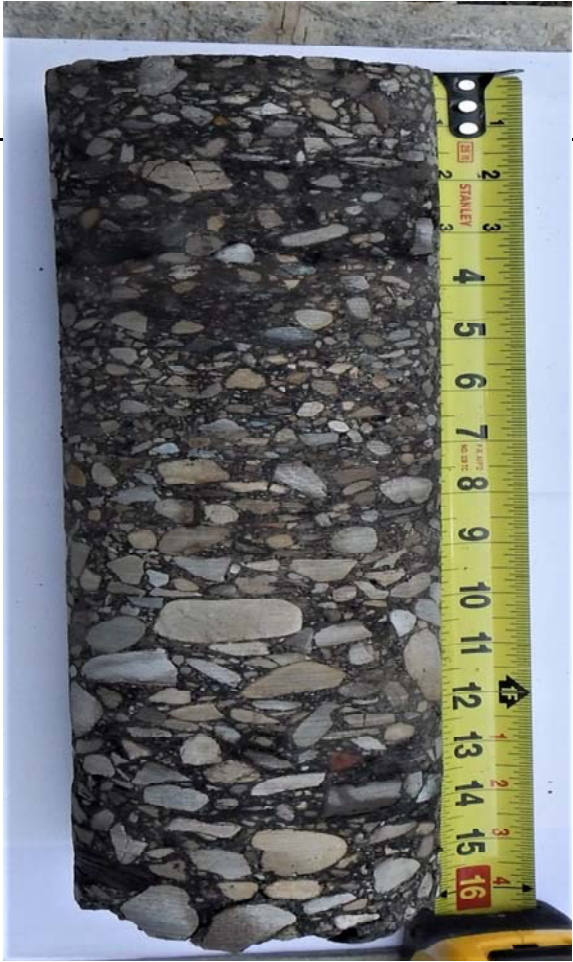
# C-11 CORE LOG

<p><b>Note:</b> Due to the angle at which the photographs were taken, the description to the right of the above core may appear to be slightly above or below the actual feature being described.</p> <p>FACE OF THE CORE IS AT ZERO</p> <p>ASPHALT PAVEMENT TO FULL DEPTH</p> <p>ASPHALT PAVEMENT DEPTH FROM 0.0" - 15.0"</p> <p>PAVEMENT CORE DIAMETER = 3.75"</p> <p>JOINT AND WHEEL RUTTING CRACKS WERE OBSERVED ON THE PAVEMENT SURFACE IN THE VICINITY OF THE CC LOCATION.</p> <p>ASPHALT PAVEMENT APPEARS TO BE IN FAIR TO POOR CONDITION.</p> <p>PAVEMENT HOLE DEPTH = 15.0"</p>

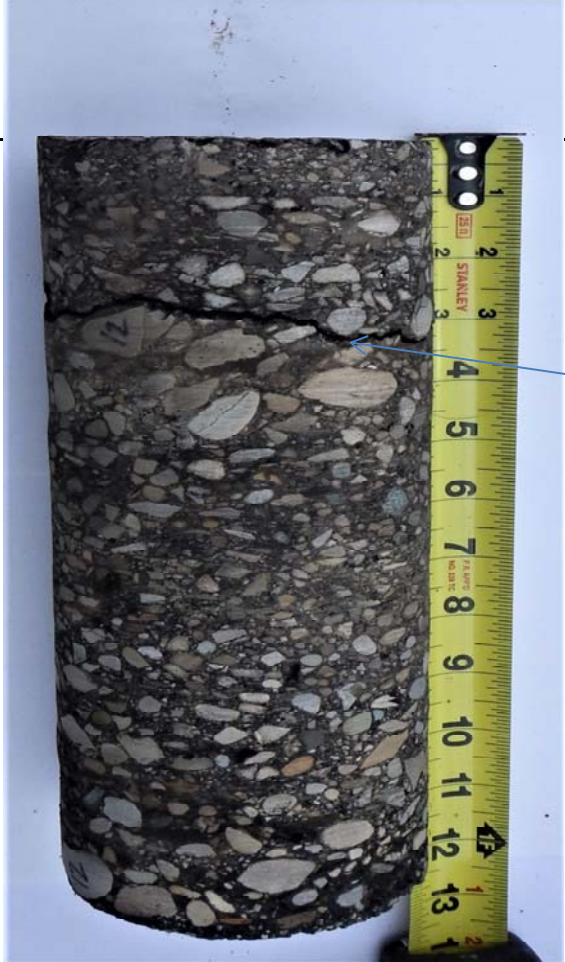
# C-12 CORE LOG

<p><b>Note:</b> Due to the angle at which the photographs were taken, the description to the right of the above core may appear to be slightly above or below the actual feature being described.</p> <p>FACE OF THE CORE IS AT ZERO</p> <p>ASPHALT PAVEMENT TO FULL DEPTH</p> <p>ASPHALT PAVEMENT DEPTH FROM 0.0" - 11.0"</p> <p>PAVEMENT CORE DIAMETER = 3.75"</p> <p>MECHANICAL BREAK</p> <p>JOINT AND WHEEL RUTTING CRACKS WERE OBSERVED ON THE PAVEMENT SURFACE IN THE VICINITY OF THE CORE LOCATION.</p> <p>ASPHALT PAVEMENT APPEARS TO BE IN FAIR TO POOR CONDITION.</p> <p>PAVEMENT HOLE DEPTH = 11.0"</p>
	<p><b>Core Location</b></p>

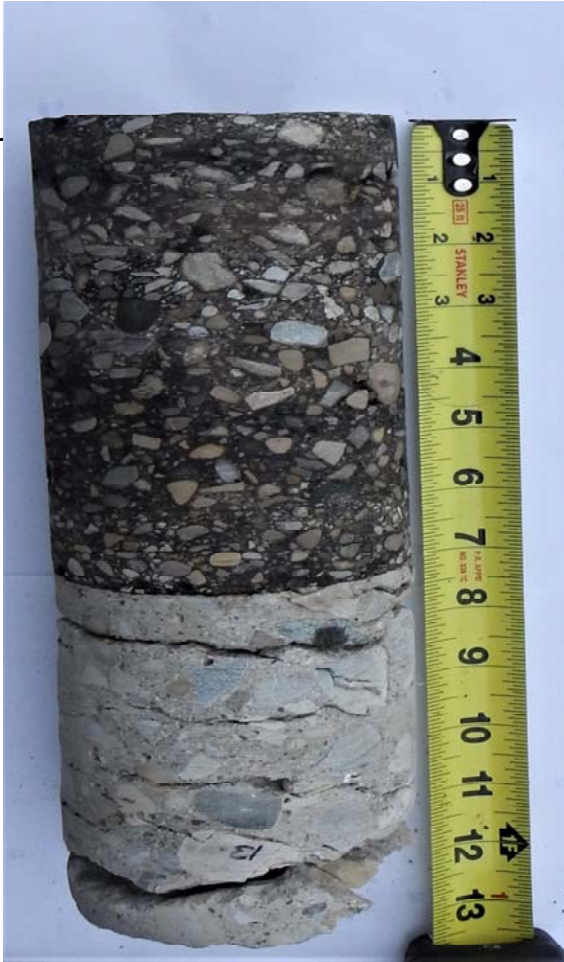
# C-13 CORE LOG

<p><b>Note:</b> Due to the angle at which the photographs were taken, the description to the right of the above core may appear to be slightly above or below the actual feature being described.</p> <p>FACE OF THE CORE IS AT ZERO                  COMPOSITE PAVEMENT TO FULL DEPTH</p> <p>ASPHALT PAVEMENT DEPTH FROM 0.0" - 7.0"</p> <p>PAVEMENT CORE DIAMETER = 3.75"</p> <p>JOINT, WHEEL RUTTING, ALLIGATOR, LONGITUDINAL, AND LATERAL CRACKS WERE OBSERVED ON THE PAVEMENT SURFACE IN THE VICINITY OF THE CORE LOCATION.                  ASPHALT PAVEMENT APPEARS TO BE IN FAIR TO POOR CONDITION.</p> <p>CONCRETE PAVEMENT DEPTH FROM 7.0" - 12.0"</p> <p>DELAMINATION CRACKS WERE OBSERVED.</p> <p>CONCRETE PAVEMENT APPEARS TO BE IN POOR CONDITION</p> <p>PAVEMENT HOLE DEPTH = 12.0"</p>

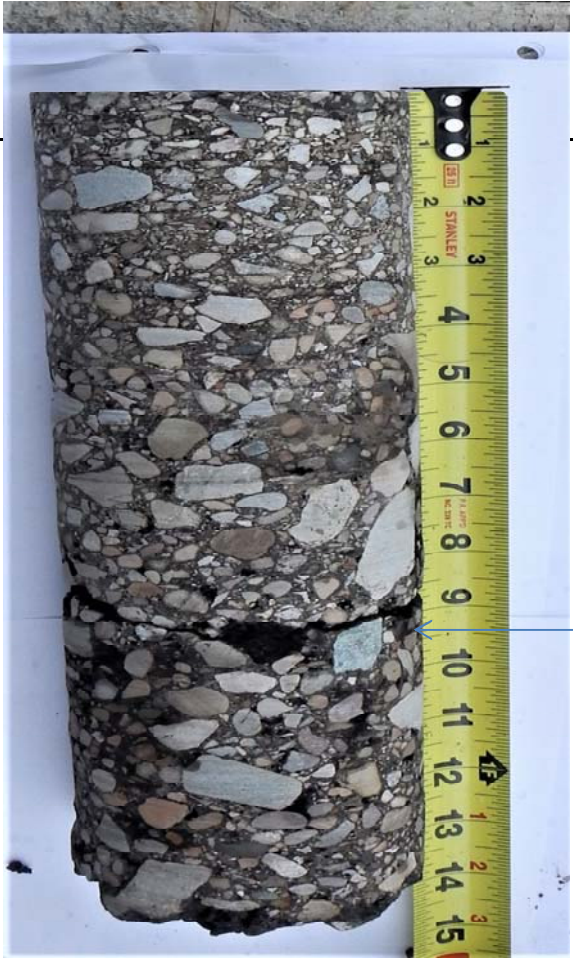
# C-14 CORE LOG

<p><b>Note:</b> Due to the angle at which the photographs were taken, the description to the right of the above core may appear to be slightly above or below the actual feature being described.</p> <p>FACE OF THE CORE IS AT ZERO</p> <p>ASPHALT PAVEMENT TO FULL DEPTH</p> <p>ASPHALT PAVEMENT DEPTH FROM 0.0" - 13.0"</p> <p>PAVEMENT CORE DIAMETER = 3.75"</p> <p>JOINT AND WHEEL RUTTING CRACKS WERE OBSERVED ON THE PAVEMENT SURFACE IN THE VICINITY OF THE CC LOCATION.</p> <p>ASPHALT PAVEMENT APPEARS TO BE IN FAIR CONDITION.</p> <p>MECHANICAL BREAK</p> <p>PAVEMENT HOLE DEPTH = 13.0"</p>
