## Engineer's Report

### Bridge No. RIC-30-1642

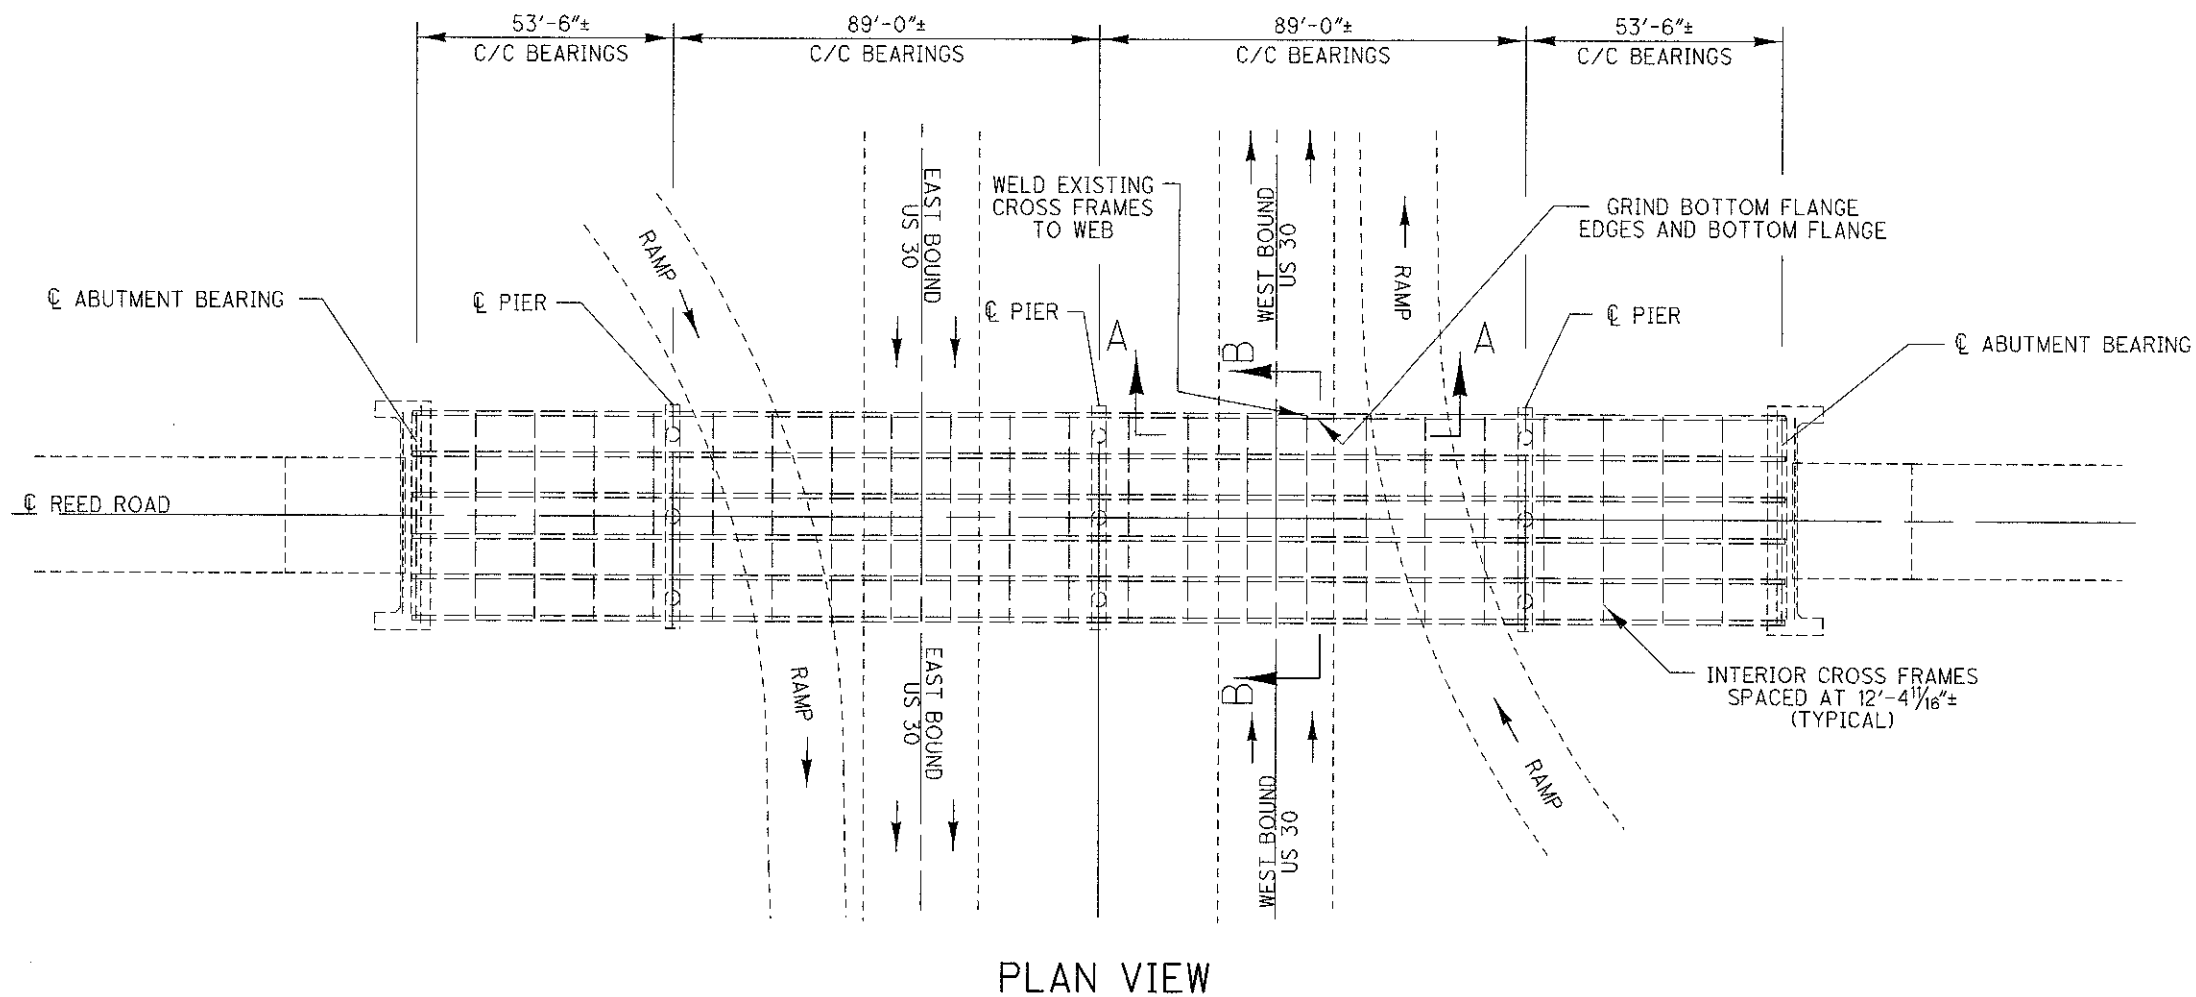
**Attachment C**  
**Selected Details from Previous**  
**Bridge Hit Repairs**

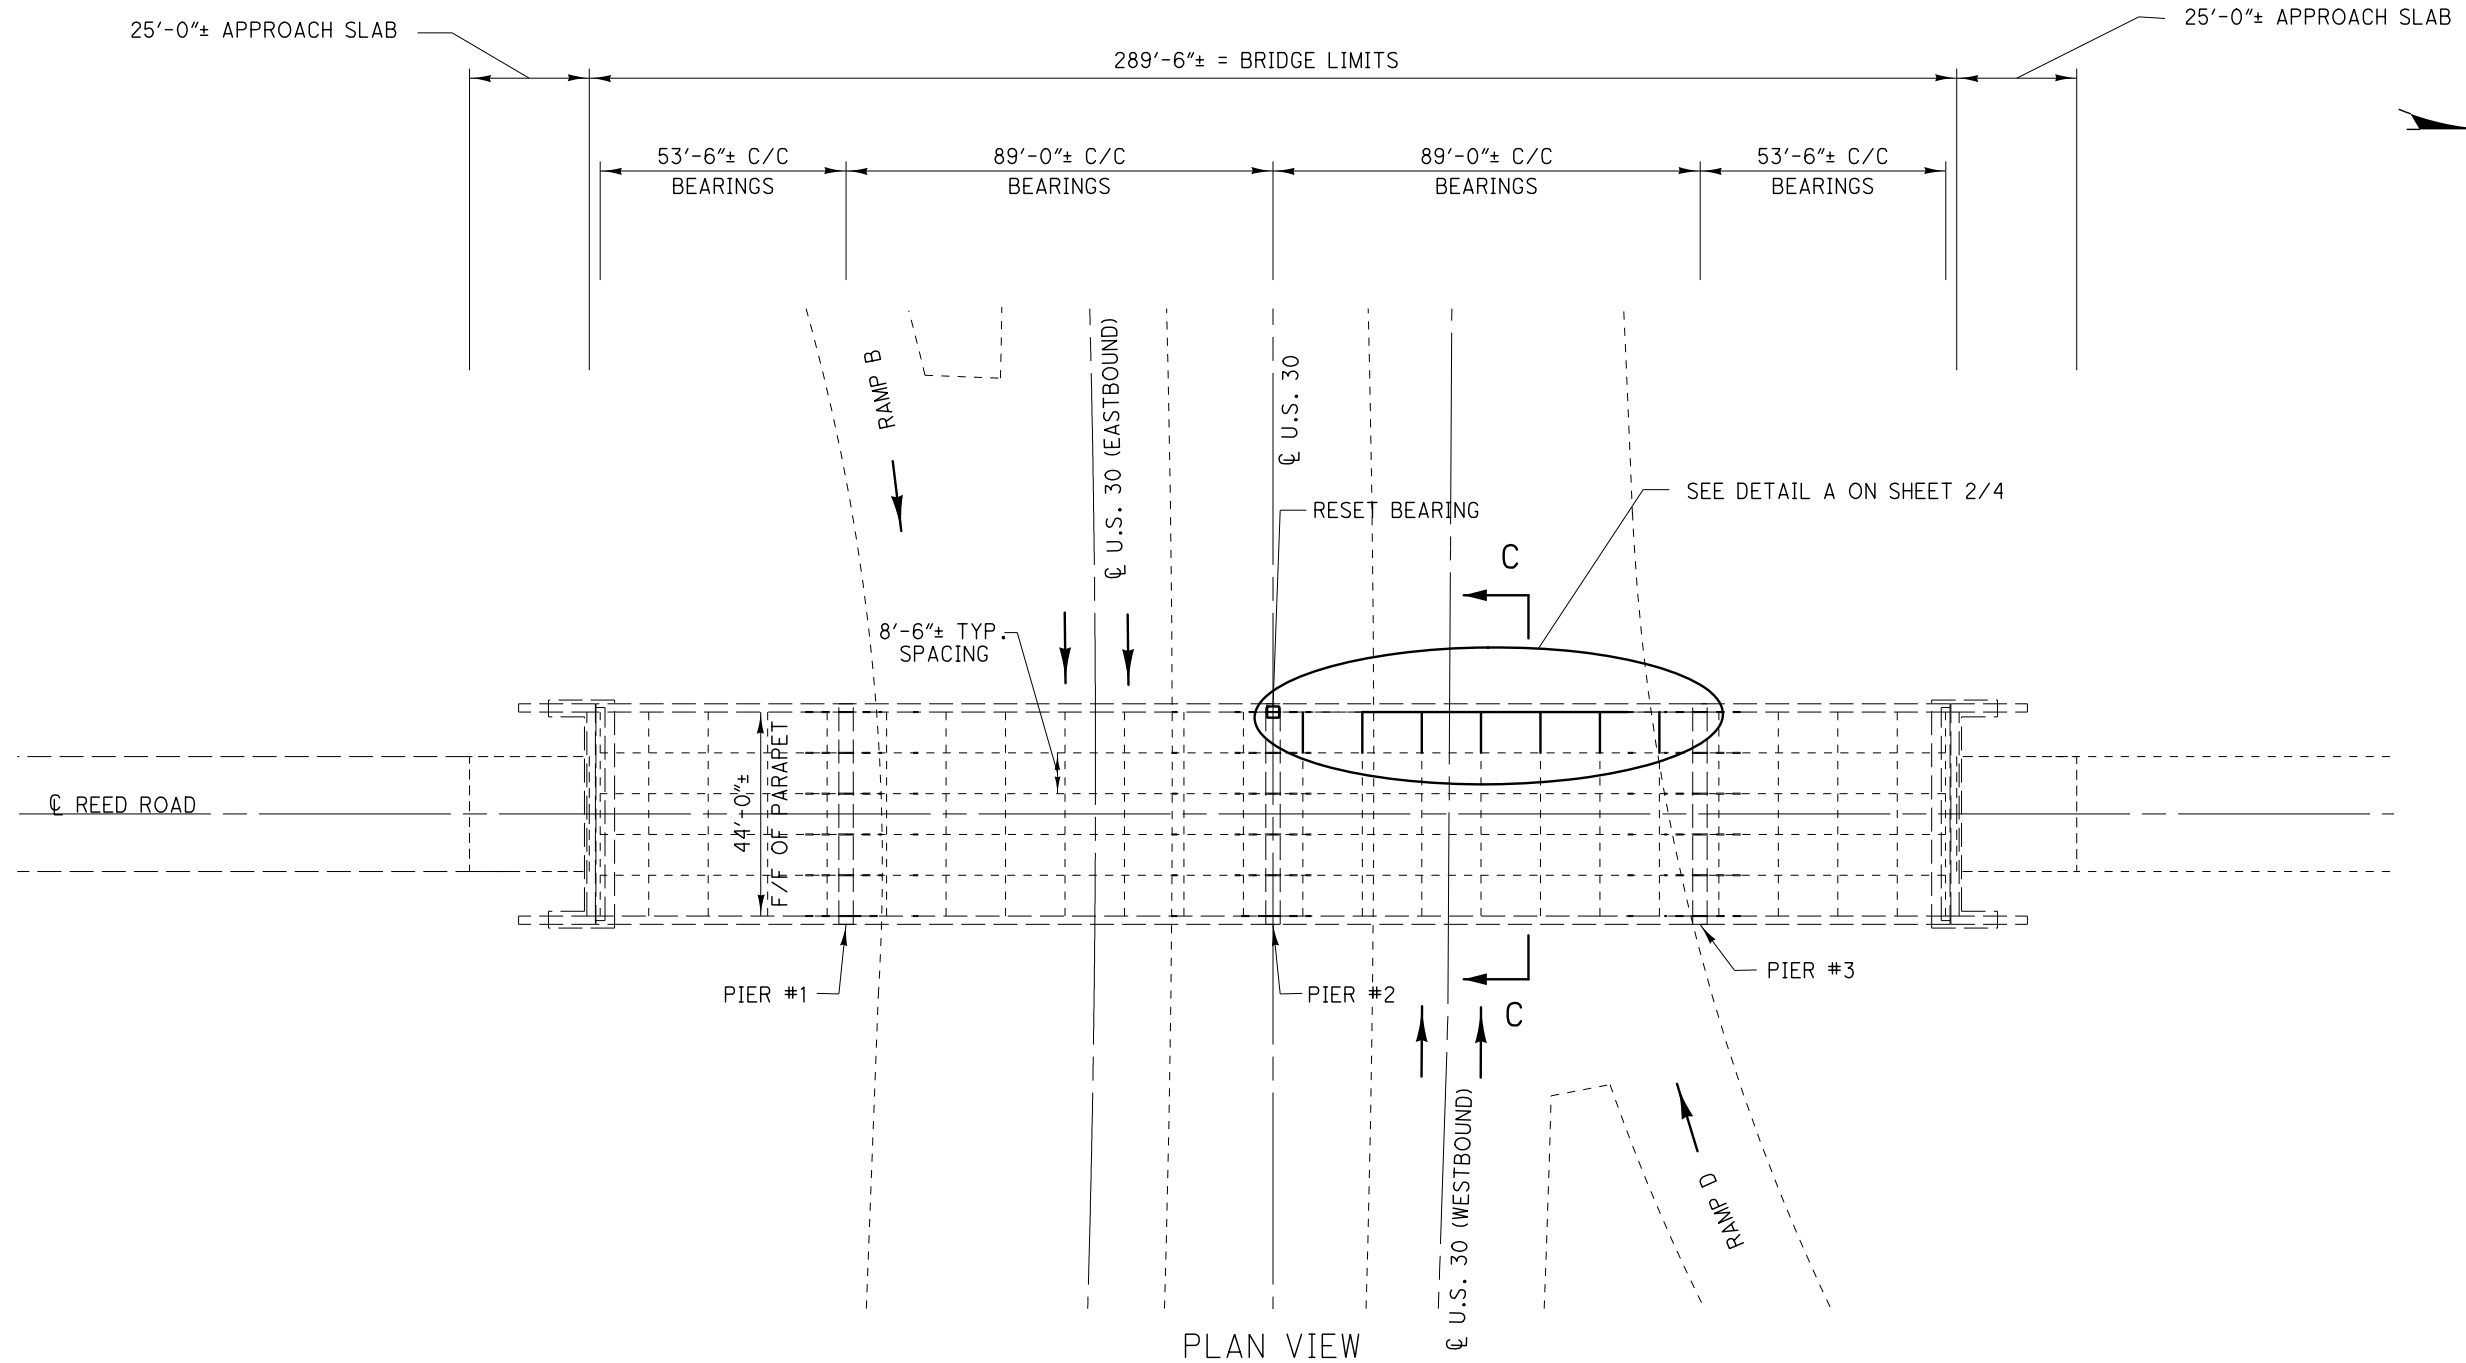
DESIGNED DCM	CHECKED DUJ	DRAWN DCM	REVIEWED RCN	DATE 6/10	DESIGN AGENCY ODOT DISTRICT THREE OFFICE OF PRODUCTION
COLLISION REPAIR DETAILS RIC-30-1640 UNDER REED ROAD				STRUCTURE FILE NUMBER 7001517	
RIC / ASD-30-13.18 / 0.00 RIC-42-13.74					
3 / 4					
104					
116

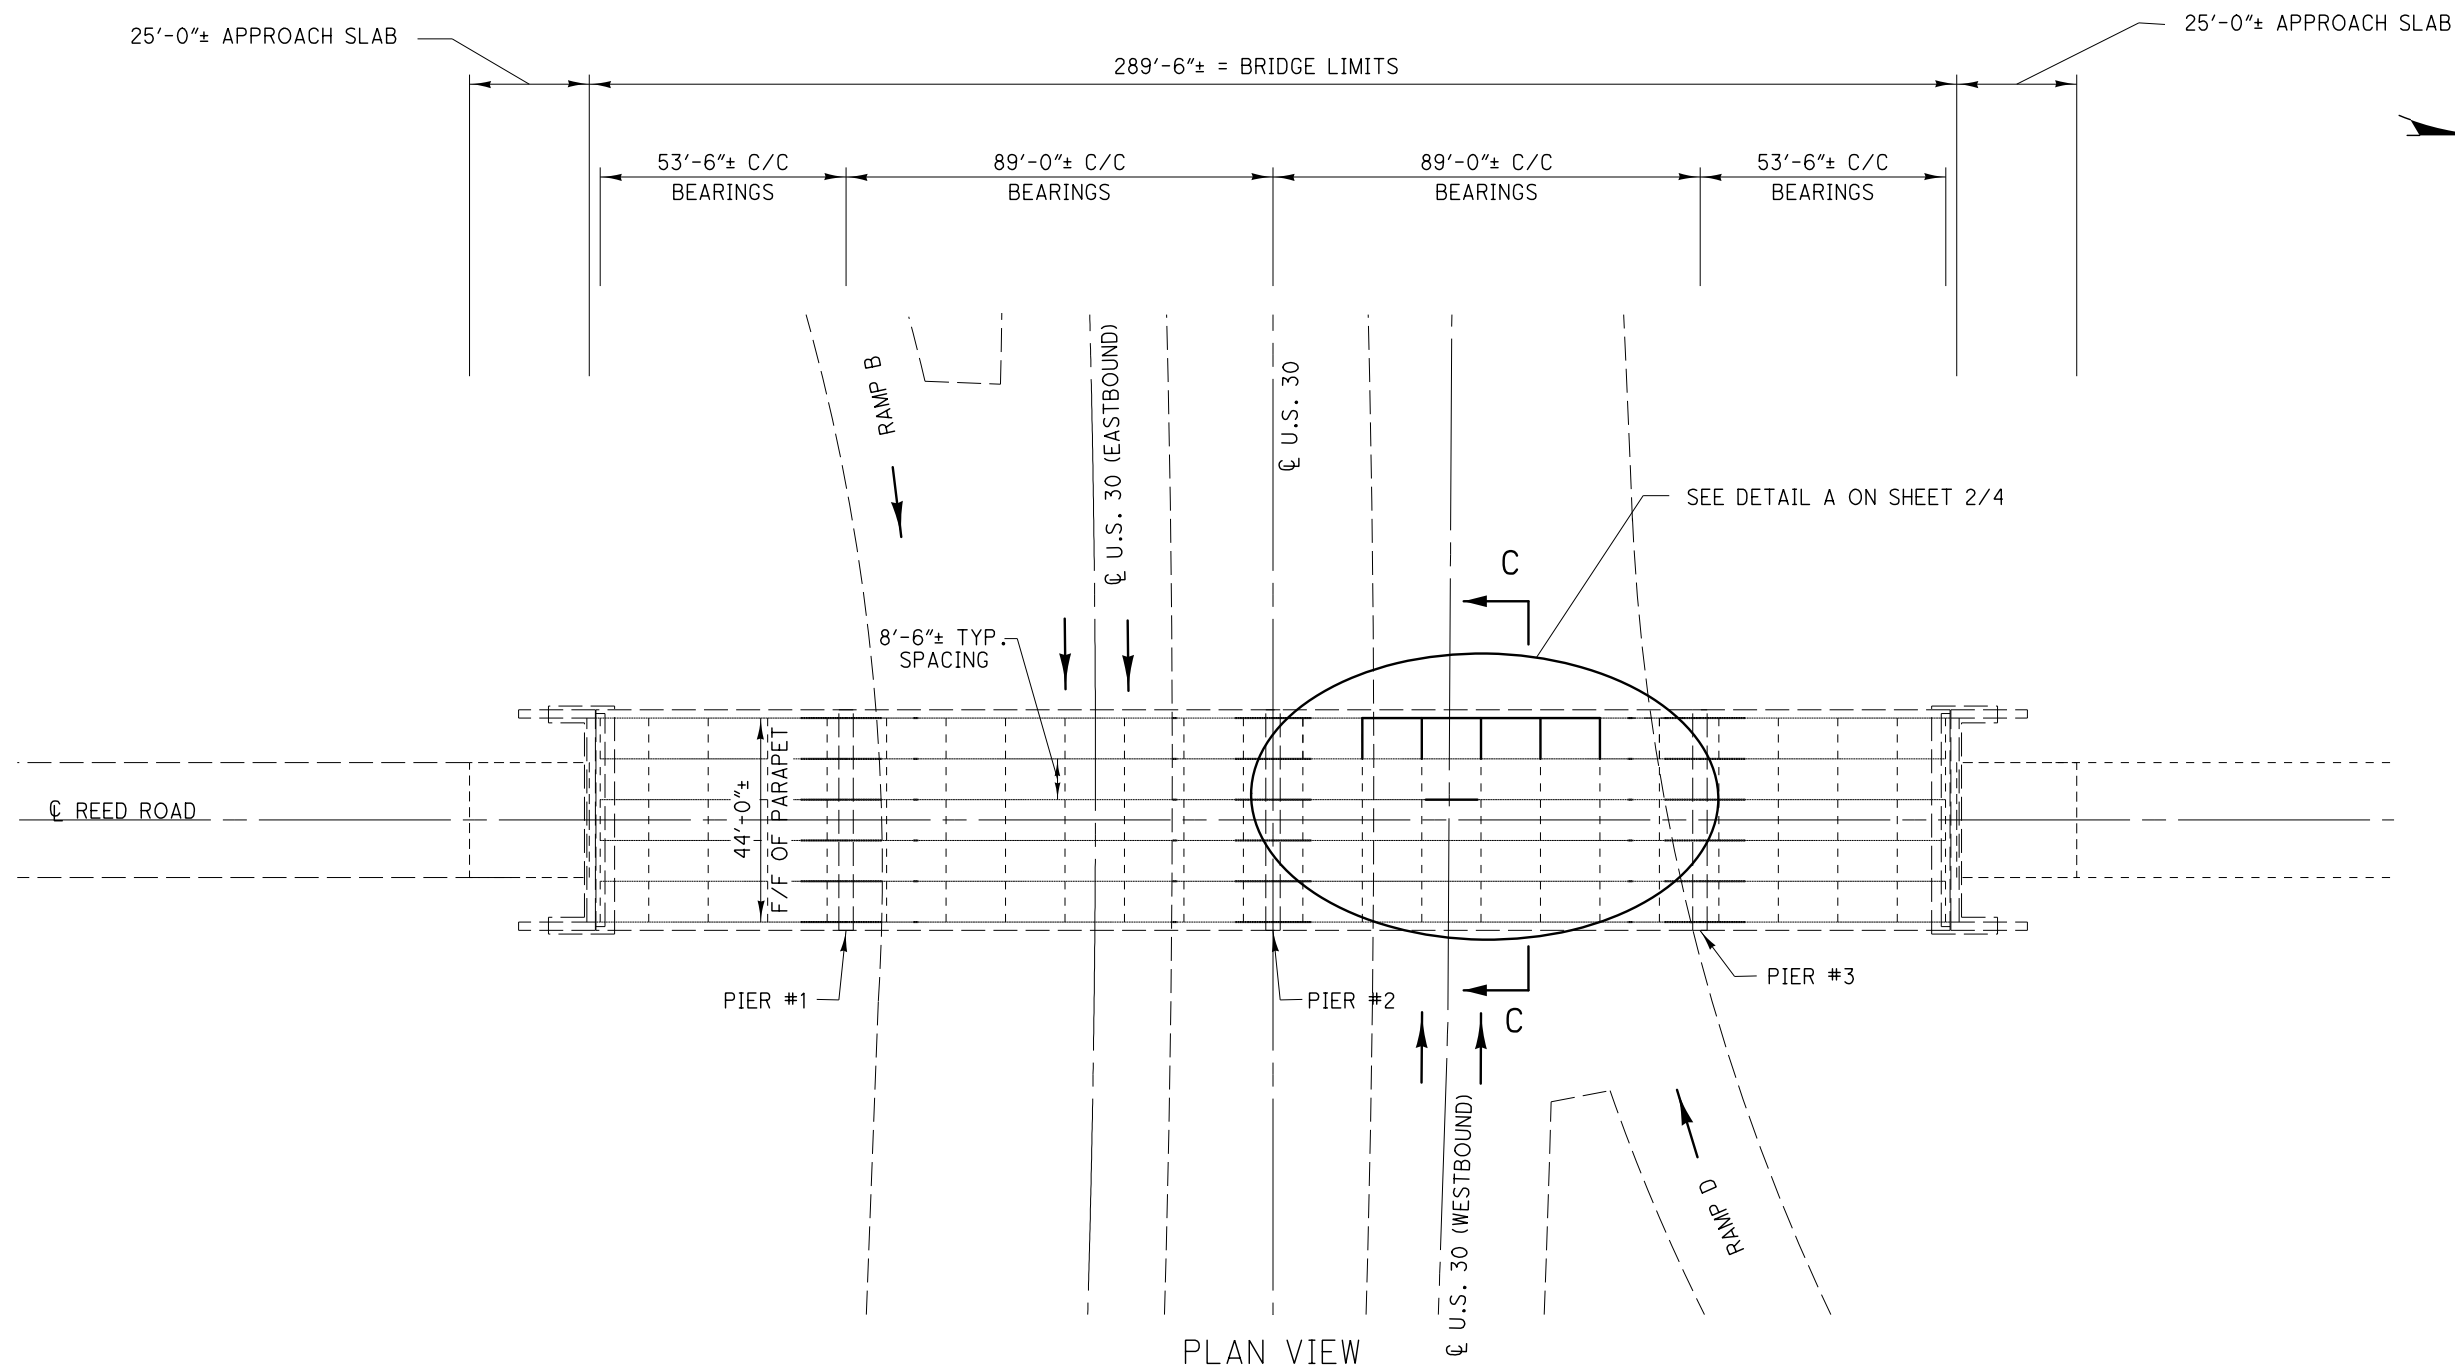
DESIGN AGENCY		ODOT DISTRICT THREE CAPITAL PROGRAMS	
DESIGNED	NR	CHECKED	KCK
DRAWN	NR	REVISED	
REVIEWED	KAK	STRUCTURE FILE NUMBER	7001517
DATE	05/19		
DETAIL A AND SECTION A-A U.S. 30 UNDER REED ROAD.			
RIC-30-16.42			
2 / 4		10 / 12

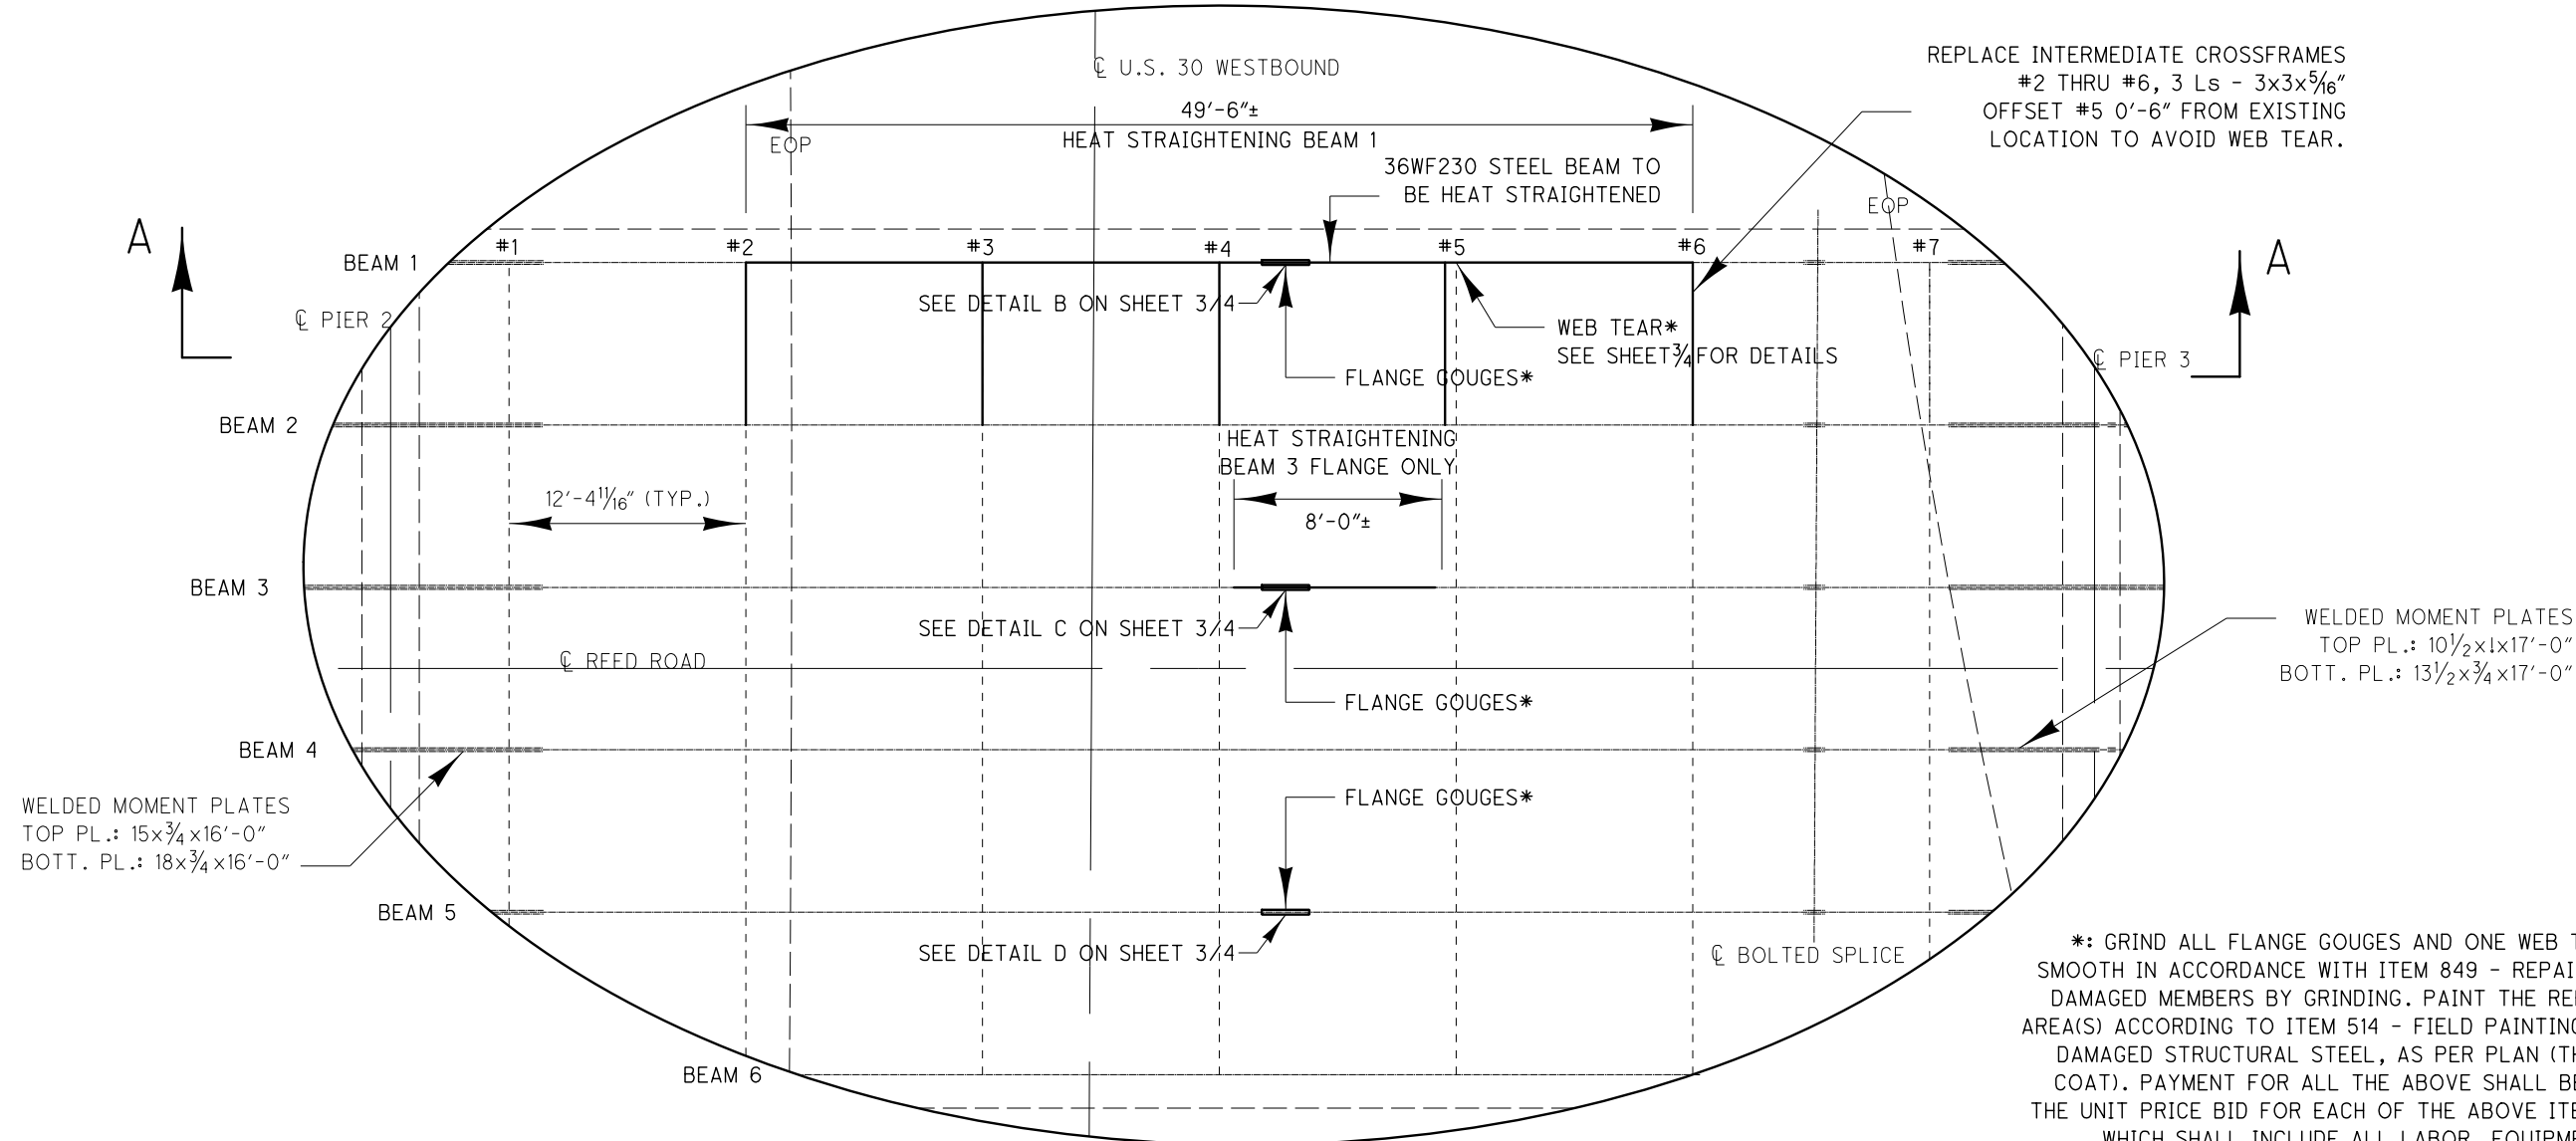
RIC-30-16.42  
PID No. 114029

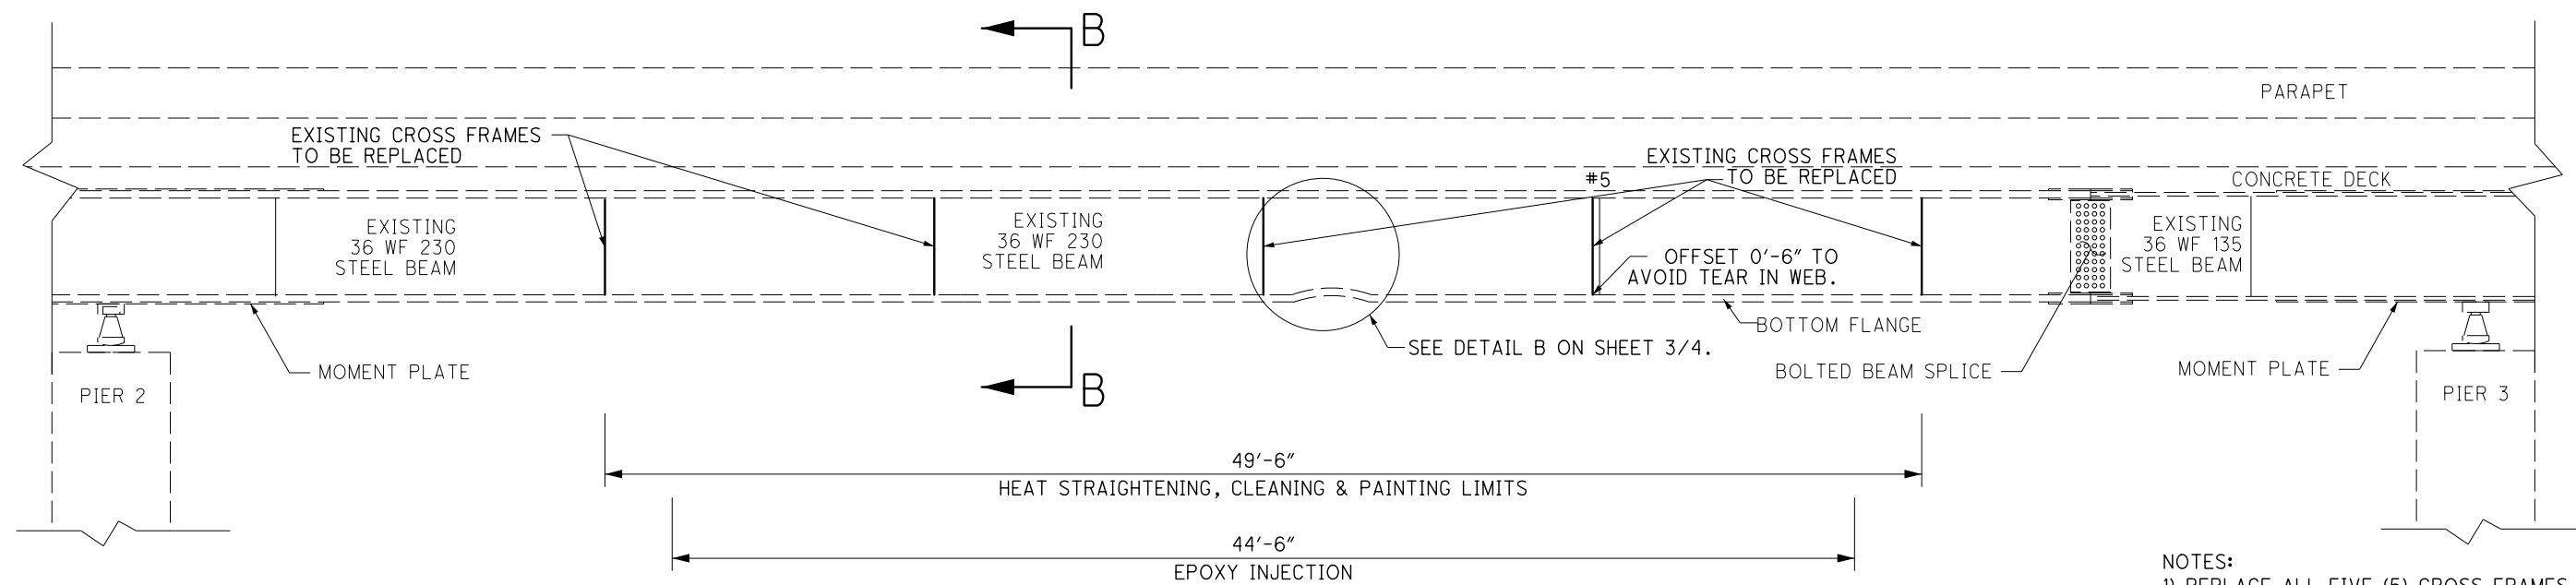
\*: GRIND ALL FLANGE GOUGES AND ONE WEB TEAR SMOOTH IN ACCORDANCE WITH ITEM 849 - REPAIRING DAMAGED MEMBERS BY GRINDING. PAINT THE REPAIR AREA(S) ACCORDING TO ITEM 514 - FIELD PAINTING OF DAMAGED STRUCTURAL STEEL, AS PER PLAN (THREE COAT). PAYMENT FOR ALL THE ABOVE SHALL BE AT THE UNIT PRICE BID FOR EACH OF THE ABOVE ITEMS, WHICH SHALL INCLUDE ALL LABOR, EQUIPMENT, MATERIALS AND INCIDENTALS NECESSARY TO COMPLETE THE ABOVE DESCRIBED WORK.

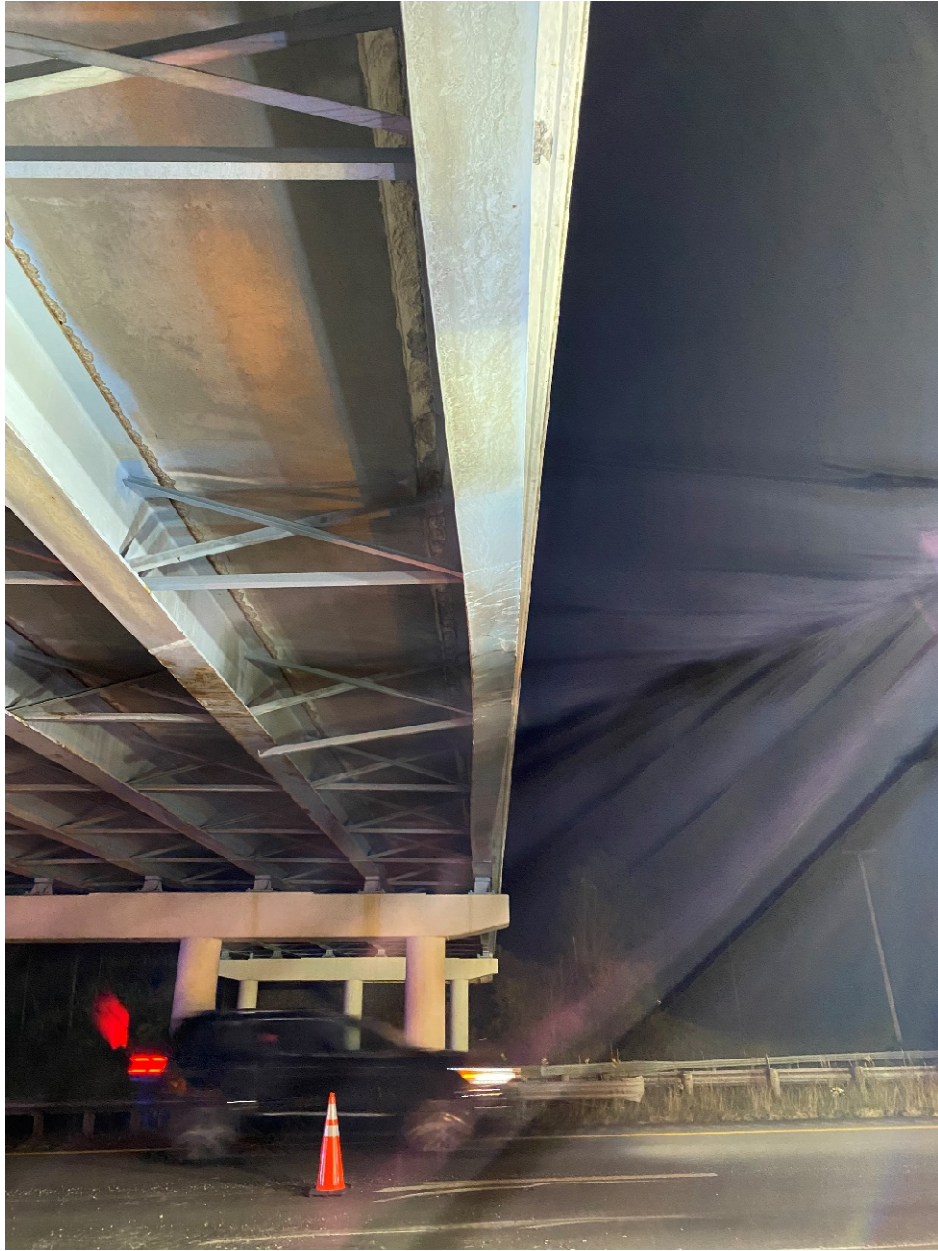
*Photo # 1 - Span 3 Beams 1 and 2, looking south, immediately following impact*

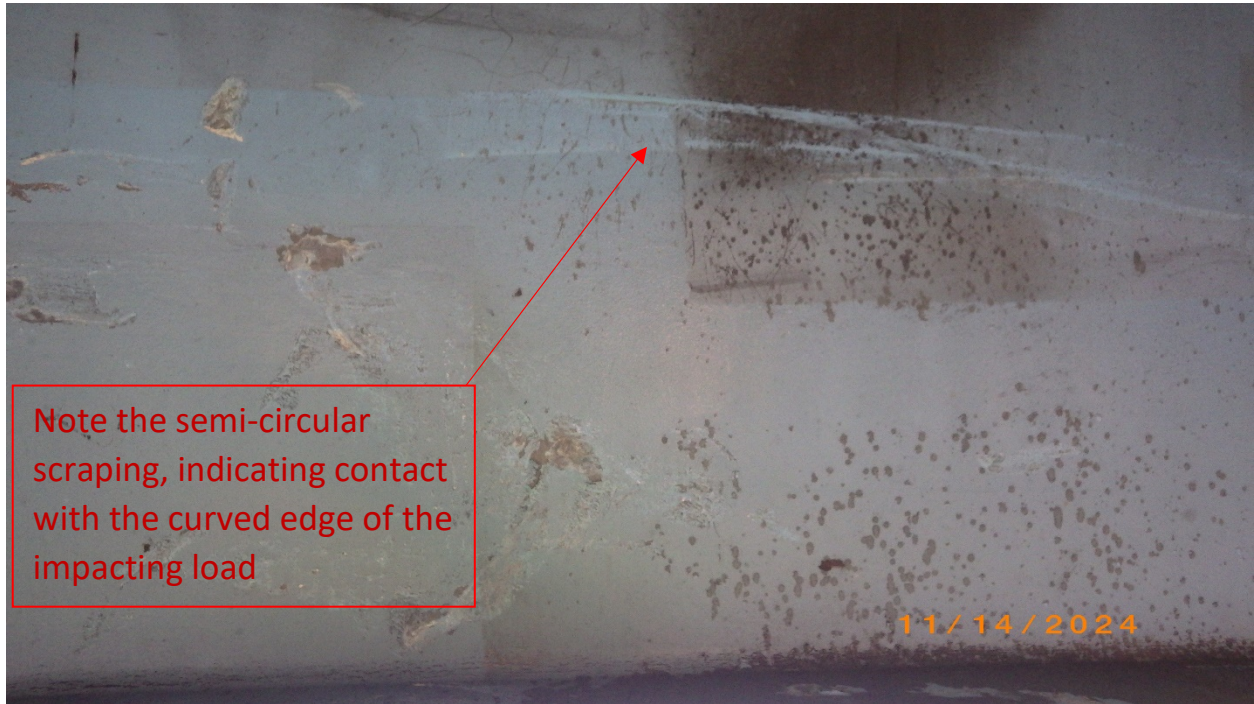
**Photo # 4** - Beam 1, inside surface of web at point of impact, showing superficial damage

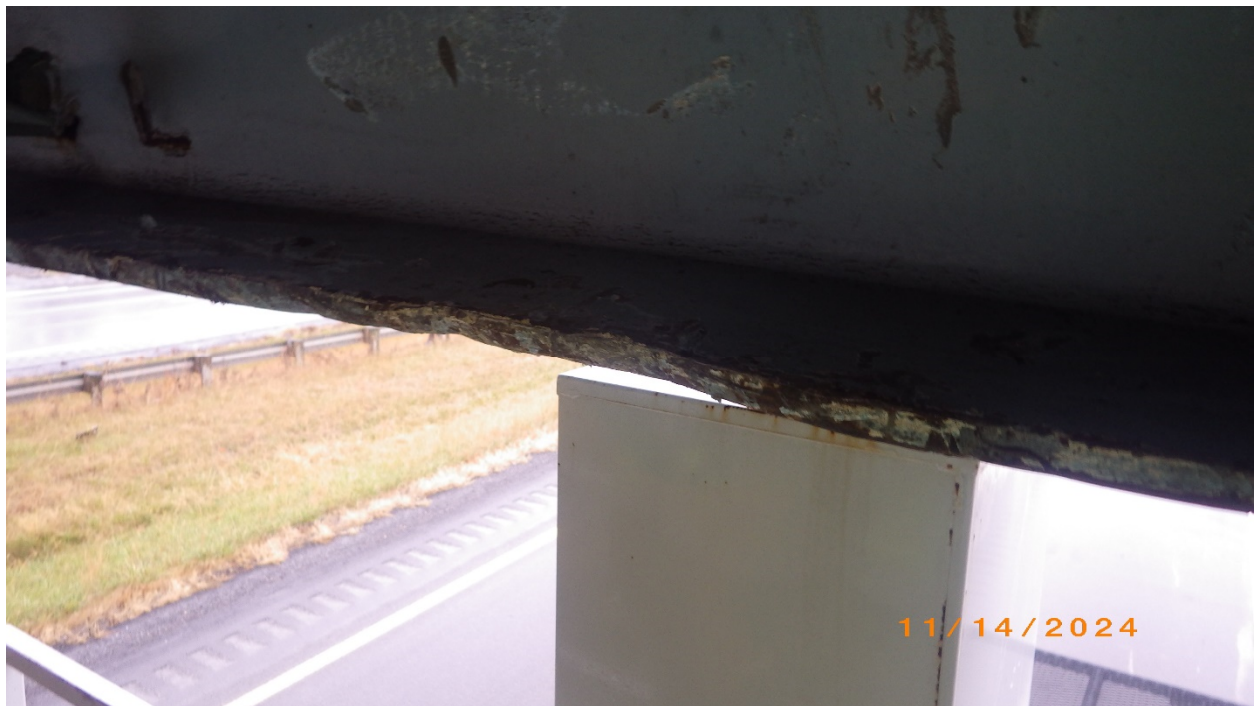
**Photo # 5** - Beam 1, bottom flange condition at point of impact

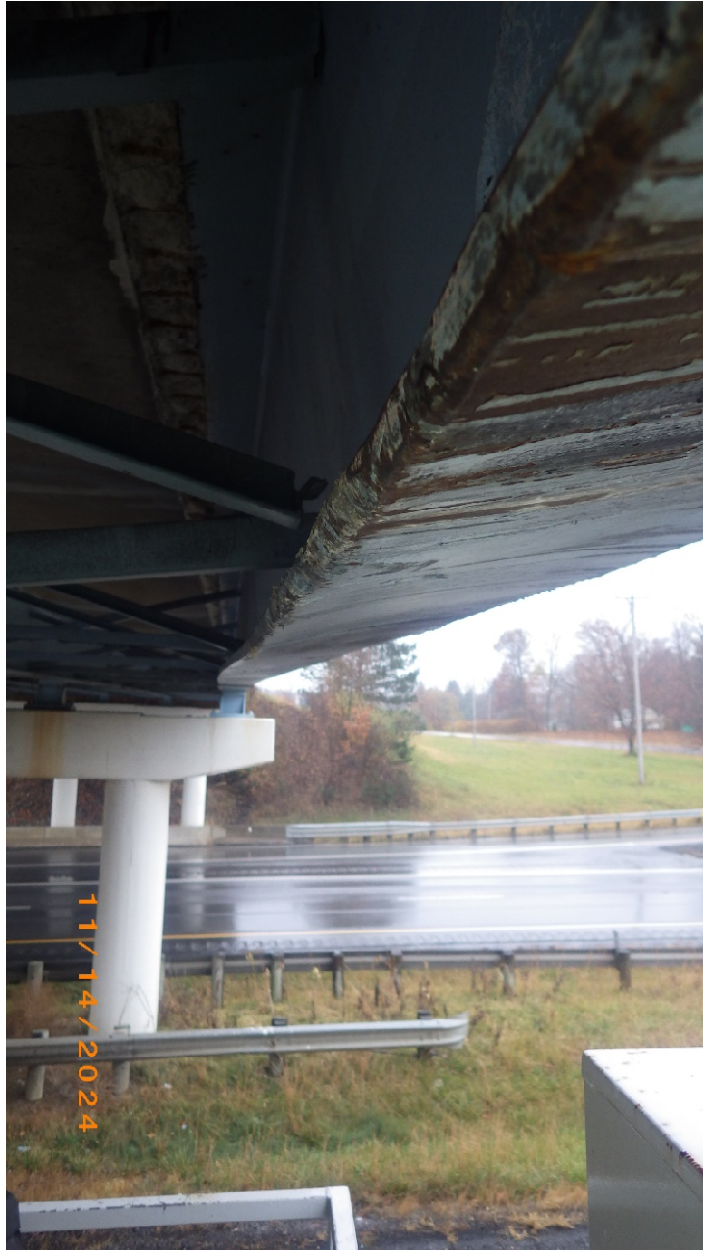
*Photo # 6 - Beam 1, bottom flange, looking South from point of impact*

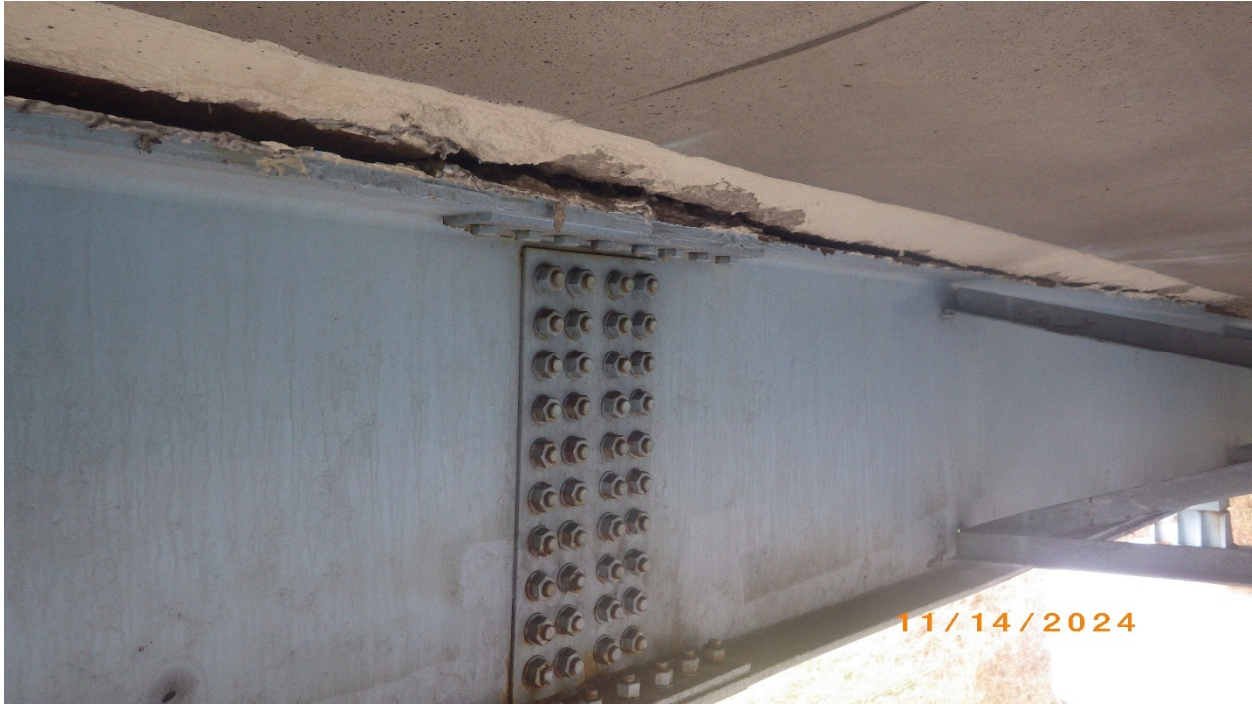
**Photo # 15** – Beam 1 Span 3 Splice Plate. Note fresh spalling

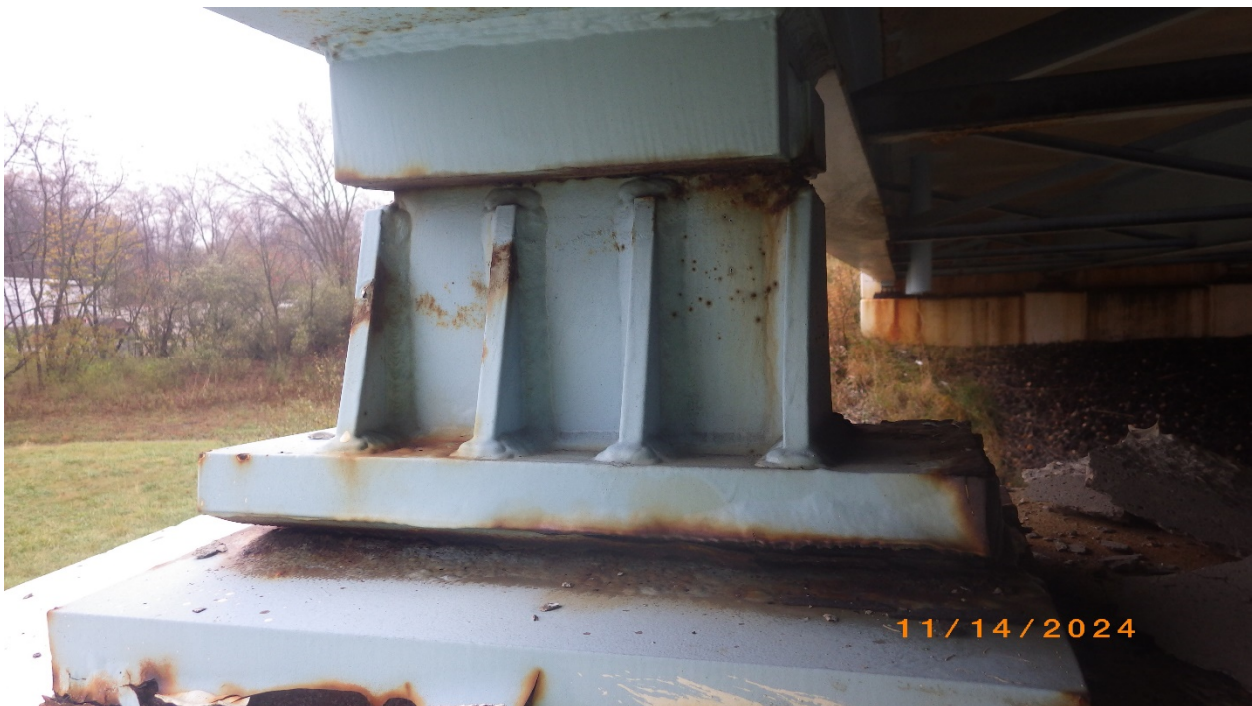
**Photo # 16** – Bearing 1, Pier 3

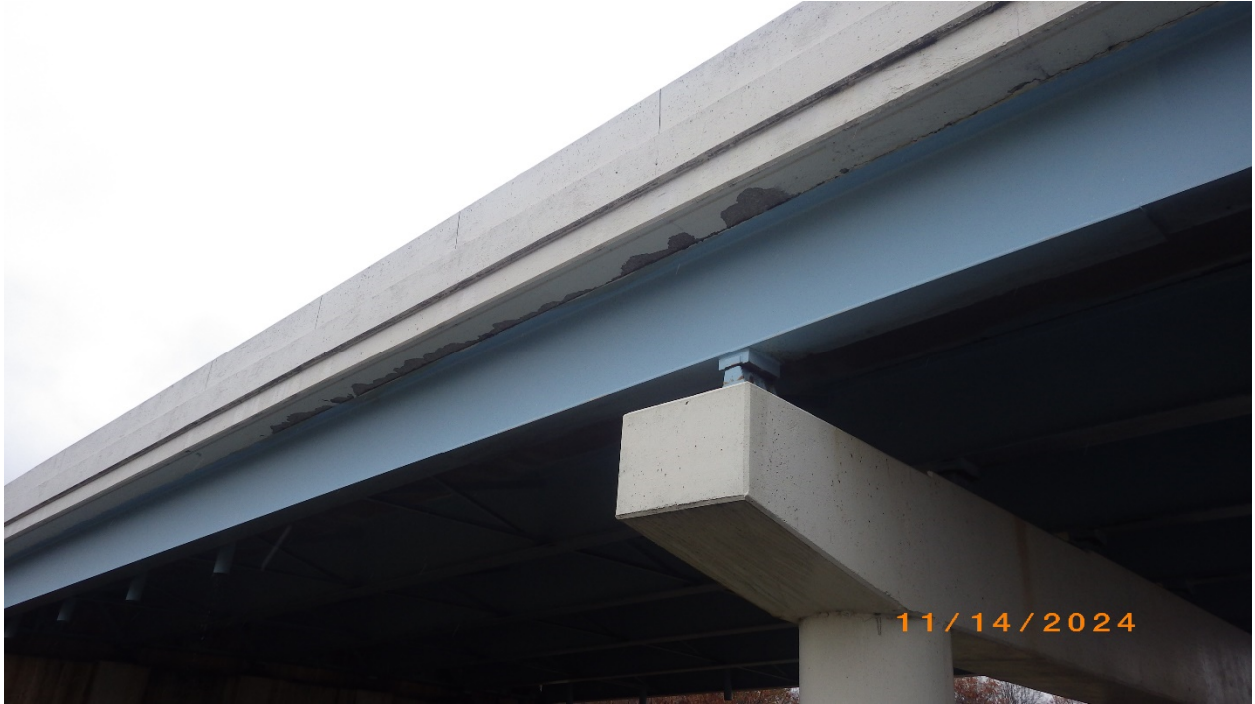
**Photo # 17** – Span 3, Beam 1, outside, looking South. Note spalling

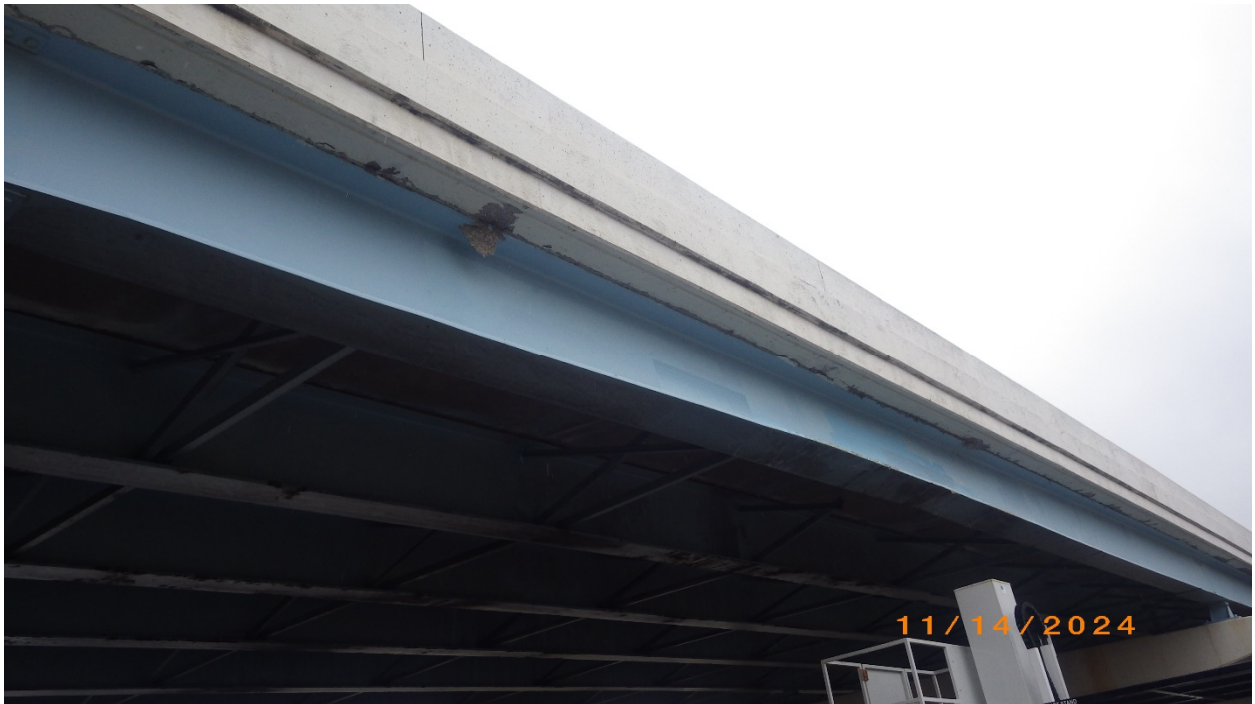
**Photo # 18** – Span 3, Beam 1, outside, looking North. Note spalling. The hanging spall was removed by ODOT forces

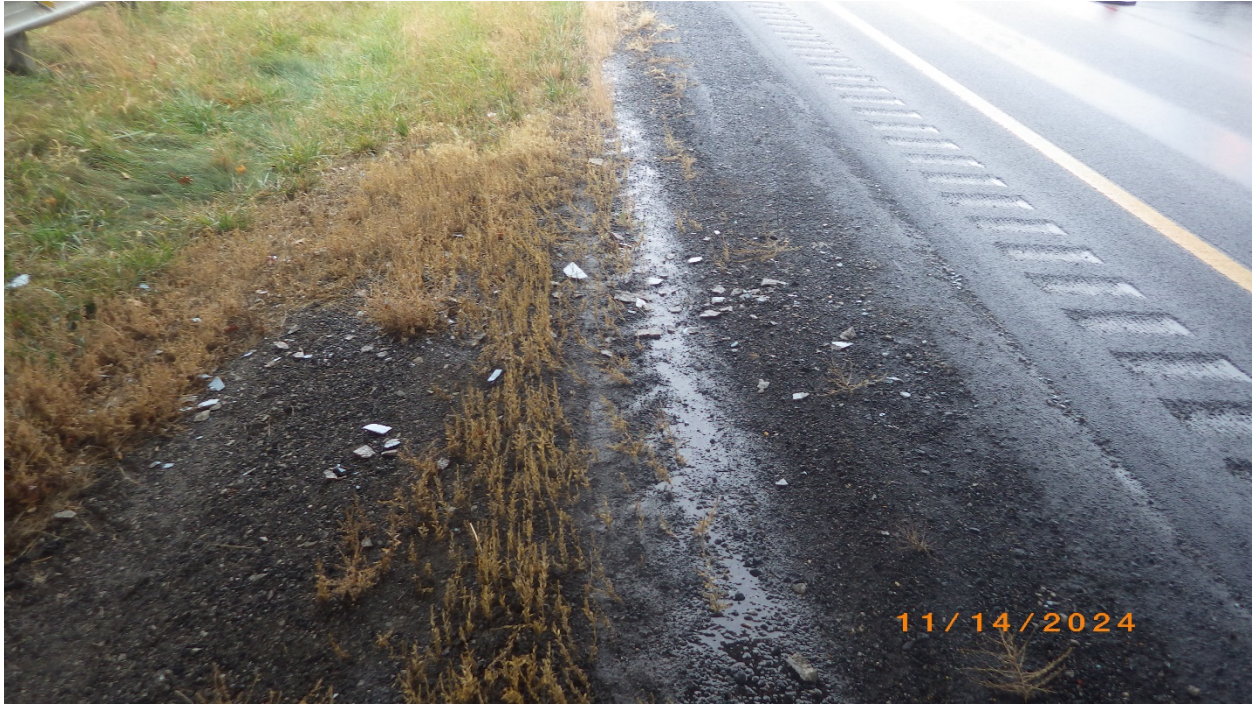
**Photo # 19** – Fresh spalling on shoulder, South side of Westbound roadway

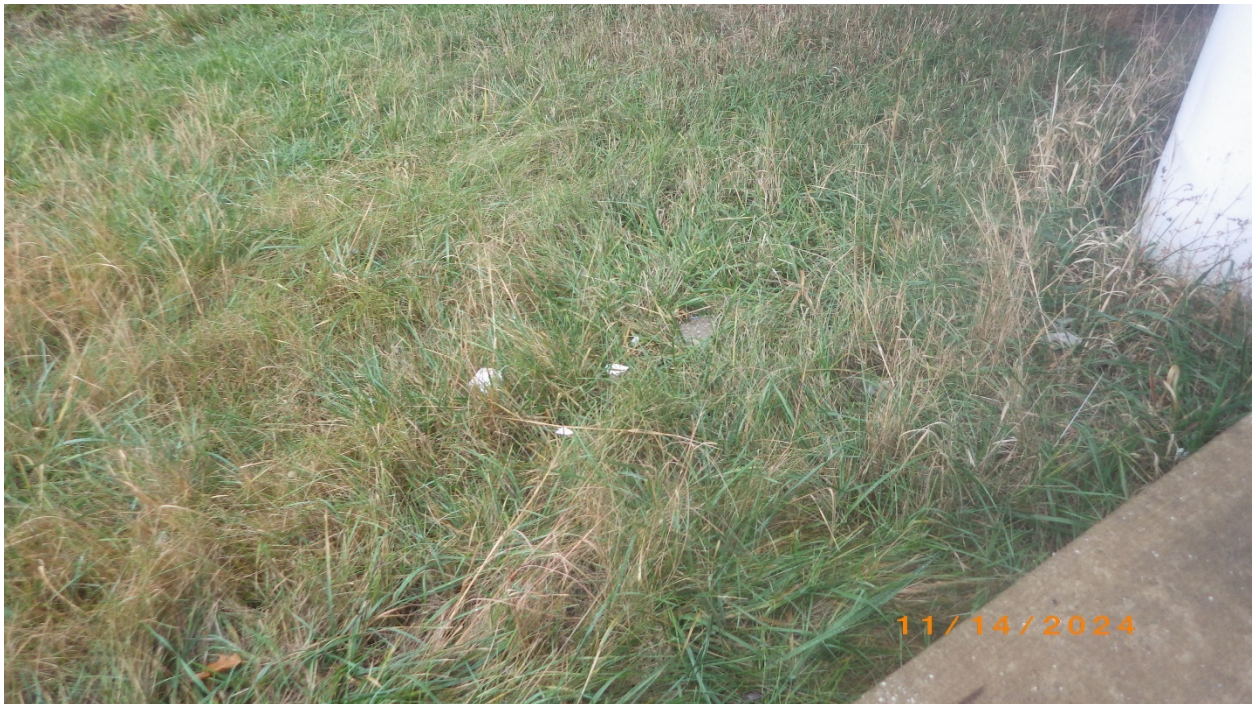
**Photo # 20** – Fresh spalling on shoulder, North side of Westbound roadway
