## Engineer's Report

### Bridge No. RIC-30-1642

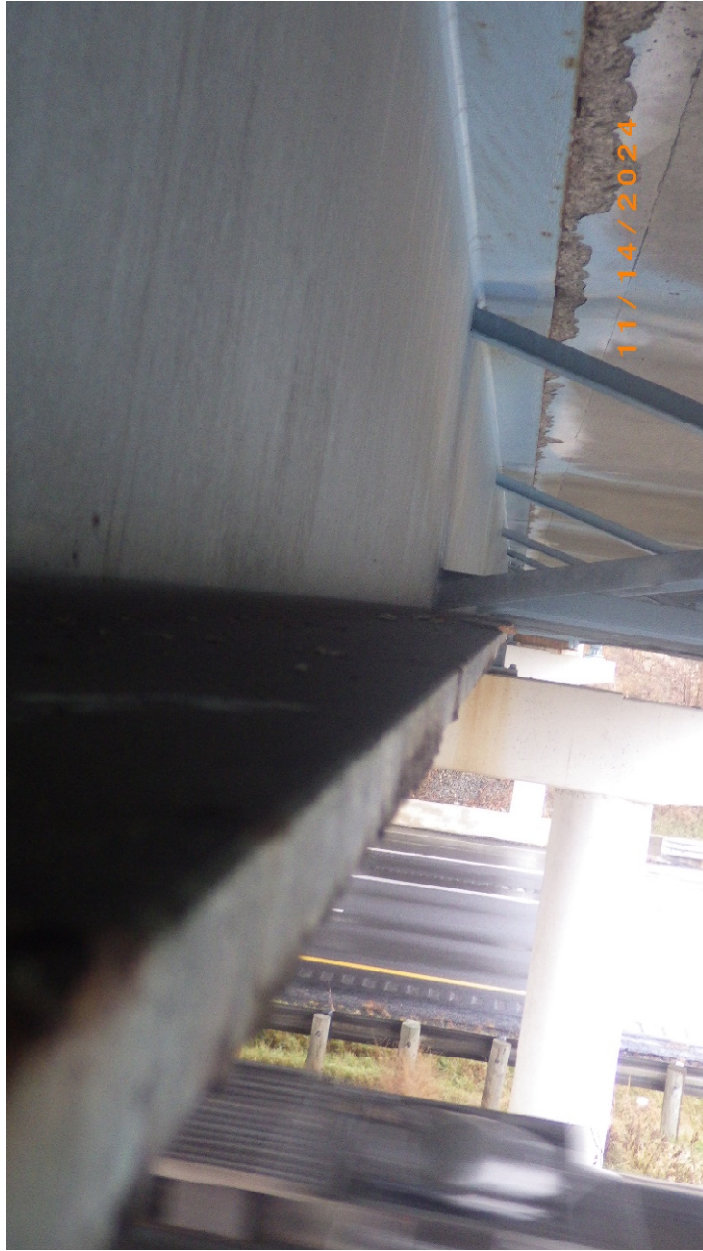
**Photo # 21** – Beam 2, looking South from point of impact. Note spalling

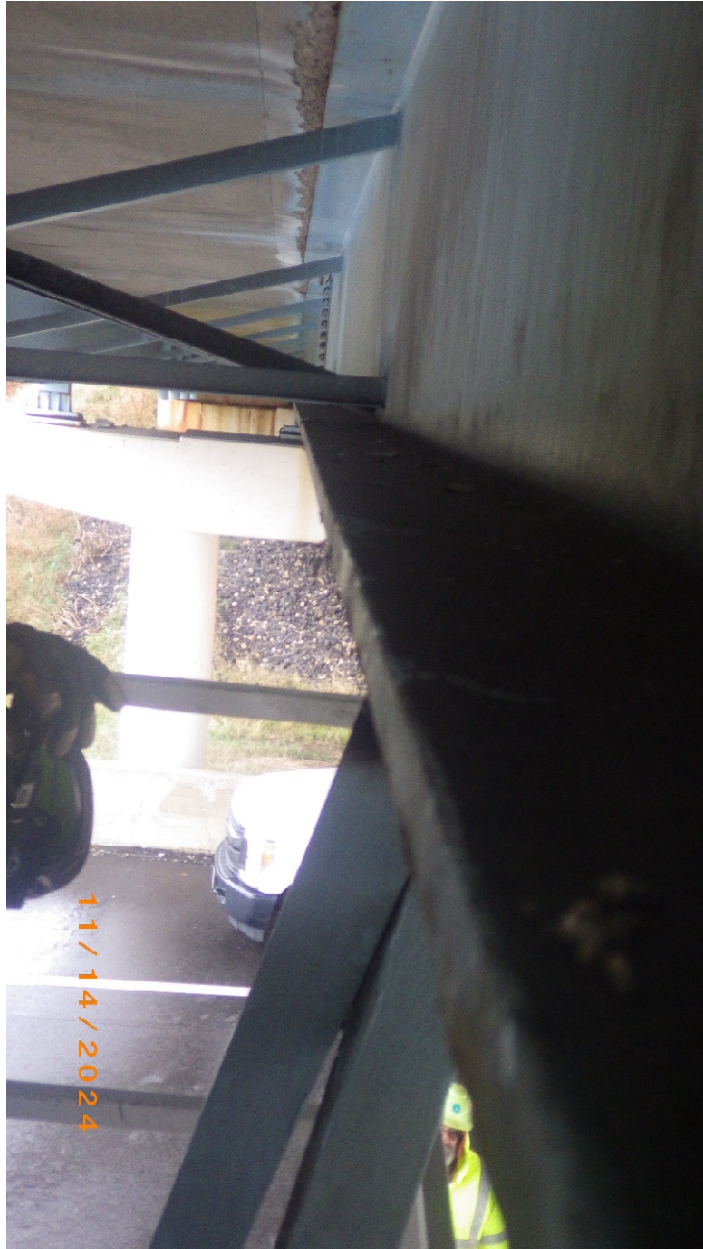
**Photo # 22:** *Beam 2, looking North from point of impact. Note spalling*

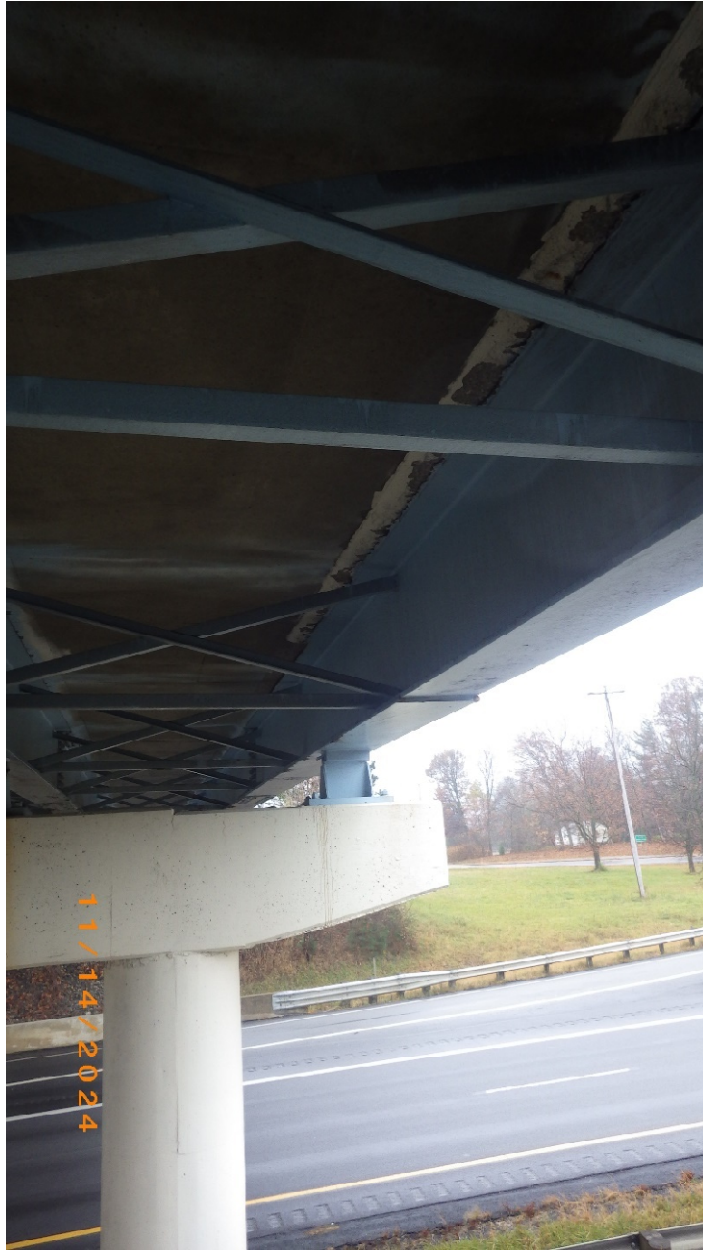
**Photo # 23** – Crossframe 1 & 2, looking south

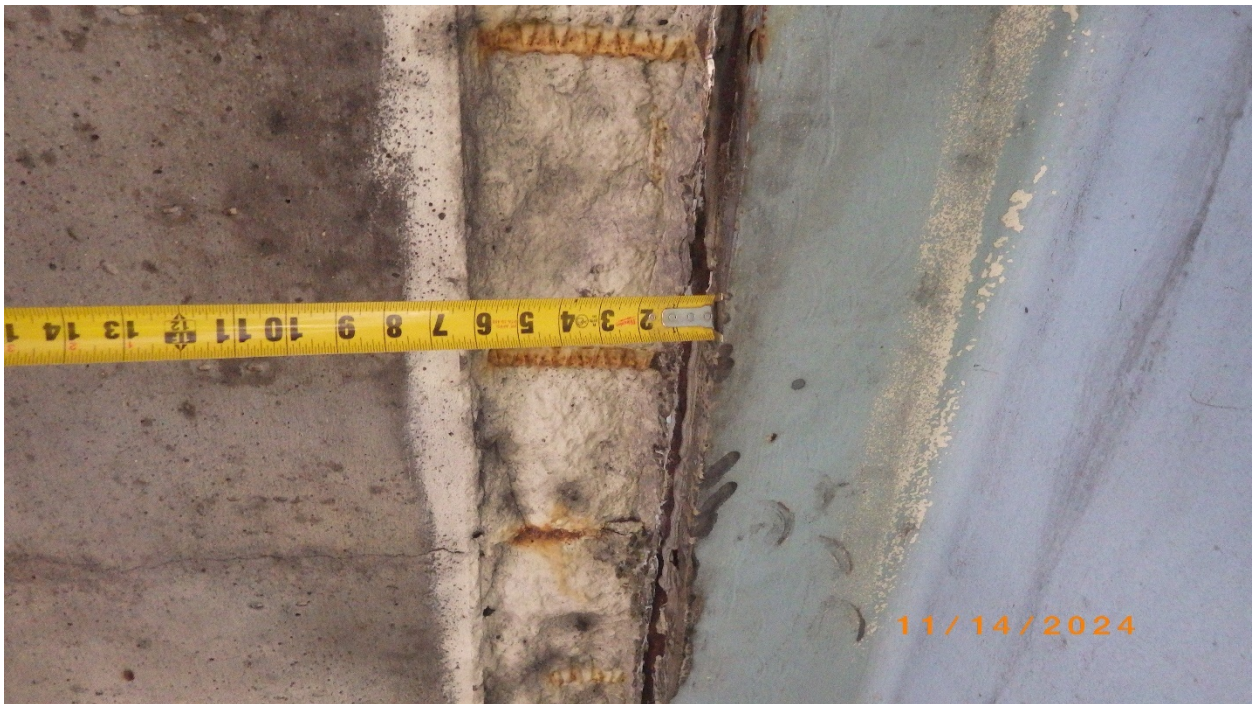
**Photo # 39** – Existing spall from prior incidents, inside of Beam 1 top flange, shown near point of impact

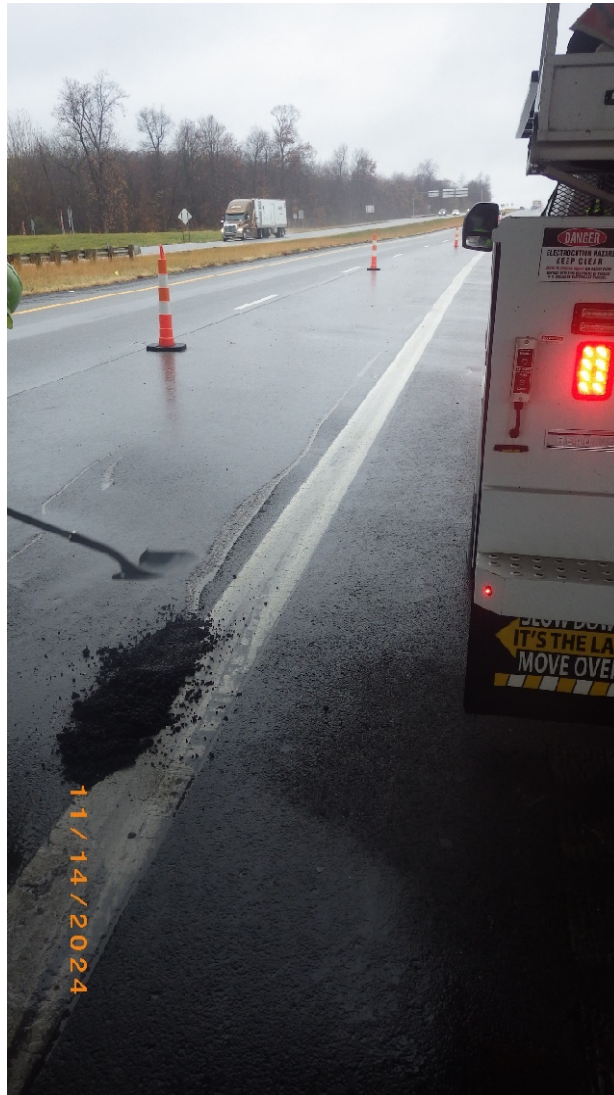
*Photo # 40 – Pavement gouge in Westbound driving lane*
