September 21, 2018 File: 175527006

Reference: Addendum to Report of Geohazard Exploration – SUM-271-8.87 – PID: 103930 - FINAL Summit County, Ohio

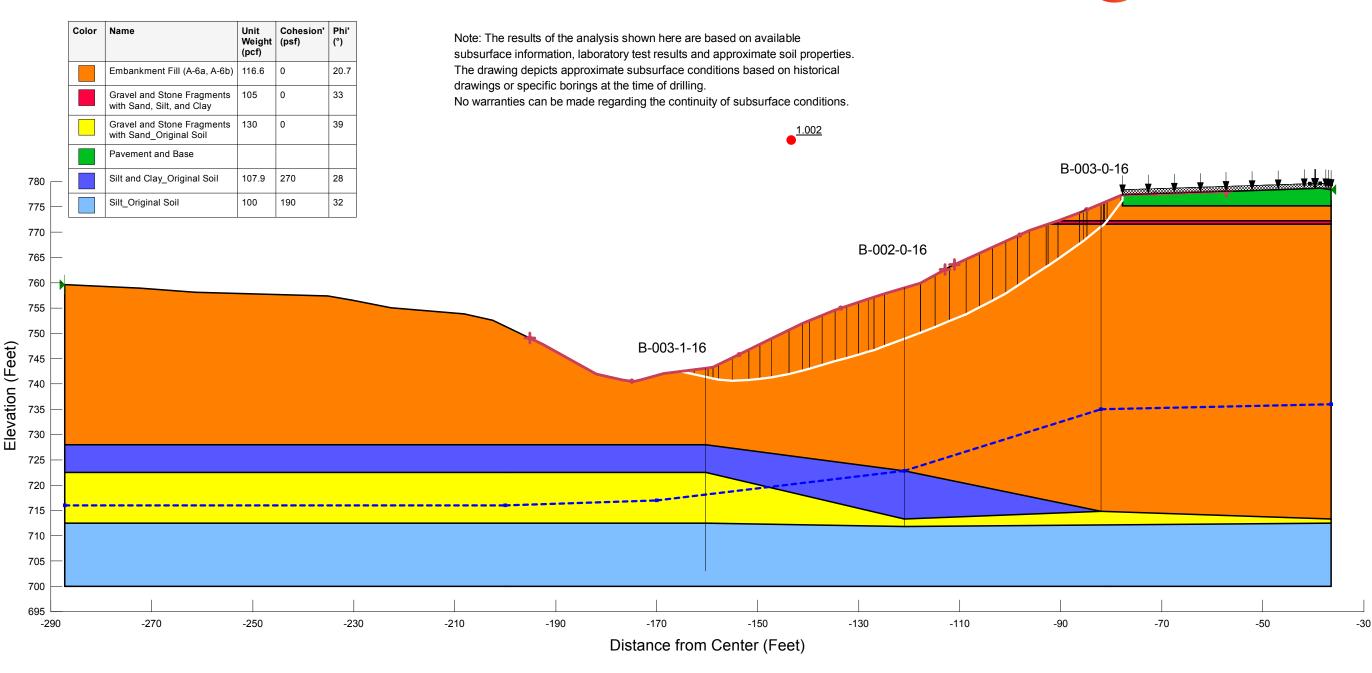
FS=1.0 - 10 ft Slip Surface

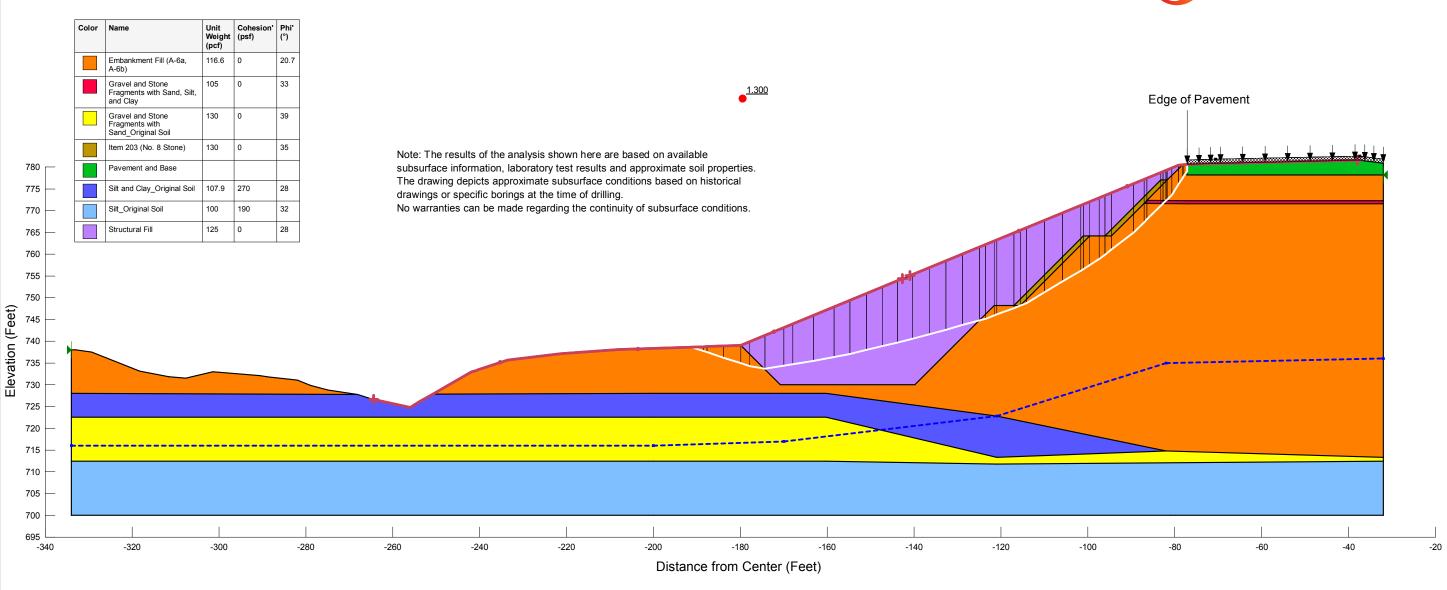
Station 468+00 - Benching Plan

Name	Unit Weight (pcf)	Cohesion' (psf)	Phi' (°)		Stante
Embankment Fill (A-6a, A-6b)	116.6	0	20.7		
Gravel and Stone Fragments with Sand, Silt, and Clay	105	0	33	Note: The results of the analysis shown here are based on available subsurface information, laboratory test results and approximate soil properties.	
Gravel and Stone Fragments with Sand_Original Soil	130	0	39	The drawing depicts approximate subsurface conditions based on historical drawings or specific borings at the time of drilling. No warranties can be made regarding the continuity of subsurface conditions.	
Item 203 (No. 8 Stone)	130	0	35	No warrantes can be made regarding the continuity of subsurface conditions.	
Pavement and Base				4 222	Edge of Pavement
Silt and Clay_Original Soil	107.9	270	28	<u>1.322</u>	
Silt_Original Soil	100	190	32		
Structural Fill	125	0	28		B-003-0-16
				B-002-0-16 B-003-1-16
