**REPORT
ROADWAY EXPLORATION REPORT
UNI/DEL 42-4.92/0.00
UNION & DELAWARE COUNTIES, OHIO
PID#: 111381**

NEAS PROJECT 20-0072

May 25, 2021

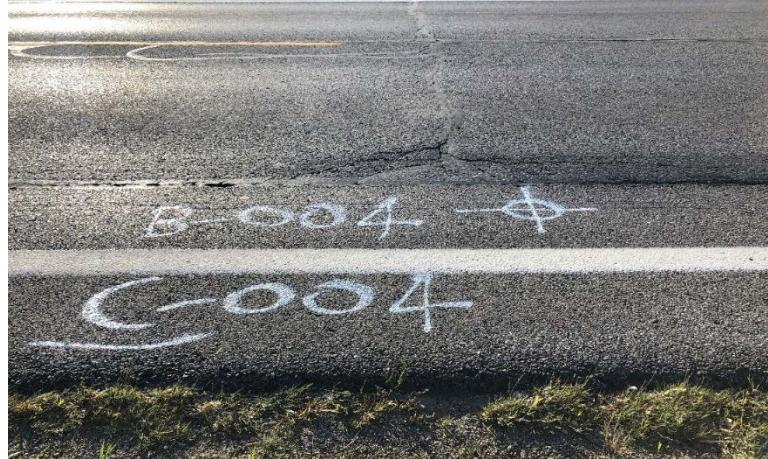
In general, the pavement condition along this section US-42 was observed to be fair with signs of weathering and surface wear consisting of frequent moderate severity longitudinal and transverse cracking, as well as occasional moderate severity patching and wheel track cracking (Photograph 1). The roadway in this section is close to grade with the surrounding area which is relatively flat. The roadway slopes very gradually downwards from southwest to northeast. The roadway drains to vegetated open drainage swales on either side of the roadway. Signs of standing water (i.e., cattails) were observed in areas off the eastern shoulder of the roadway along the section of US-42 between Bell Rd and Harriott Rd (Photograph 2).

Photograph 1: Pavement condition near beginning of project

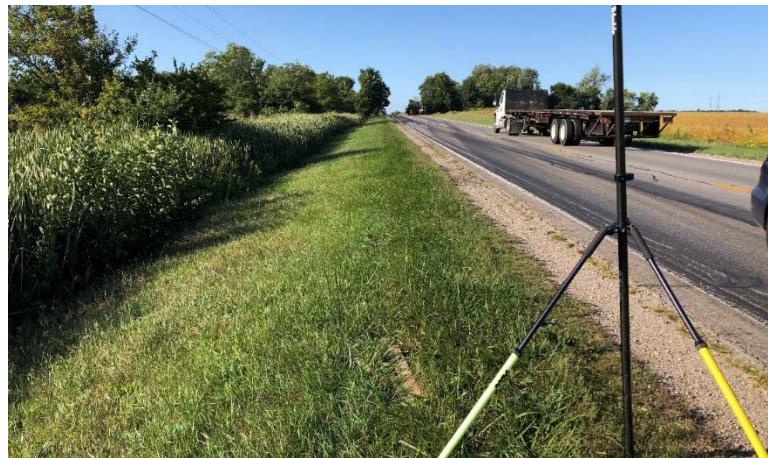
Photograph 2: Signs of standing water off eastern shoulder of US-42

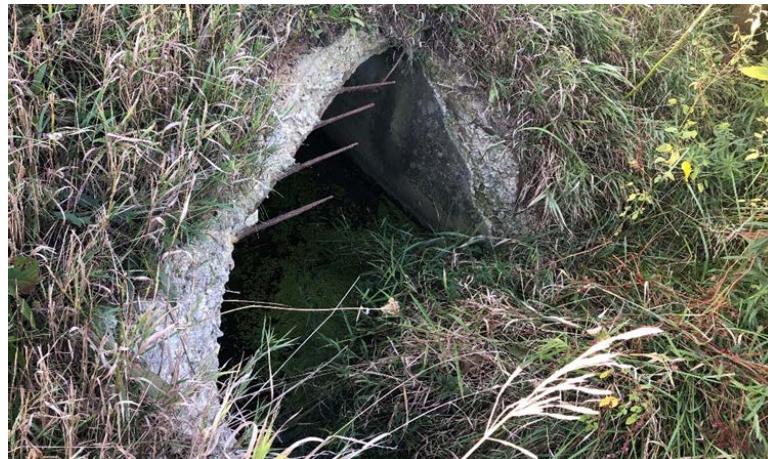
Three (3) project culverts were observed along this section of US-42 during our site visit. The first culvert located near the beginning of the project (Culvert UNI-42-5.019) consisted of a reinforced concrete box culvert with signs of concrete deterioration at the outlet (i.e., exposed reinforcing steel) observed as well as standing water within the culvert (Photograph 3). The second project culvert located directly across from the Living Waters Church (Culvert UNI-42-5.371) also consisted of a box culvert with the outlet (westside) appearing to be in similar condition to the first culvert. The inlet consisted of a catch basin with a steel grate which appeared to be in good condition. The third project culvert located about a half mile south of Harriott Rd along US-42 (Culvert UNI-42-7.048) consisted of a 30-inch diameter concrete pipe with headwalls which showed signs of concrete deterioration (i.e., spalling and exposed reinforcing steel) at both inlet and outlet. The outlet of UNI-42-7.048 was also noted as partially obstructed by debris (Photograph 4).

Photograph 3: Outlet of Culvert UNI-42-5.019

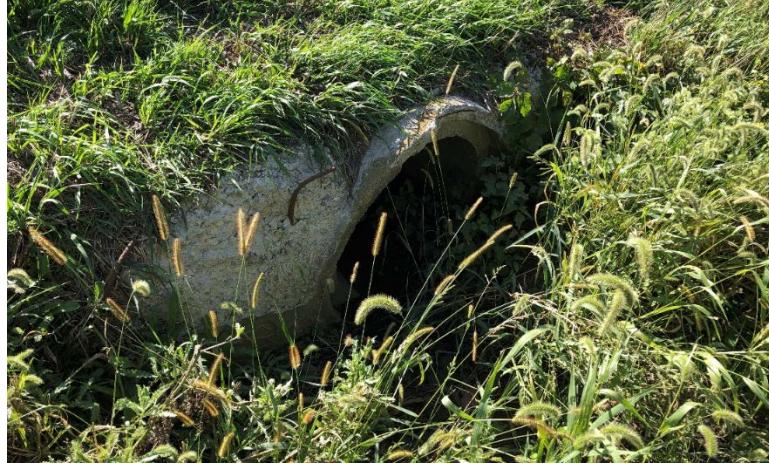
Photograph 4: Outlet of Culvert UNI-42-7.048

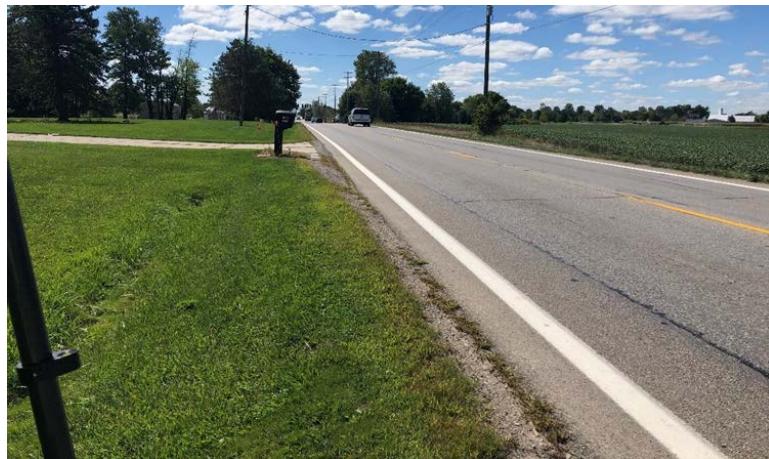
In general, the pavement condition along this section of US-42 was observed to be fair to good with signs of weathering and surface wear consisting of frequent low severity longitudinal and transverse cracking, as well as occasional crack sealing deficiencies (Photograph 5). The roadway in this section is close to grade with the surrounding area which is relatively flat. The roadway slopes very gradually downwards from southwest to northeast. The roadway drains to vegetated open drainage swales on either side of the roadway. The roadway along this segment appeared to be stable with no signs of instability due to geotechnical related issues.

Photograph 5: Pavement condition of US-42 from Harriott Road to End

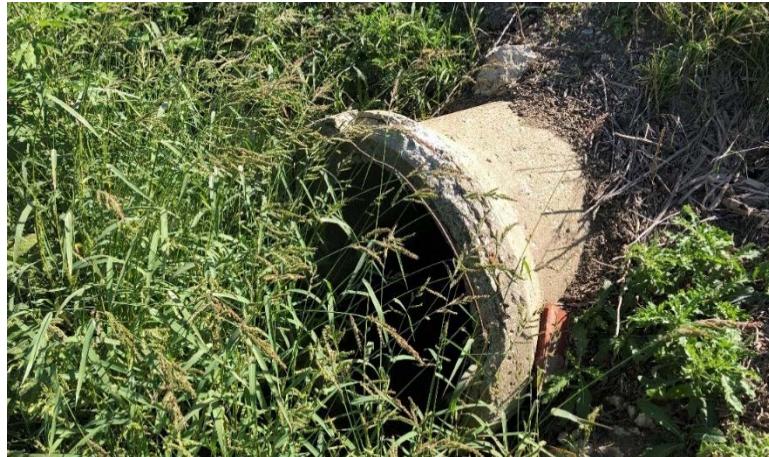
One (1) project culvert (Culvert UNI-42-7.661) was observed along this section of US-42 located just north of Harriott Rd. This culvert consisted of a 36-inch diameter concrete pipe culvert with minor signs of concrete deterioration (i.e., spalling and exposed rebar) observed at both the inlet and outlet but otherwise appeared to be functioning properly with no significant obstructions.

Photograph 6: Inlet of Culvert UNI-42-7.661

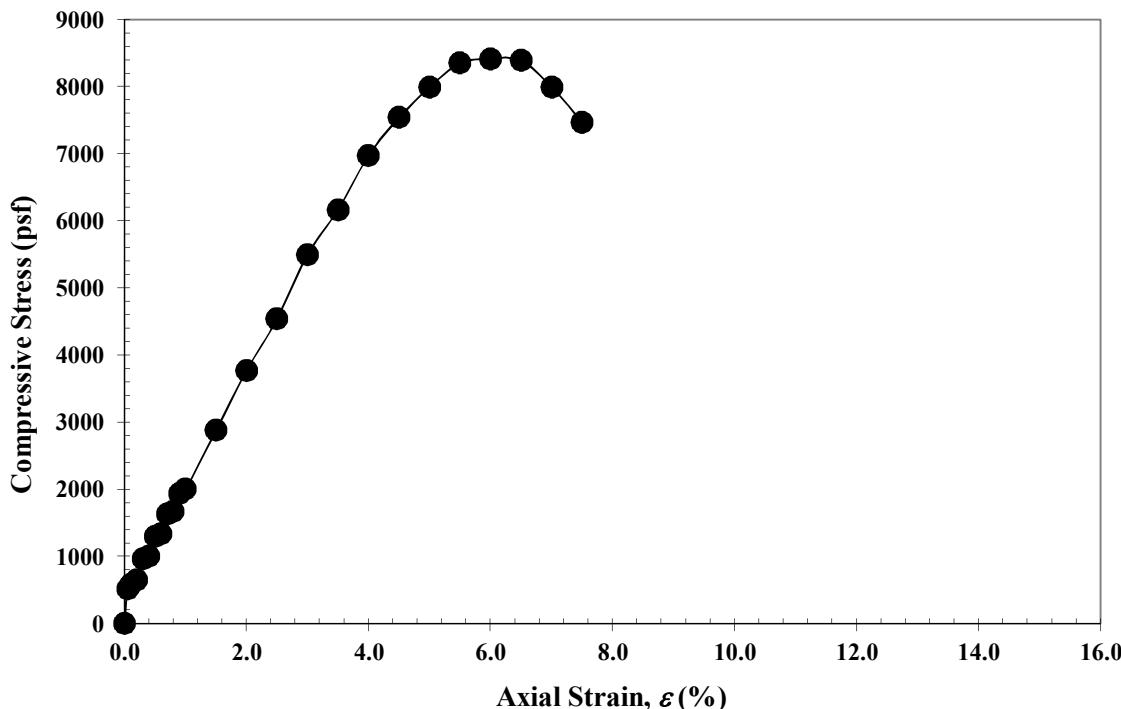
Unconfined Compressive Strength (psf): 8417
 Strain (%): 6.0

Notes: Hard, brown mottled with orangish brown and gray, SILTY CLAY, little sand, trace gravel, damp. Specimen contains gravel >1/6 of the specimen diameter, results shown may differ from the results of a specimen which meets the maximum particle size allowance of ASTM D2166

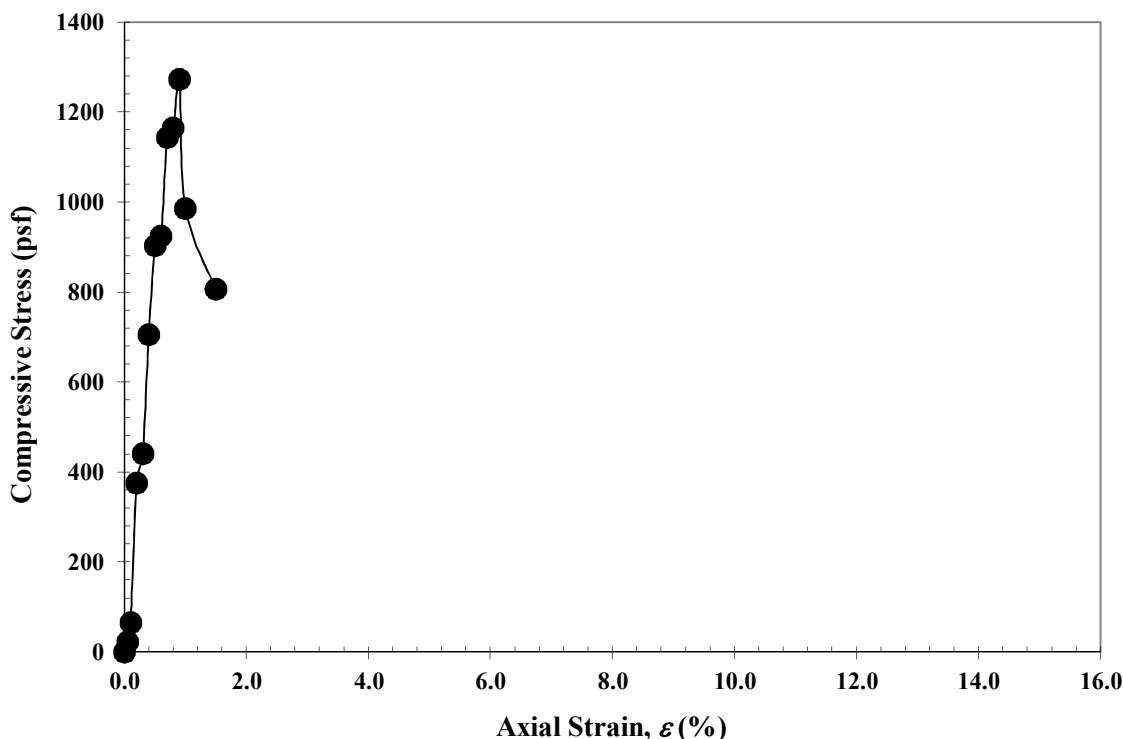
Unconfined Compressive Strength (psf): **1273**
 Strain (%): **0.9**

Notes: Medium stiff, brownish gray mottled with orangish brown, CLAY, "and" sand, trace silt, trace gravel, moist. Specimen contained slickensides after testing
