SUBJECT: Pre-Demolition Asbestos Survey
231 South Market Street
Van Wert, Ohio 45891
PSI Project Number: 06552463

PRE-DEMOLITION ASBESTOS SURVEY

**231 South Market Street
Van Wert, Ohio 45891**

December 9, 2020

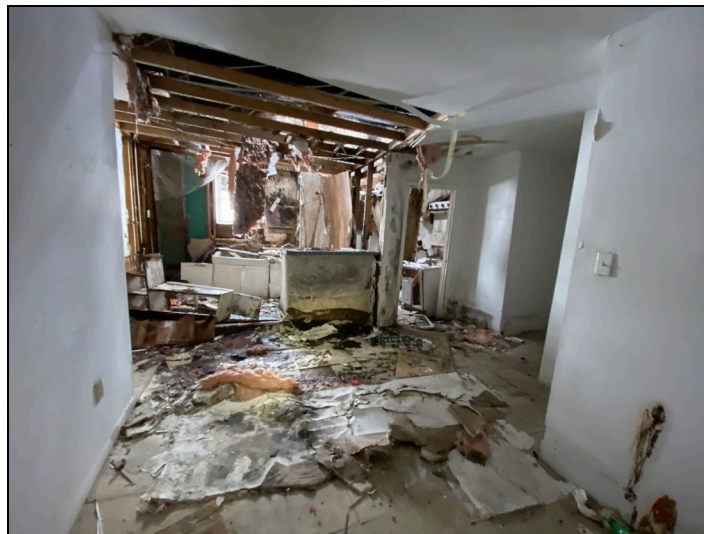
Due to safety concerns, PSI was only able to visually inspect the southwest section of the second floor of the building. See picture below.
