# **B&N Local Route Study** (Reference Document)

Innerbelt Bridge
Construction Contract Group 1 (CCG1)

CUY-90-15.24 PID No. 83680

# LOCAL ALTERNATE ROUTES STUDY

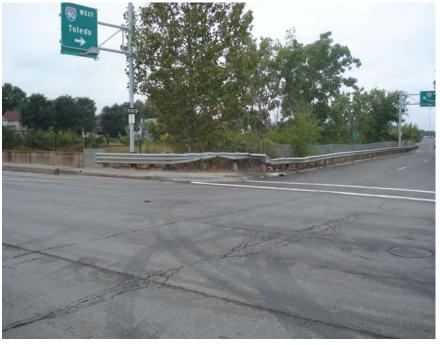
West 25th @ Vega Looking West

Damaged guardrail

Replace damaged guardrail in southwest quadrant of intersection

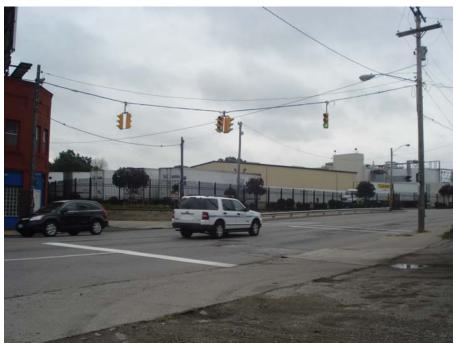
West 25th @ Potter Court

Replace damaged catch basin (near southbound stop bar).

Eliminate traffic signal and convert Potter Court to one-way eastbound. There is limited traffic using Potter Court and it appears the only reason for the traffic signal is the sight distance restriction (building) in the northeast quadrant. If the traffic signal can not be removed then a new signal must be constructed. For estimating purposes it is assumed the signal will be replaced.

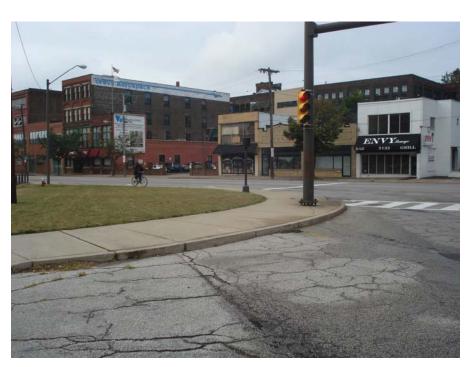
West 25th @ Gehring Looking Southwest from Gehring

Showing northbound right turn lane and traffic calming area

Increase northbound right turn radius to accommodate a free flow right turn. This essentially removes that the traffic calming currently installed at the intersection which will need to be removed once the detour is no longer needed.

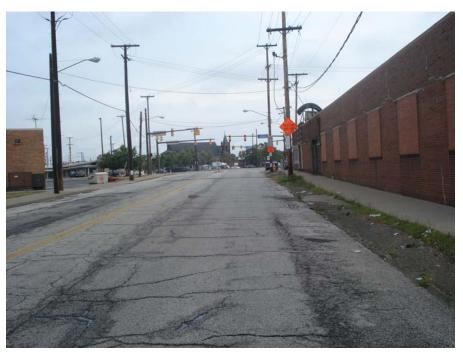
Gehring Looking Northeast

Poor is in pavement condition on Gehring

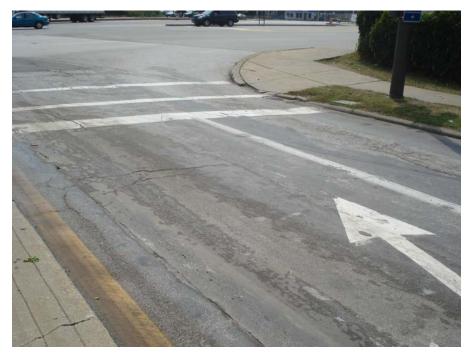
Ontario Spur @ Lorain Looking South

Pavement is in poor condition on Ontario Spur

Resurface the Ontario Spur at the intersection of Lorain as the pavement condition is poor with rutting and cracking.

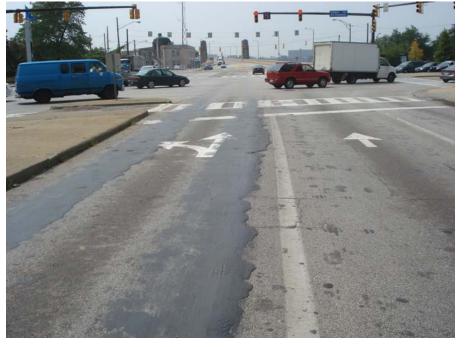
Lorain / Carnegie @ Ontario Broadway Commercial Looking West

Pavement is in poor condition of eastbound left –turn lane east of intersection

Resurface the intersection area from the Ontario spur to Carnegie since as the pavement condition is poor with heavy cracking.

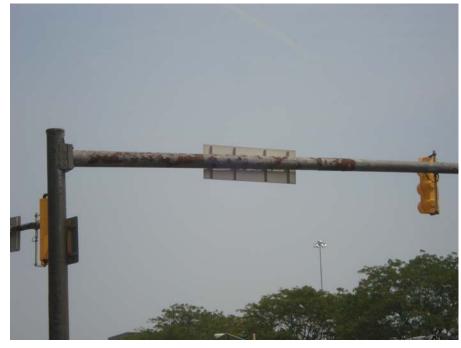
Lorain / Carnegie @ Ontario Broadway Commercial Looking West

Signal poles and mast arms showing deteriorated condition.

Reconstruct the traffic signal on Lorain/Carnegie at Ontario/Broadway

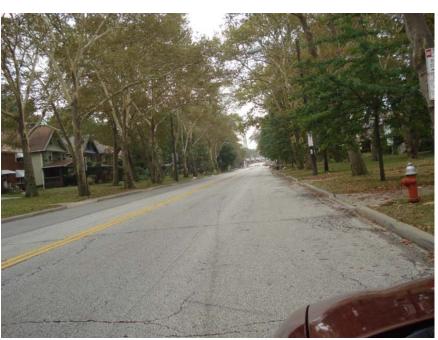
West between Western and Madison Looking South

Pavement is in poor condition in southbound curb lane.

Resurface southbound curb lane (~Sta 15+85 to ~Sta 32+75). The curb lane exhibits cracking and is in poor condition.

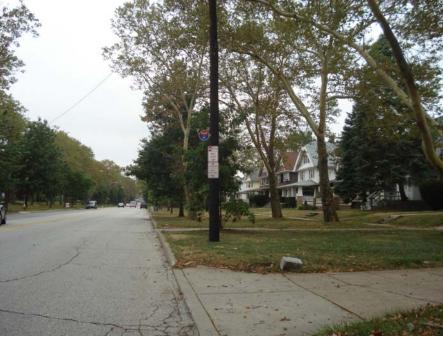
West between Madison and Western Looking South

Pavement is in poor condition in southbound curb lane.

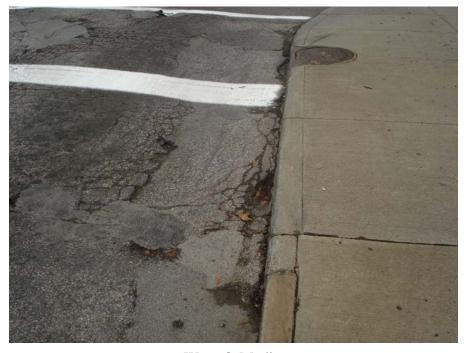
West @ Madison Looking North

Pavement is in poor condition at intersection area (looking as northbound stop bar).

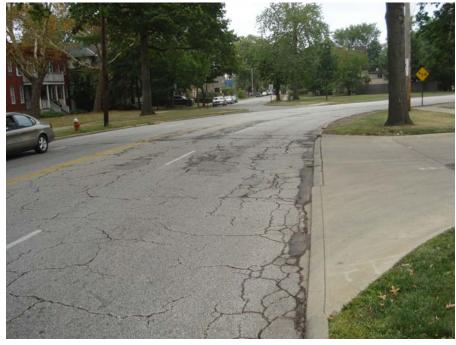
West between Madison an Detroit Looking North

Pavement is in poor condition on West

Resurface the road as the pavement condition is poor with heavy cracking and potholes.

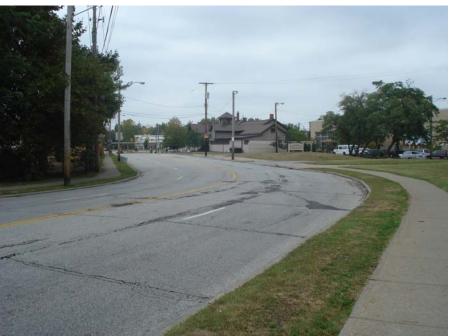
West between Madison an Detroit Looking North

Notes: Pavement is in poor condition on West

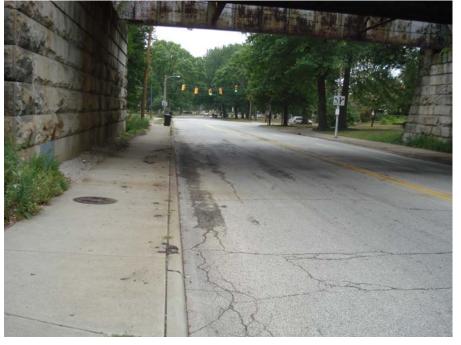
West @ Baltic Looking North

Pavement condition is poor and beginning of 3-lane section to the north.

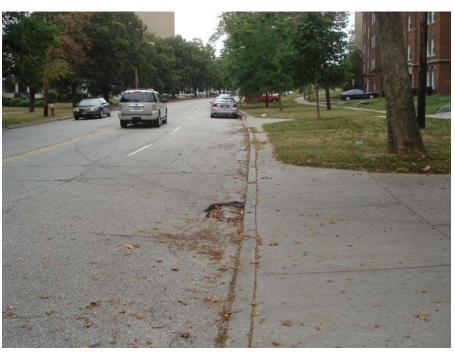
West between Detroit and Baltic Looking South

Pavement is in poor condition.

Resurface southbound curb lane. The pavement is in poor condition with heavy cracking and ride ability is poor.

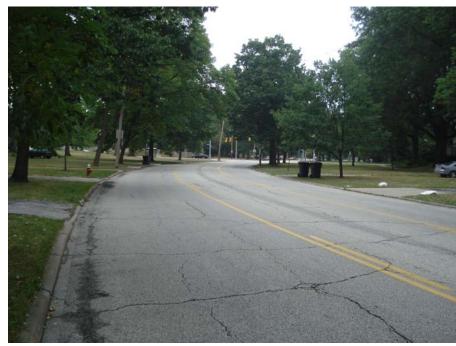
West between Baltic and Clifton Looking North

Notes: 3-lane section

Pavement condition is poor in southbound curb lane.

Resurface southbound curb lane. The pavement is in poor condition with heavy cracking and ride ability is poor.

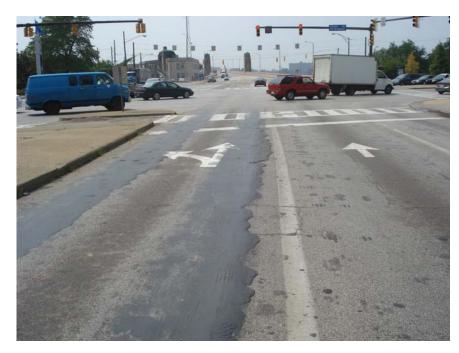
Carnegie between East 9th and Lorain Looking West

Pavement in westbound left-turn lane is in poor condition.

Resurface roadway as the pavement is in fair to poor condition with rutting noted in the westbound left turn lane at Ontario.

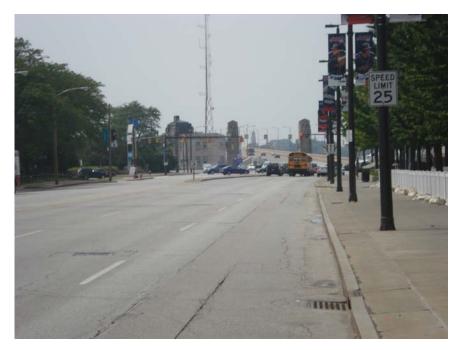
Carnegie between East 9th and Lorain Looking West

Pavement in westbound curb lane is in poor condition with poor rideability.

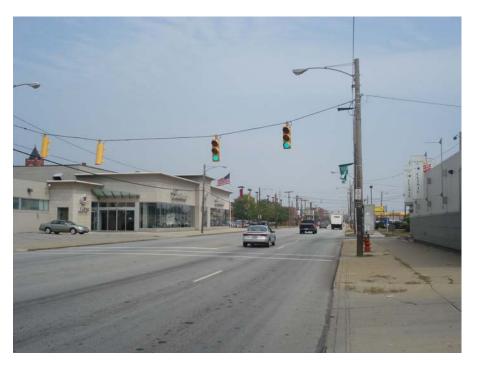
Carnegie between I-90 eastbound off-ramp and East 28th Looking East

Eliminate mid-block cross walk.

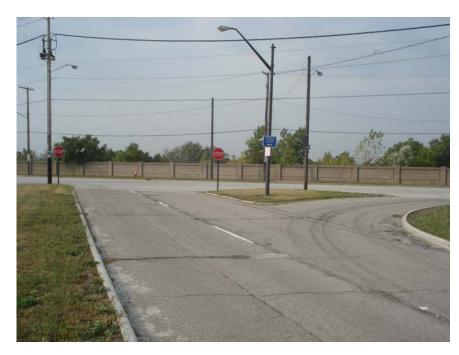
East 14th @ Broadway Looking South

Pavement is in poor condition.

East 14<sup>th</sup> from Orange to Broadway Resurface the roadway as the pavement is in poor condition.

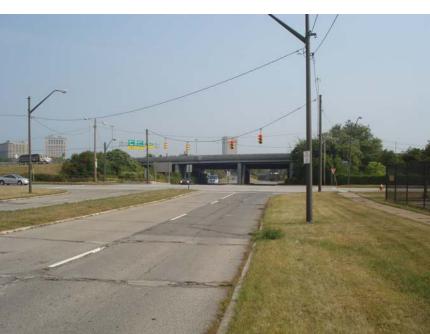
East 14th @ Orange

Pavement is in poor condition.

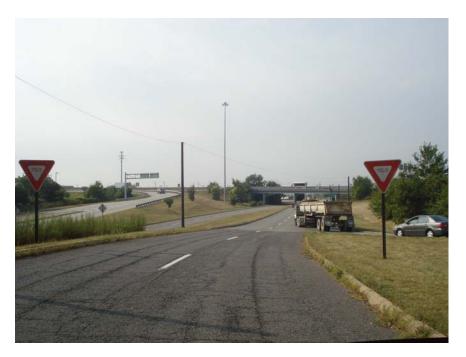
East 14th @ IR-77 NB Exit Ramp terminal Looking South

Notes: Poor pavement condition north of ramp merge.

East 14<sup>th</sup> from Carnegie to the East 9<sup>th</sup> Street exit ramp from I-77 northbound. Resurface the roadway as the pavement is in poor condition.

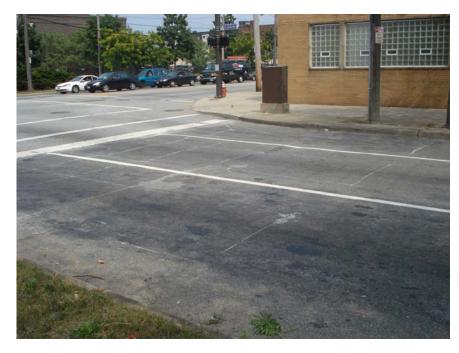
East 22nd between Carnegie and Cedar Looking East

Pavement is in poor condition.

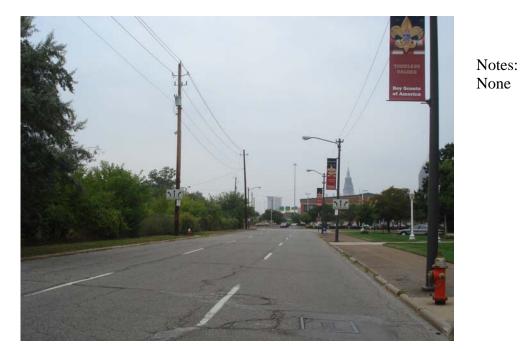
Woodland @ East 22nd Looking West

Pavement is in poor condition.

Woodland from East 22<sup>nd</sup> to the Orange Avenue spur Resurface the roadway as the pavement is in fair to poor condition.

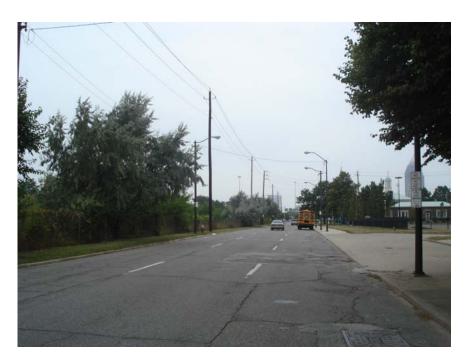
Woodland west of Orange Spur Looking West

Pavement is in poor condition.

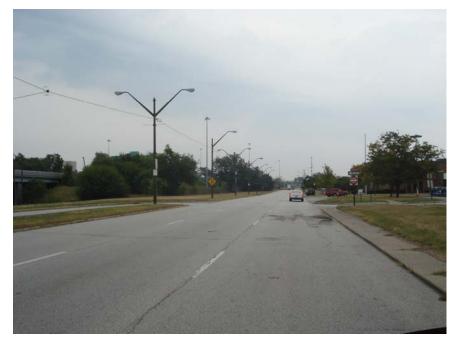
Orange @ USPS Drive Looking East

Poor pavement condition in curb lane just before drive
