# Waterville City Council

## June 1, 2026

## **Roche de Boeuf Bridge Physical Condition Report May 2026**

***ROCHE DE BOEUF BRIDGE COMMITTEE  
PHYSICAL CONDITION & PRESERVATION  
ALTERNATIVES REPORT***

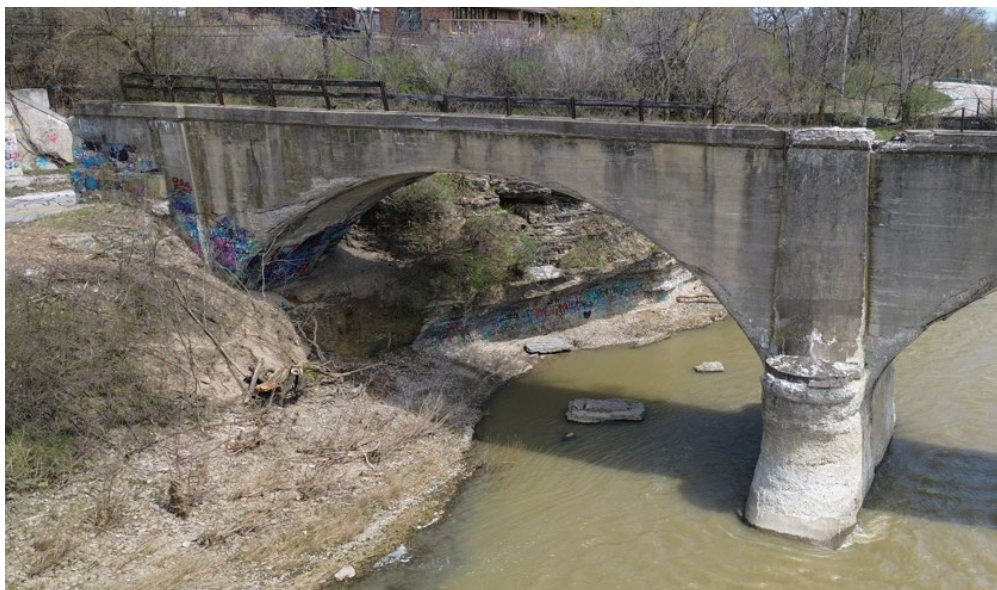
North end span (looking downstream) showing sound spandrel wall

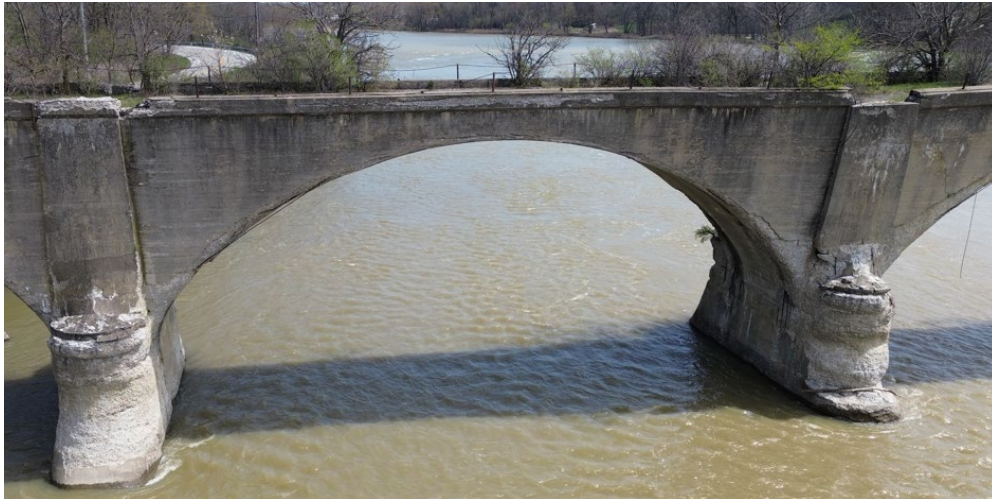
Span 11 (looking downstream) showing mostly sound spandrel walls. There is evidence that spandrel failure is starting to occur over the pier to the right.

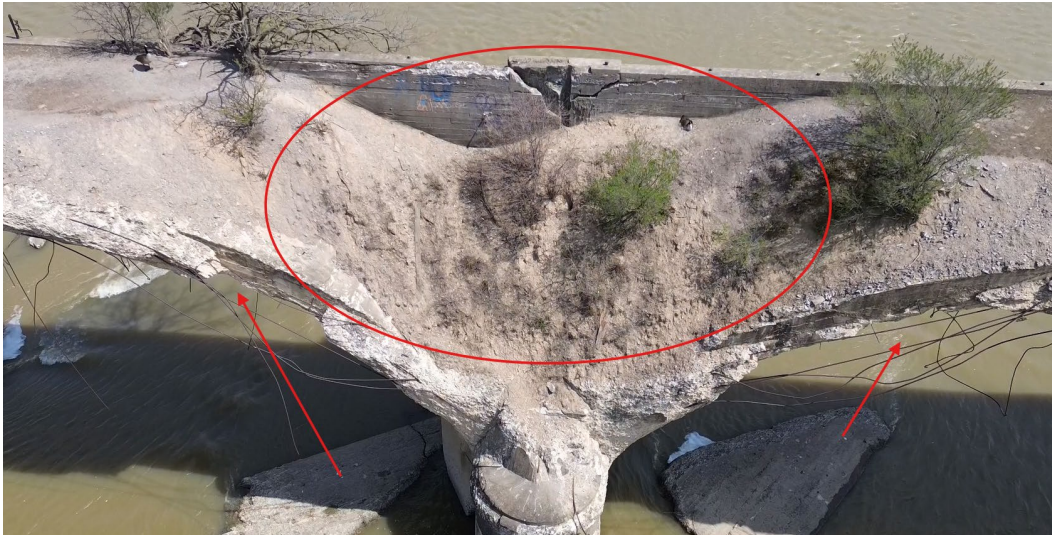
**B.C.02 - Superstructure Condition Rating – 0 – Failed:** There are 6 sections of the spandrel wall that have completely failed over the piers and an additional 3 spandrel locations that are in a state of failing. The only spans of the arch that visually seem stable enough to continue carrying their dead load are the 2 north end spans nearest S River Rd.

Typical condition of failed arch spandrels over piers. There are outer sections of the arch that have failed with only the rebar hanging. This condition below would justify a General Appraisal rating of a "0" if it occurred at a singular location. This issue is occurring at 50% of the pier locations.

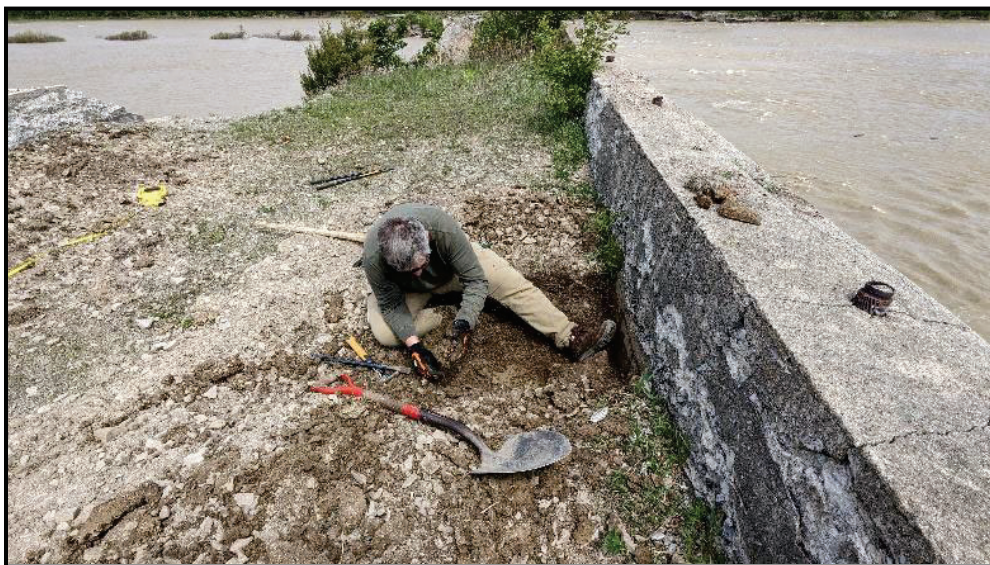
Photo 1 – Excavation of Span 3 Arch Intrados, May 3, 2026.

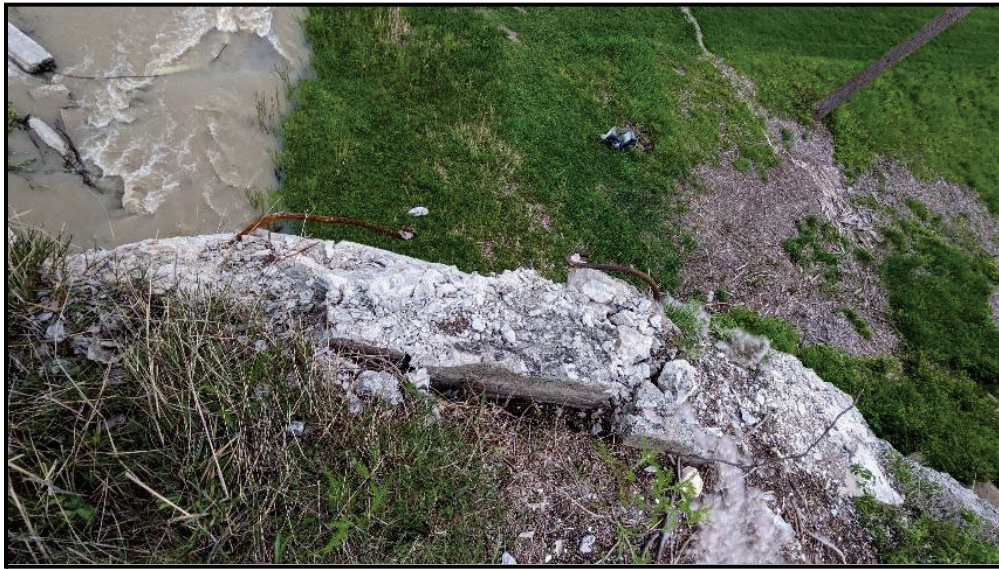
Access to the grade of Spans 2 and 3 provided observation within arm's reach of the remaining portions of spandrel wall at their failure planes. Among these observations are that the spandrel walls have considerably less steel reinforcement than contemporary design practice.

**Photo 2 – Sparse Spandrel Wall Reinforcement, Span 2 East Spandrel Wall/**

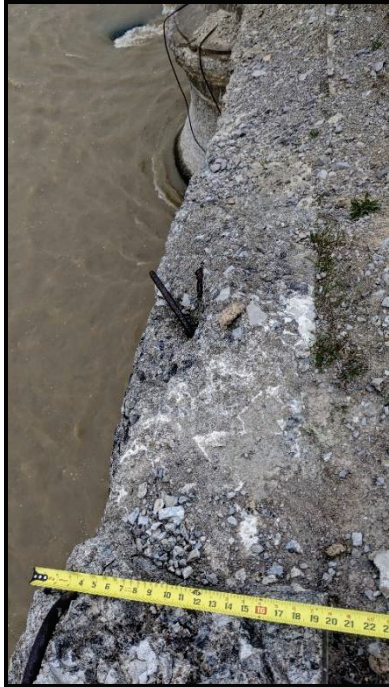
**Photo 3 – Vertical & Horizontal Reinforcement  
Placed along Exterior Surface with 3-Inch  
Cover, Span 3.**

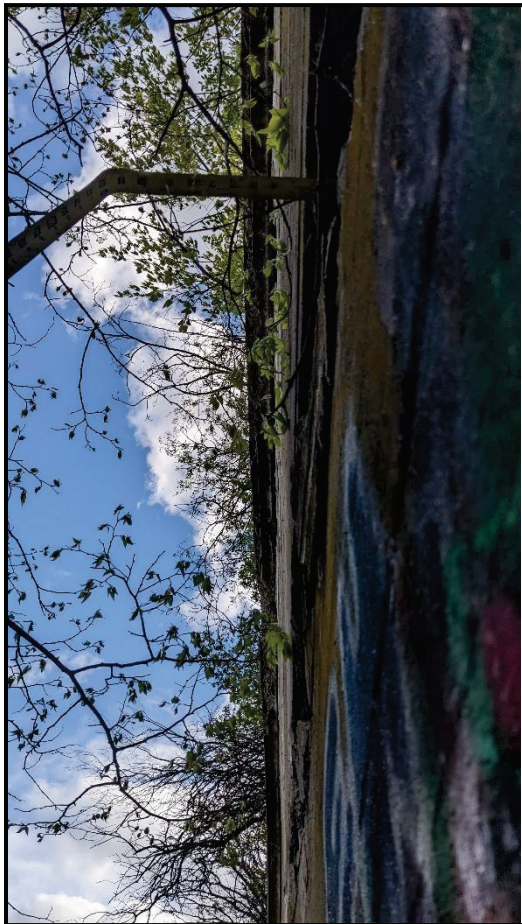
- Span 3: Near Pier 2, both spandrel walls lean outward approximately 12 inches. This suggests that the center of gravity of each wall has shifted outward up to 8 inches and may have produced a longitudinal crack 1.25 inches in the interior wall surface above the top of the arch barrel, the point of greatest bending.

**Photo 4 – East Spandrel Wall Movement 1.5  
inches above Longitudinal Crack, Span  
12.**

The above observations add concern for the viability to retain the existing spandrel walls. If any spandrel walls are retained in order to maintain the property's standing within the National Register of Historic Places, consultation with the Ohio State Historic Preservation Office is recommended.

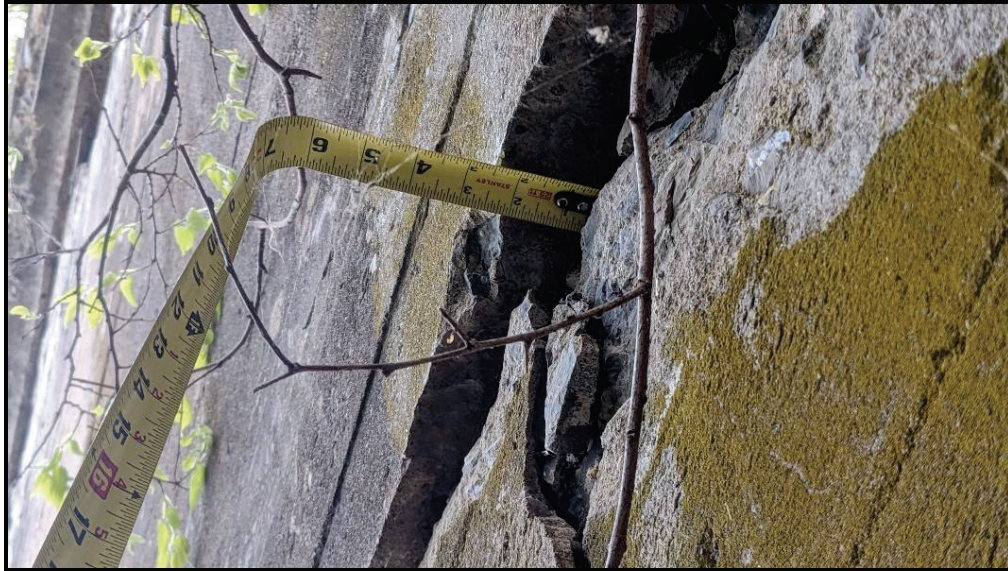
**Photo 5 – Close-Up of East Spandrel Wall Movement 1.5 inches above Longitudinal Crack, Span 12.**

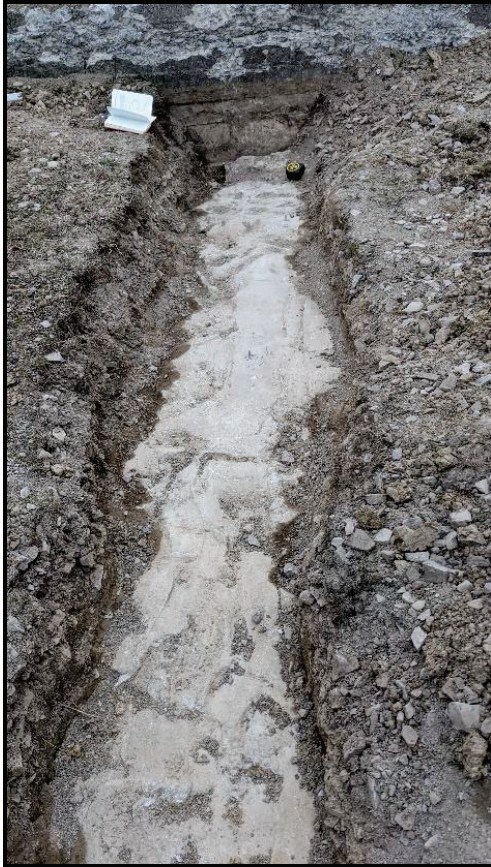
The excavated extrados of the Span 3 arch is in good condition with no deficiencies (**Photos 6 & 7**). The surface observed was at the center of the arch where laborers placed the last portions of fresh concrete in 1907 and trowel-finished the surface to a smooth but uneven surface. The level survey performed confirmed that the arch is a minimum 24 inches thick per Daniel Lutens's writings. The arch intrados below this section exhibits longitudinal efflorescence which has been described as being non-corrosive calcium hydroxide (quick lime) leaching from the cement paste (**Photo 8**).

**Photo 6 – Arch Extrados Exposed, Span 3.**

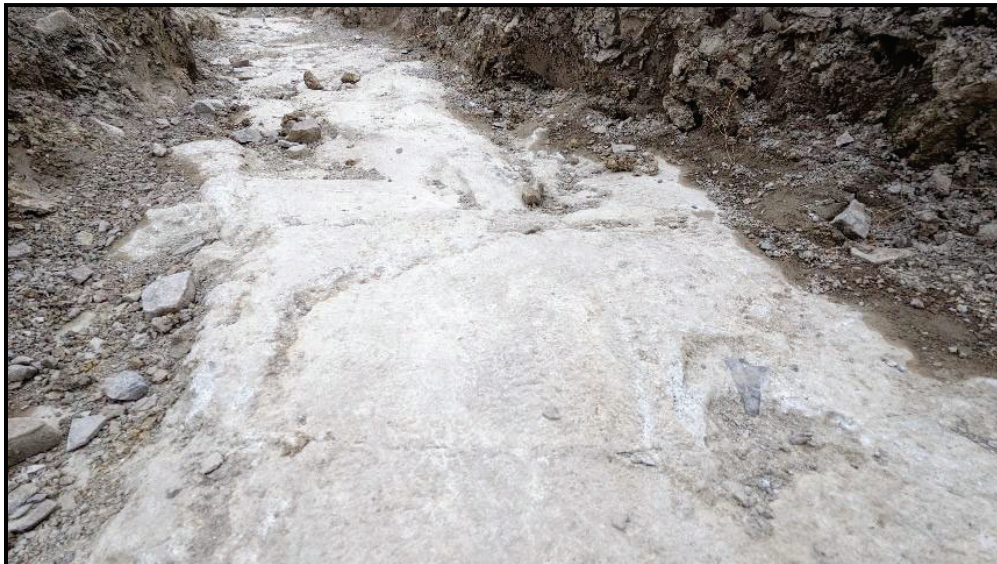
**Photo 7 – Close-Up of Trowel-Finish and Good Condition of Arch Extrados Exposed, Span 3.**

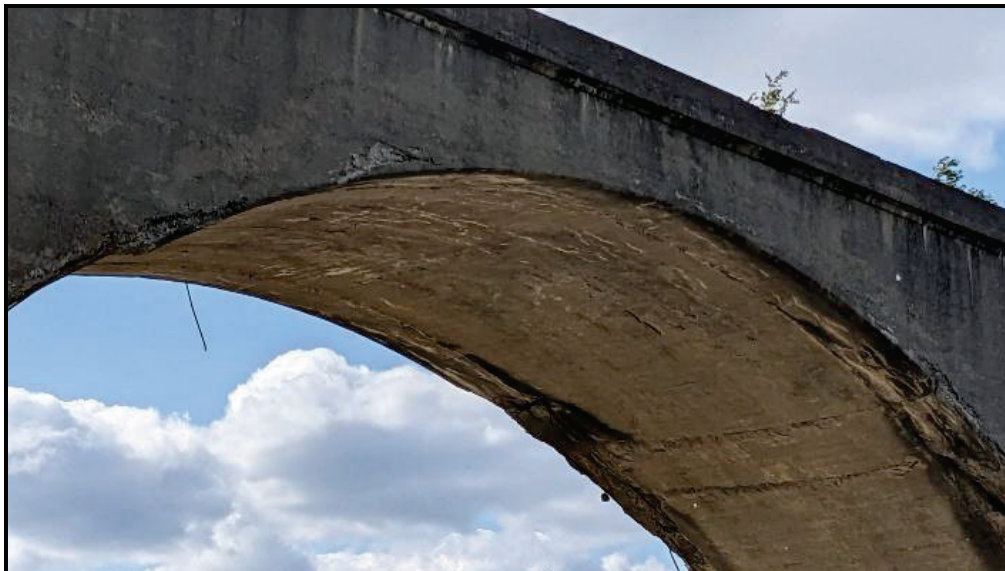
Throughout all 12 spans, observation of water staining and spalling of the arch intrados and bottom of spandrel walls suggest that rain water passing through the fill above generally follows the path of least resistance, which likely is the vertical arch barrel-spandrel wall construction joint and through the hidden longitudinal cracks in the spandrel wall above the arch barrels (**See Photo 8**). Thus, it is anticipated that when uncovered, the tops of all arch barrels will show little if any deterioration.

**Photo 8 – Longitudinal Cracking with Calcium Hydroxide Efflorescence and Construction Joint Infiltration, Span 3.**
