Inspector: Osting,Matthew
 Inspection Date: 12/14/2024

Structure Number: 2500639
 Facility Carried: FOURTH ST (US23)

Ohio Bridge Inspection Summary Report

FRA-00023-1075 (2500639)

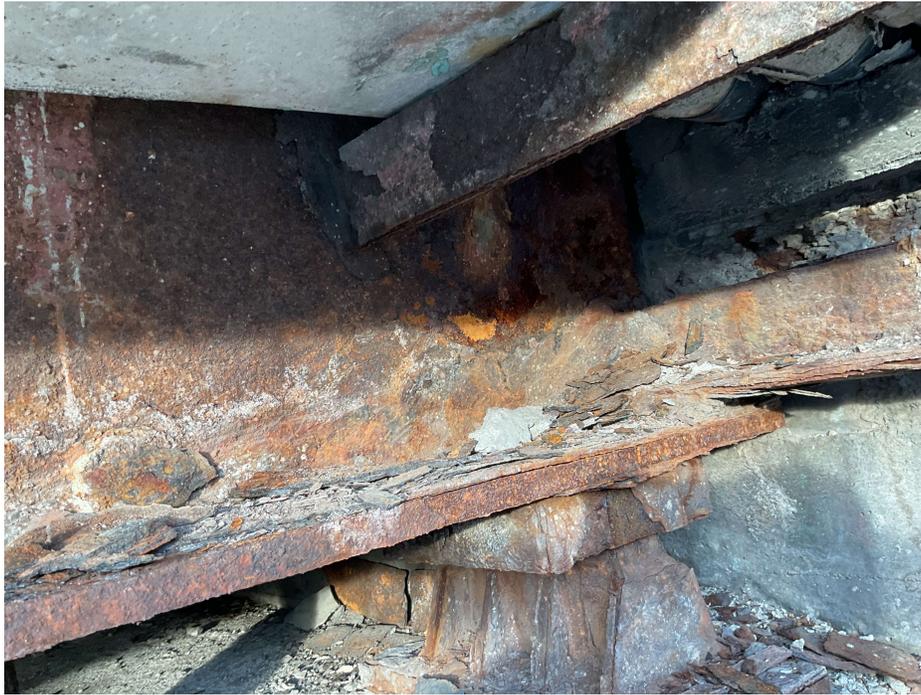
PHOTO 1

Description 2024 B7 fwd

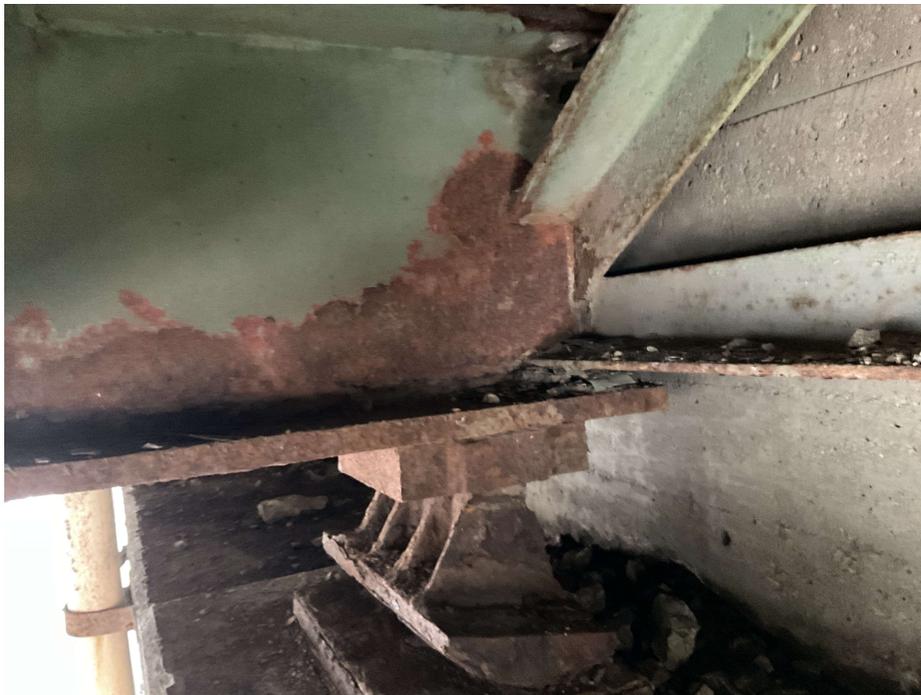
PHOTO 2

Description 2024 fwd B3

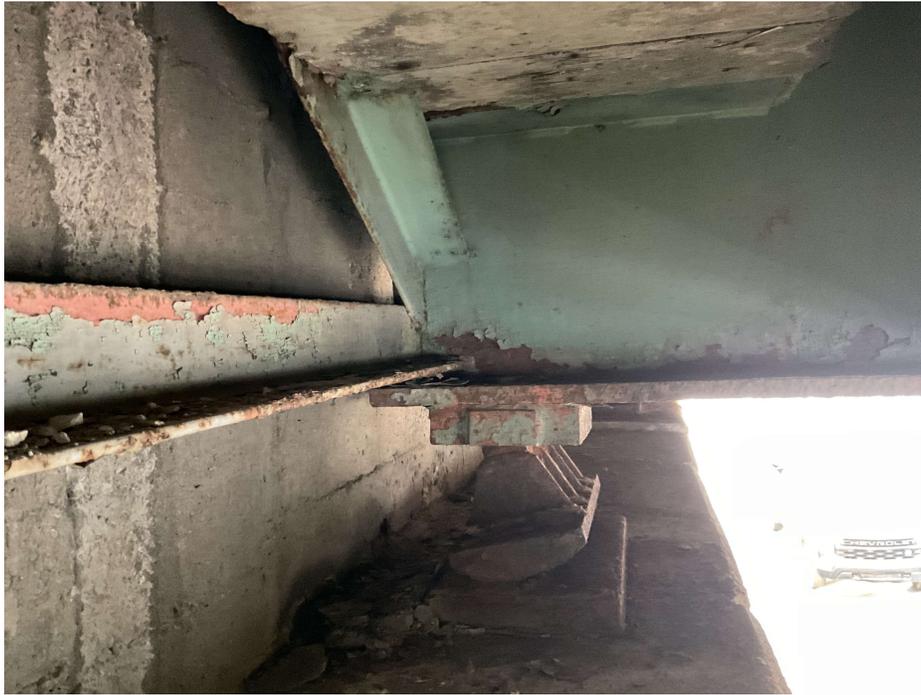
PHOTO 3

Description 2024 fwd B4

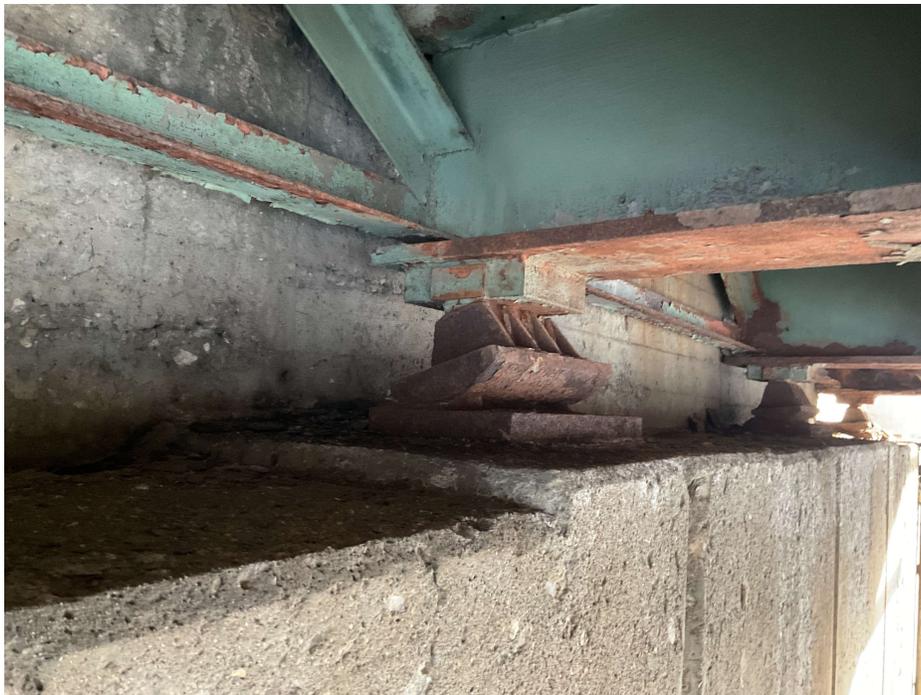
PHOTO 4

Environment	Total Quantity	Units	Condition State 1	Condition State 2	Condition State 3	Condition State 4
205-Reinforced Concrete Column	3 - Mod.	8	each	3	0	5	0
2024 CS3 PS1 C 1 spalled with exposed rebar that has section loss. PS2 columns 1-4 large spalls with exposed rebar.							
215-Reinforced Concrete Abutment	3 - Mod.	121	ft.	61	60	0	0
2024 CS2 Rear abut saturated with scaling and vert cracks thru out 60 ft.							
234-Reinforced Concrete Pier Cap	3 - Mod.	242	ft.	222	20	0	0
2024 CS2 Areas of rust staining in both piers 20 ft.							
305-Assembly Joint without Seal	3 - Mod.	121	ft.	0	0	0	121
2024 CS4 Rear broke and banging. Complete closed fwd and rear 121 ft. Over half is covered with steel plates rear.							
311-Movable Bearing	3 - Mod.	24	each	0	0	8	16
2024 CS3 Rusted with section loss 8 CS4 Rusted with section loss not moving 16 2024 **Special Report** CS3 Rusted with section loss (8) CS4 Rusted with section loss, not moving as designed, (14). Rear bearing 6&7 tilted to max, sole plate has shifted, (1). Fwd bearing #2 tilted to near max, (1). Dec 14 2024 same + Fwd bearing 2-5 tilted to max

Description 2024 fwd Bearing 5

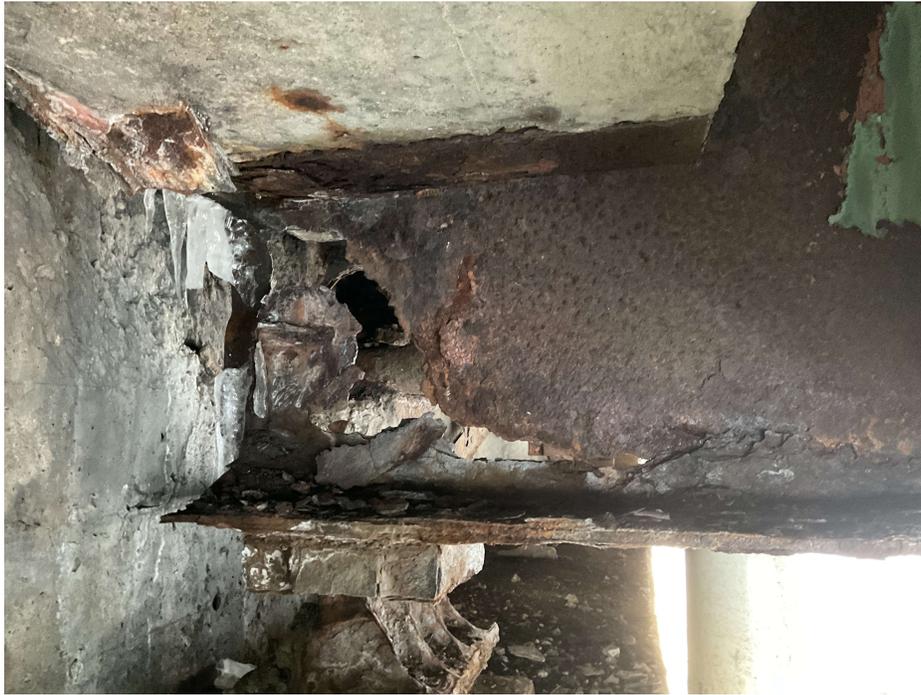
PHOTO 5

Description Beam 2 Fwd

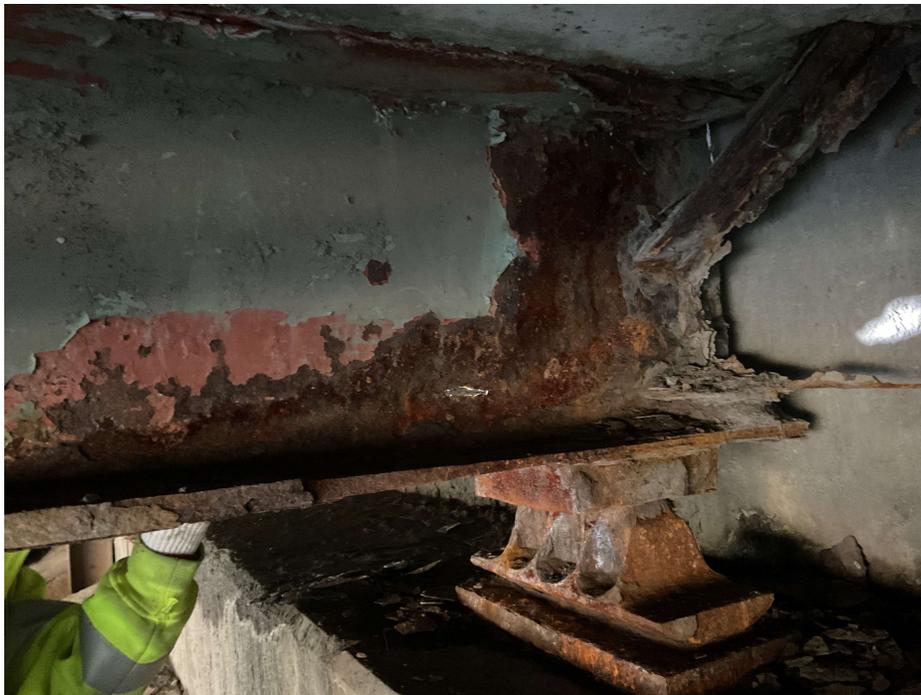
PHOTO 6

Environment	Total Quantity	Units	Condition State 1	Condition State 2	Condition State 3	Condition State 4
12-Reinforced Concrete Deck	3 - Mod.	12942	sq. ft.	0	6442	6500	0
2024 Floor covered with false work. Deck edges netted. Years past floor was saturated thru out and spalls with exposed rebar.							
510-Wearing Surfaces		8151	sq. ft.	0	0	8151	0
Asphalt overlaid 2024 CS3 Open cracks,wheel rutted and pothole forming thru out.							
107-Steel Open Girder/Beam	3 - Mod.	1716	ft.	438	1000	150	128
2022 CS2 Heavy collision dmg beam 8 span 2 20 ft CS3 Rusted with section loss at beam ends fwd and rear 150 ft. 2023 same 2024 ** Special Inspection** falsework in place limits visibility of beams CS2- rust and corrosion initiated at bottom flanges and webs throughout (1000') CS3- Fwd and Rear beam ends pack rusted and section loss throughout bottom flanges and webs, (50'). Heavy rust and corrosion at bottom flanges throughout, (100') CS4- Rear beam end #8 (SE) web crushing over the bearing and bottom flange, deflection of 1inch, (4'). Beam #8 span 3 web and flange torn at mid span due to collision damage that occurred Jan 2024. This location has been temporarily supported with an additional beam placed on the deck above and secured with chains, (60'). Fwd beam end #2 has through holes in the web above the abut bearing, approx 50% section loss of the bottom flange at bearing, (3'). Rear beam end #3 approx 66% section loss at bottom flange at the abut bearing, (1'). 2024 same as listed + CS4 Span 3 beam 8 has been removed 58 ft. 12/14/2024 same + CS3 Fwd B 7 fwd heavy pack rust with section loss 11 ft. CS4 Rear B8 1 3/4" deflection in bottom flange Rear B8 3 1/2" deflection in web Rear beam 3 small thru hole 1 ft from beam end in lower web (2ft)

Description 2024 rear beam 3 thru hole

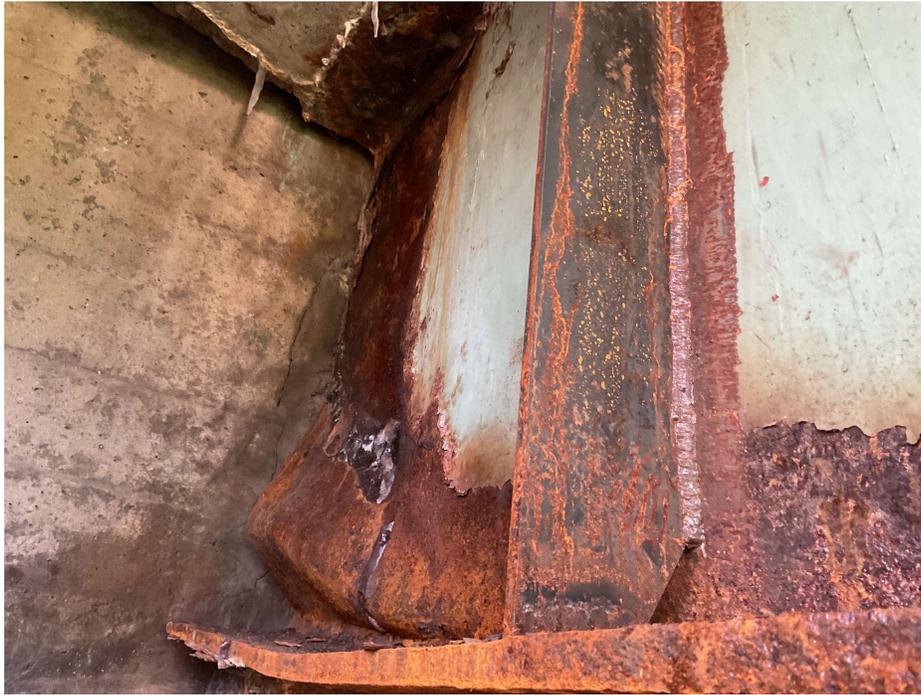
PHOTO 7

Description 2024 rear B 8

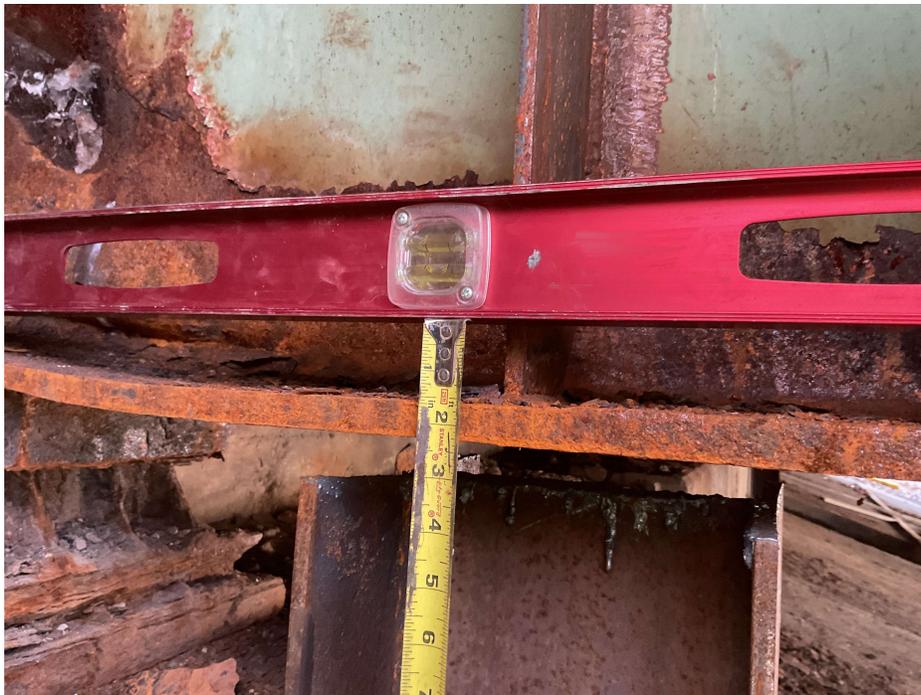
PHOTO 8

Description 2024 B8 1 3/4 inch deflection

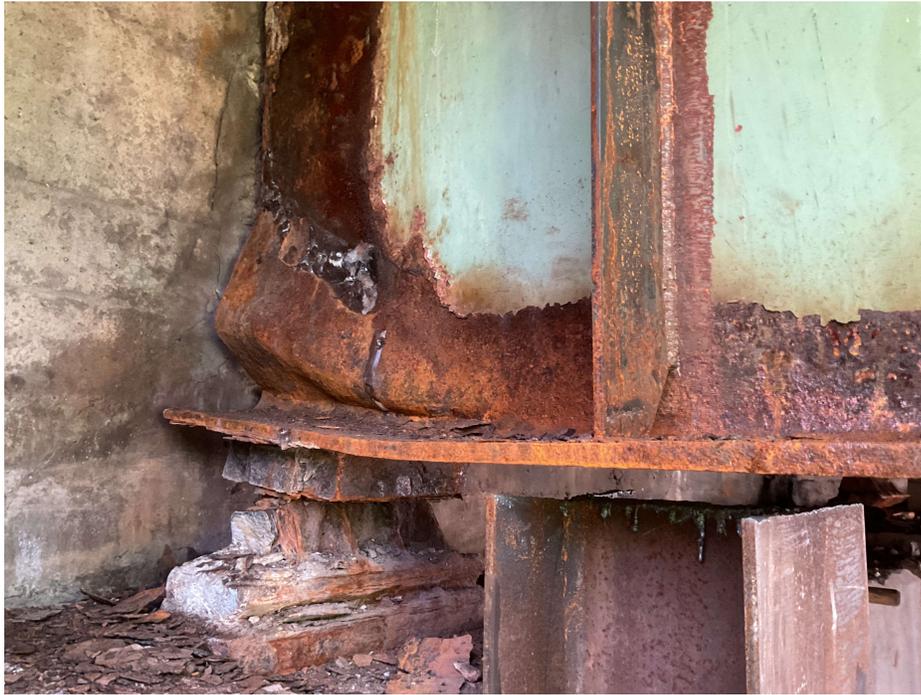
PHOTO 9

Description 2024 beam 8
