Ohio Bridge Inspection Summary Report

FRA-00033-1747 (2504596)

7: Facility On THIRD ST
 6: Feature Ints S 3RD (US-33) OVER I-70
 9: Location 0.82 E OF SR 3
 Lat, Lon 39.953481415 ,-82.996248894

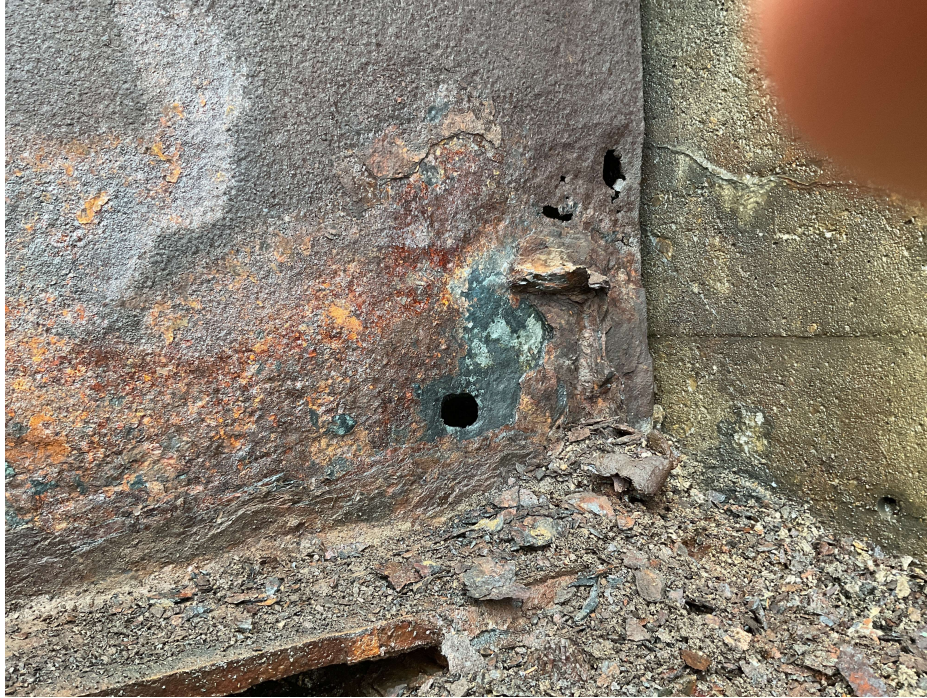
PHOTO 1

Description 2025 fwd beam 2

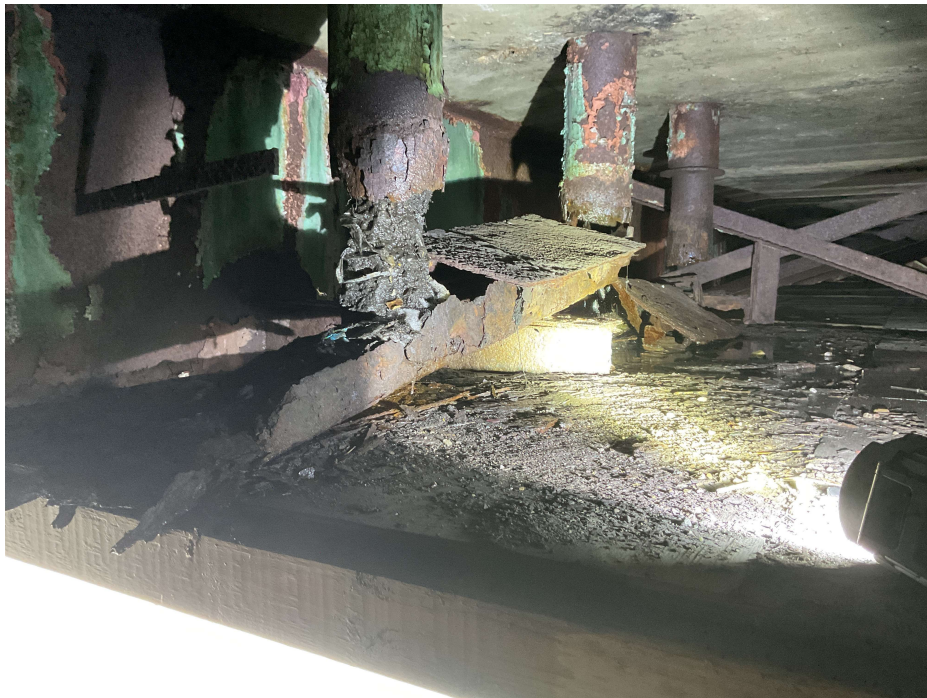
PHOTO 2

DOWNSPOUTS RUSTED THRU-.,LG PIECES FALLING OFF.,PLUGGED/WATER RELEASED AT BEAMS

Description Drainage failure at SW corner

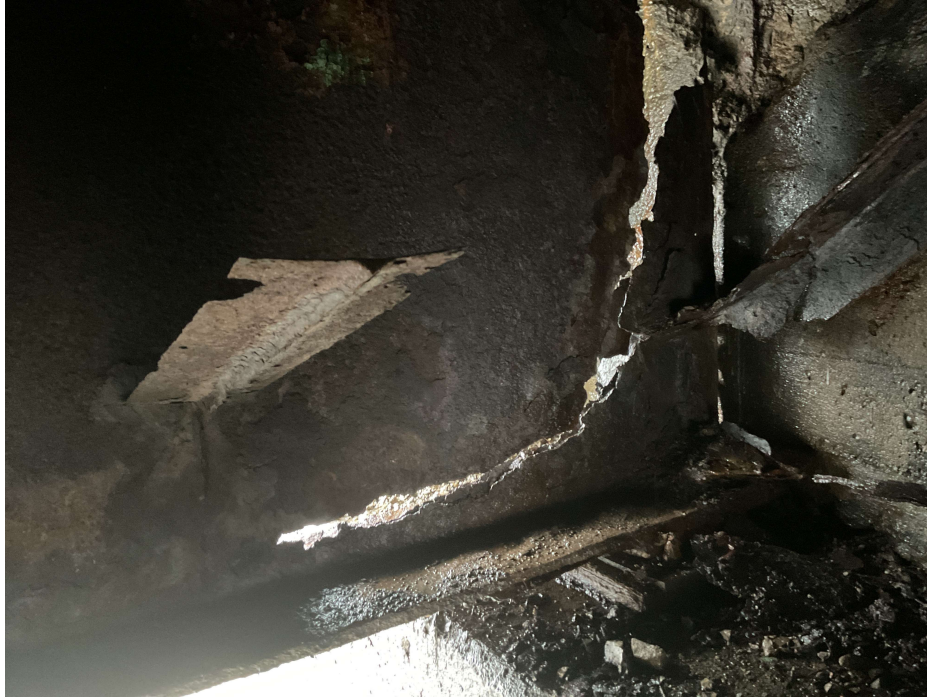
PHOTO 3

Description 2025 beam 11

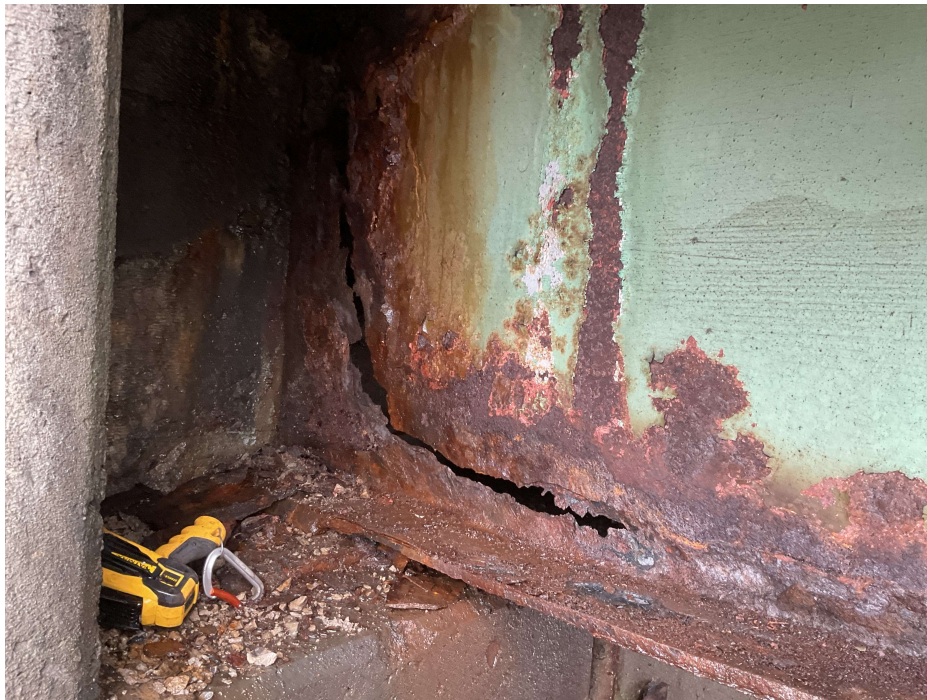
PHOTO 4

Description 2025beam 11

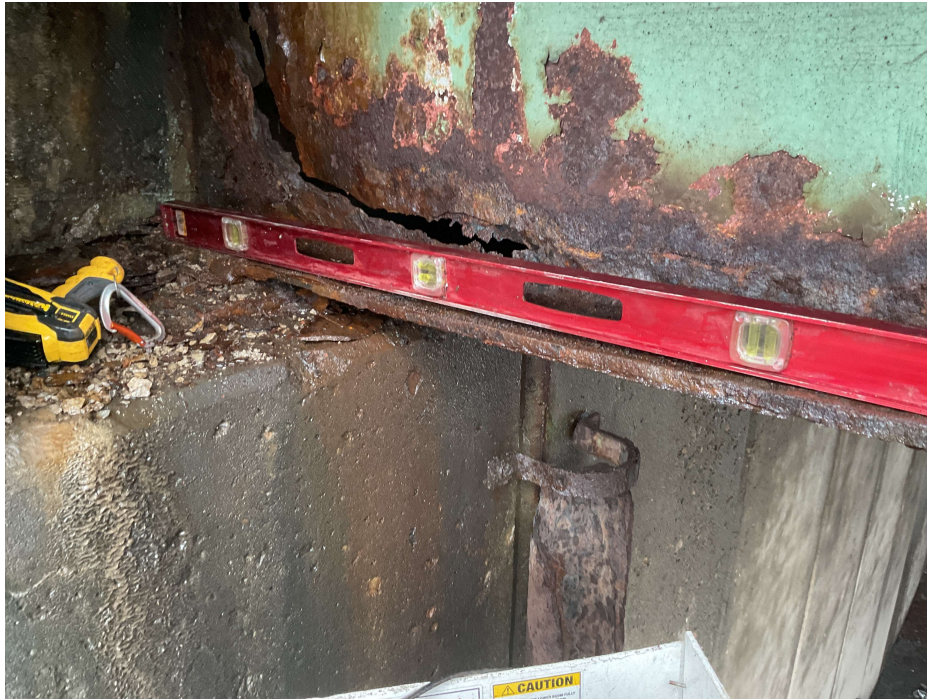
PHOTO 5

Description 2025 beam 11
