Inspector: Mathews,Timothy  
 Inspection Date: 02/15/2025

Structure Number: 5101174  
 Facility Carried: CR 26

## Ohio Bridge Inspection Summary Report

**MAR-00023-1692 (5101174)**

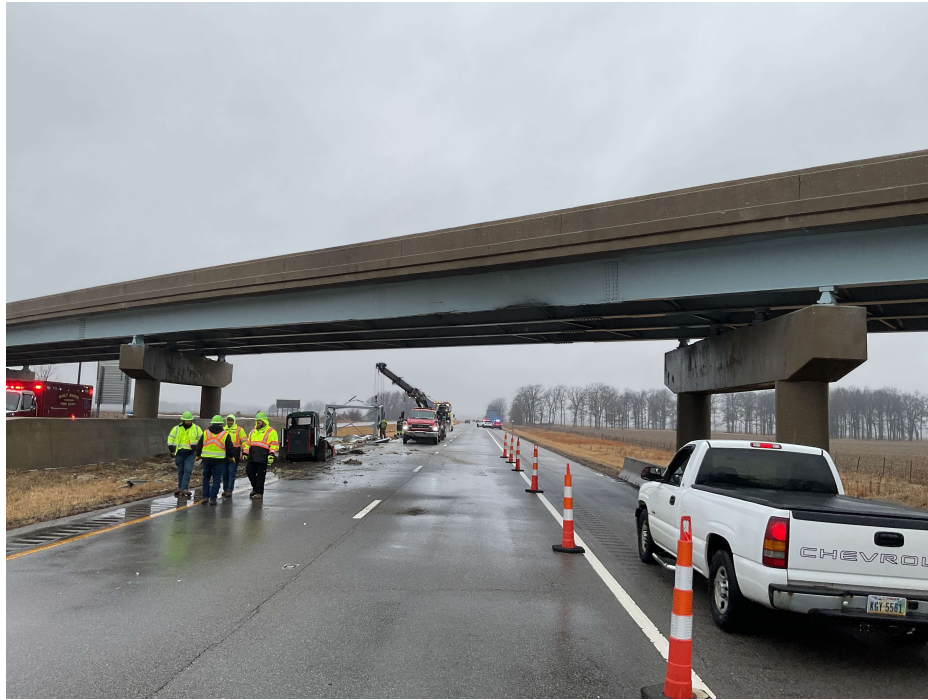
PHOTO 1

Span 3 B4 near the splice plate was struck with an oversized load traveling on 23NB. Impact caused severe lateral distortion in Beam 4. Approximately 50' of B4 is distorted laterally as well as torsional damage to the bottom flange and web at the impact site. Vertical clearance measurements were taken under Beam 4 at the yellow line = 14' 11 and 15/32", c/l = 14' 7 and 31/32", edge line = 14' 8 and 27/32". Impact site now measures 14' 10 and 25/32". Cross frames in all bays of span 3 were damaged and are as follows; Bay1- x frame # 5 damaged and lateral brace removed, Bay2- x frames 2&5 damaged with lateral bracing removed and x frames 3&4 completely missing, Bay3- x frames 5-7 damaged with lateral bracing removed at 5&6.

Description 23 NB Span3 Beam 4

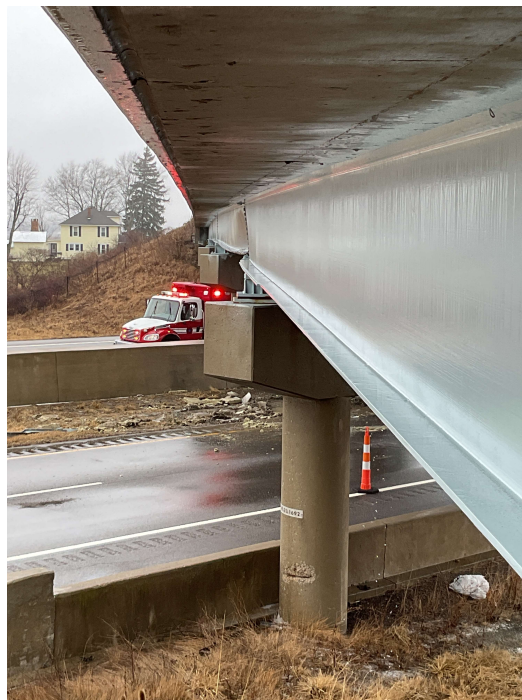
PHOTO 2

Description Span3 B4

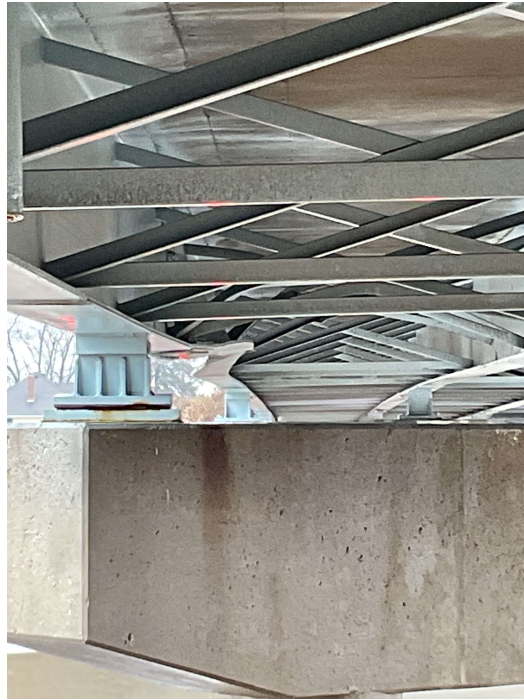
PHOTO 3  
Description Span3 B4

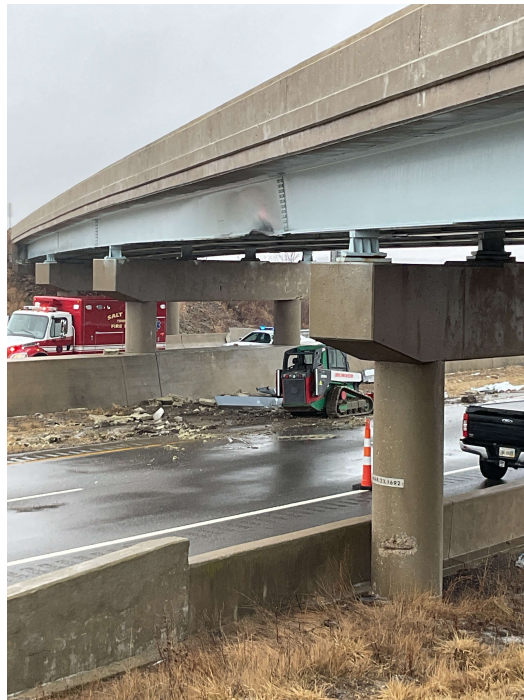
PHOTO 4  
Description Span3 B4 23nb

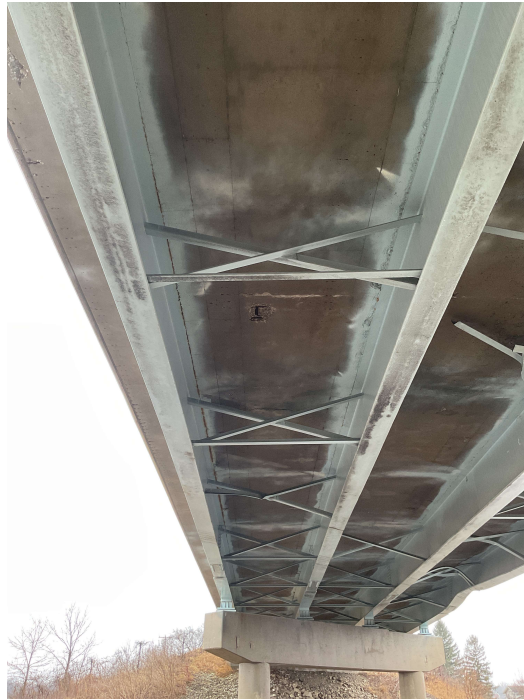
PHOTO 5

RUSTED 1 BROKEN AND BENT OVER NB IN BAY 1 SPAN 3.

Description Span3 bay1 x frame 5 bent

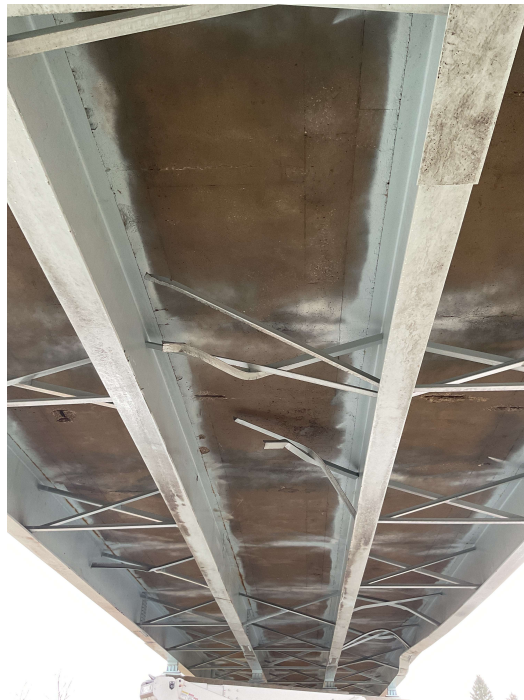
PHOTO 6

Description Span3 bay2 x frames 2-4 damaged

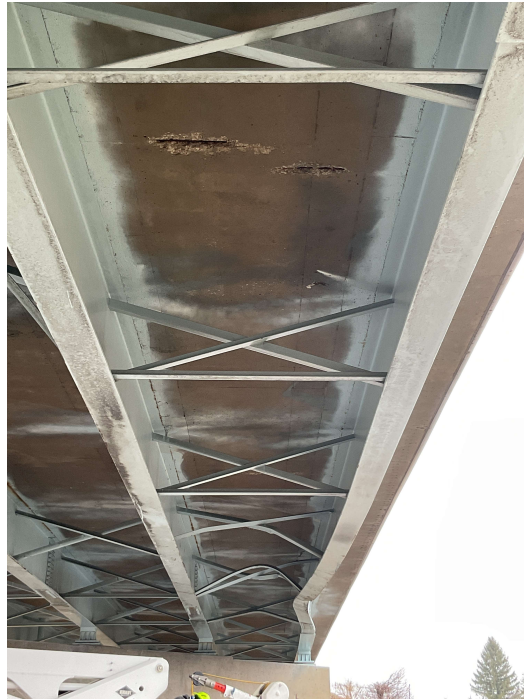
PHOTO 7

Description Span3 bay 3 x frames 5-7 damaged

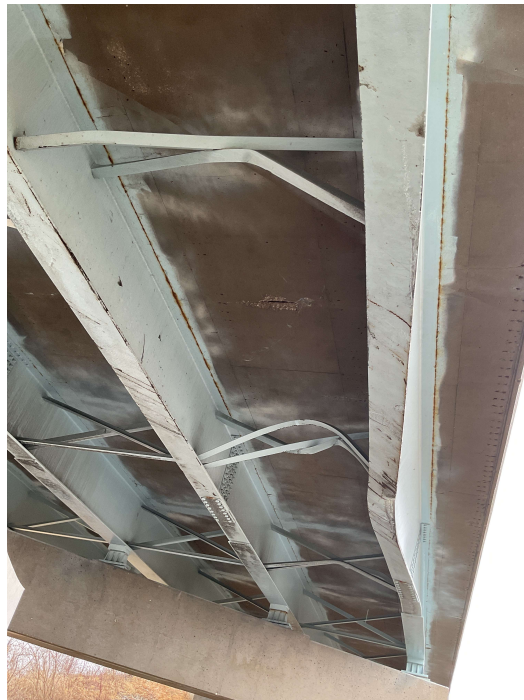
PHOTO 8

Description Span 3 bay 3

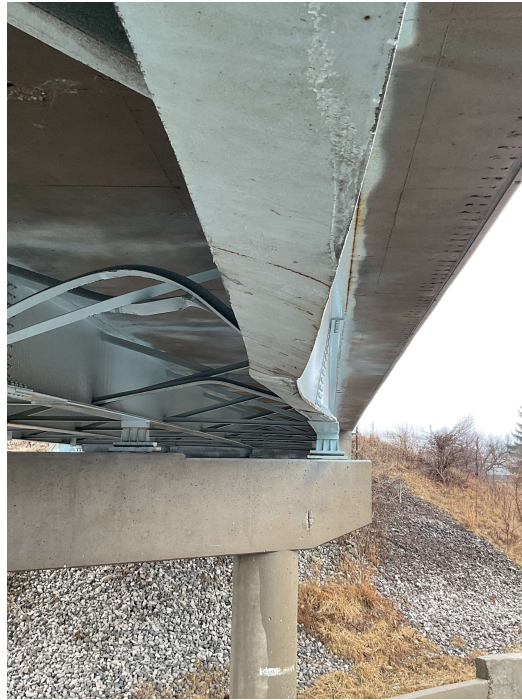
PHOTO 9

Description Span3 B4 over 23nb

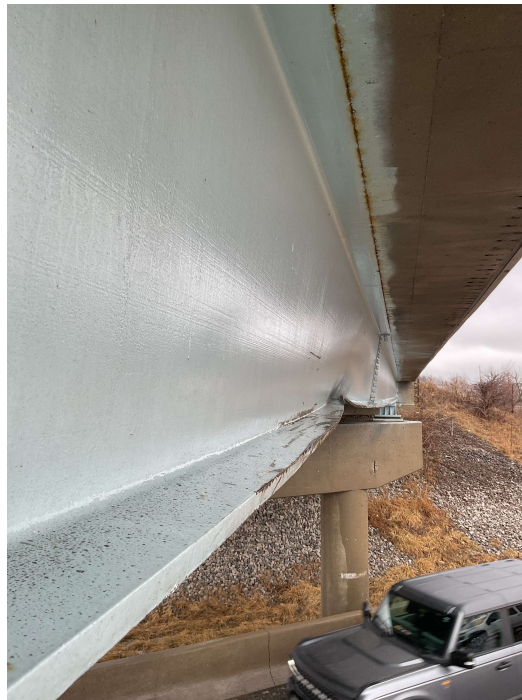
PHOTO 10

Description Span3 B4

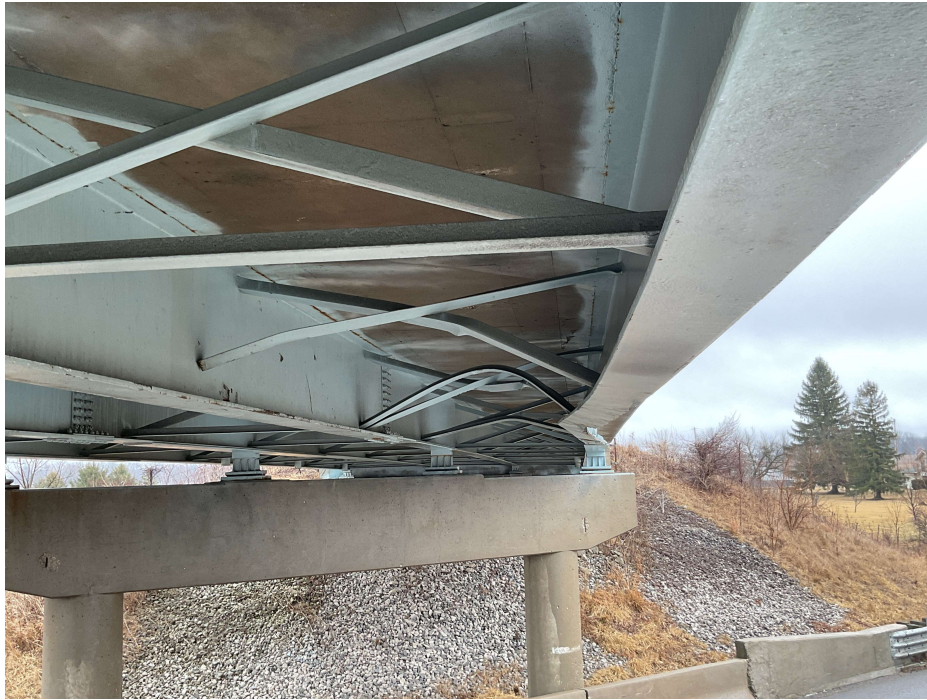
PHOTO 11

Description Span3 B4

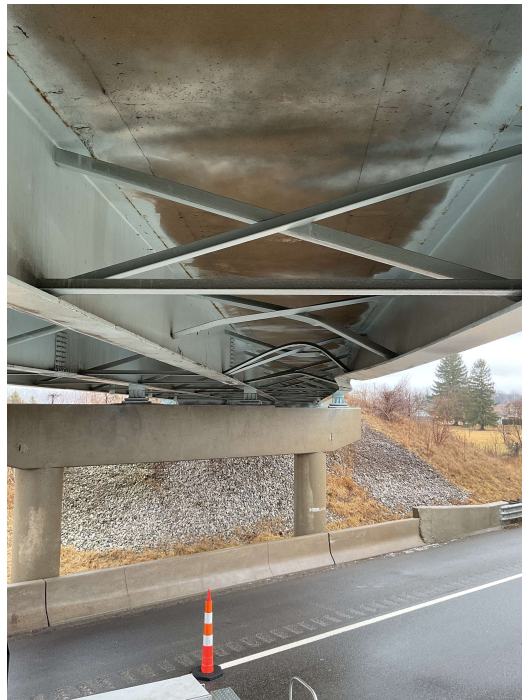
PHOTO 12

Description Span3 bay3

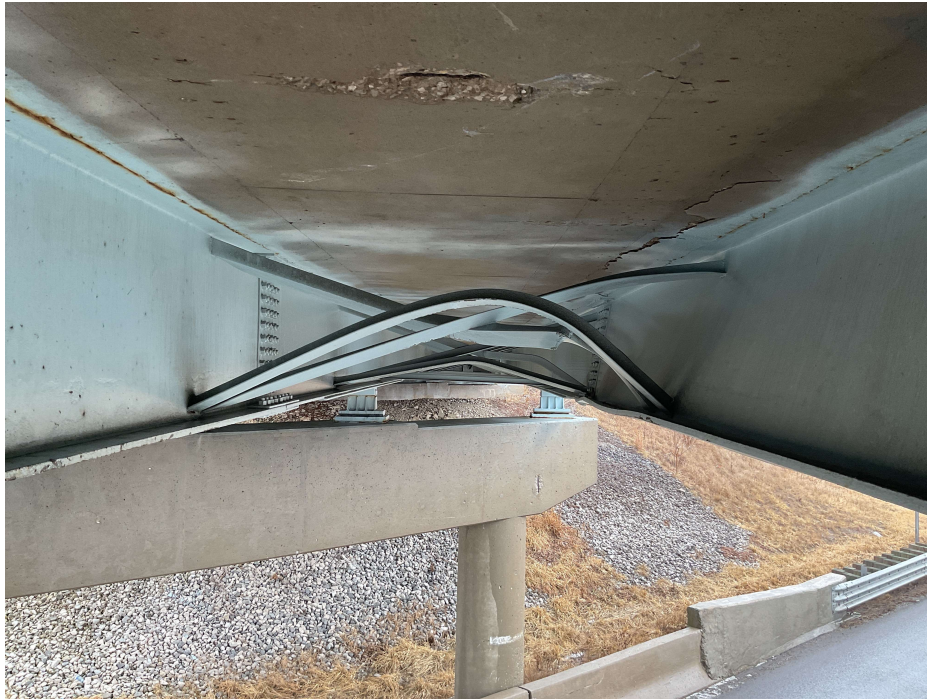
PHOTO 13

Description Span3 bay 3 x frame 6

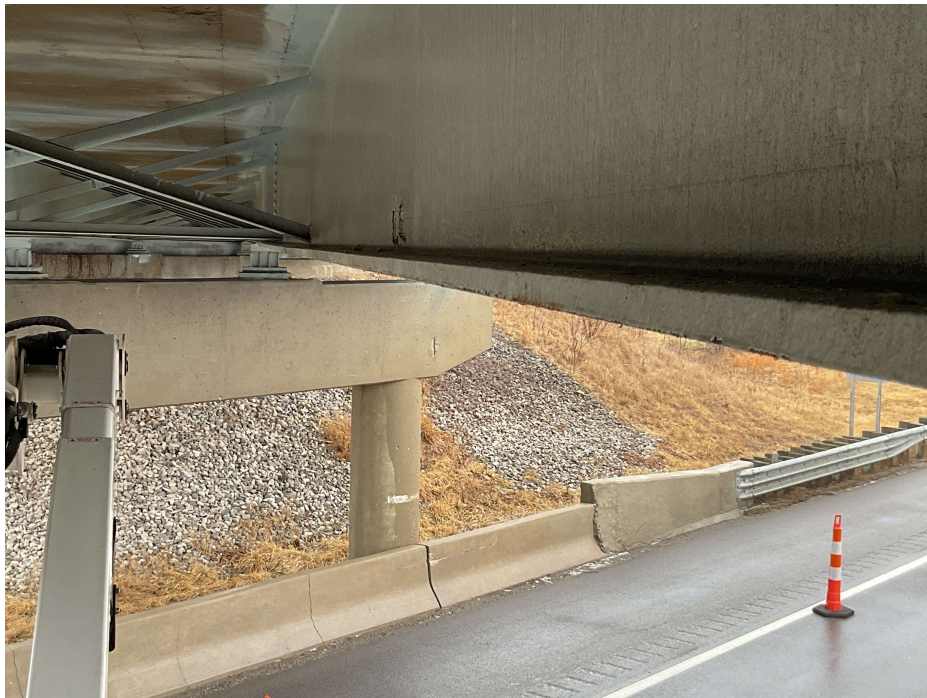
PHOTO 14

There appears to minor lateral distortion in Beam 2 Span 3 near mid span caused by impact. Possible loss of camber in Beams 2&3 in Span 3, (162').

Description Span3 B3 possible loss of camber

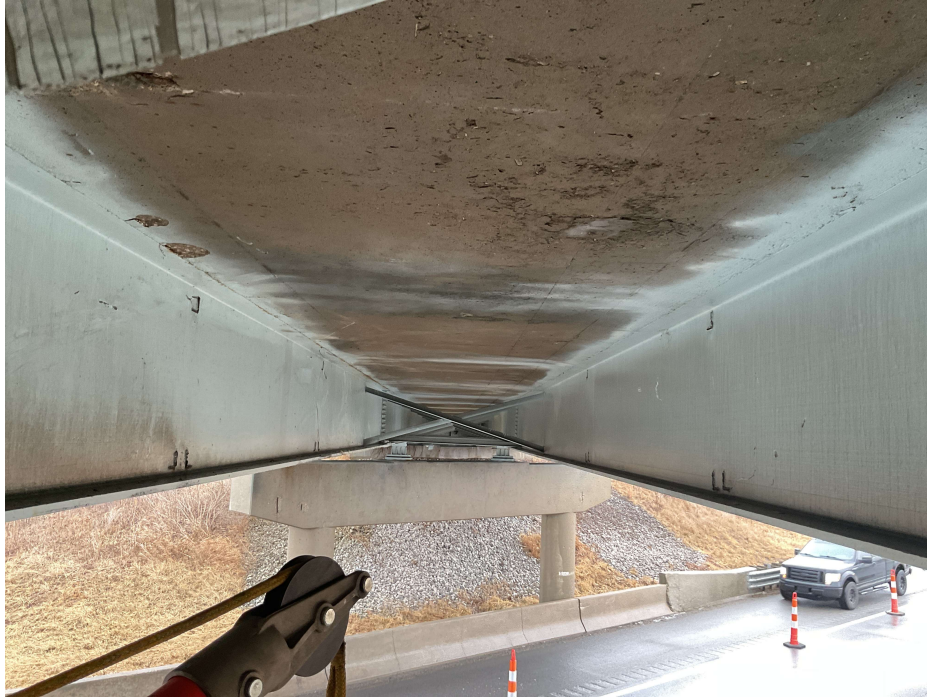
PHOTO 15

Description Span3 bay2 (1 lateral brace@#2 removed- xframes #3&4 removed)

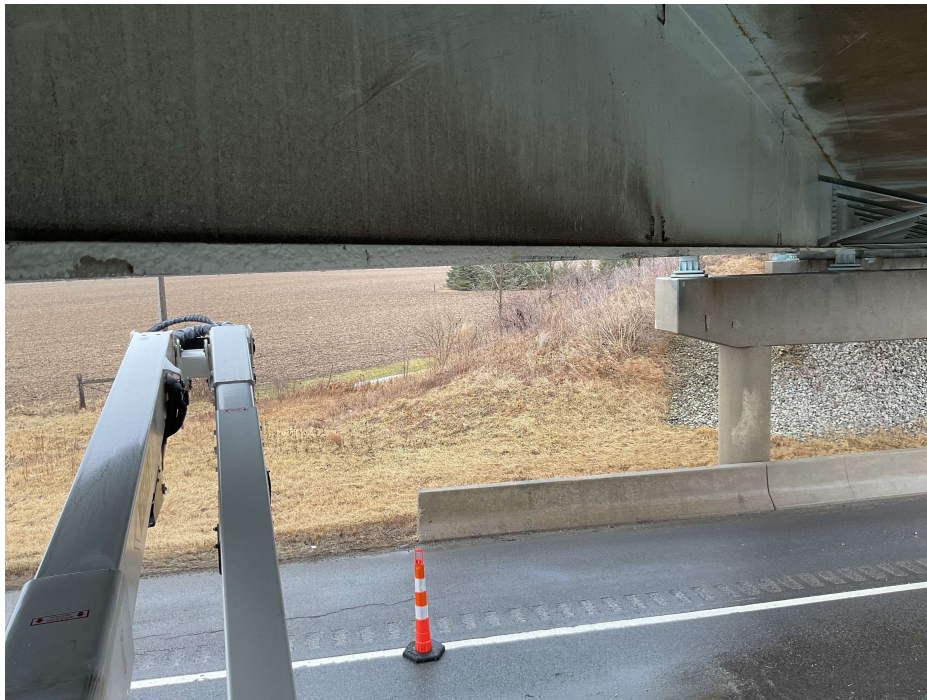
PHOTO 16

Description Span3 B2 possible lose of camber

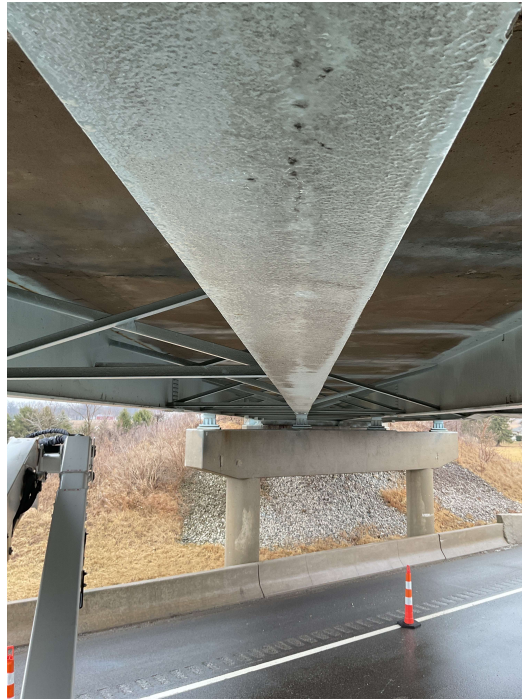
PHOTO 17

Description Span3 B2

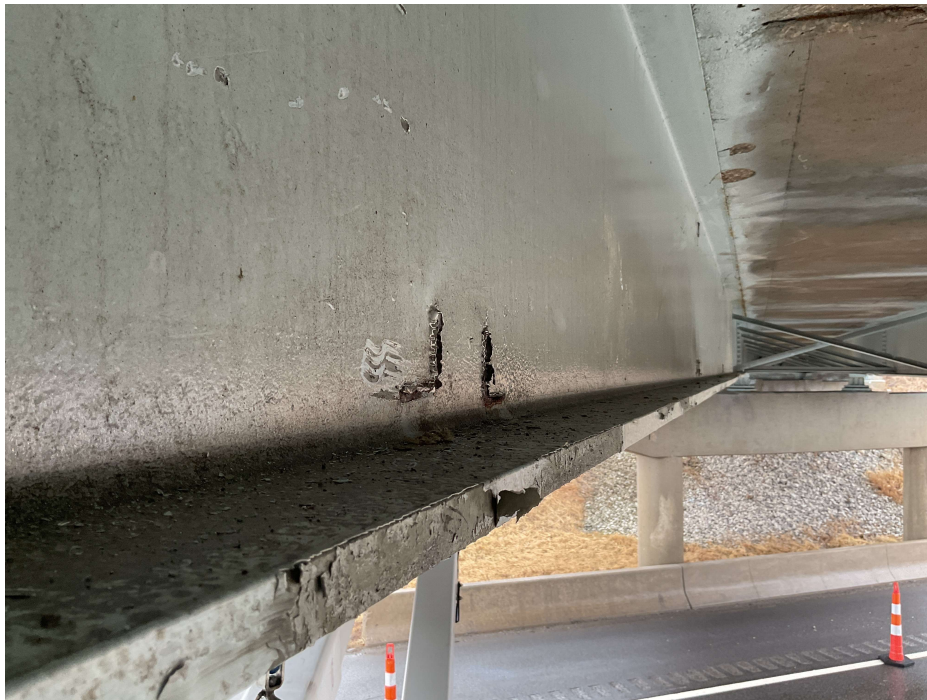
PHOTO 18

Description Span3 B2

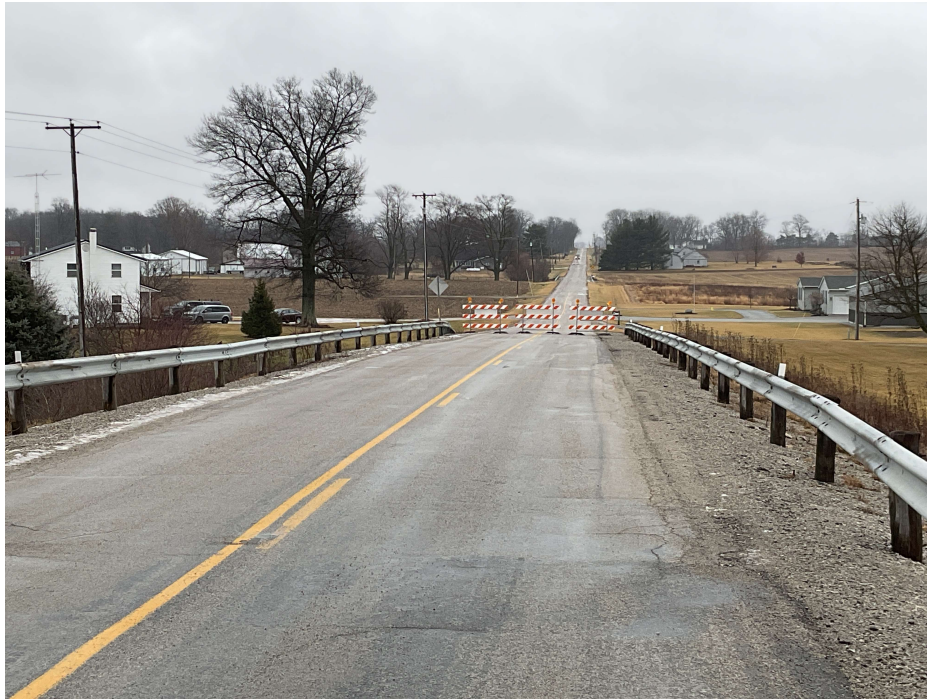
PHOTO 19

Description Barricades set at east side of structure

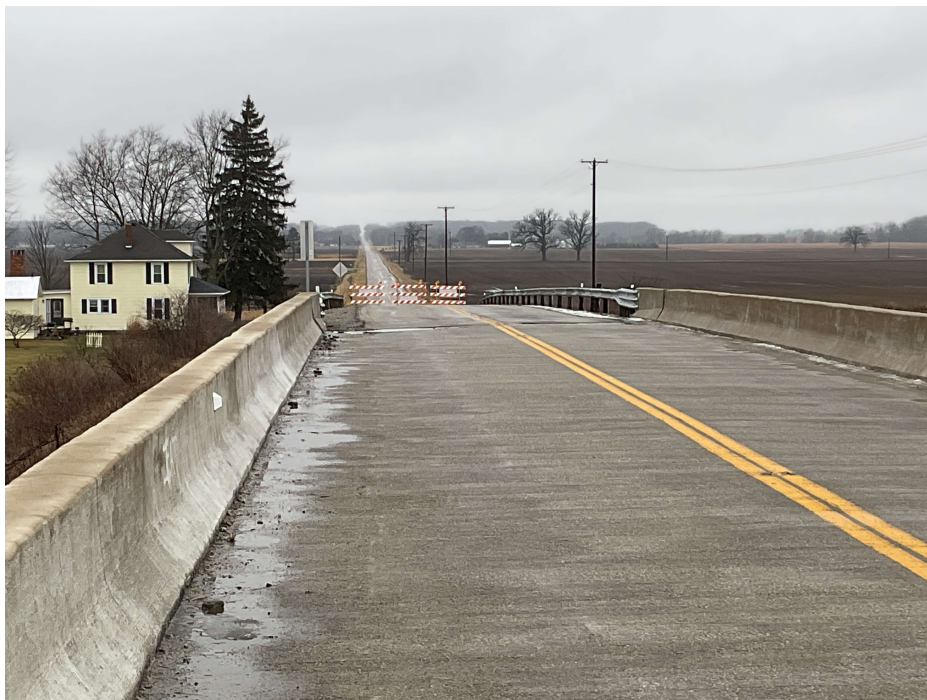
PHOTO 20

Description Barricades set at west side of structure

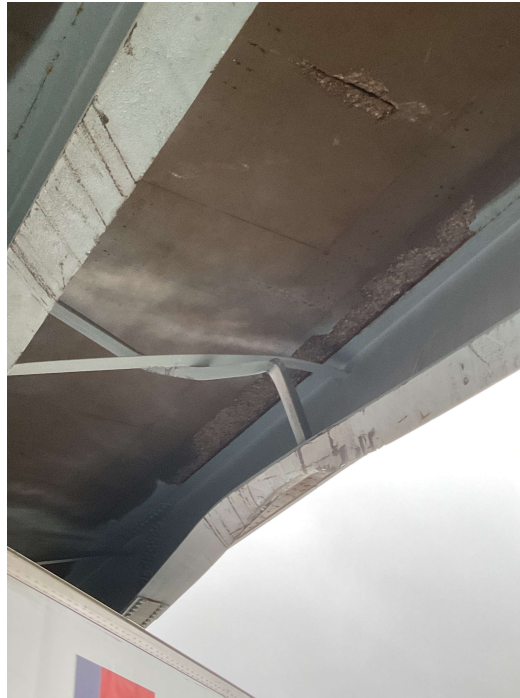
PHOTO 21

Description Loose concrete removed in span3 bay3
