Inspection Date: 10/29/2024

Structure Number: 5902797

Ohio Bridge Inspection Summary Report

MRW-00288-0007 (5902797)

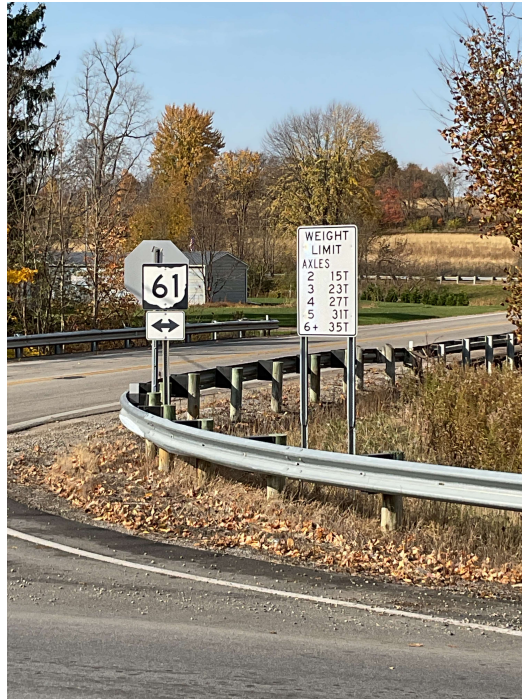
PHOTO 1

Description Fwd

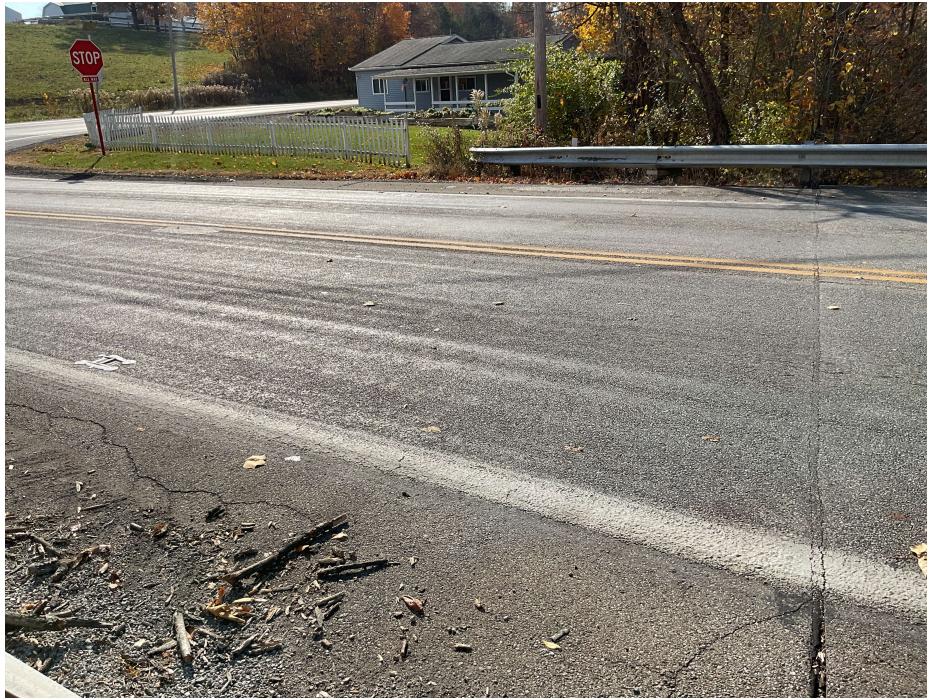
PHOTO 2

Description Fwd approach

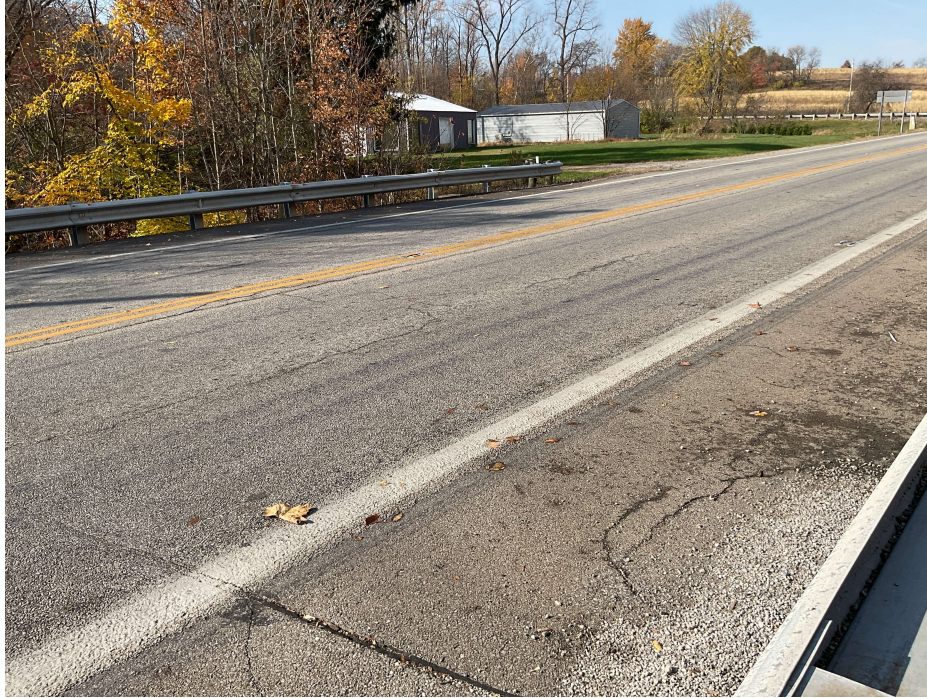
PHOTO 3

Description WS

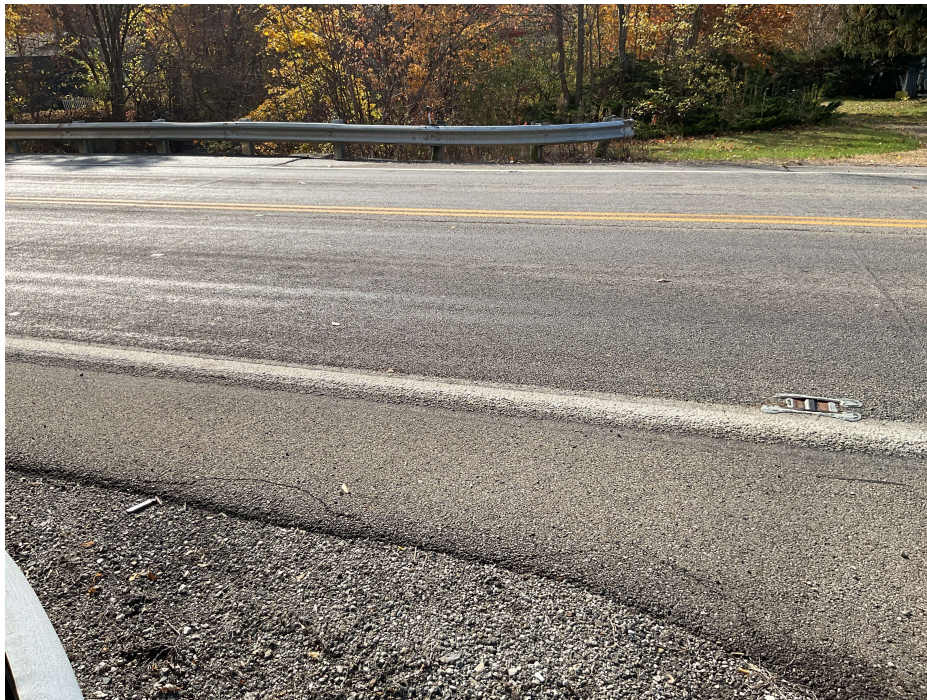
PHOTO 4

Description Rear approach

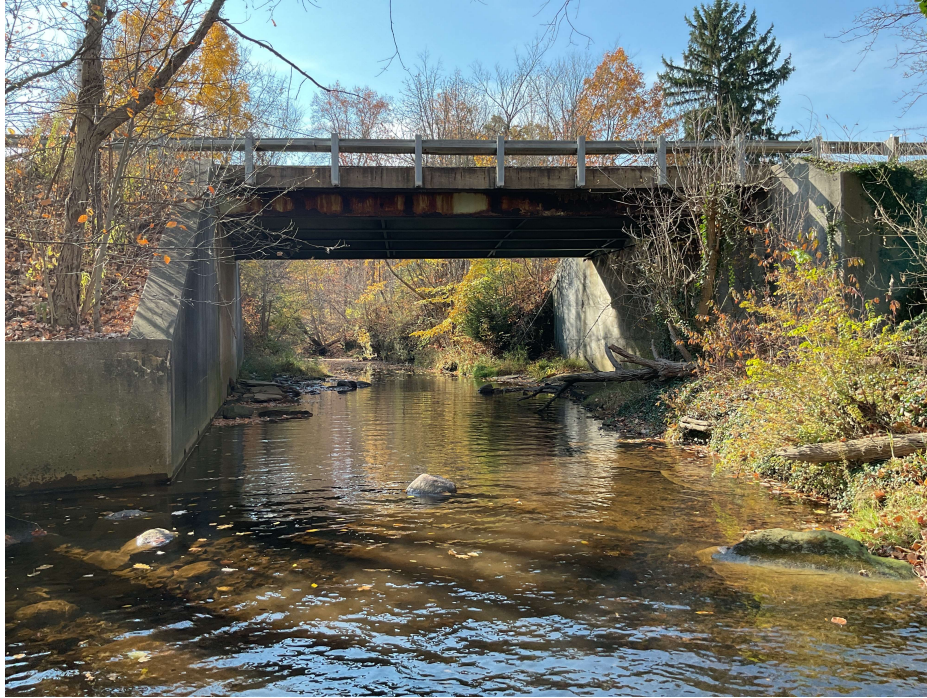
PHOTO 5

Description Lt

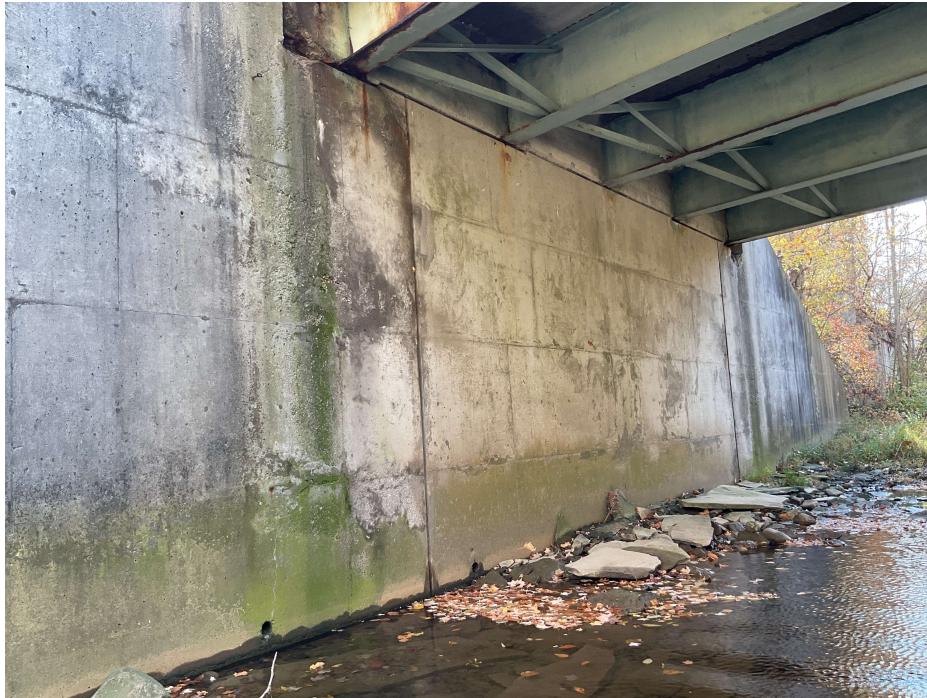
PHOTO 6

Description Fwd

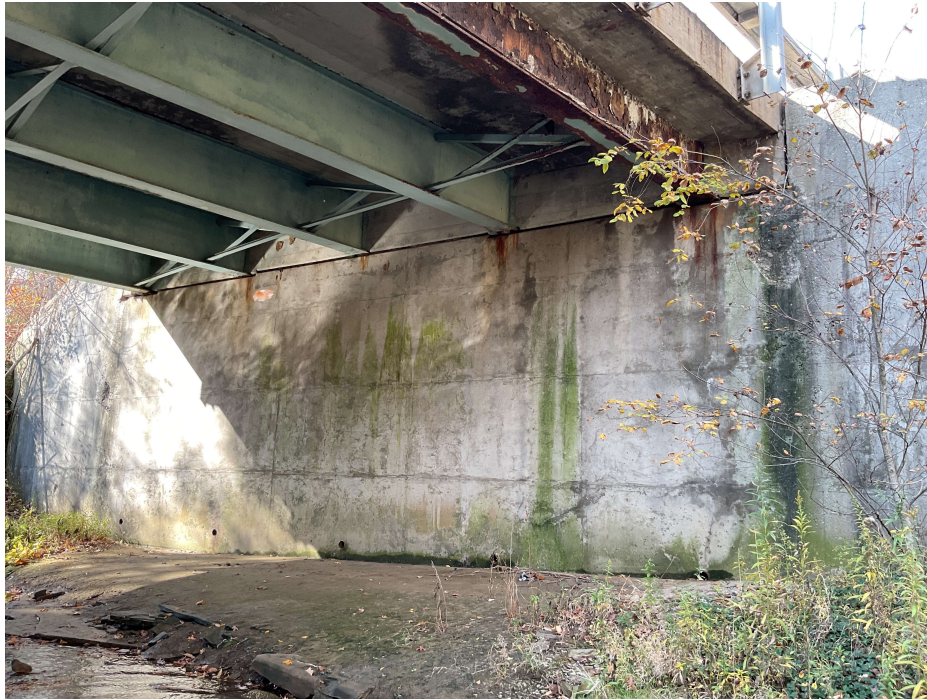
PHOTO 7

Description Rear

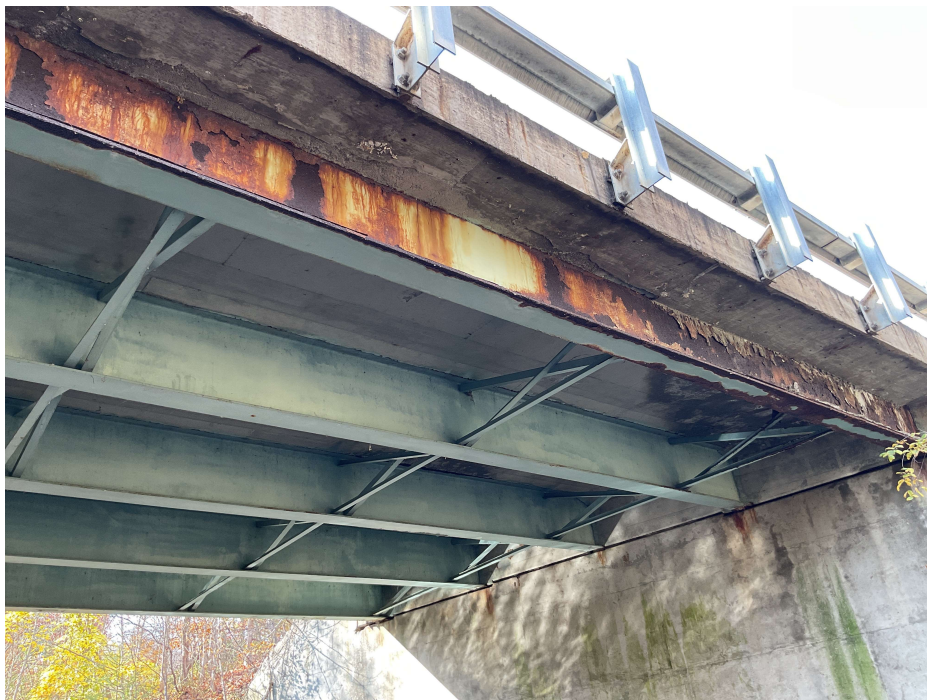
PHOTO 8

Description B1 Rear

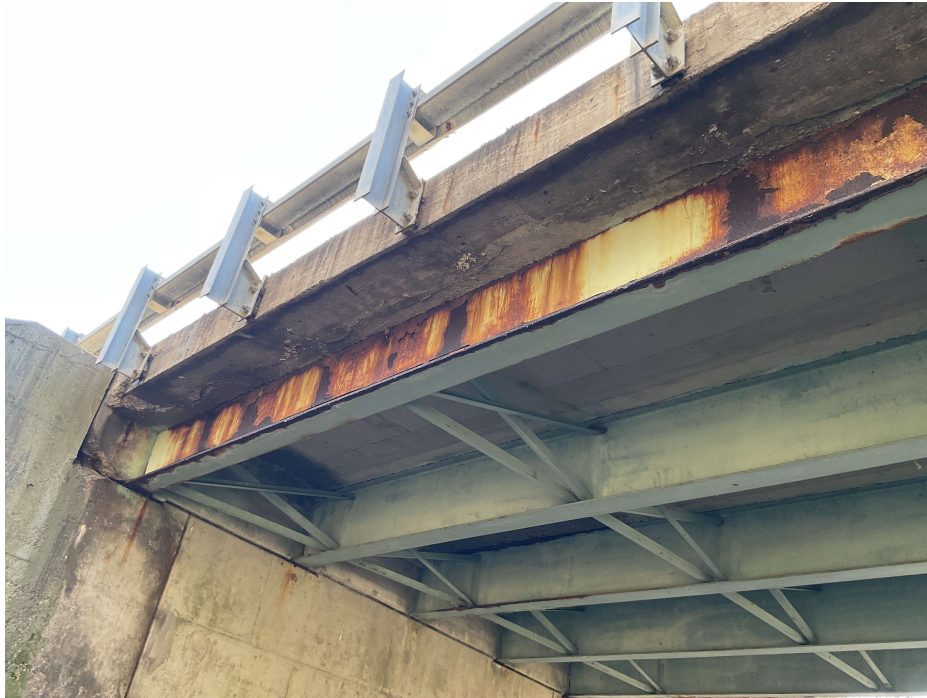
PHOTO 9

Description B1 Fwd

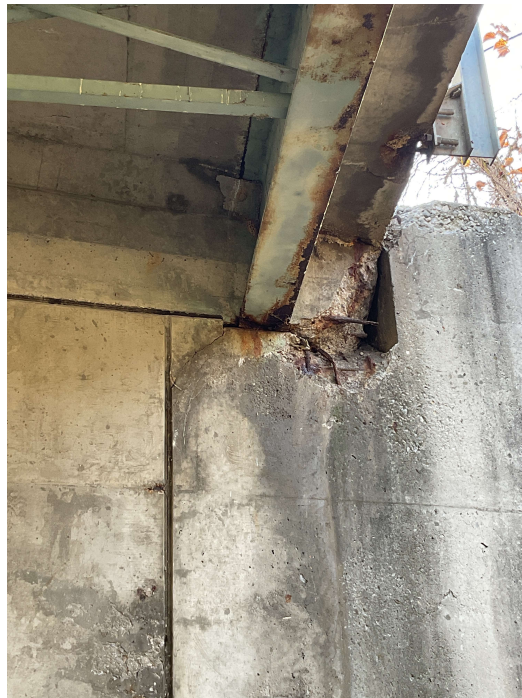
PHOTO 10

Description Fwd Rt

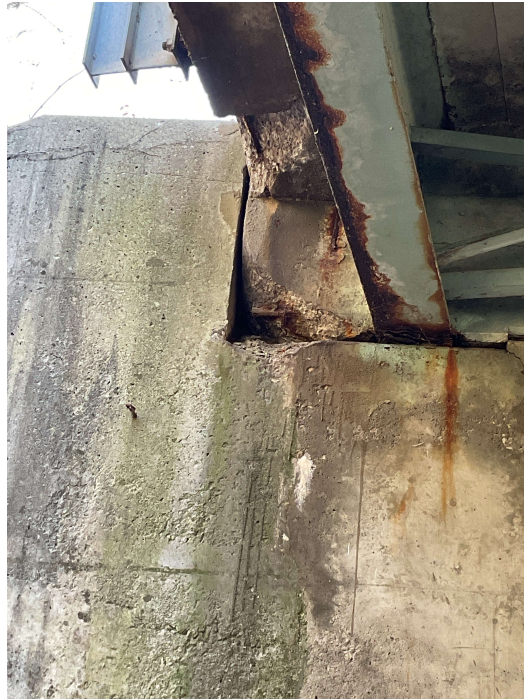
PHOTO 11
Description Fwd Lt

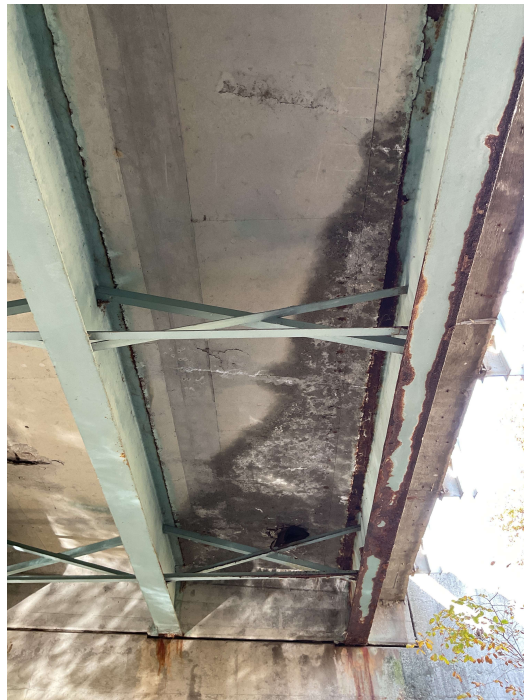
CRACKING W/EFFLOR., SATURATED AREAS LT.REAR AND RT.FWD.,,A 3X3 AREA DELAMINATED AND SPALLED BAY 1 REAR.,,A 2X3 AREA SPALLED BAY 3 FWD.

PHOTO 12
Description Bay1, Rear

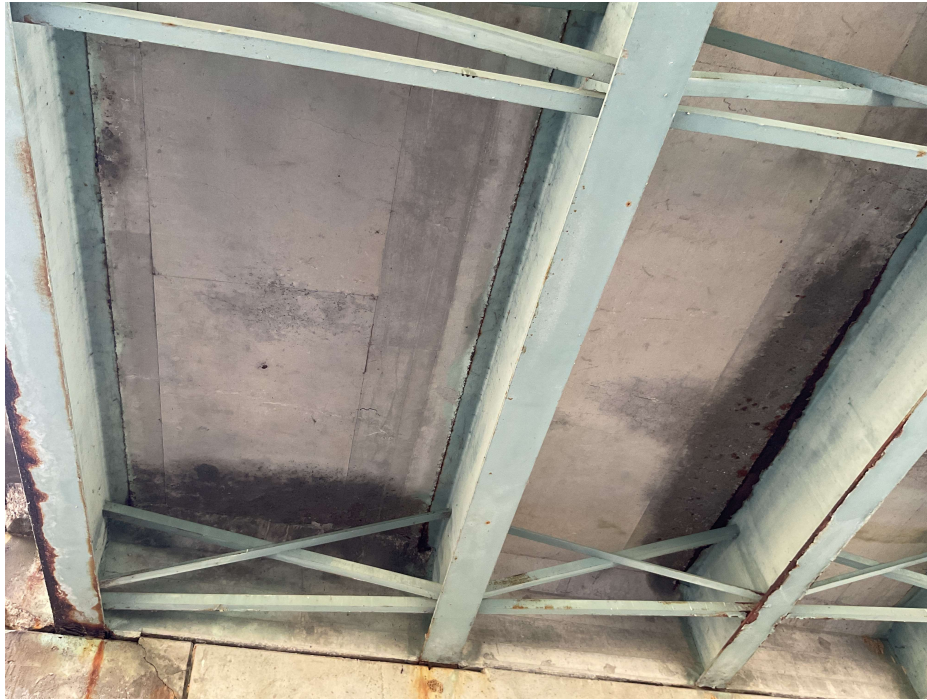
PHOTO 13

Description Bays 1&2 , Fwd

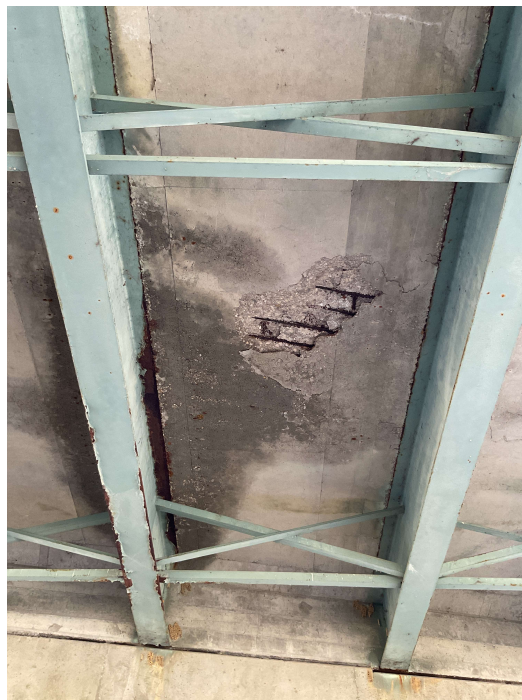
PHOTO 14

Description Bay3 Fwd

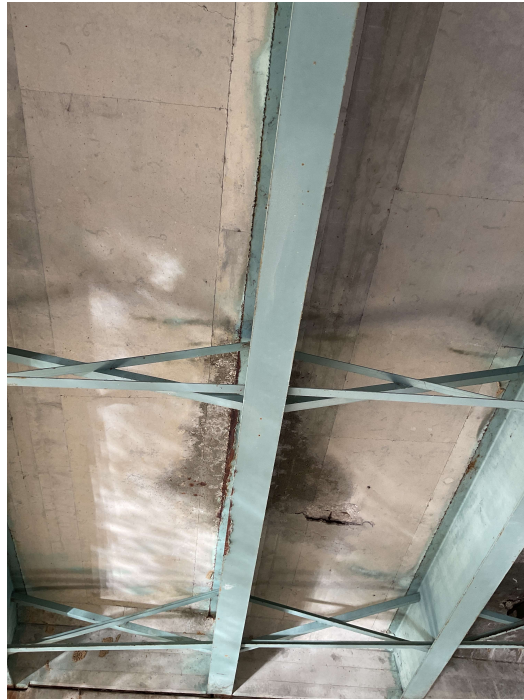
PHOTO 15

Description Bays2&3 Rear

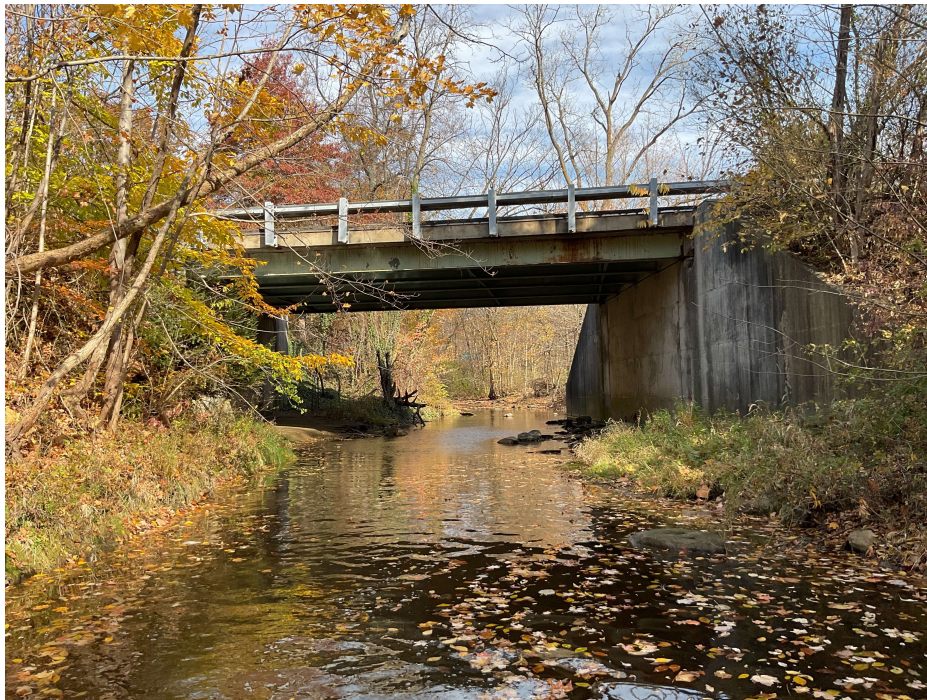
PHOTO 16

Description Rt

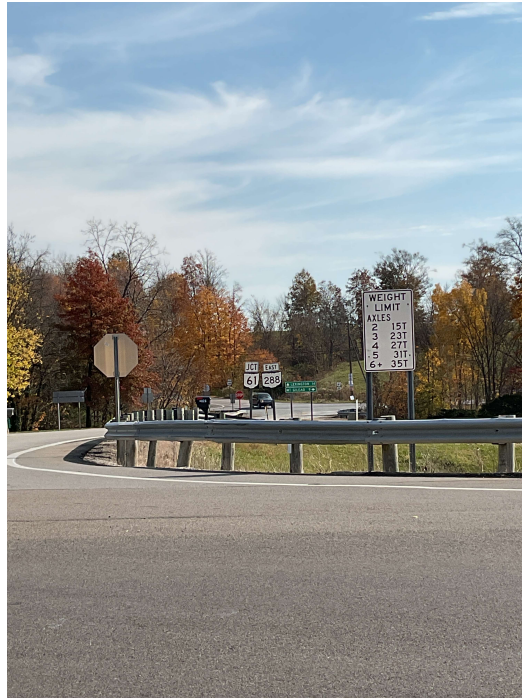
PHOTO 17

Description Rear
