Structure Number: 2400553  
 Facility Carried: USR 35

## Ohio Bridge Inspection Summary Report

**FAY-00035-1666L (2400553)**

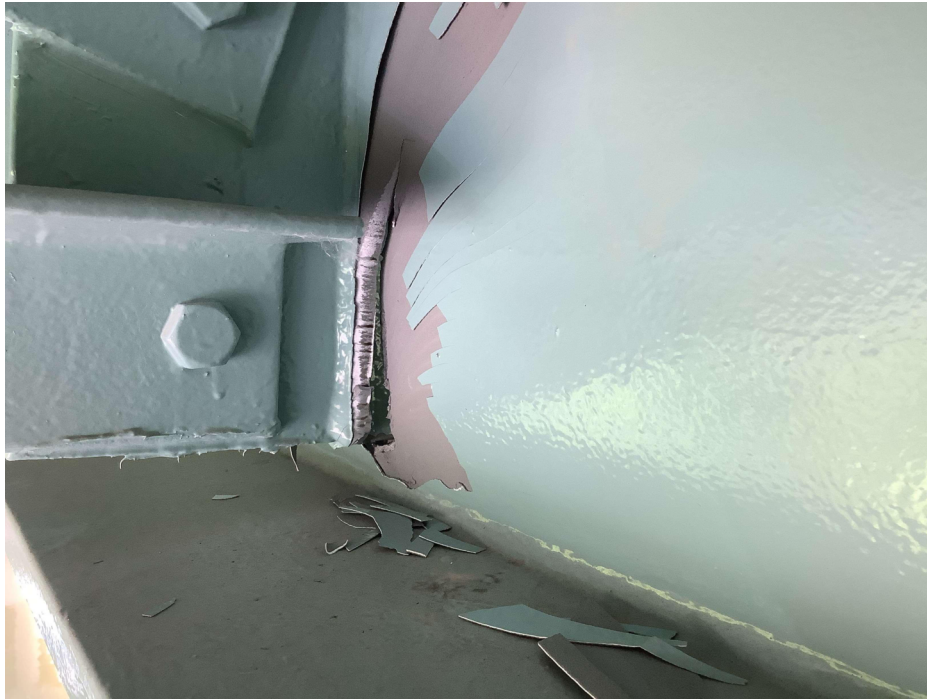
PHOTO 1

Description 2024 bridge hit B3

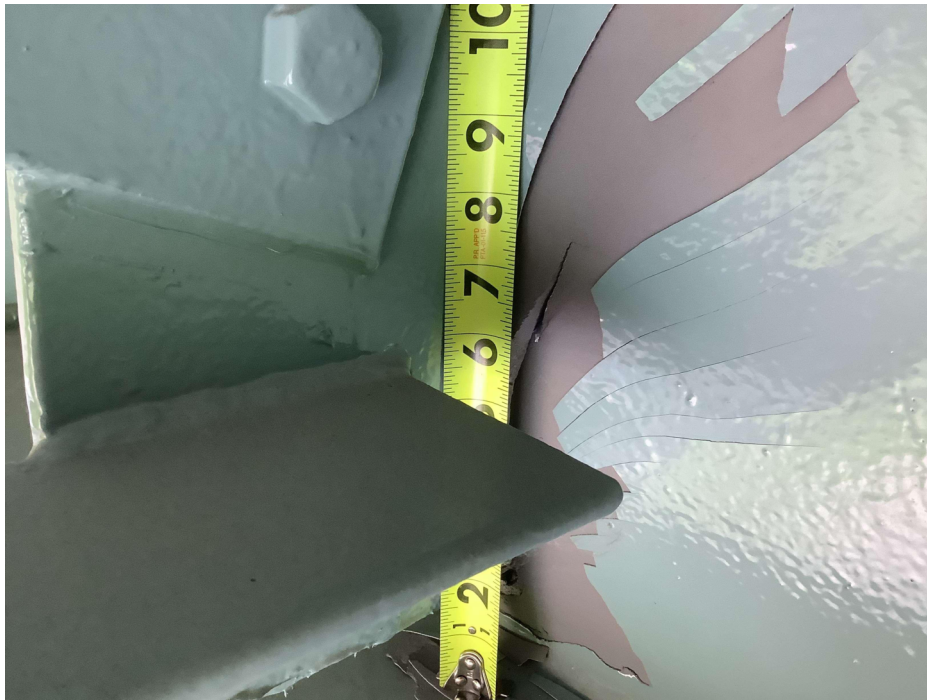
PHOTO 2

Description 2024 bridge hit B3

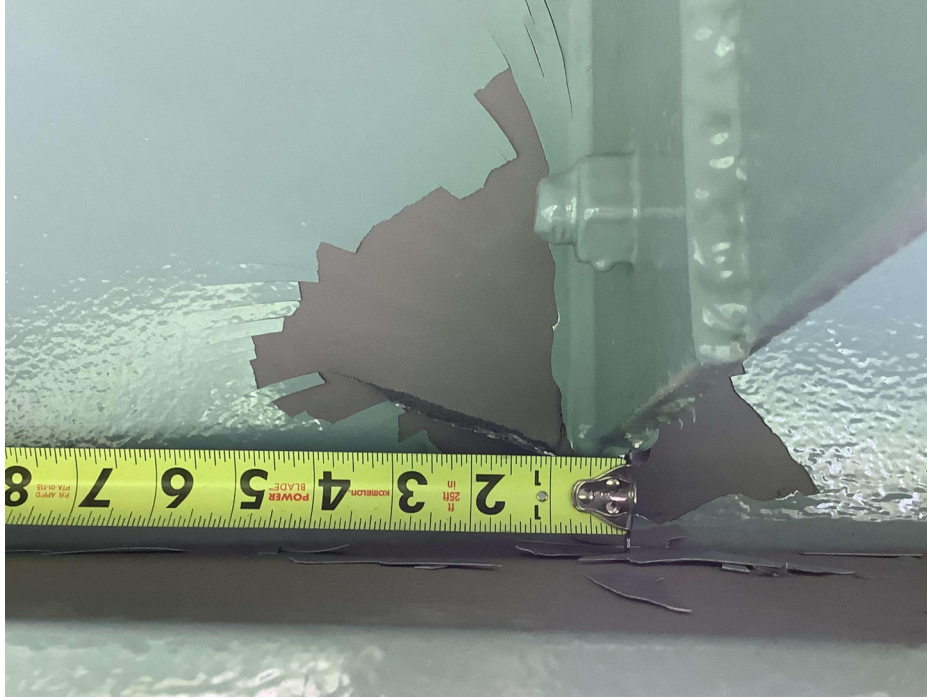
PHOTO 3

Description 2024 Bridge hit B3

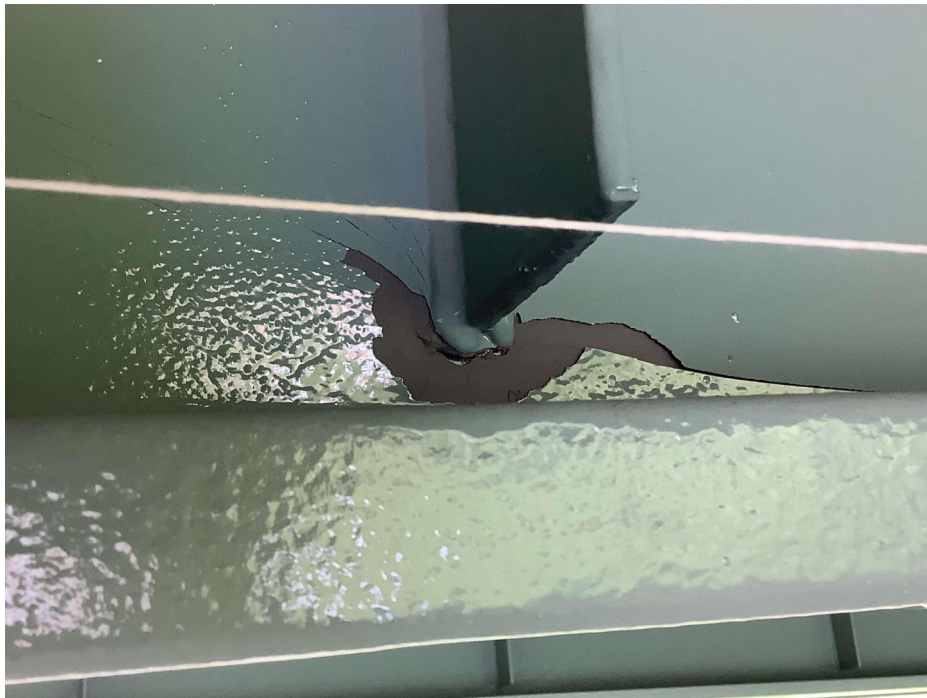
PHOTO 4

Description 2024 Bridge hit B3

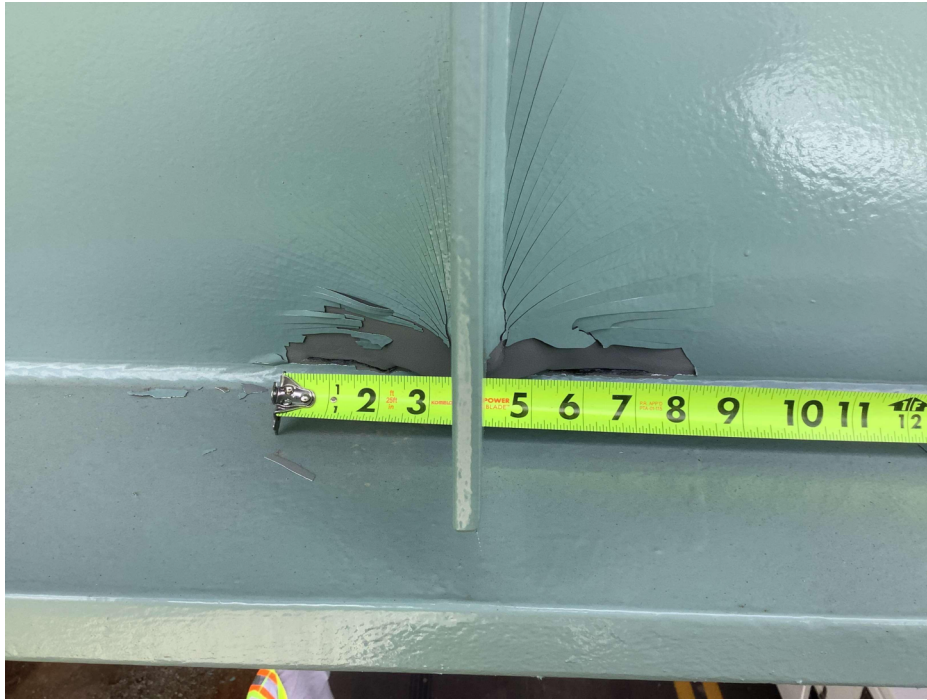
PHOTO 5

Description 2024 B1 xframe 4

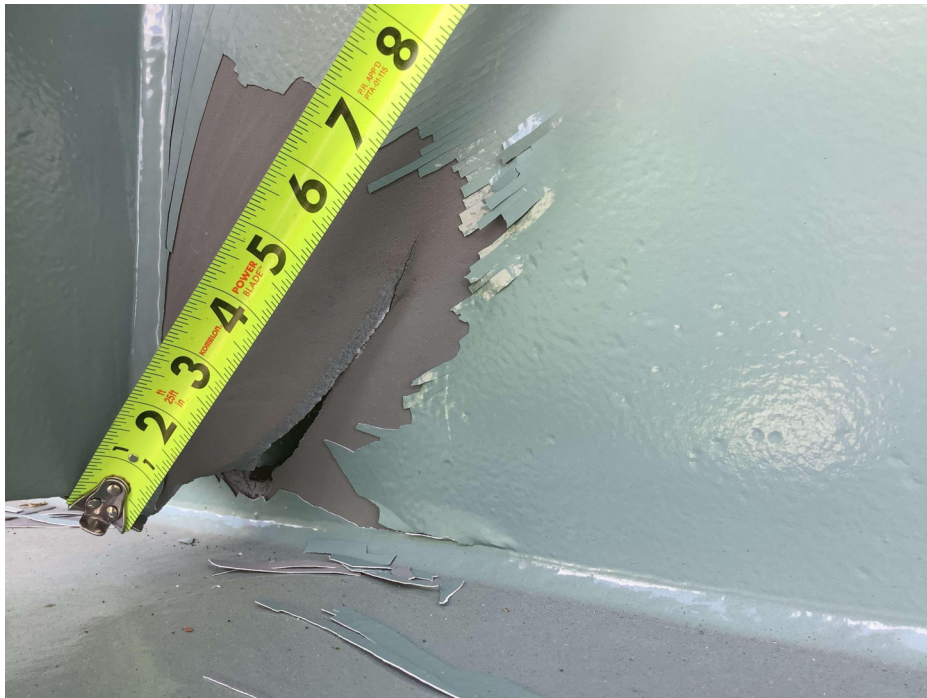
PHOTO 6

Description 2024 B1 xframe 3

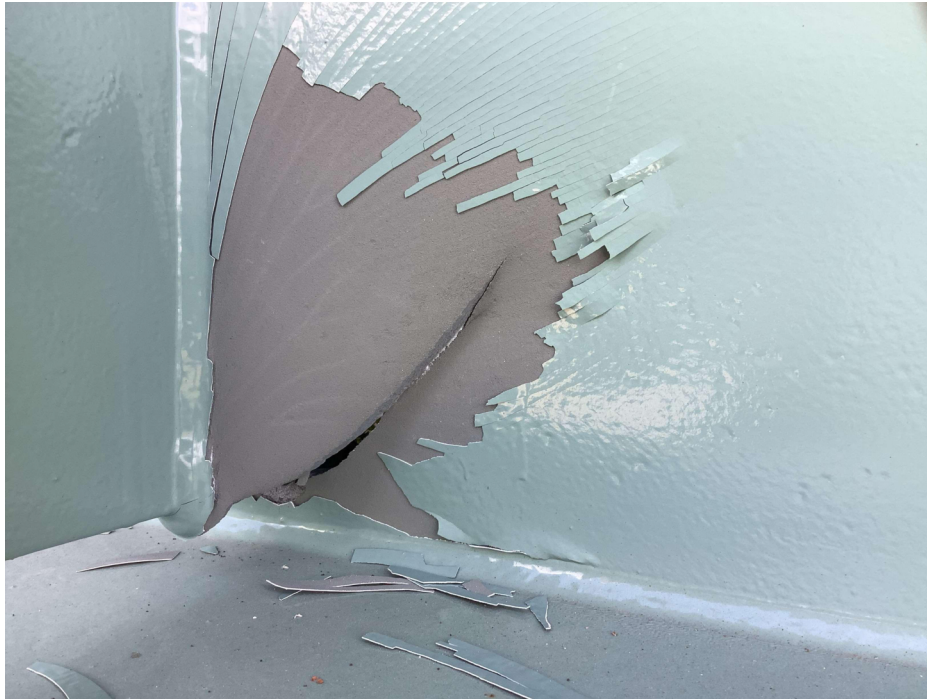
PHOTO 7

Description 2024 xframe3

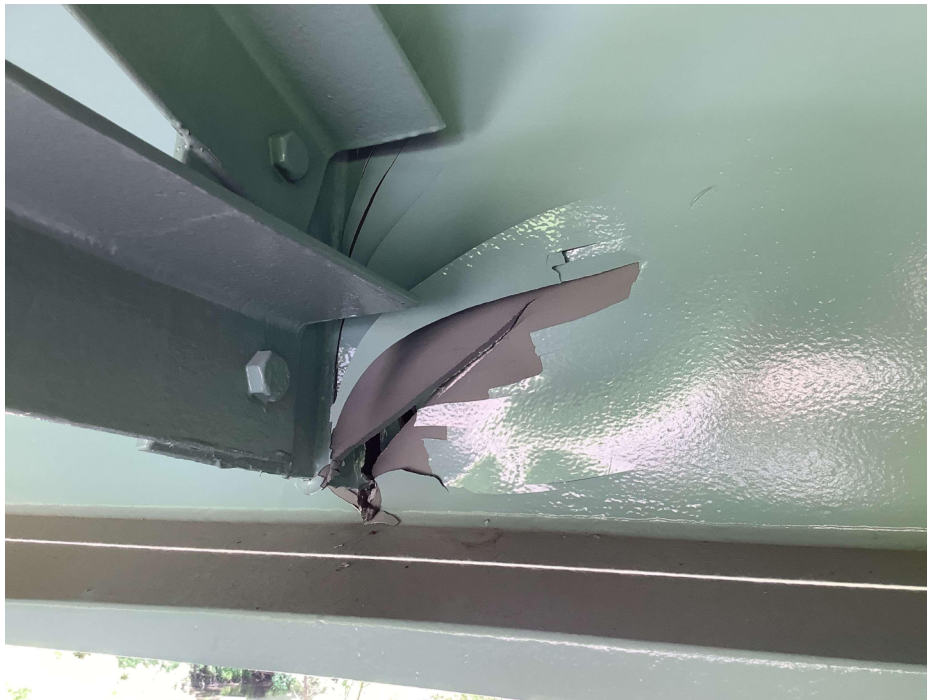
PHOTO 8

Description 2024 B1 xframe 2

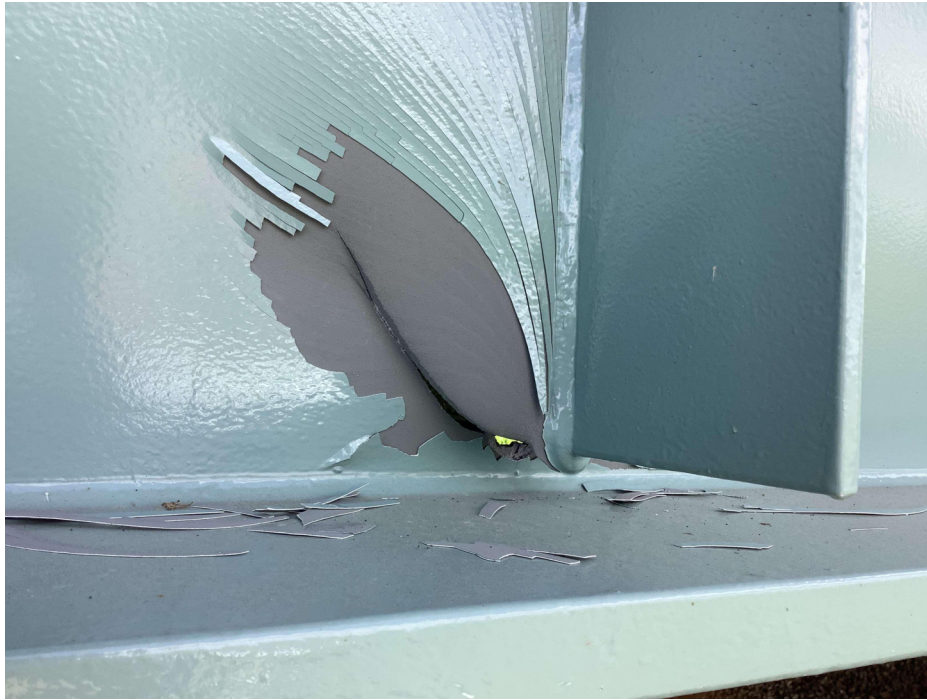
PHOTO 9

Description 2024 B1 xframe 2
