Structure Number: 5902827  
 Facility Carried: SR 288

**MRW-00288-0050 \_(5902827)**

Feature Inters: FLAT RUN

### Bridge Inspection Report

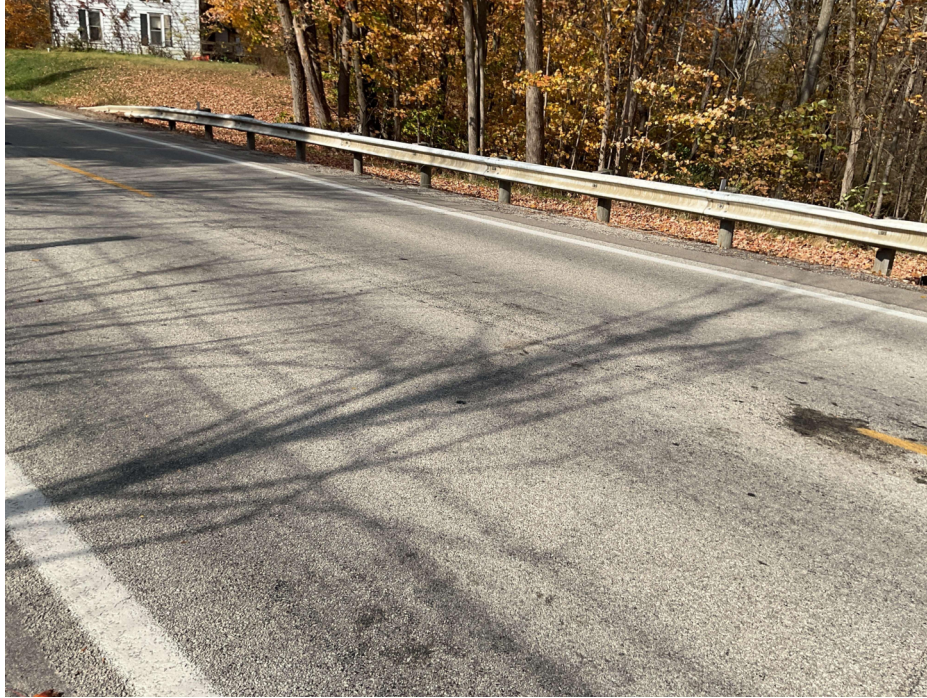
PHOTO 1

Description Rear Approach

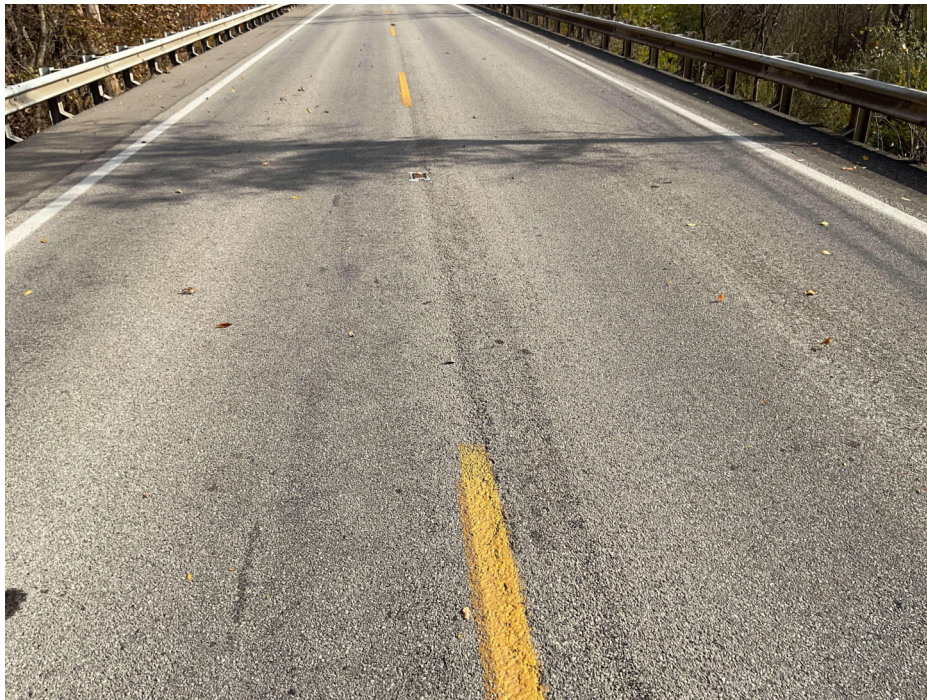
PHOTO 2

Description Wearing Surface

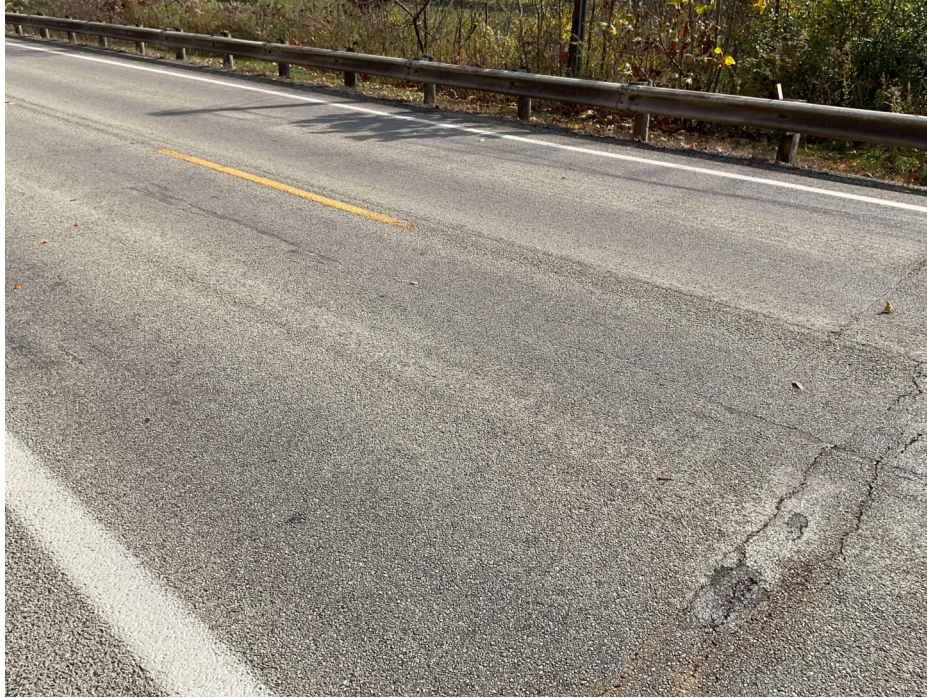
PHOTO 3

Description Fwd Approach

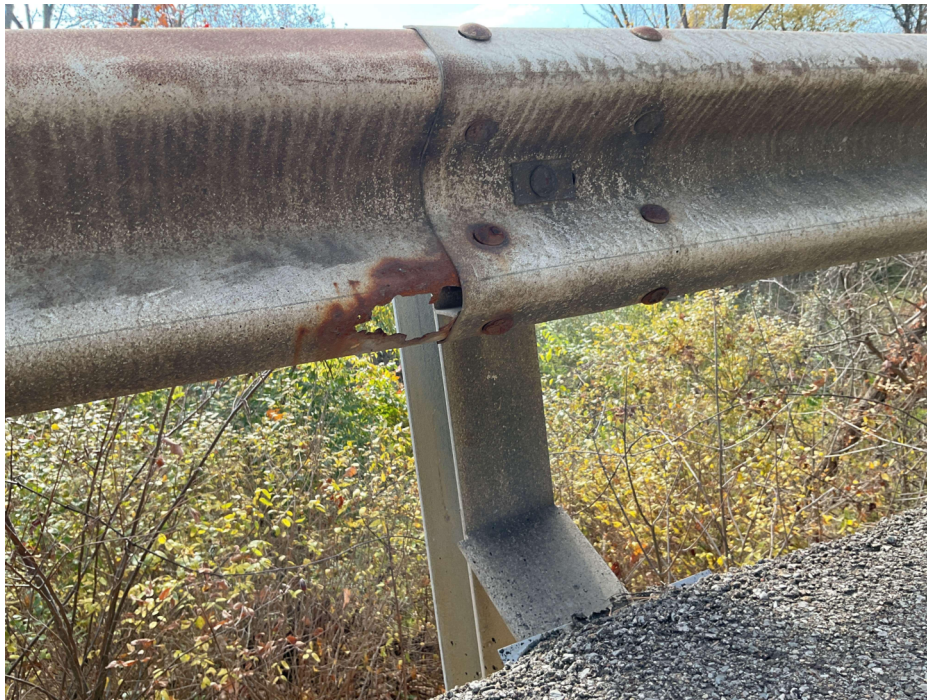
PHOTO 4

2022- chip sealed. 2024 CS2 Fwd & Rear - trans & longitudinal cracks 21 SF (Fwd-15 SF)(Rear-6 SF)							
<b>330-Metal Bridge Railing</b>	3 - Mod.	293	ft.	228	0	65	0
2024 CS3 LT & RT (lower portion of panels) - rusted w/ various thru holes 65'							
<b>815-Drainage</b>	3 - Mod.	2	each	2	0	0	0
<b>830-Abutment Backwall</b>	3 - Mod.	64	ft.	38	26	0	0
2024 CS2 Fwd & Rear - open trans cracks in asphalt over backwall 16' Fwd bays 4&5 saturated, horizontal cracks with efflorescence and areas of unsound concrete 10'

Description RT railing (typical rust w/ thru holes)

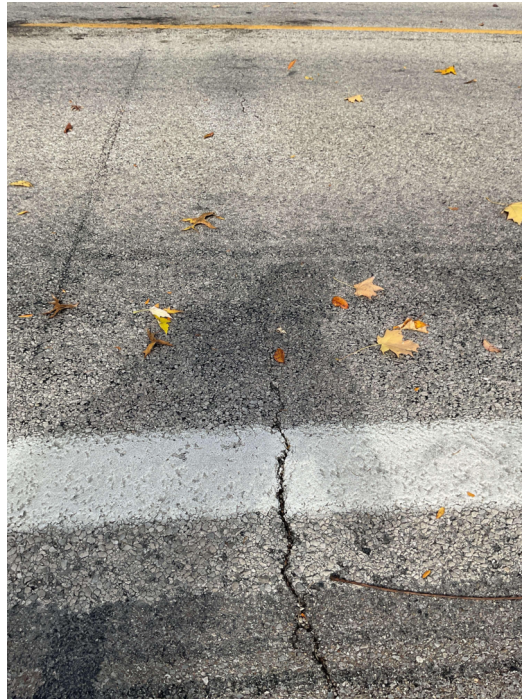
PHOTO 5

Description Wearing Surface (Rear RT)

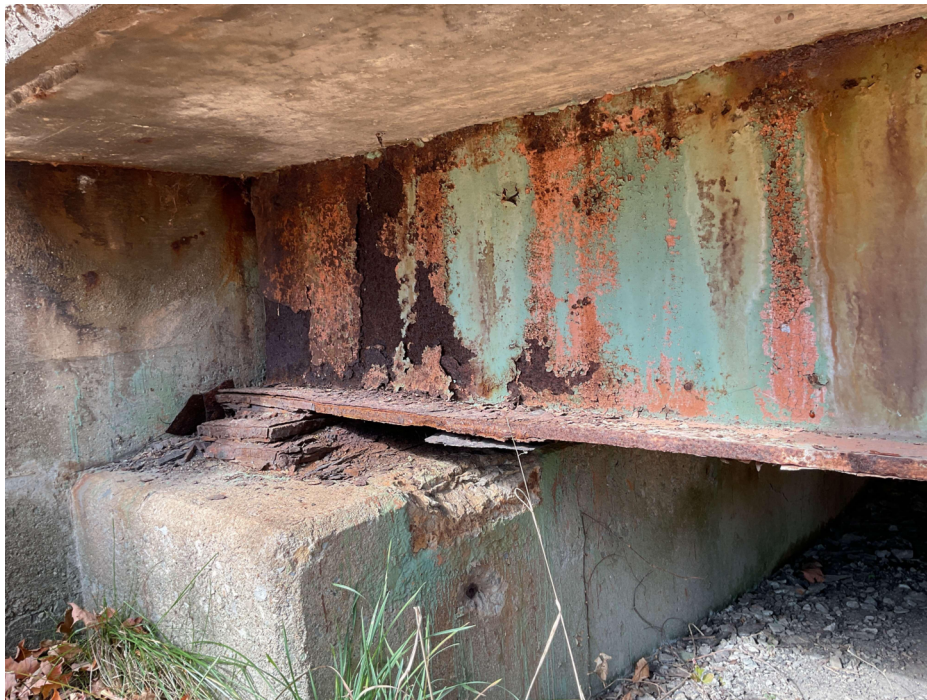
PHOTO 6

Description B6 @ Rear Abut

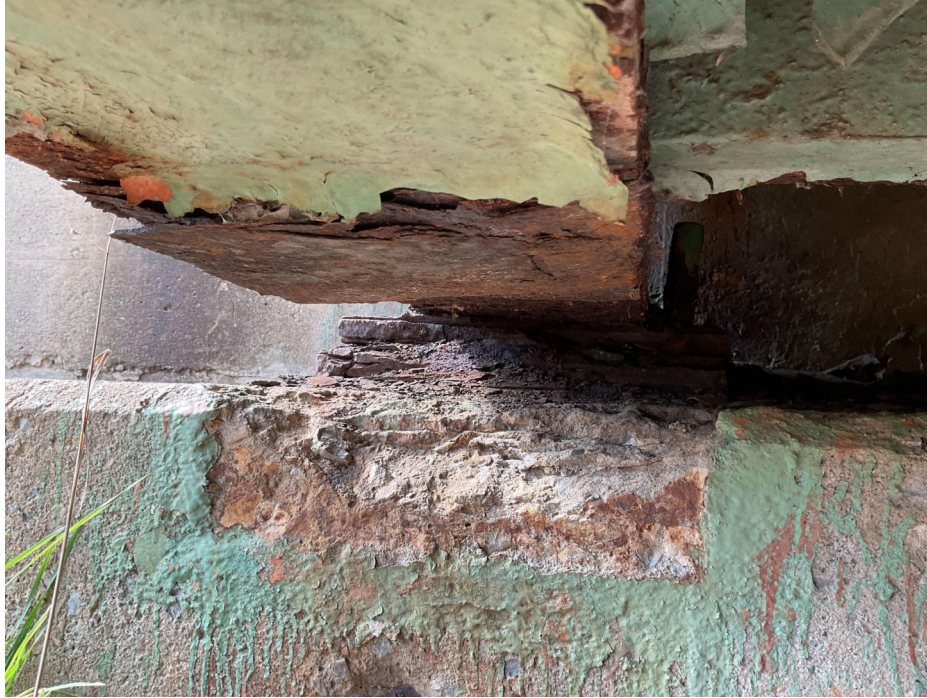
PHOTO 7

Description Rear Abut bearing 6

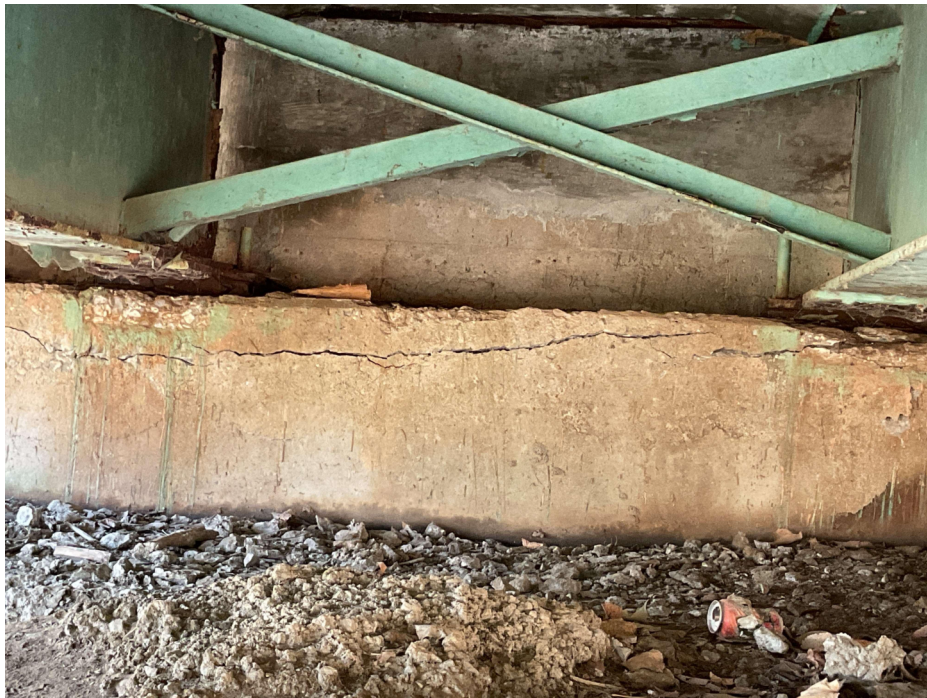
PHOTO 8

Description Rear Abut bay 4

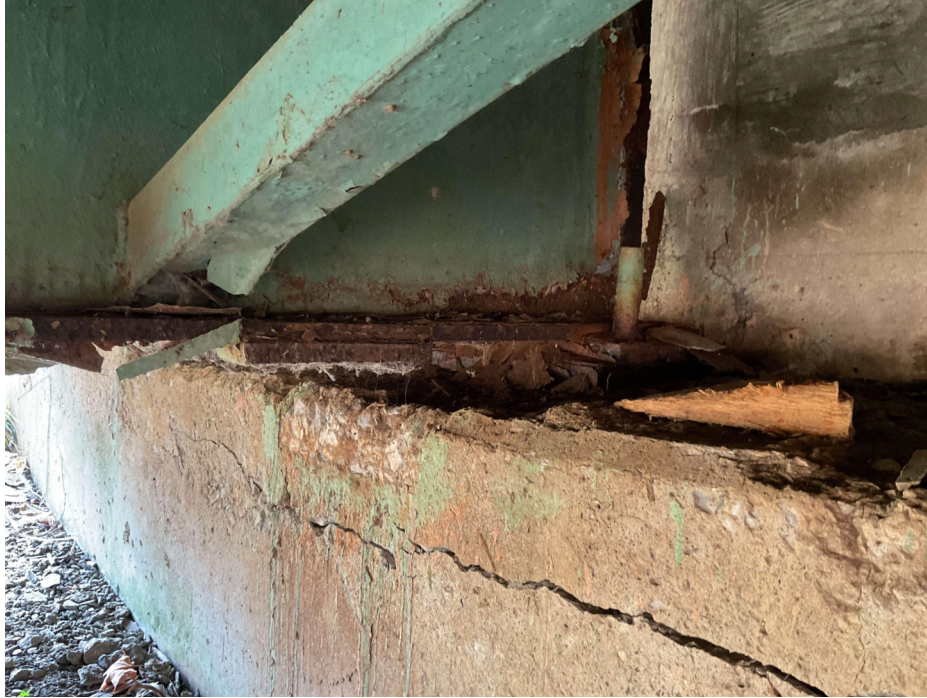
PHOTO 9

<b>107-Steel Open Girder/Beam</b>	3 - Mod.	879	ft.	703	159	5	12
2024 *Negative camber in all beams CS2 All Spans (near top & bottom flanges) - light rust w/ minor section loss 159' (Span 1-64')(Span 2-40')(Span 3-55') CS3 Span 1 B5 (at Rear abut) - heavy rust and corrosion with moderate section loss 5' CS4 Span 1 B1 & B6 (@ Rear Abut) - pack rusted w/ heavy section loss / bottom flange beginning to distort & sag 8' (B6-4')(B1-4') Span 3 B1 (@ Fwd Abut) - heavy rust w/ moderate section loss / bottom flange distorted & sagging, approx 50% section loss to bottom flange 4'							
<b>515-Steel Protective Coating</b>		7208	sq. ft.	0	3708	3000	500
2024 CS2- Chalking thin throughout CS3- Peeling, flaking throughout, worse at bottom flanges and low web area. CS4- PC has failed at bottom flanges, web, and beam ends throughout.							
<b>205-Reinforced Concrete Column</b>	3 - Mod.	6	each	6	0	0	0
<b>215-Reinforced Concrete Abutment</b>	3 - Mod.	64	ft.	12	52	0	0

Description Span 1 B5 @ Rear Abut

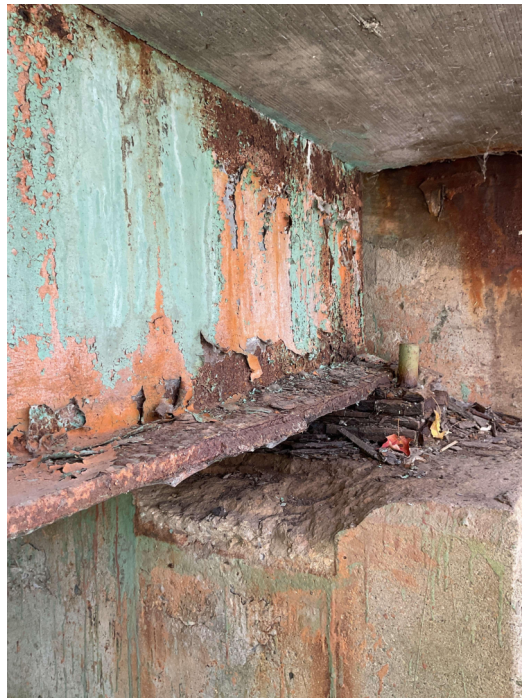
PHOTO 10

Description Span 1 B1 @ Rear Abut

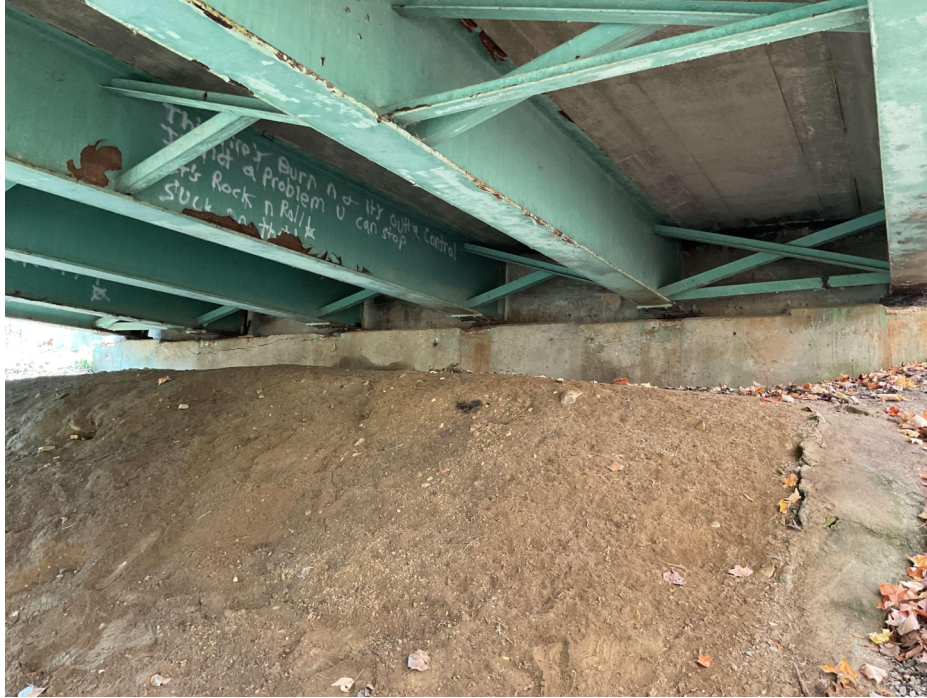
PHOTO 11

2024 CS2 Rear- small spalls under B1-6, open horizontal cracks & scaling t/o 30' Fwd- small spalls under B1-6, horizontal cracks with some minor delams & scaling 22'

Description Rear Abut

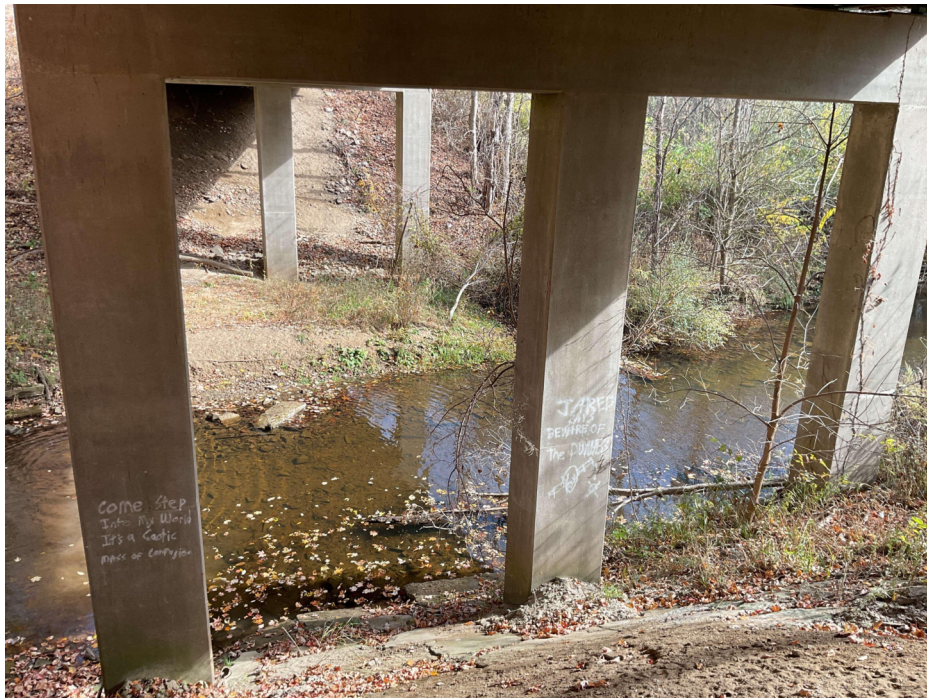
PHOTO 12

Description PS1

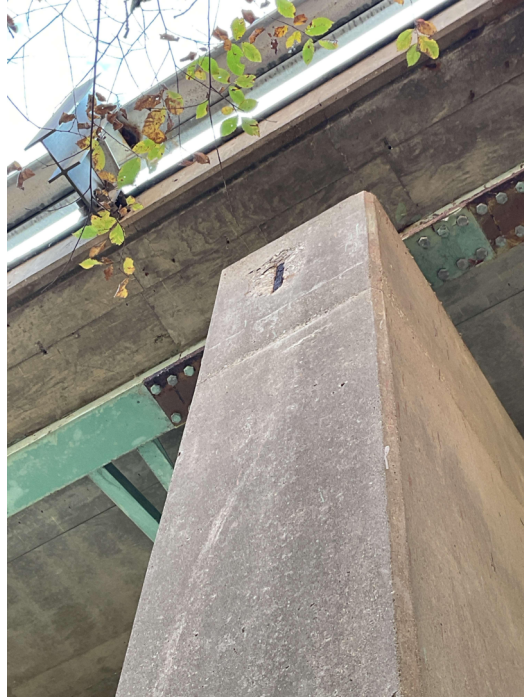
PHOTO 13

Environment	Total Quantity	Units	Condition State 1	Condition State 2	Condition State 3	Condition State 4
<b>234-Reinforced Concrete Pier Cap</b>	3 - Mod.	64	ft.	60	2	2	0
2024 CS2 PS2 Rt corner - delam 1' PS2 Lt top - small spall 1' CS3 PS1 LT & RT (outside face) - spall with exposed rebar with section loss 2'							
<b>302-Compression Joint Seal</b>	3 - Mod.	64	ft.	0	0	0	64
2024 CS4 Fwd & Rear - paved over, closed & no longer functional 64'							
<b>311-Movable Bearing</b>	3 - Mod.	18	each	5	1	6	6
2024 CS2 PS2 bearing # 5 - rust initiated (1) CS3 Fwd & Rear abuts bearings - pack rusted, all bearing seats Fwd&Rear are spalled (6) CS4 Rear Abut bearings (1,5,6) - heavy rust w/ section loss & rust debris impacting function ability (3) Fwd Abut bearings (1,2,6) - heavy rust w/ section loss & rust debris impacting function ability (3)							
<b>313-Fixed Bearing</b>	3 - Mod.	6	each	6	0	0	0
<b>321-Reinforced Concrete Approach Slab</b>	3 - Mod.	1600	sq. ft.	1579	21	0	0

Description PS1 cap LT end

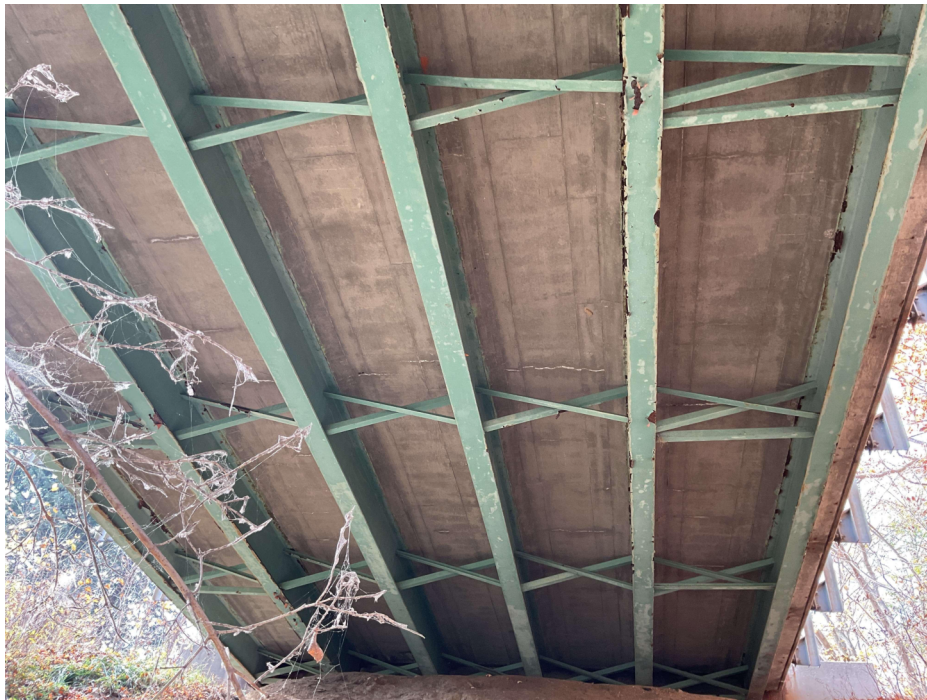
PHOTO 14

Description Span 1

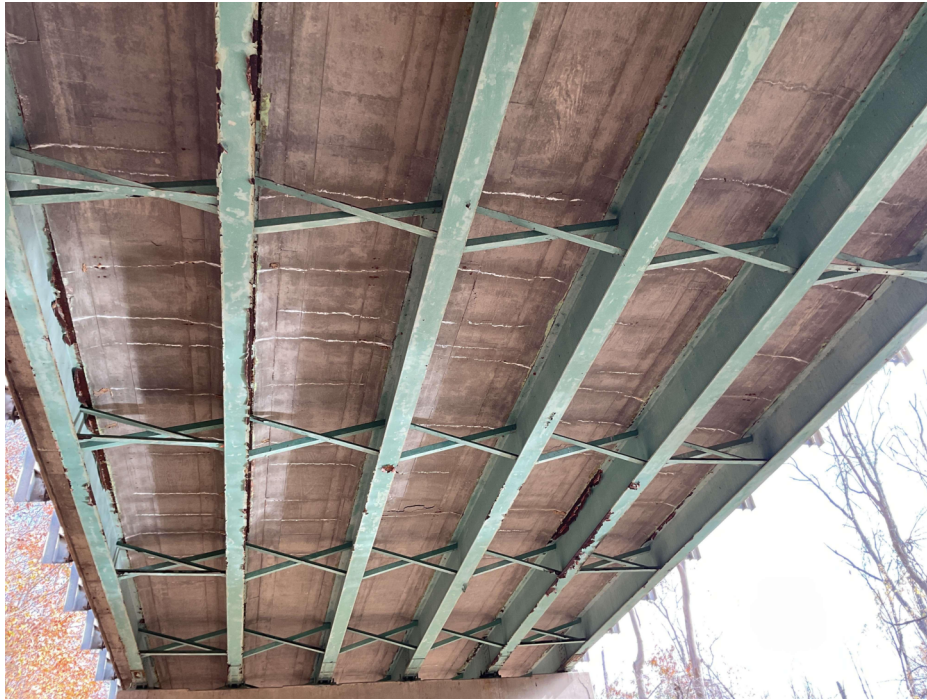
PHOTO 15

Description Span 2

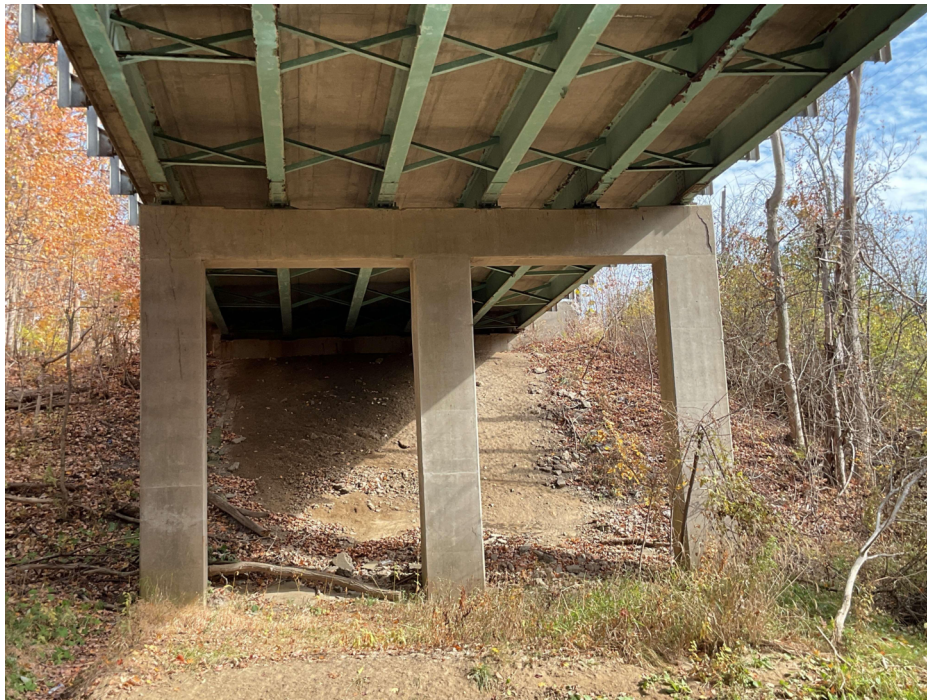
PHOTO 16

Description PS2

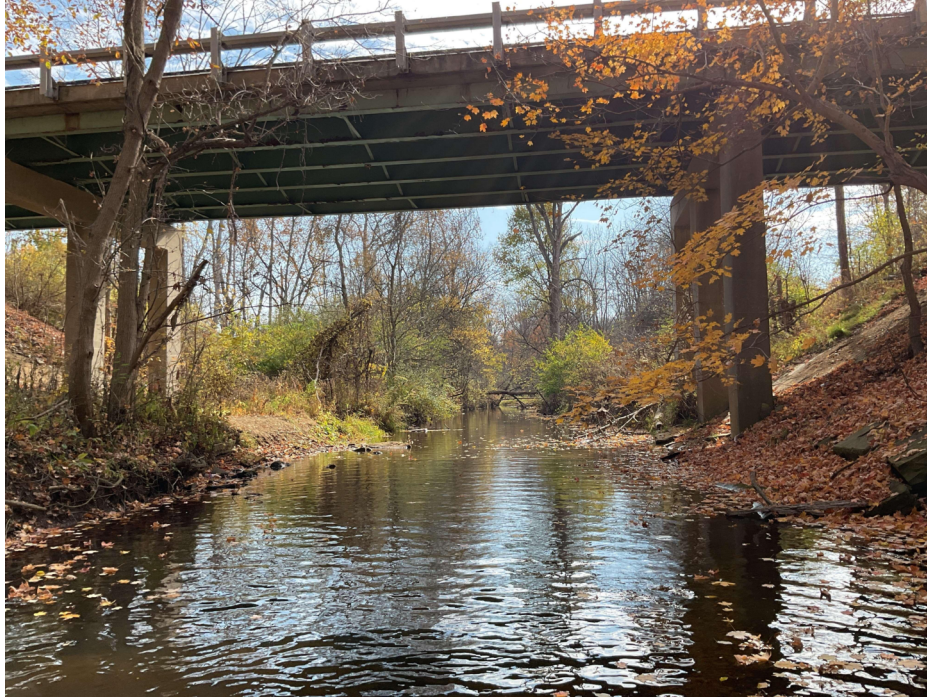
PHOTO 17

Description LT

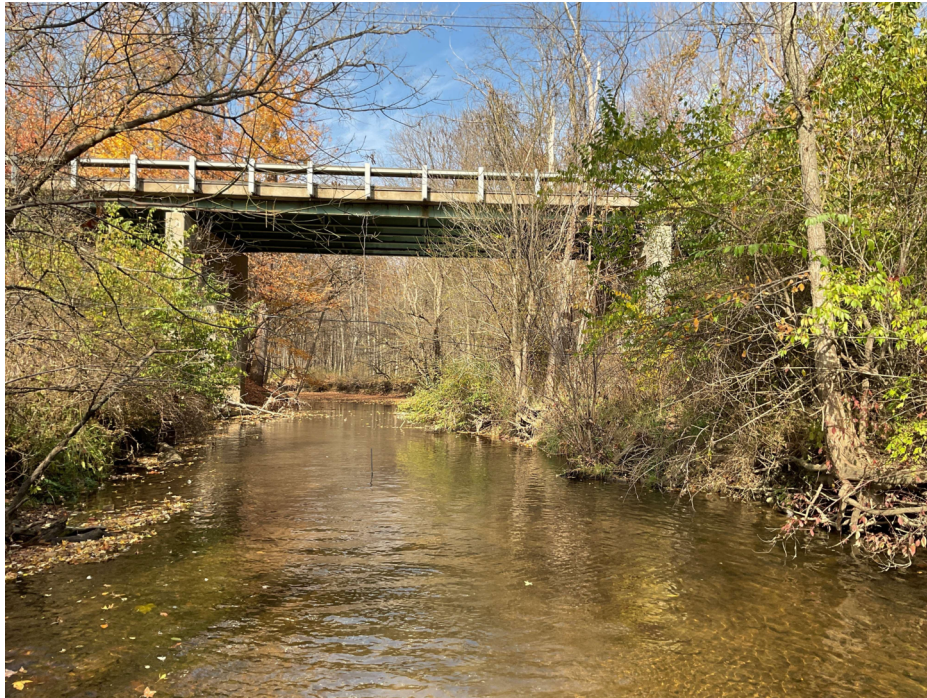
PHOTO 18

Description RT

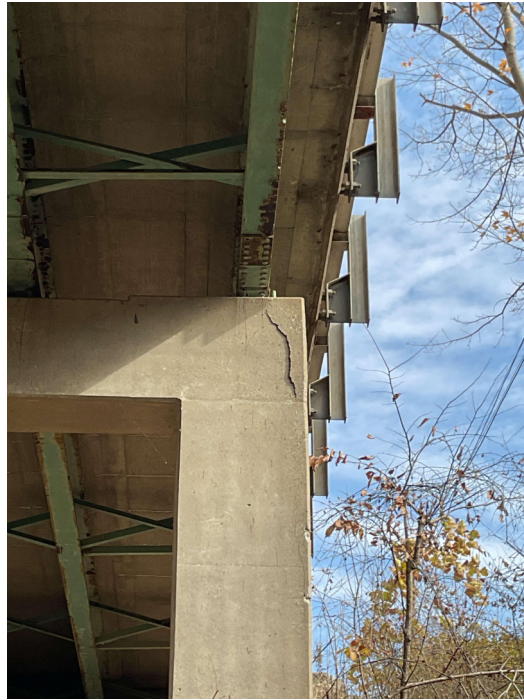
PHOTO 19  
Description PS2 cap RT

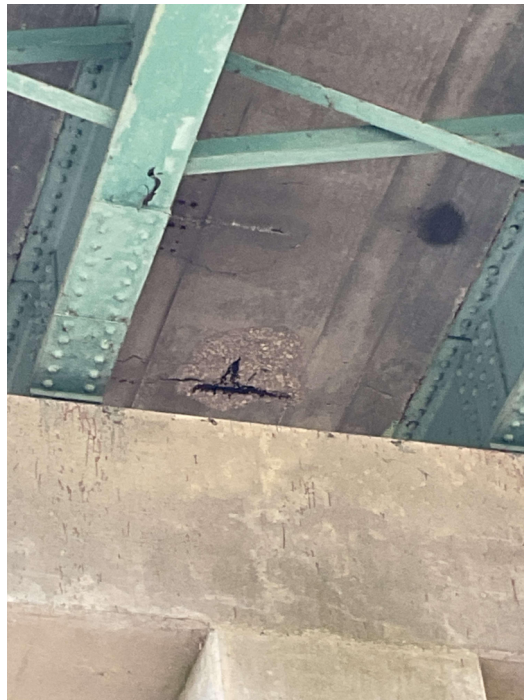
PHOTO 20  
Description Span 1 bay 3 (near PS1)

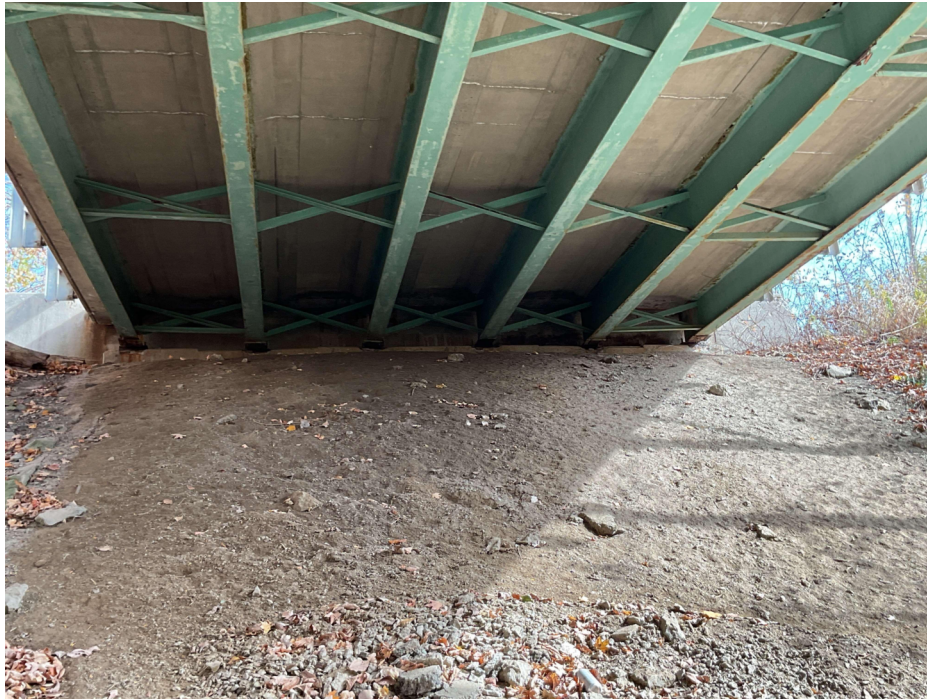
PHOTO 21

Description Fwd Abut

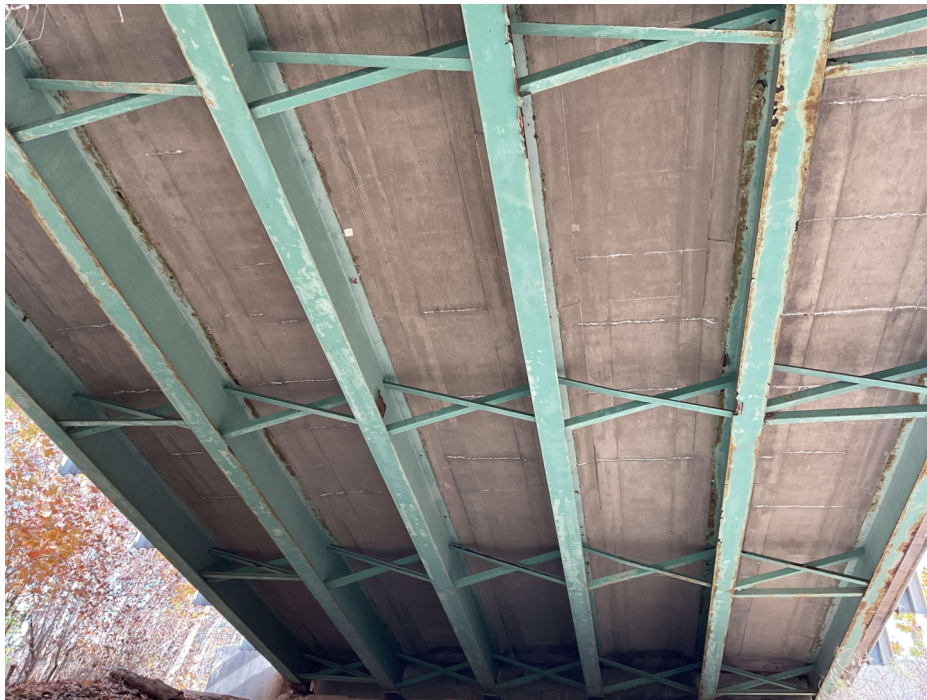
PHOTO 22

Description Span 3

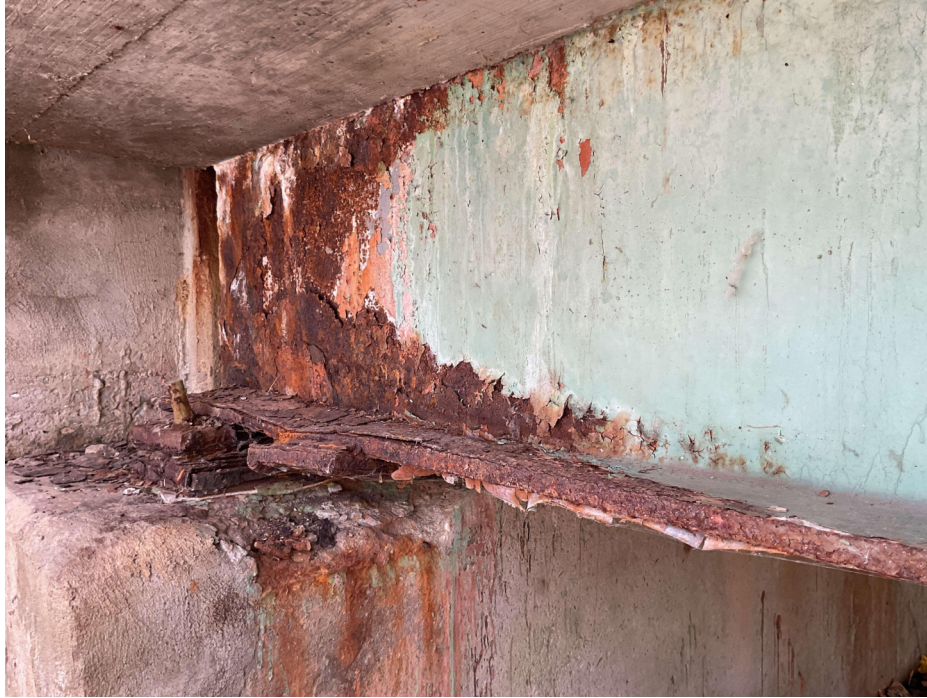
PHOTO 23

Description Span 3 B1 @ Fwd Abut

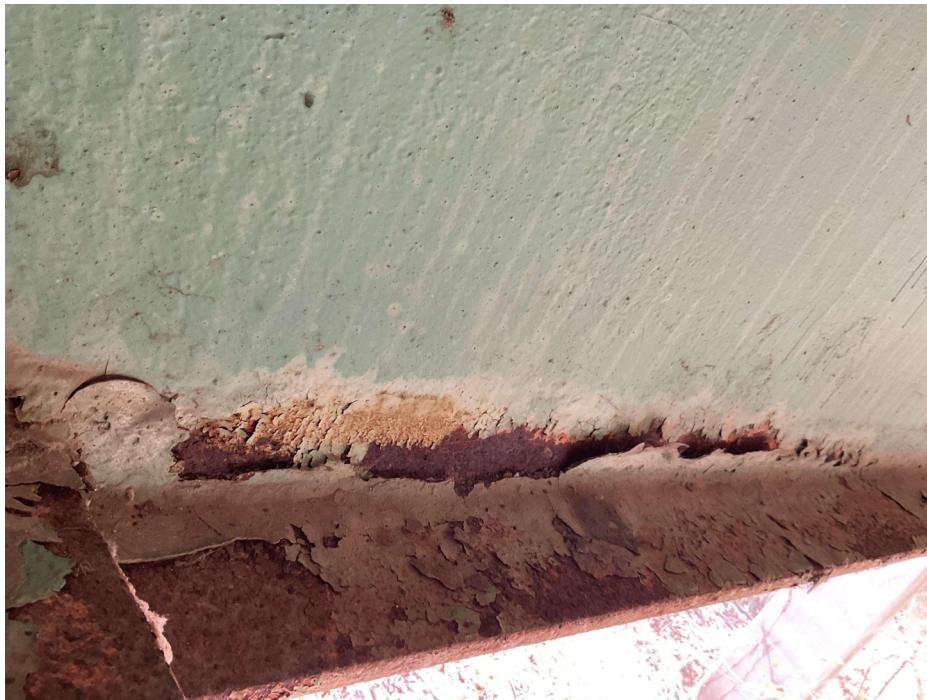
PHOTO 24

Description Typical rust t/o

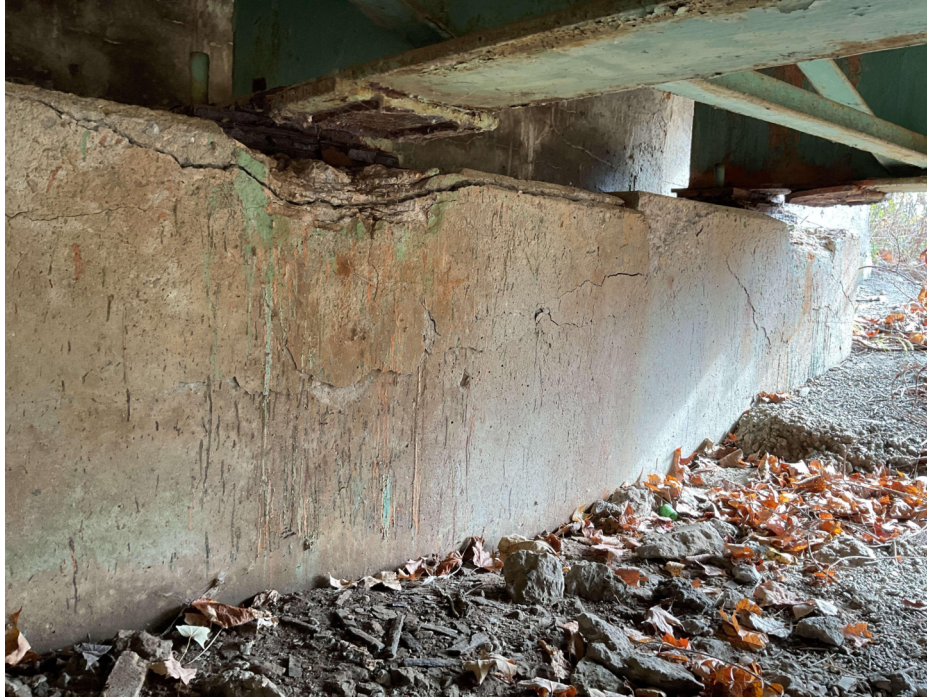
PHOTO 25

Description Fwd Abut RT

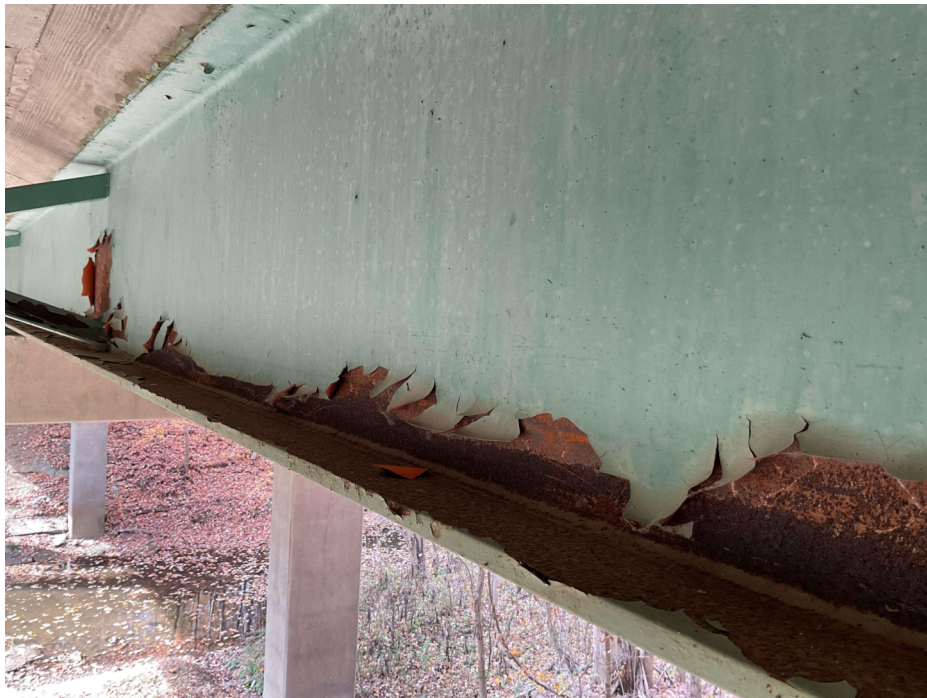
PHOTO 26

Description Span 3 B3

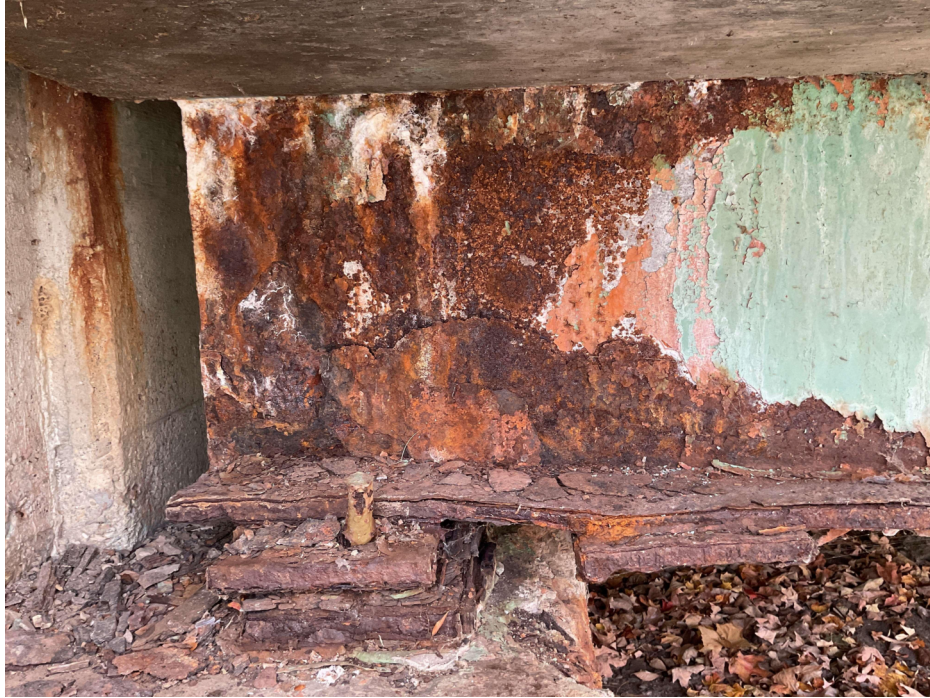
PHOTO 27

Description Span 3 B1 @ Fwd Abut

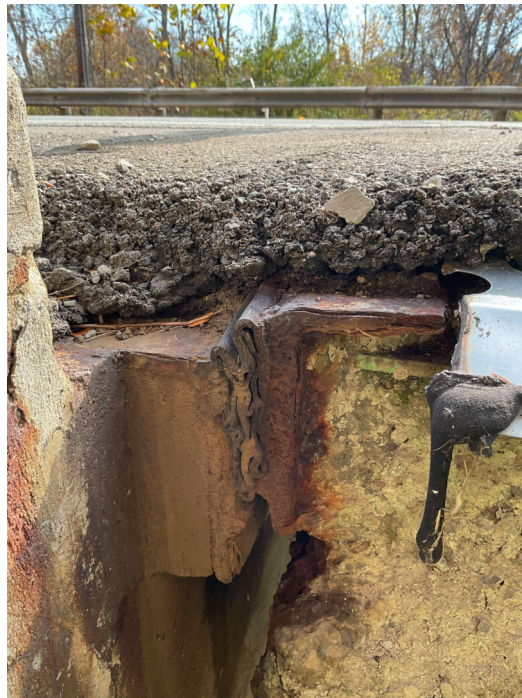
PHOTO 28

Description Fwd Joint
