ODOT District 8
2024 In-Depth & NSTM Inspection Report

INSPECTION July/Aug 2024
REPORT Sept 2024

Bridge No. HAM-50-2181N
SFN: 3103390

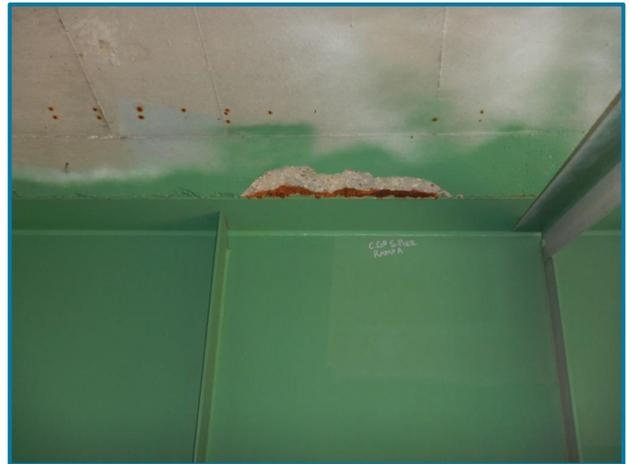
The reinforced concrete deck is in satisfactory condition with isolated haunch spalls (see Photo 1) and hairline cracks, some with light efflorescence. In Span 2, along Girder A, there is an 8' L shallow haunch spall (see Photo 2). At Pier 1, the east soffit, outboard of Girder A, has a 1'-6" L x 1' W x 6" D spall with exposed steel (see Photo 3).

Photo 1 – 2' L haunch spall in the deck (Girder B, Span 2, looking southwest).

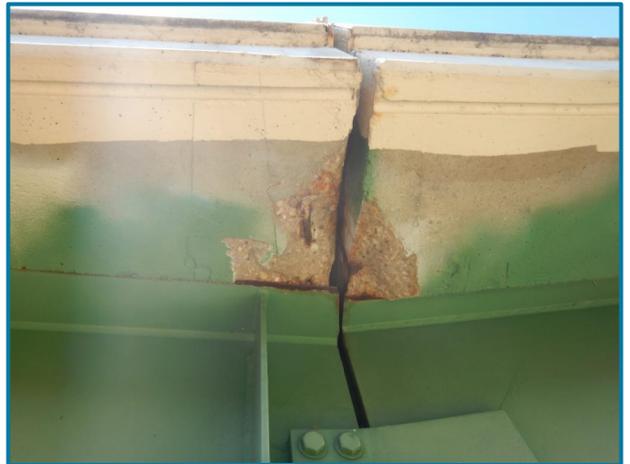
Photo 3 – 1'-6" L x 1' W x 6" D spall in the deck overhang (Girder A, Spans 1-2, looking west).

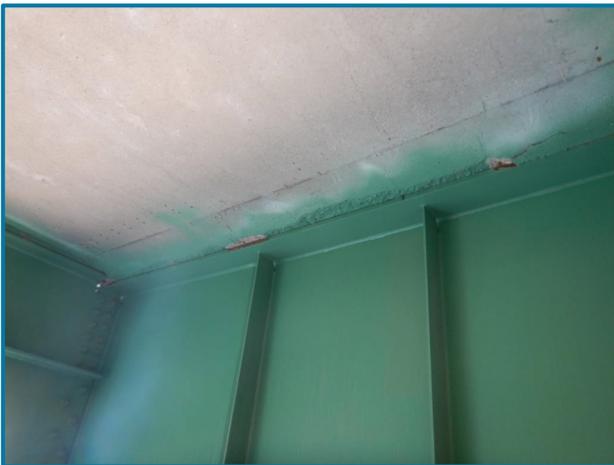
Photo 2 – 8' L shallow haunch spall in the deck (Girder A, Span 2, looking northeast).

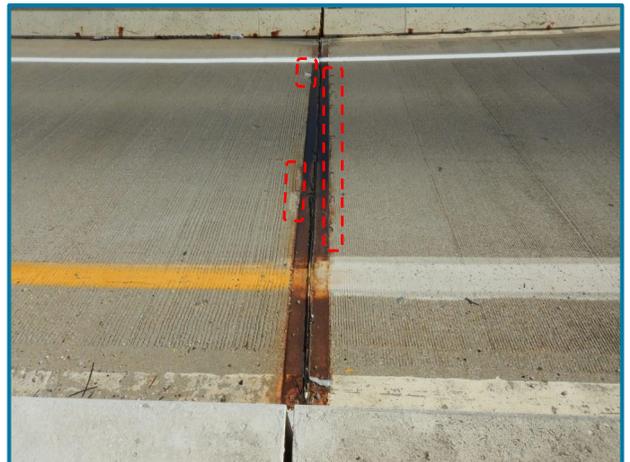
The monolithic concrete wearing surface is in good condition overall with some hairline transverse cracks, isolated shallow spalls along the joint near Pier 1 (see Photo 4), and hairline map cracking near the east end of the bridge.

Photo 4 – Shallow spalls along the joint at Pier 1 and missing/deteriorated compression seals (Pier 1, Spans 1-2, looking east).

The compression seal expansion joints located at the Rear Abutment, Pier 1, and Pier 2 are in fair condition overall. The joint material is deteriorated with tears and portions missing (see Photo 4). The joint armor has surface corrosion over the entire length.

1. Replace the expansion joint material at Pier 1.

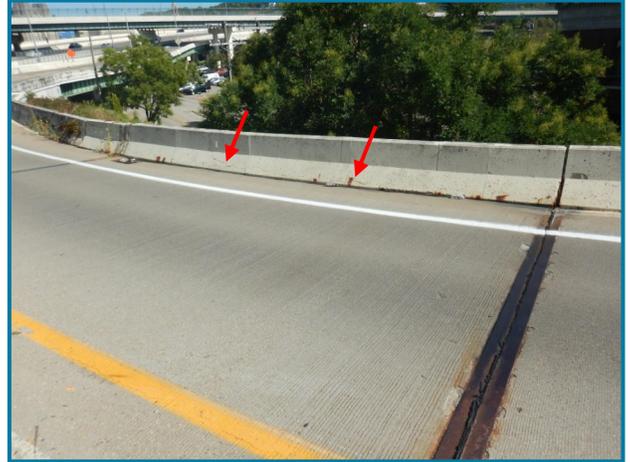
The reinforced concrete bridge railings run the full length of both sides of the ramp and are the New Jersey barrier style. The railing has locations of longitudinal cracking with rust staining along the lower portion (see Photo 5).

Photo 5 – Bridge railing with longitudinal cracking with rust stains (looking east).

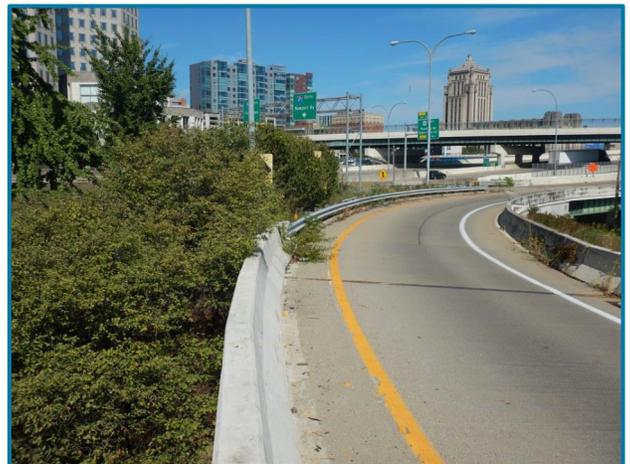
The bridge railing transitions are in GOOD CONDITION [7-SNBI] overall with isolated chips in the concrete. At the northwest railing transition, there is vegetation growing in the shoulder along the base of the railing (see Photo 6). At the northeast corner, the transition is a continuation of the New Jersey barrier. The northwest corner transitions into a steel guardrail. At the south end, the southeast corner is the concrete panel rail that smoothly transitions into the New Jersey rail and the southwest corner has a crash attenuator. The condition of the crash attenuator is detailed in the approach guardrail section.

Photo 6 – Transition at the north end. Vegetation in the shoulder (North Approach, looking north).

The reinforced concrete approach slab is in good condition. There is vegetation growing in the shoulders (see Photo 6).

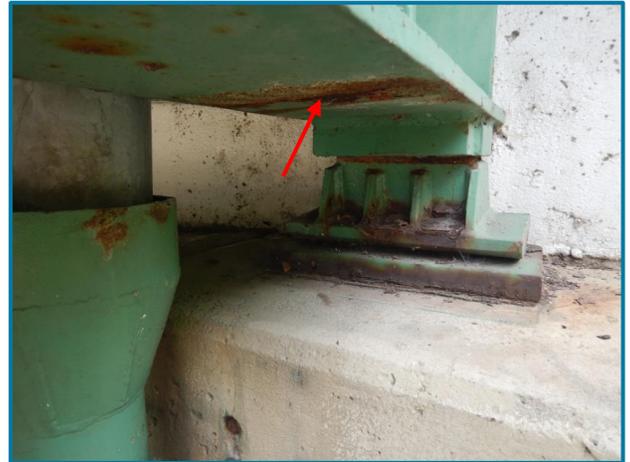
The steel built-up plate girders are in very good condition. There are no significant deficiencies noted. There is surface corrosion to the underside of the bottom flanges at the ends near the Rear Abutment (see [Photo 7](#)).

Photo 7 – Surface corrosion to the girder bottom flange (Girder A, Span 1, looking north).

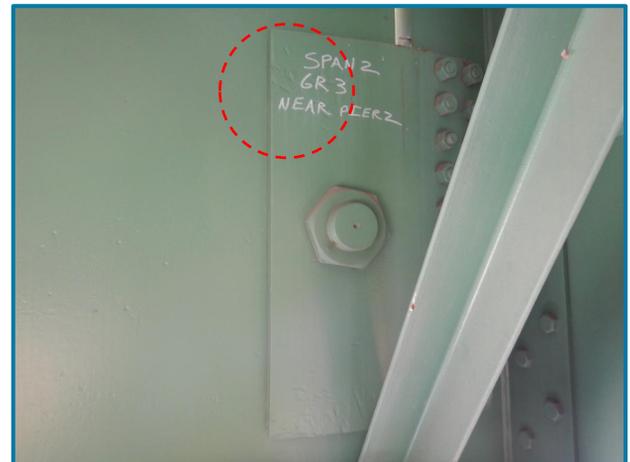
At Pier 1, there are hinges at all three girders made up of a pin with a plate on each side. The pins are in very good condition with no significant deficiencies noted. The plate on the interior face of Girder A has 1/32” gouges in it near the top (see [Photo 8](#)).

Photo 8 – Gouges in the plate at the hinge over Pier 1 (Pier 1, Girder A, looking east). The markings on the bridge as shown in the photo are incorrect.

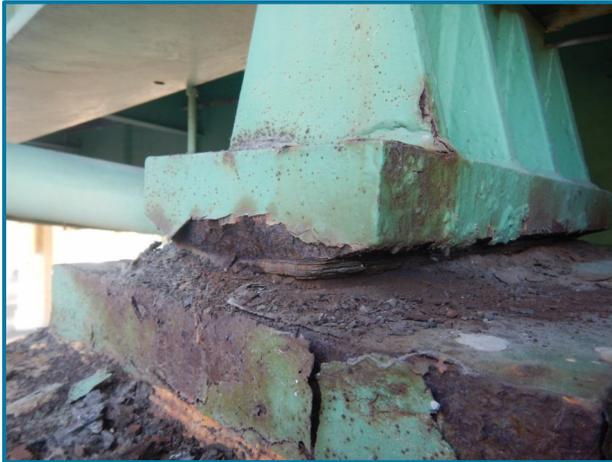
The rocker bearing devices are in satisfactory condition overall with up to 1/2" pack rust between the rocker and the masonry plate at Pier 2 (see [Photo 9](#)). The masonry plates at the rocker bearings have both surface corrosion and laminar corrosion. The rockers also have laminar corrosion on them at this location. Girder A is contacting the backwall at the Rear Abutment (see [Photo 10](#)).

Photo 9 – 1/2” pack rust between the rocker and the masonry plate (Girder A, Pier 2, Span 3, looking south).

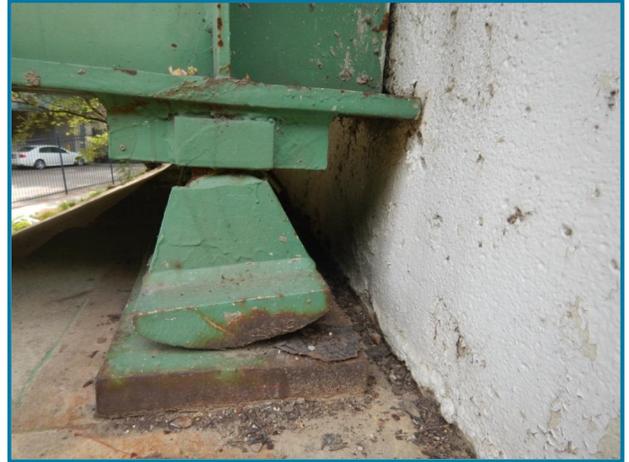
Photo 10 – Corrosion to the bearing and Girder A contacting the backwall (Girder A, Rear Abutment, 4, looking west).

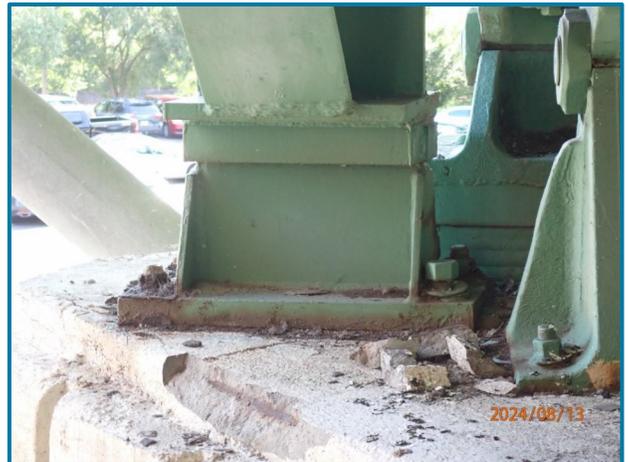
The fixed bearing devices are in satisfactory condition overall. The bearing at Pier 4 of HAM-50-2180N has a loose anchor bolt nut and two anchor nuts that have up to 30% section loss (see Photo 11). The masonry plate has minor laminar corrosion.

Photo 11 – Loose anchor nut and section loss (Girder A, Pier 4 (HAM-50-2180N), Span 3, looking east).

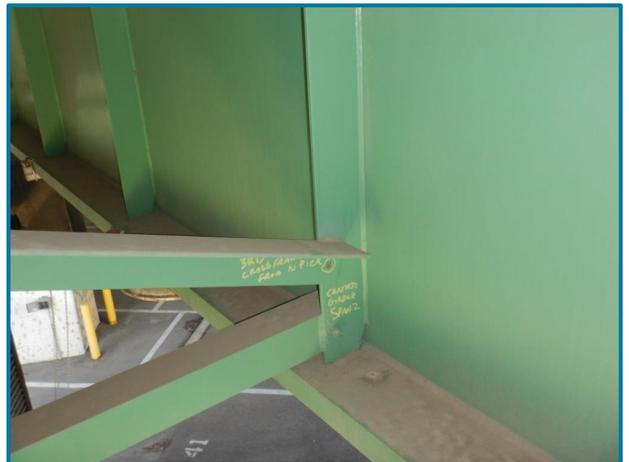
The crossframes are in good condition. In Span 2, the 3rd crossframe south of Pier 1 has insufficient weld length and there are no connection bolts at the top east connection and the bottom west connection between Girders A and B (see Photo 12).

Photo 12 – Insufficient weld length and missing connection (Girder A, Span 2, looking north).

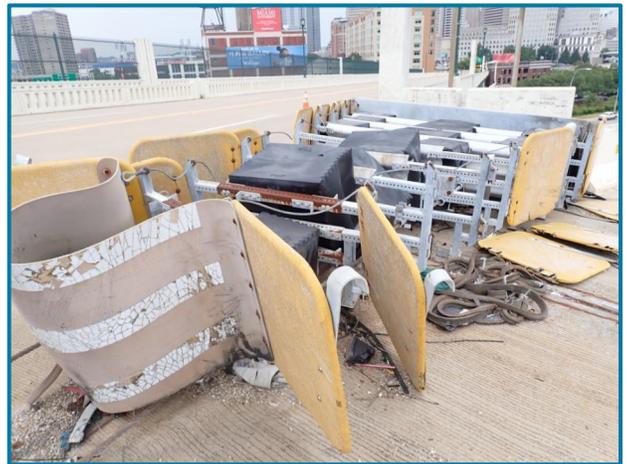
The approach guardrail is in poor condition due to the condition of the crash attenuator at the southwest corner. It has impact damage with loose panels, loose cables, and deployed cushions (see Photo 13). See the report for HAM-50-2080N for details on the crash attenuator. The guardrail near the Rear Abutment is a W-beam rail with no noted deficiencies.

Photo 13 – Impact damage to the crash attenuator at the exit (South Approach, looking west).

2. Replace the crash attenuator at the Sixth St. Downtown exit ramp.
