PIK-23-11.11 (2nd Street) PIK-32 & SR 104 Safety Study

June 30, 2025

Prepared by: Jonas Smith

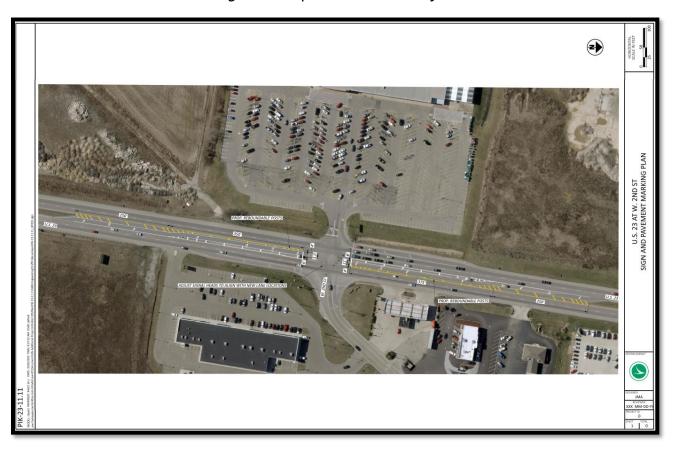
Figure 3: Proposed Turn Lane Layout

Although there were 7 rear end crashes at the intersection, all injury crashes were left turn/angle crashes. For this reason, a countermeasure addressing those crash types specifically was pursued. Given that the turn lanes are not currently positively offset, and instances of traffic shadowing were observed during a field visit, it was decided to pursue a project to restripe the turn lanes to create a positive offset. The proposed project is expected to reduce instances of traffic shadowing by increasing sight distance for mainline left turners on US 23. This alternative is low cost and addresses the crash pattern observed. For these reasons, no other alternatives were considered at this time.

Based on the crash report investigation resulting in a left turn/angle crash pattern being identified and the existing left turn lanes not being positively offset, it is recommended to restripe the left turn lanes to create a positive offset. The turn lane upgrades are expected to mitigate the injury crash pattern identified at the intersection. The estimated cost of the project is \$346,354. This cost is based on a recent estimated completed by ODOT's Office of Roadway Engineering. The project was selected for funding through ODOT Central Office's Department of Safety. **Figure 3** shows the proposed turn lane layout.
