Inspection Date: 08/06/2024

Structure Number: 2504308

Facility Carried: WILSON RD

Ohio Bridge Inspection Summary Report**FRA-00070-0794 (2504308)**2: District 18000 - COLUMBUS (DEL & FRA county)
ict
06

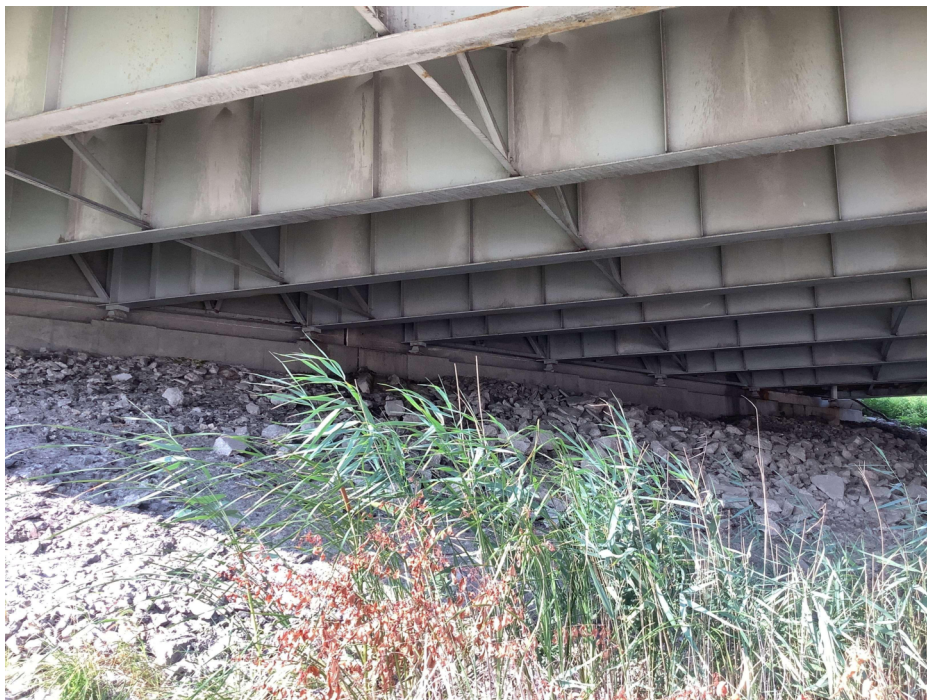
PHOTO 1

Description 2024 rear abut

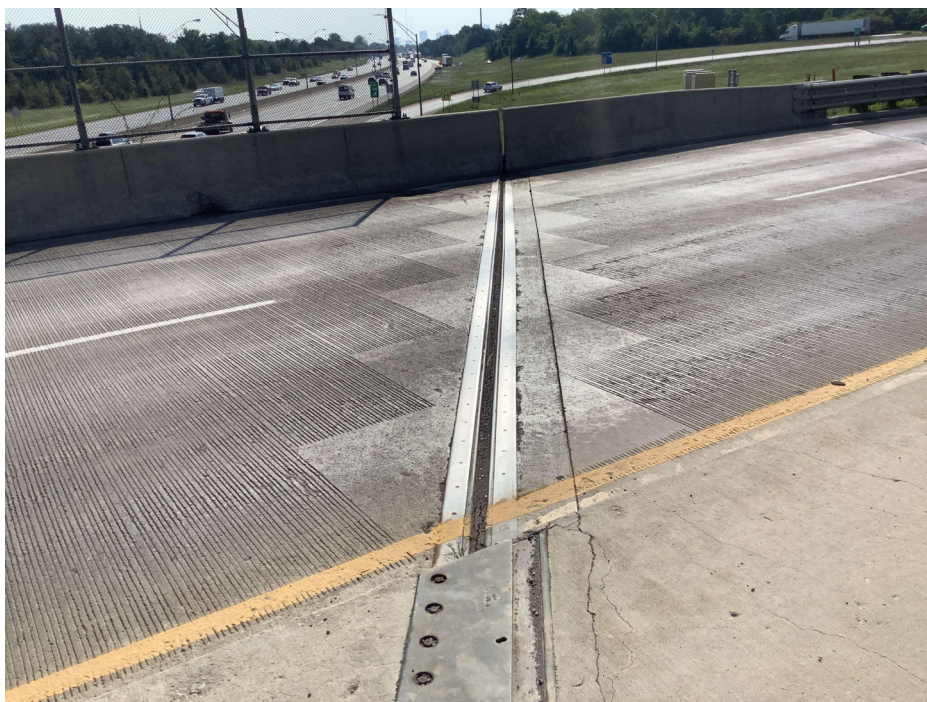
PHOTO 2

Description 2024 right rear

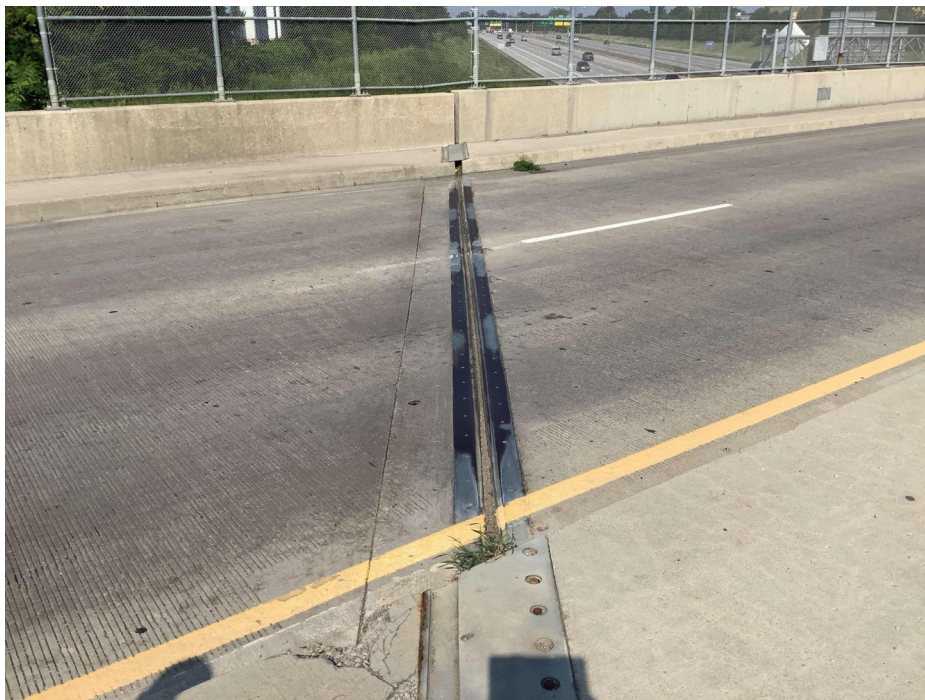
PHOTO 3

Description 2024 It rear

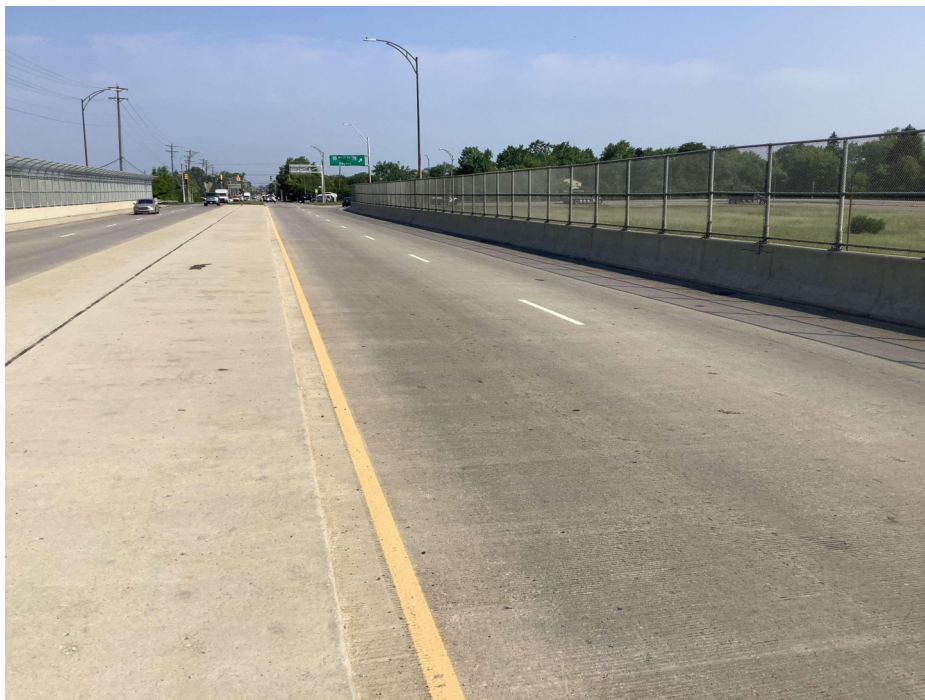
PHOTO 4

Description 2024 NB lanes

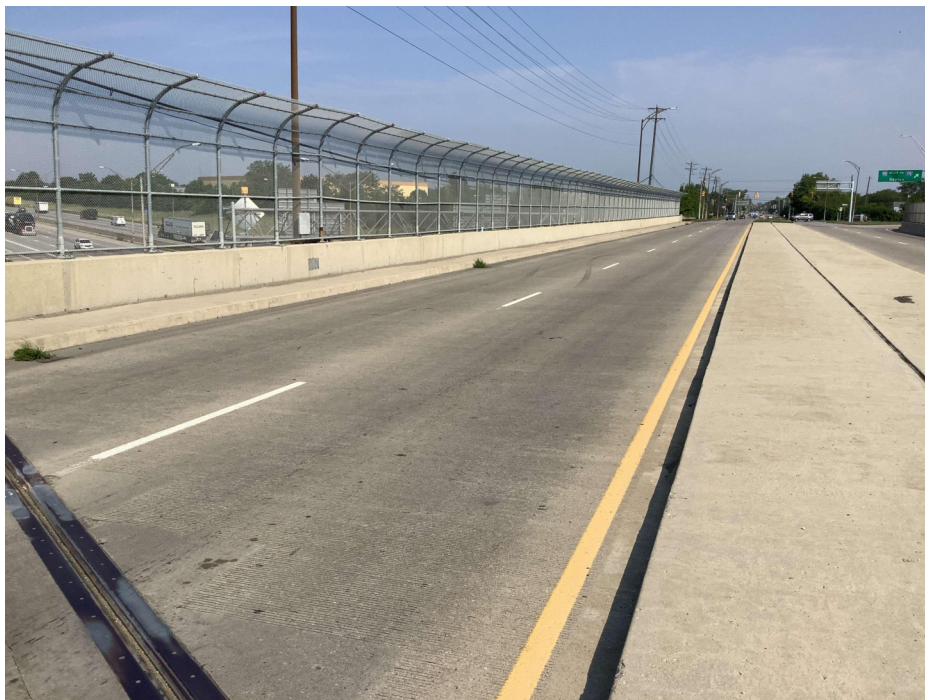
PHOTO 5

Description 2024 SB lanes

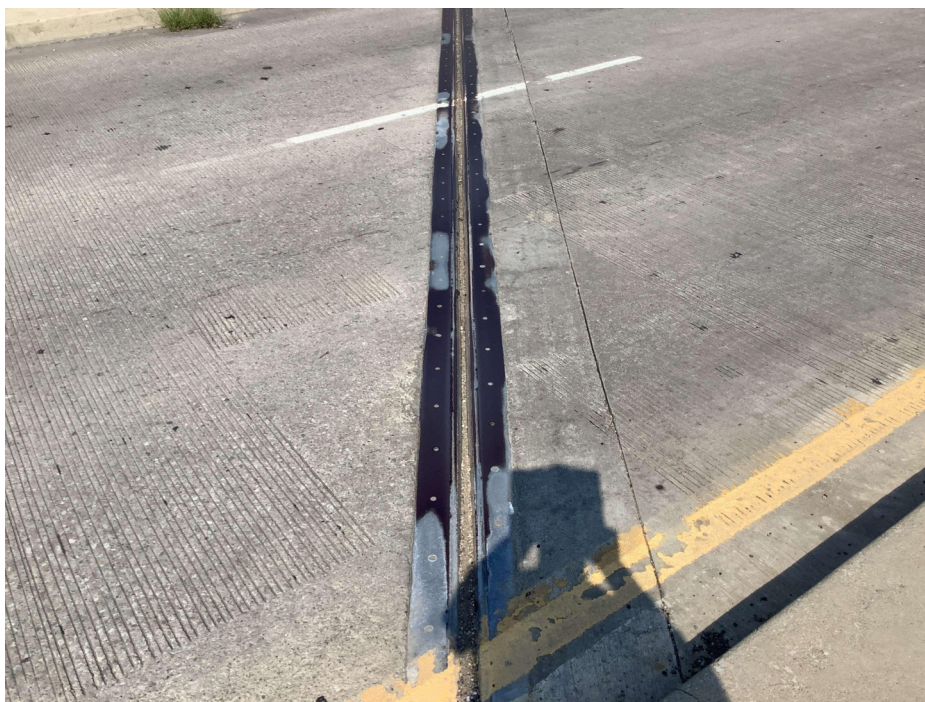
PHOTO 6

Description 2024 It joint

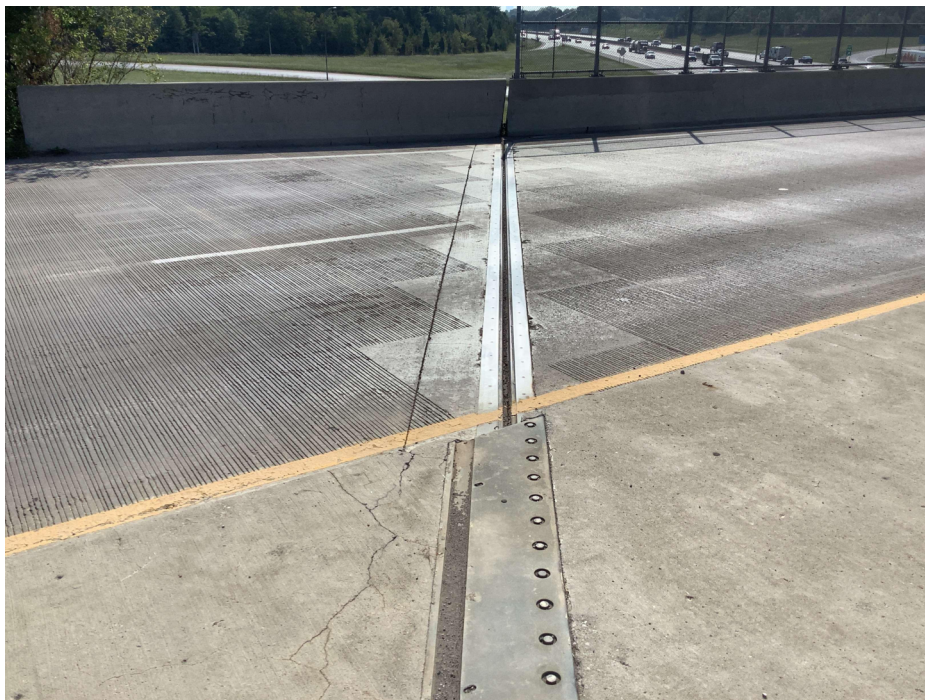
PHOTO 7

Description 2024 rt joint

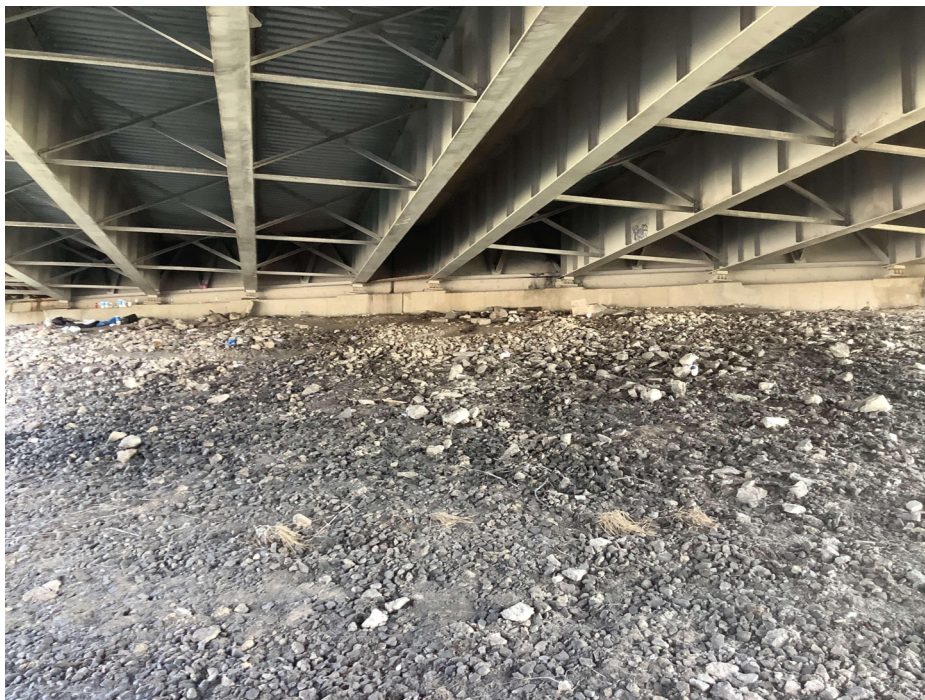
PHOTO 8

Description 2024 fwd abut
