Asbestos Inspection Reporting Form

Name, signature, and asbestos hazard evaluation number of the person writing the report

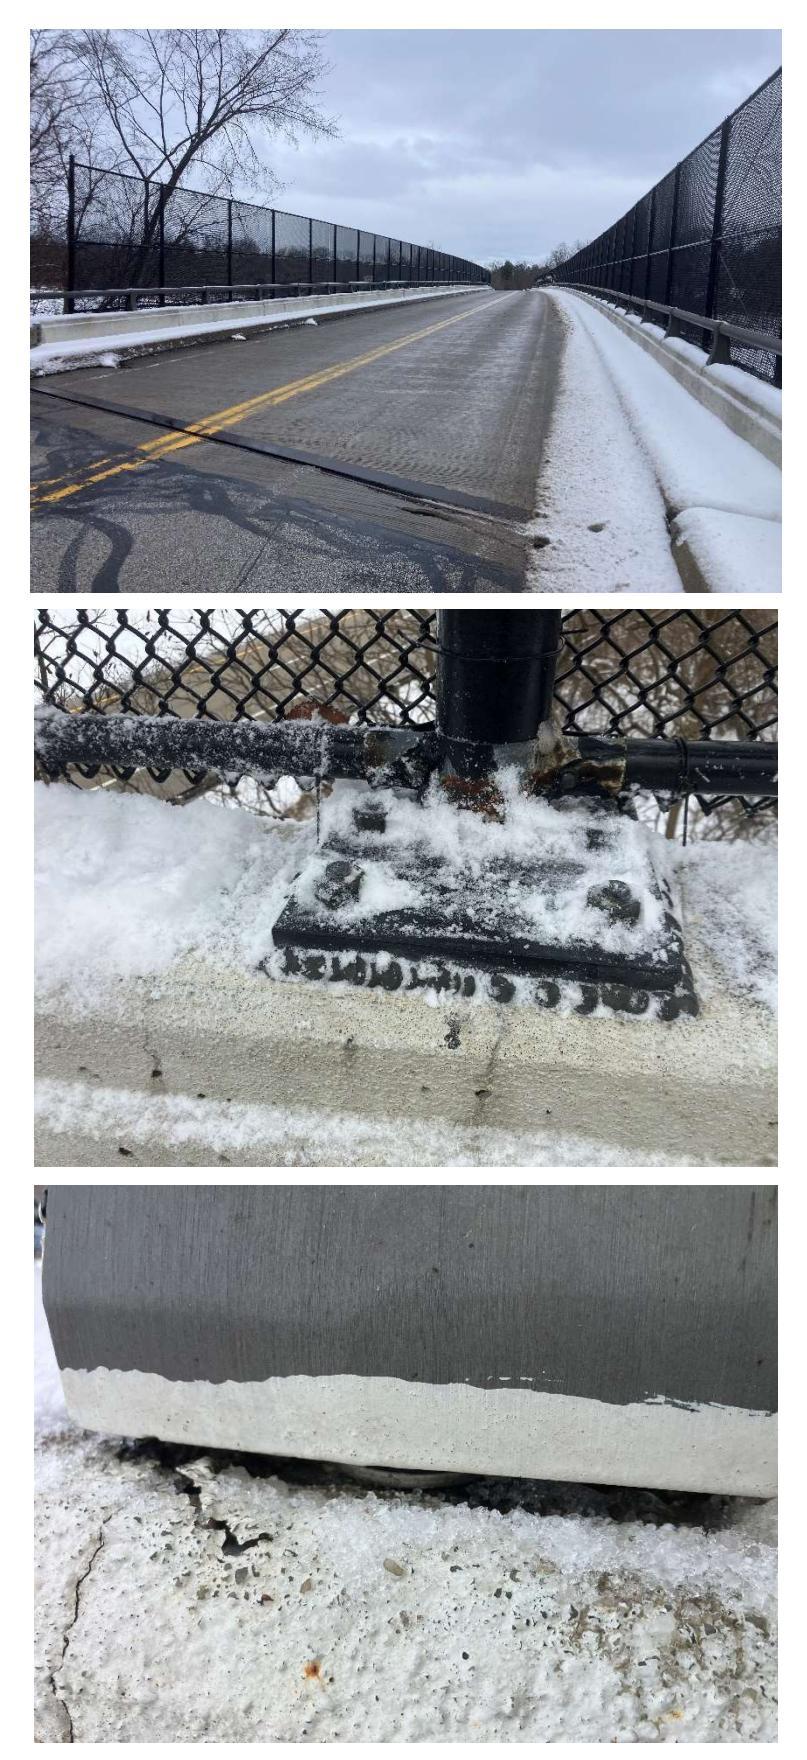
PHOTO 1 View of bridge LAK-90-11.51, facing north.

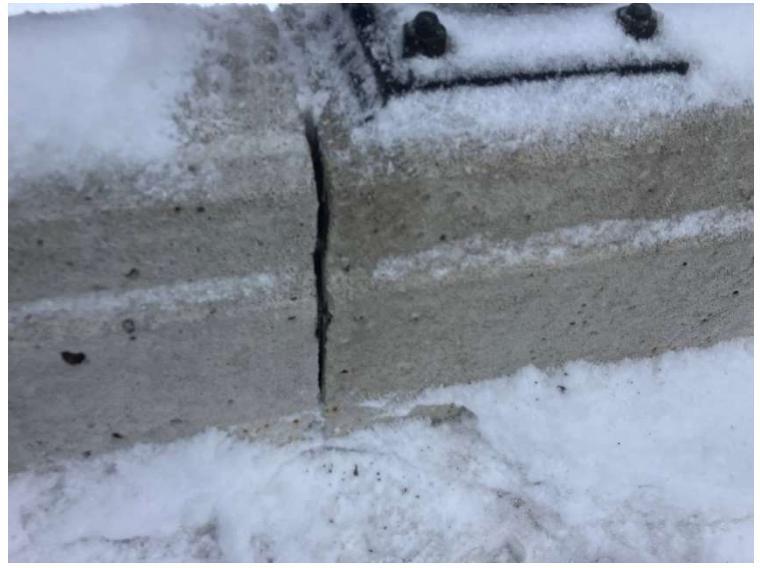
PHOTO 4 A close-up view of the parapet wall saw cuts. Caulking was discovered deep inside the saw cuts. Samples were collected and found to not contain ACM.

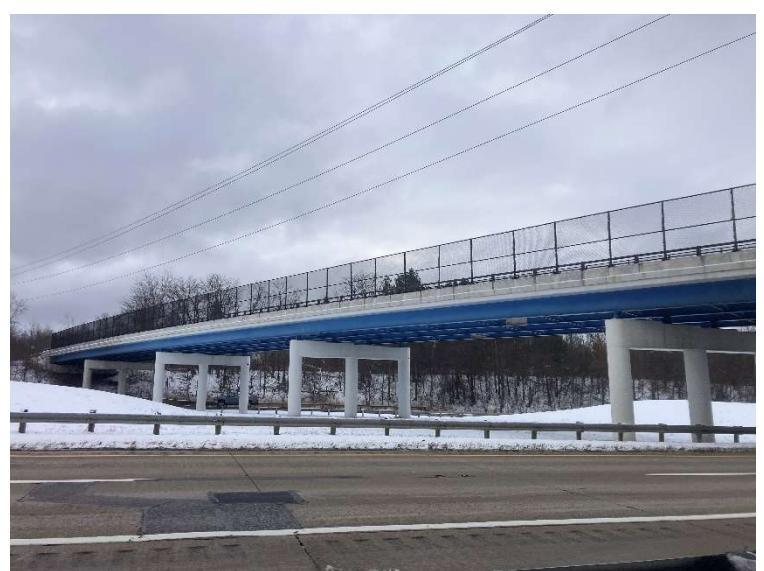
PHOTO 6 View of the westside of the structure, no utilities were affixed to the side.

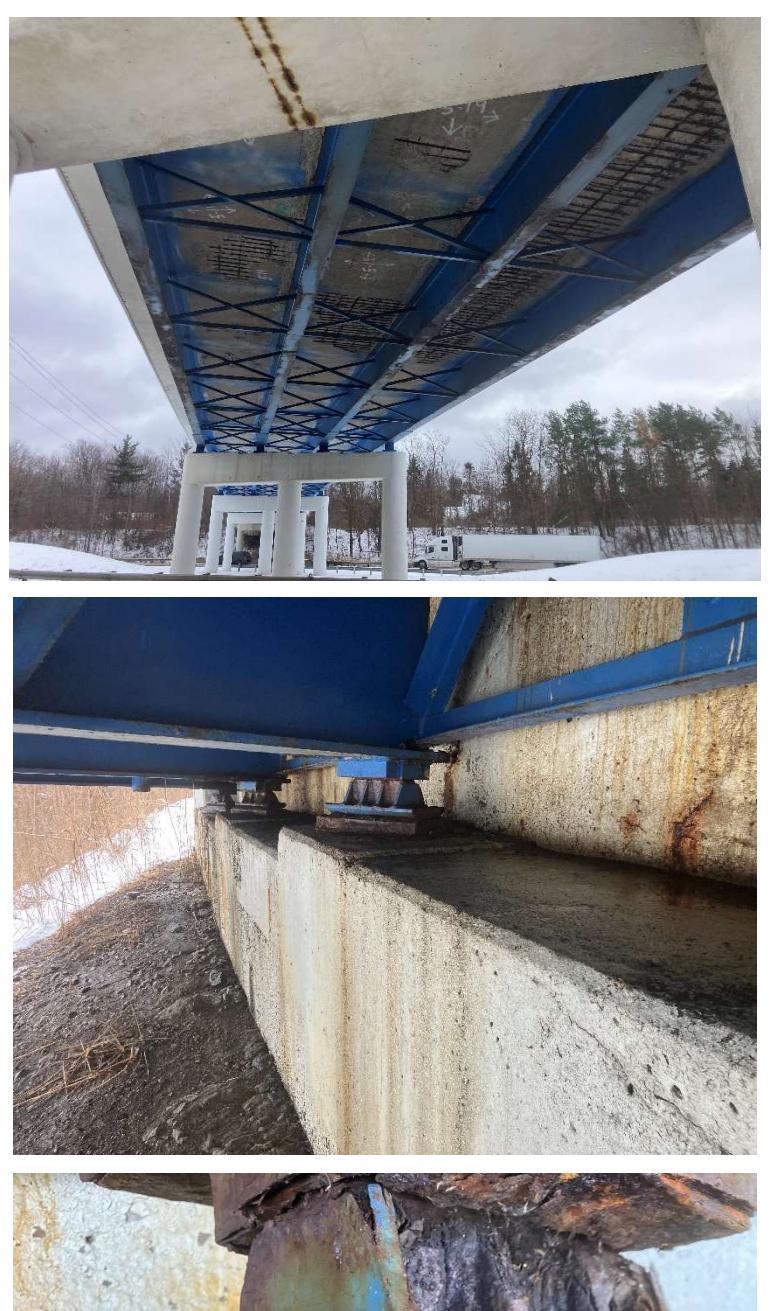
PHOTO 7 View underneath the structure, detailing steel girders, concrete piers and pier caps. No utilities were affixed to the underside of the structure.

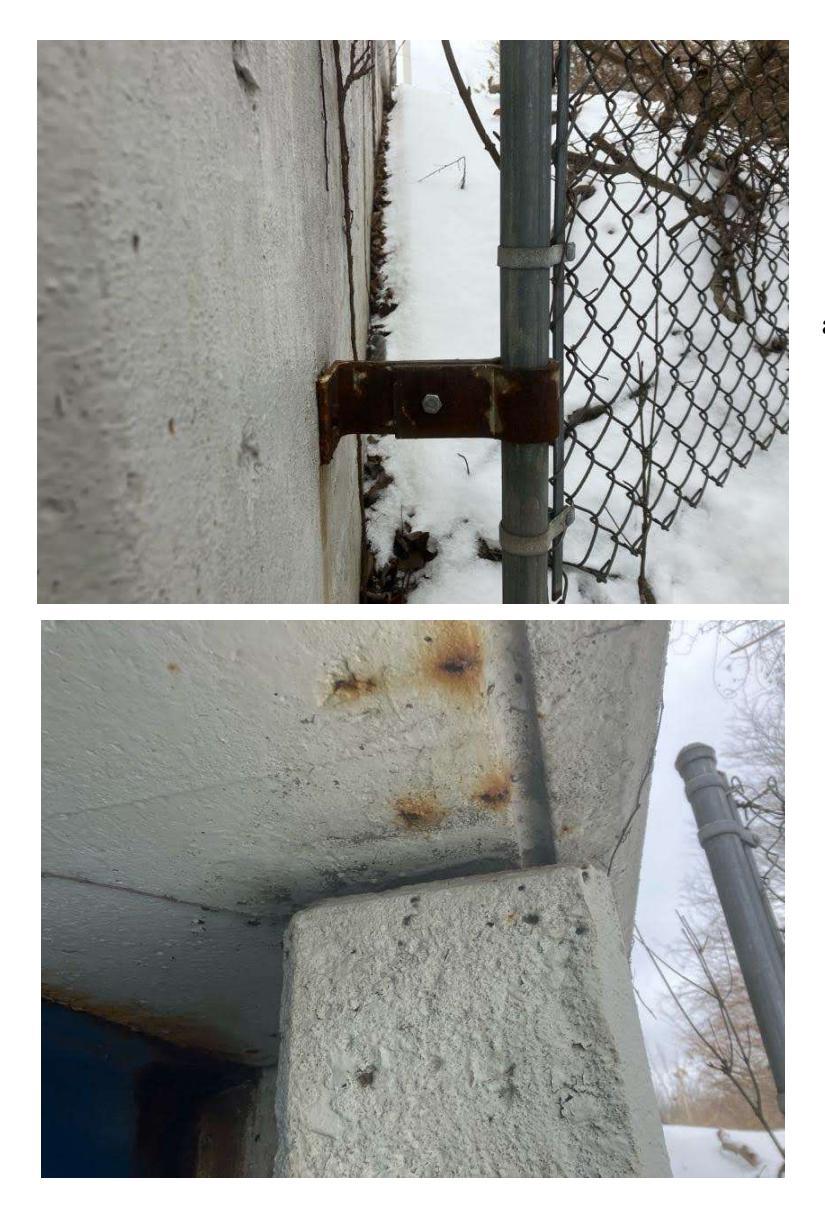
PHOTO 12 View of out of service small diameter metal conduit located underneath the southside of the structure. No wrapping, gasketing material, or other suspected ACM was observed.

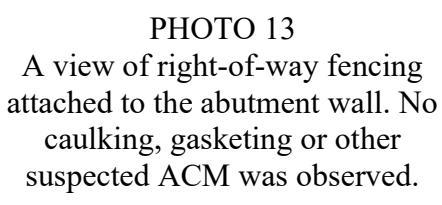
PHOTO 14 View of where the deck and abutment meet. No expansion joint material was observed.
