# Craig Memorial Bascule Bridge

Over the Maumee River

2023 Rehabilitation Alternatives Analysis Report

ODOT Bridge No. LUC-65-05.35 NBI Bridge No. 4805917

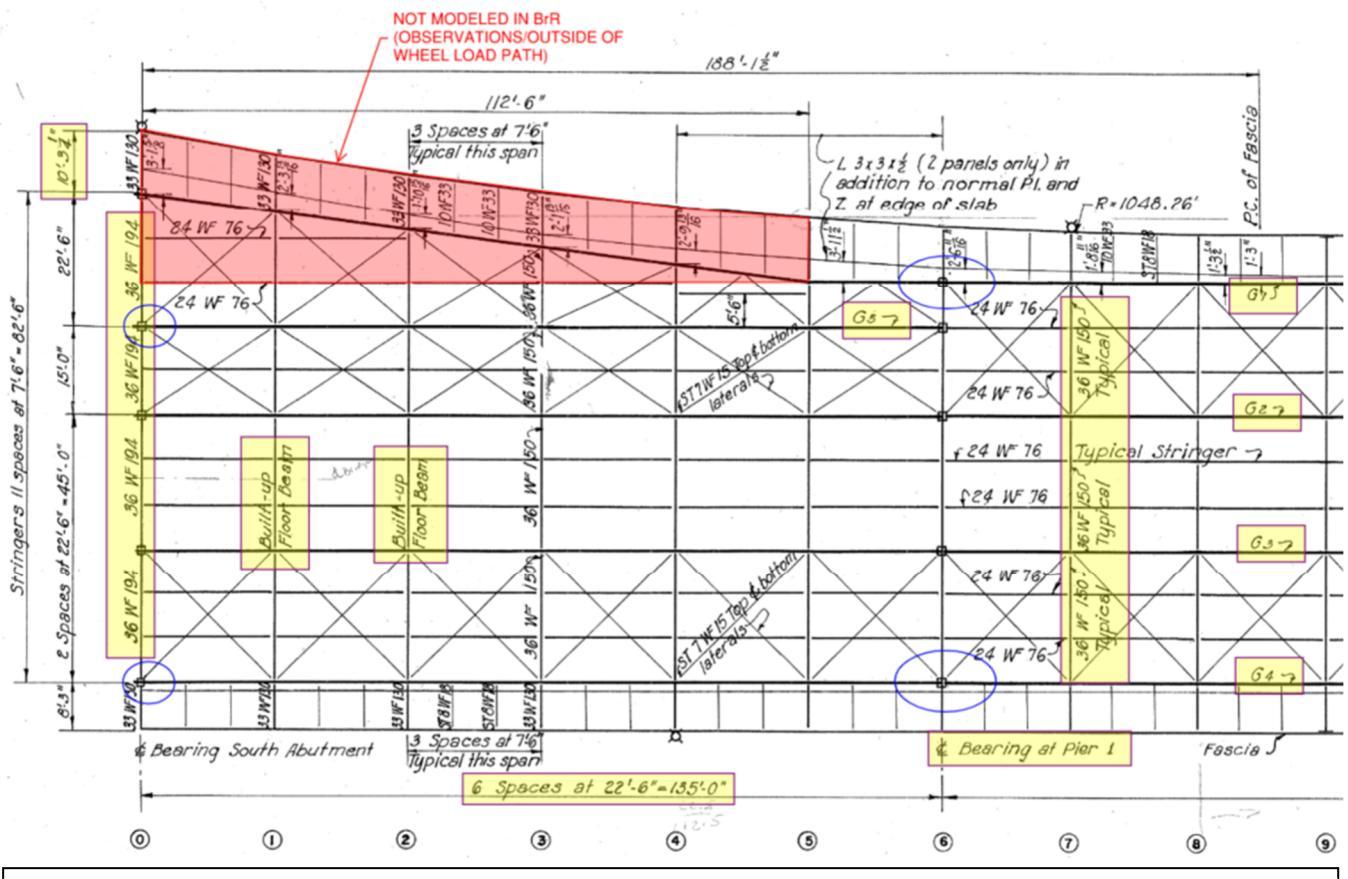
- at Pier 1 for "Section 6" in the analysis model, with an Inventory HS-20 (Lane Loading) rating of 0.310 (a.). The rating increases in the adjacent "Section 7" at 11 ft north of the pier into Span 2, to 0.697. Both ratings are for the non-composite web bend buckling failure check (AASHTO Equation 10-173). Though this is a constructability check for design, BrR includes this as the overload serviceability check and it is one of the permit load checks for ODOT.
- b. at Pier 1 for "Section 6" in the analysis model, with an Operating HS-20 (Lane Loading) rating of 0.519 (b.) for web bend buckling. This occurs only for Section 6 across the pier as described above.
- c. at Pier 1 for "Section 6" in the analysis model, with an Inventory HS-20 (Truck Loading) rating of 0.722 (c.) for web bend buckling. This occurs only for Section 6 across the pier as described above.

Figure S1: Unit 1 Framing Plan showing locations of controlling load ratings at Girder 1, Pier 1 at right, South Abutment at left

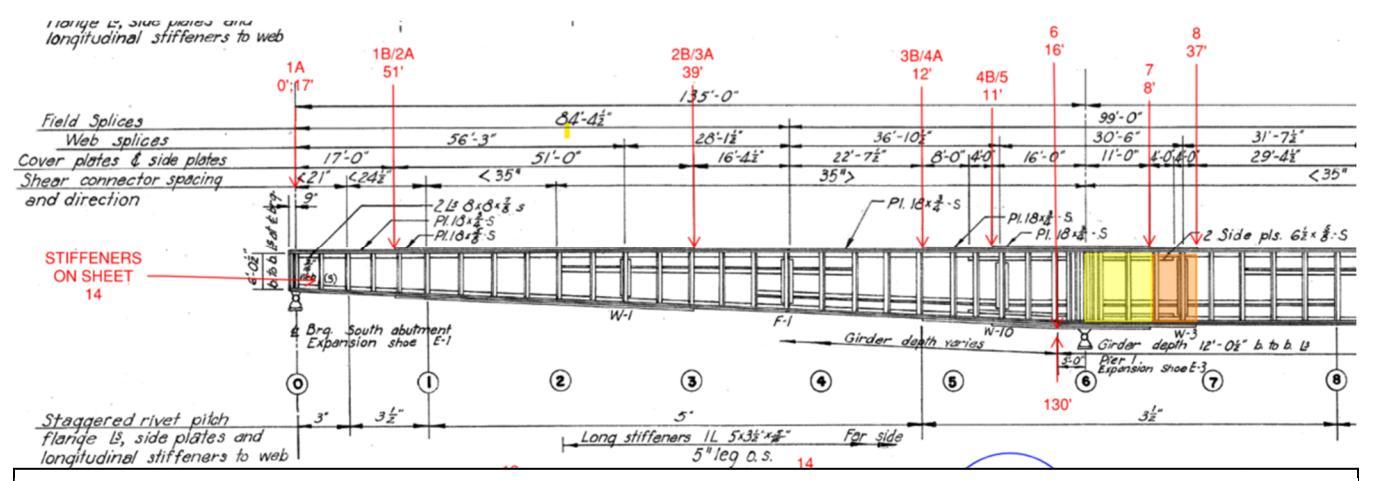
Figure S2: Exterior Girder (1 or 4) from South Abutment into Span 2; Section 6 is yellow highlight, Section 7 is orange highlight

The controlling low rating (HS-20 Inventory Lane) of 0.310 (a.) is at a constructability check for web bend buckling for the flexure negative moment at the pier, a non-composite dead load limit state in Load Factor Design and Load Factor Rating. The girder cross section in the BrR model at this location only considered the girder web plate. It did not include the additional web plates for the bearing and jacking stiffeners that are present at this location (see Figure S3) at either side of the web. A new cross section was added to the model that included the additional web plates, 0.5" thick each for full height of the web (based on flange angle size slightly different than shown in detail). Due to their size – 82" long across the bearing area – they contribute to the overall girder strength and resistance to both shear and web bend buckling at this location (thicker webs are less susceptible to buckling as they are more braced than thinner webs). In AASHTO Equation 10-173, this is represented in the D/t<sub>w</sub> term in the denominator of the stress limit, thus increasing the allowable stress of the section. This cross section was selected, and the model was re-analyzed. This change in the girder cross section to model the girder section closer to the actual section proved effective as the BrR rating improved to over 1.0 for web bend buckling, with the new rating at this location of 3.179 in negative bending for HS-20 Inventory (as would be expected for this location).

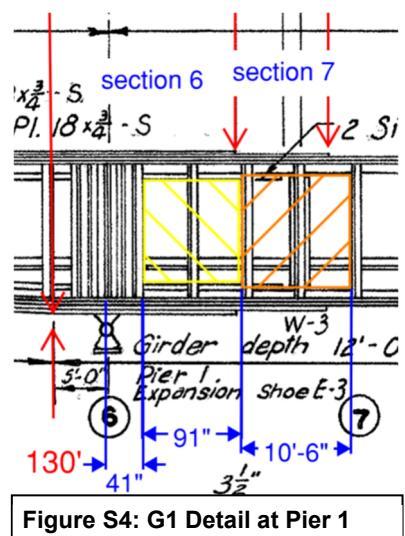
Figure S4: G1 Detail at Pier 1 showing potential additional web plates

The potential repair to the girder to add capacity for the negative moment would be to add reinforcing plates to the webs within the analyzed Section 6. This would involve fitting reinforcement plates between the upper and lower side plates from the end of the 82" bearing fill plate out to the end of "Section 6", approximately 11 ft from the bearing centerline. Accommodations would be made to fit plates around, or under, the longitudinal and vertical stiffeners. The approximate plate size would be 0.5" thick x 91" long x 115" high (**see Figure S4**). The load rating would need to be re-evaluated to determine if additional plates would need to extend into "Section 7", and how far they would extend into Span 2.

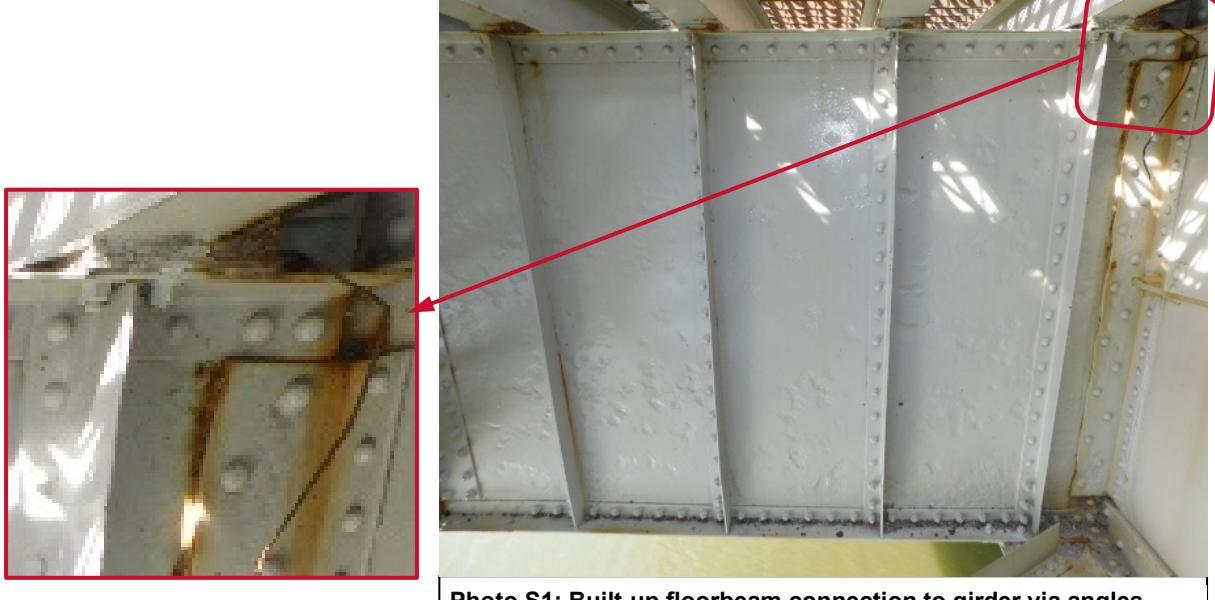
The inventory ratings below 1.0 are for negative moment at the floorbeam connections to the interior girders. The floorbeams are modeled as continuous across the girder connections, however, the floorbeams are connected to girders via angles only in a web to web configuration, see **Photo S1** below. These load ratings are invalid as controlling members, since the floorbeam connection to the girder was not modeled correctly. There are no moment connections for the floorbeam flanges over or through the girder. These should be modeled as simple span connections between the girders.

Photo S1: Built-up floorbeam connection to girder via angles, web to web only; no flange connection (inset view)

The re-analysis of the floorbeams should yield load ratings above 1.0 across the bascule span, for moment and shear.

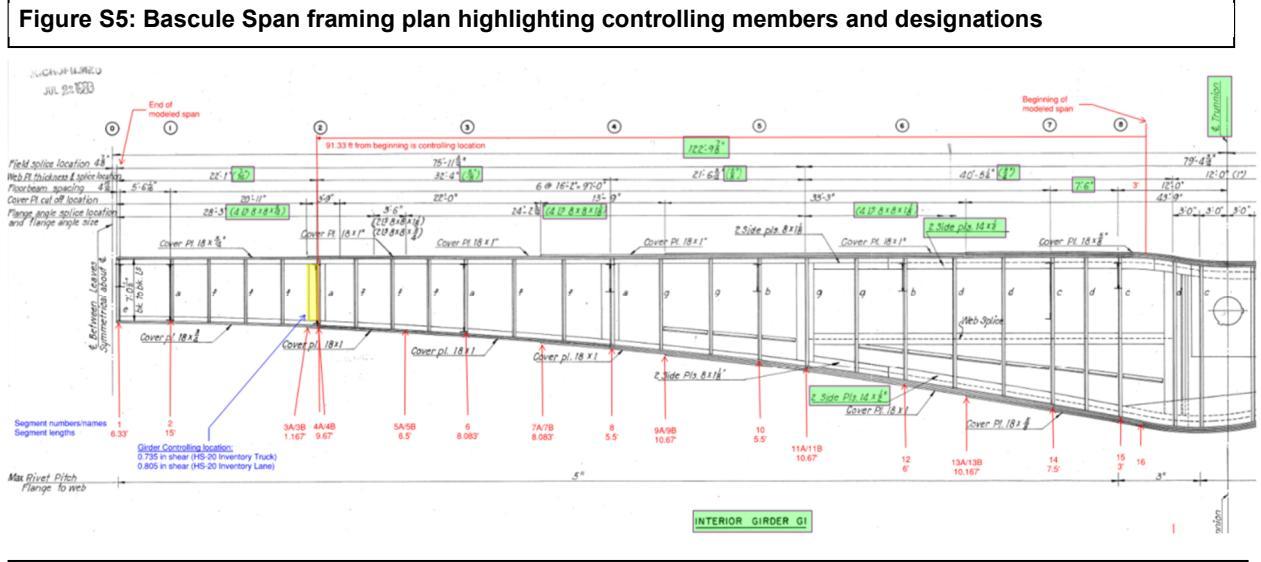
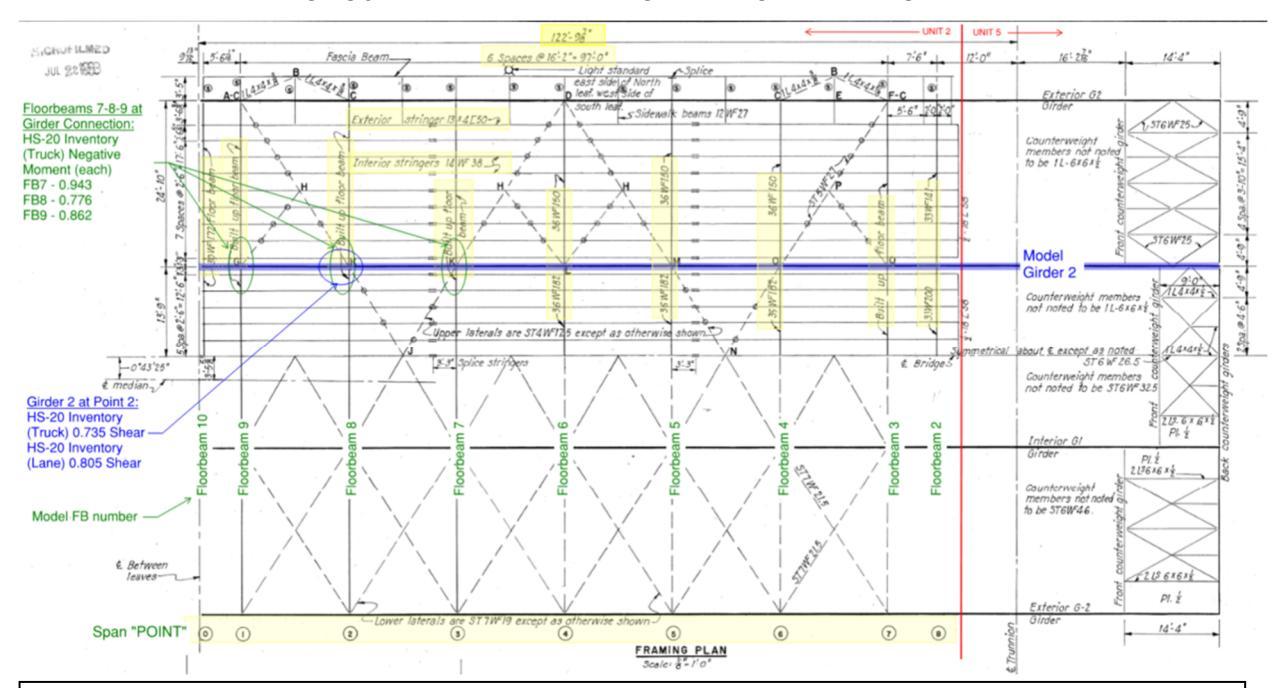
The location of the low rating is at the transition / web splice where the web plate thickness changes from 5/8" to 7/16" (trunnion side towards center break side), from the floorbeam connection at the splice, into the thinner web section, for a length of 14". The low rating at this small length is based on the girder cross section changing just before the loading on the girder changes.

Figure S6: Bascule Girder elevation view highlighting controlling rating location

The low inventory ratings (HS-20 Truck and Lane) are for shear where the web plate transitions in thickness from 5/8" to 7/16", between the FB2 and FB1 connections (inspection nomenclature). The low rating location is approximately 14 in long between the end of the 5/8" plate into the 7/16" plate, and after the web splice plates as Section 4A to 3B in the model. This is where loading changes on the girder, according to the model, as well as where the girder cross section changes. The analysis section is short due to the web splice, web thickness change, and floorbeam connection proximity.

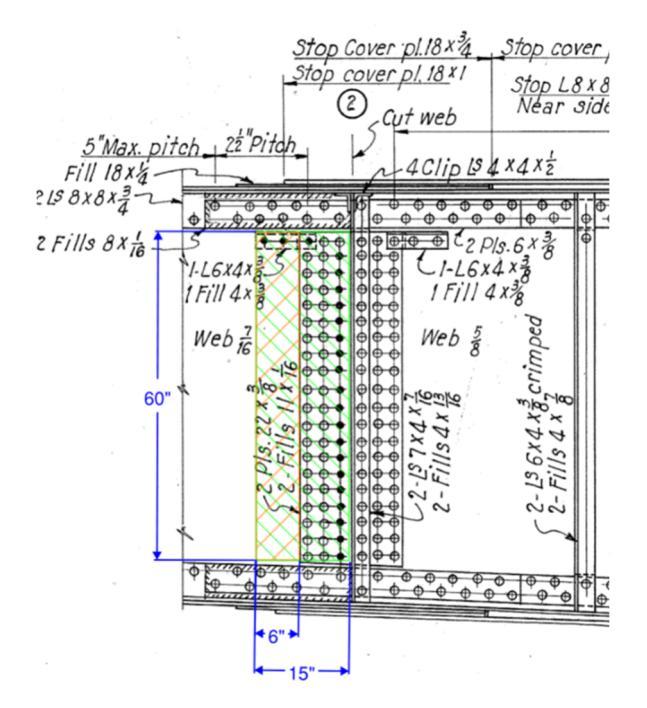
Detail Elevation view of girder at splice / FB connection location; potential reinforcement plates highlighted in yellow and green

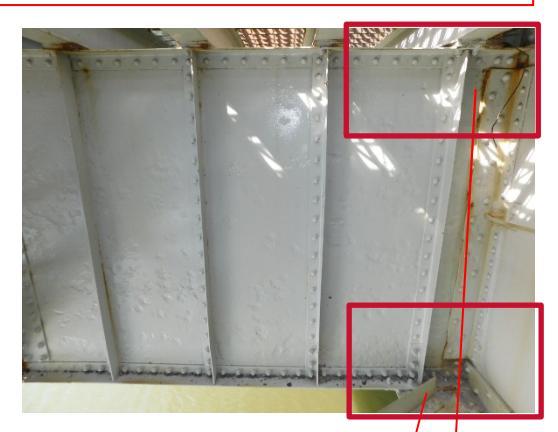
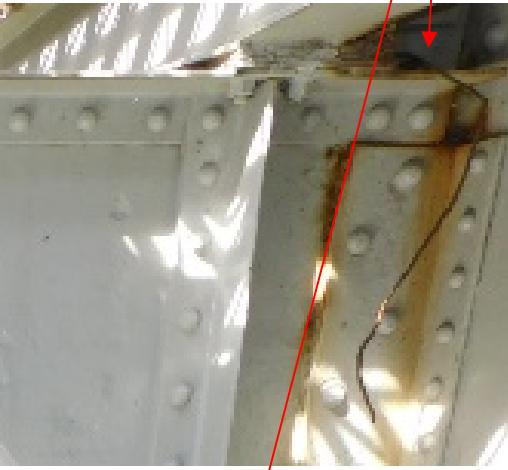
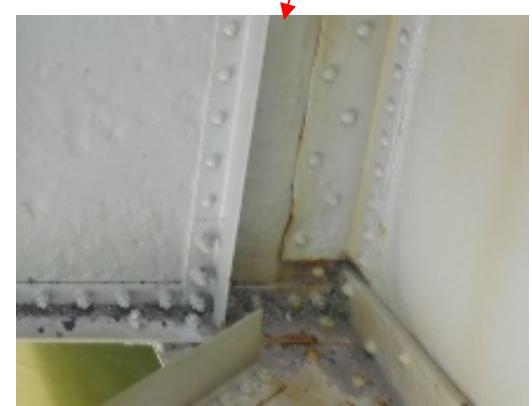
The floorbeams are modeled as continuous across the girders as supports – implying a moment connection FB to G; this is not the case, the floorbeam to girder connection is a web to web connection with angles (typical for FB7 – FB8 – FB9)
