A ELEMENT QUANTITIES

A decorative white diagonal bar with a pointed end, extending from the bottom left towards the center of the page.

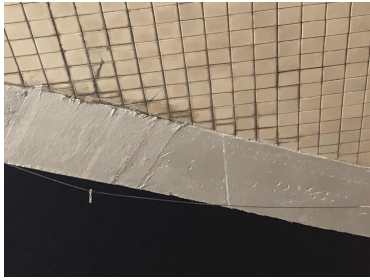
NEW
Deficient
DISCOVERED
09/12/2021
1:02 PM

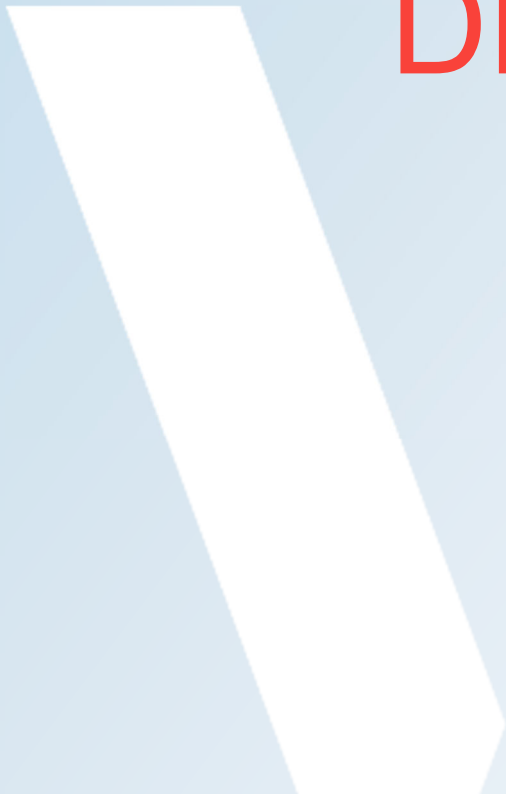
c:\pwworking\hmm\external\tyn61470\dms72783\071_0134\CP001.dgn 10/24/2014 10:59:46 AM TYN61470

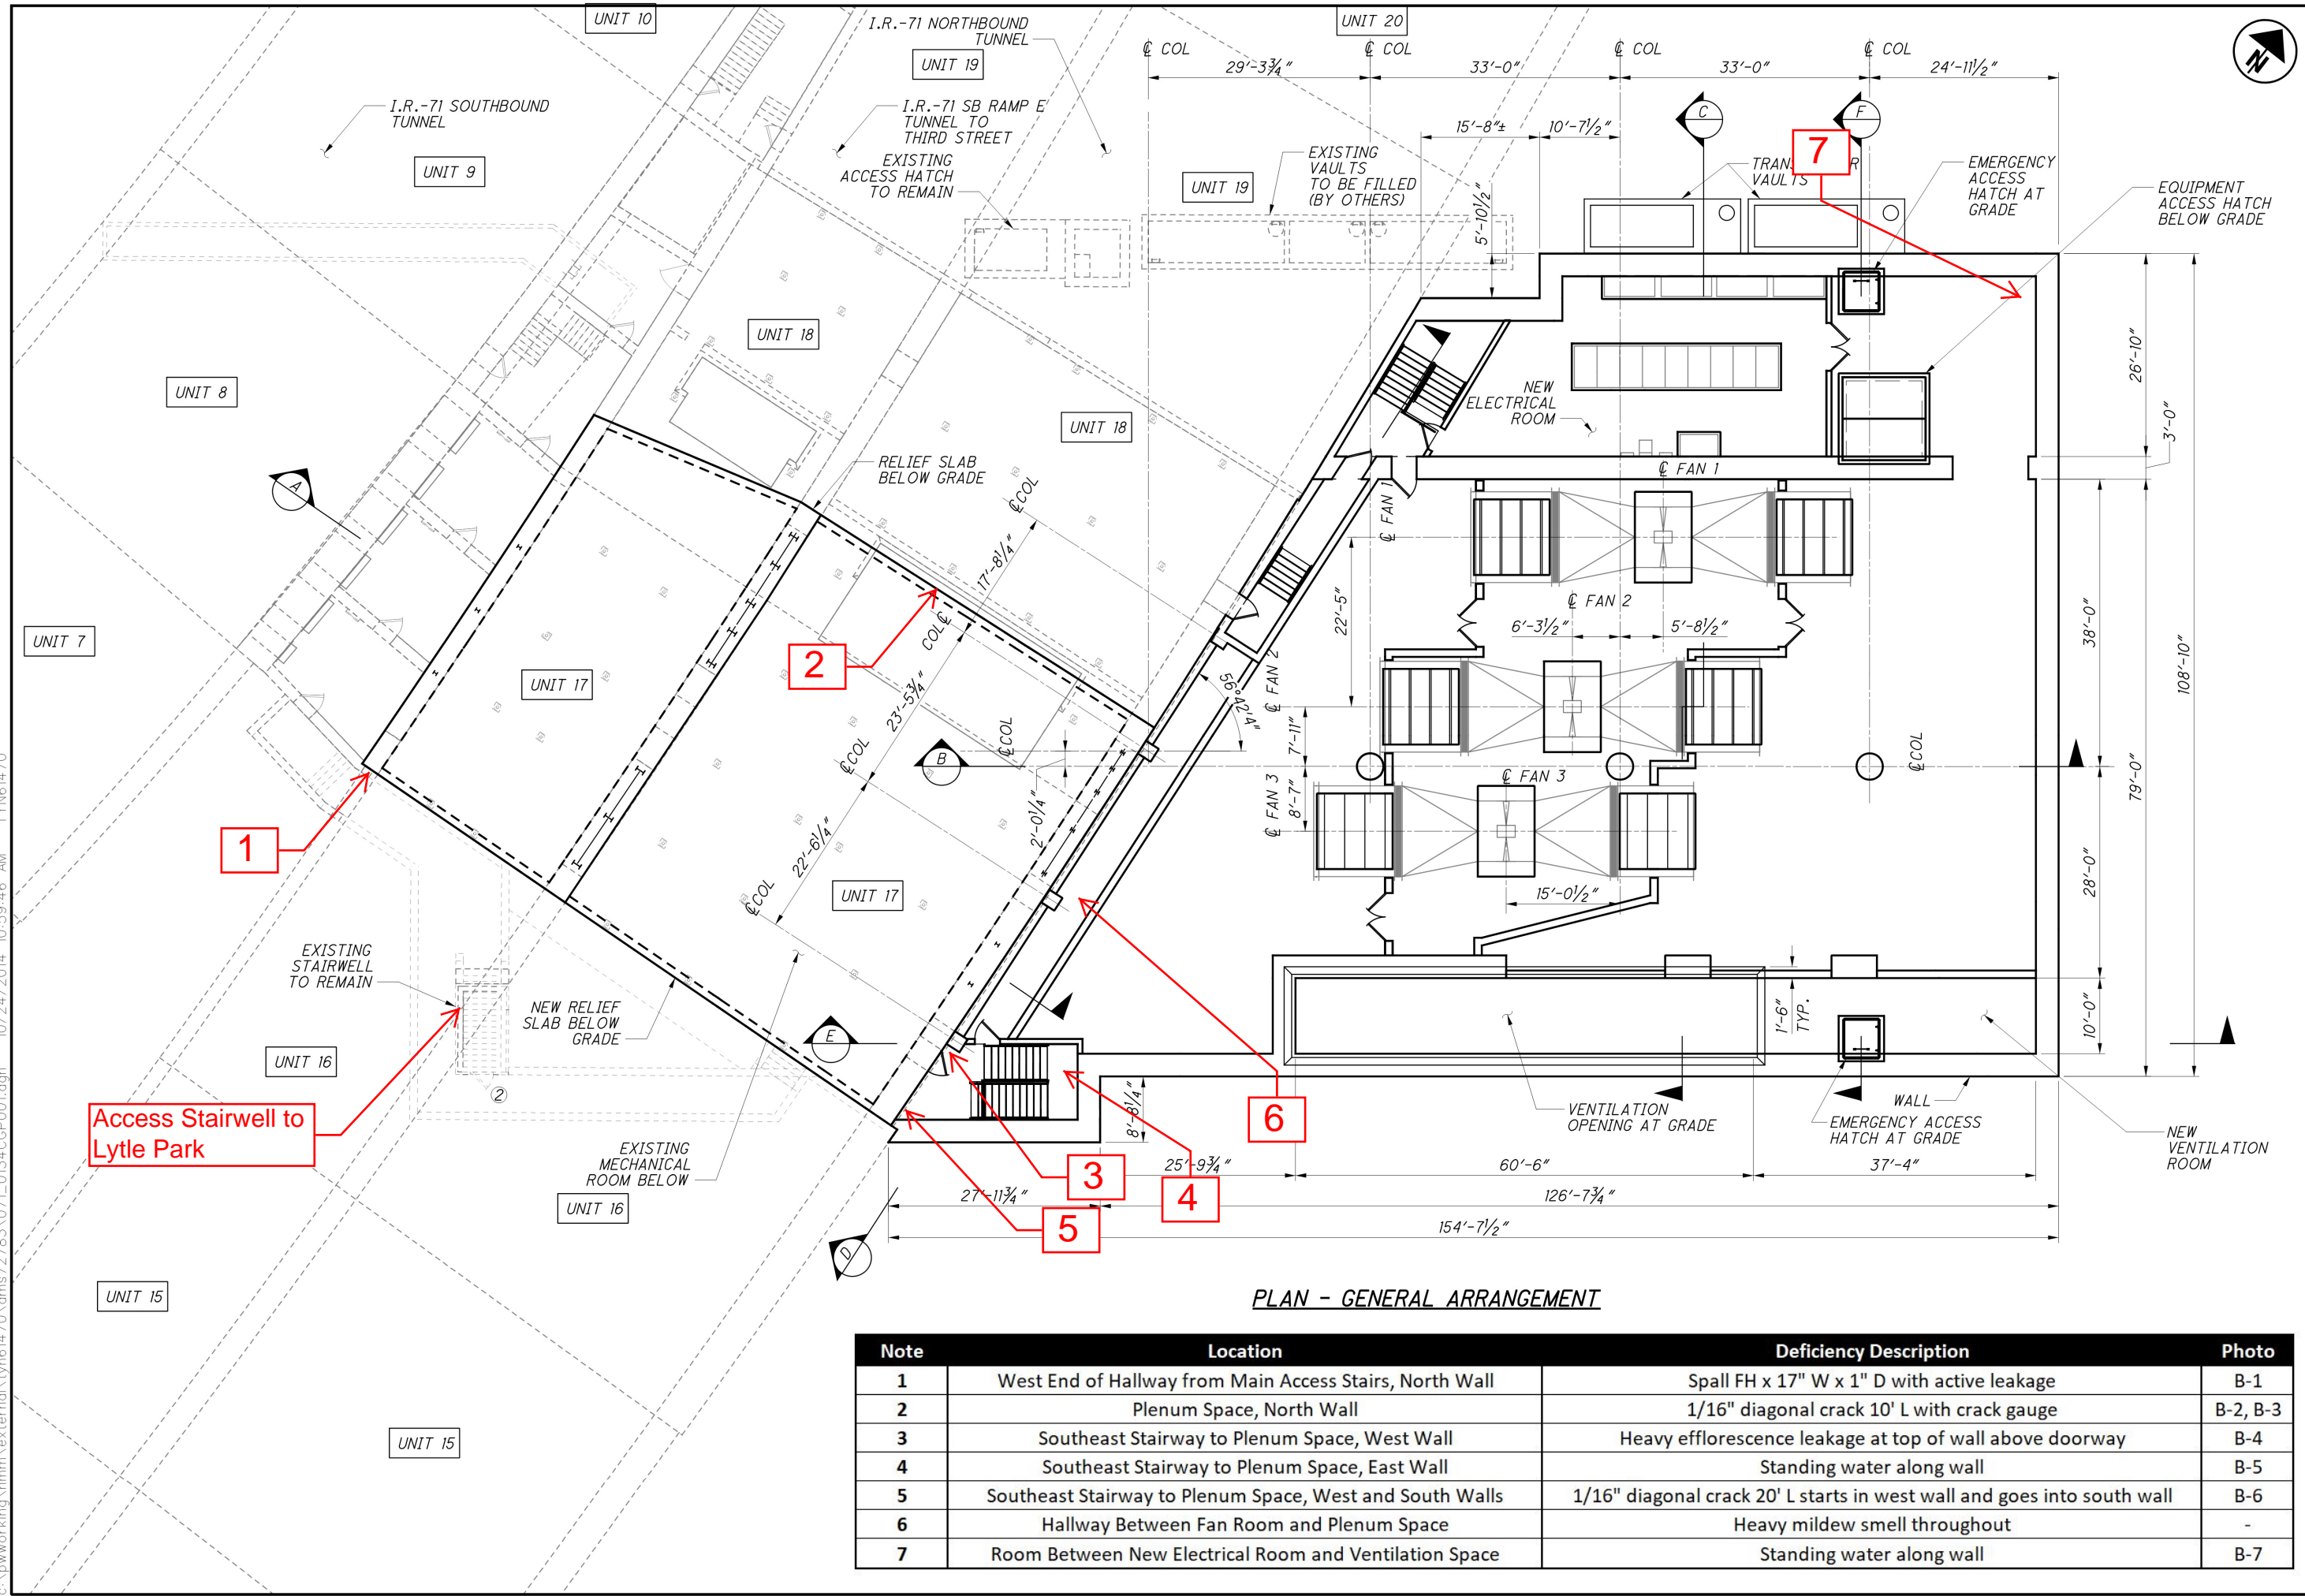
PLAN - GENERAL ARRANGEMENT

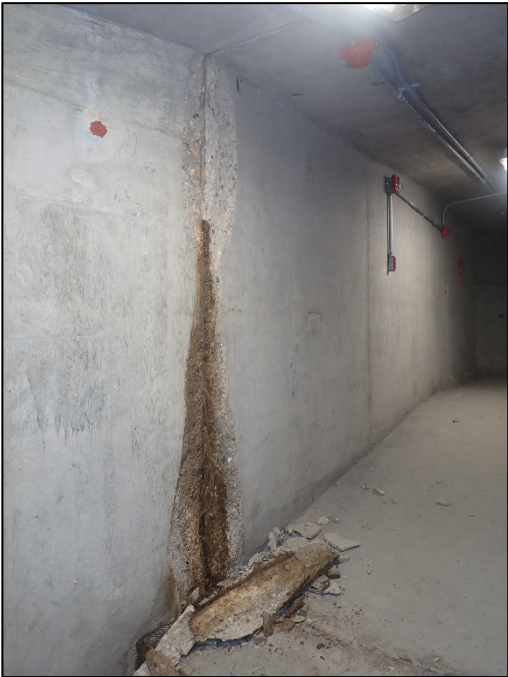
Photo B-1: Spall in north wall at west end of hallway from main access stairs with active leakage, looking northeast

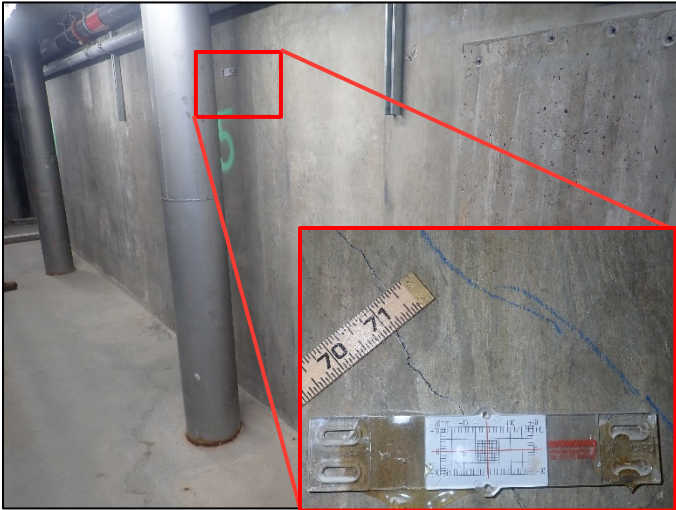
Photo B-2: 1/16" wide crack in north wall between plenum space and control room with installed crack gauge, north (control room) side shown, looking southeast

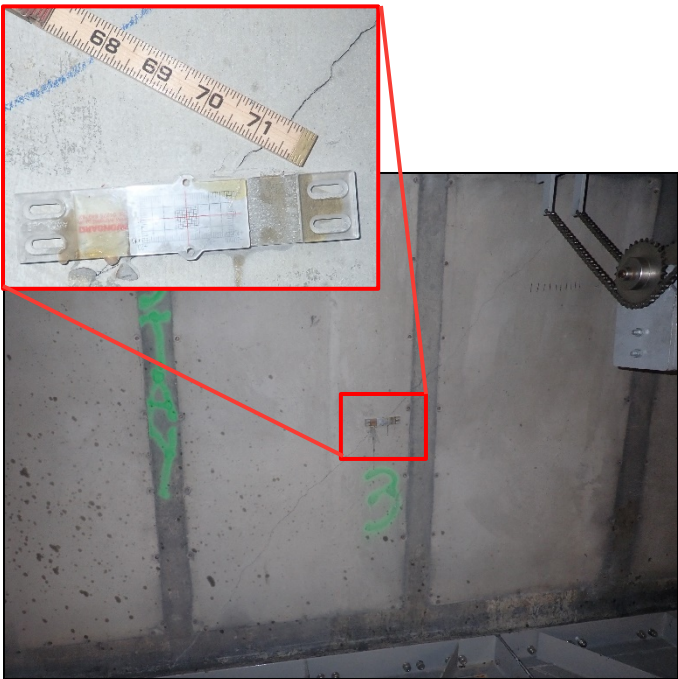
Photo B-3: 1/16" wide crack in north wall between plenum space and control room with installed crack gauge, south (plenum space) side shown, looking north

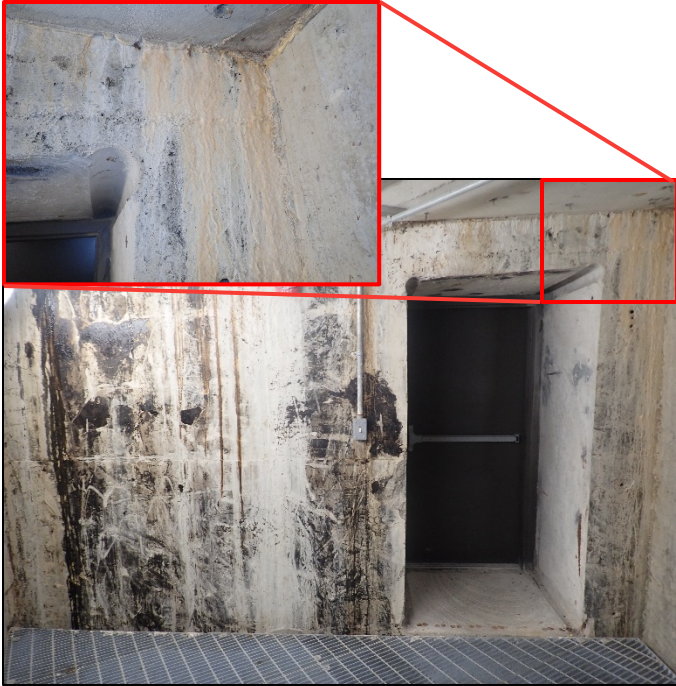
Photo B-4: Heavy efflorescence on top of west wall above door in southeast stairway to plenum space, looking west

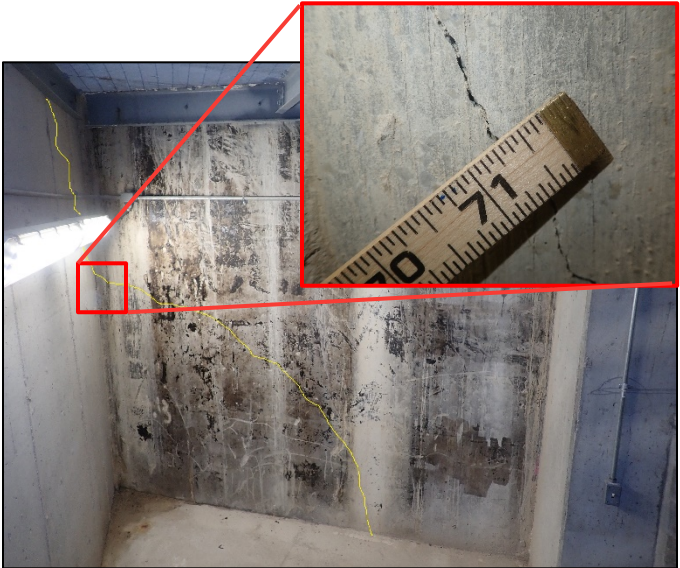
Photo B-6: 1/16" wide crack (highlighted in yellow) in south and west walls of southeast stairway to plenum space, looking west

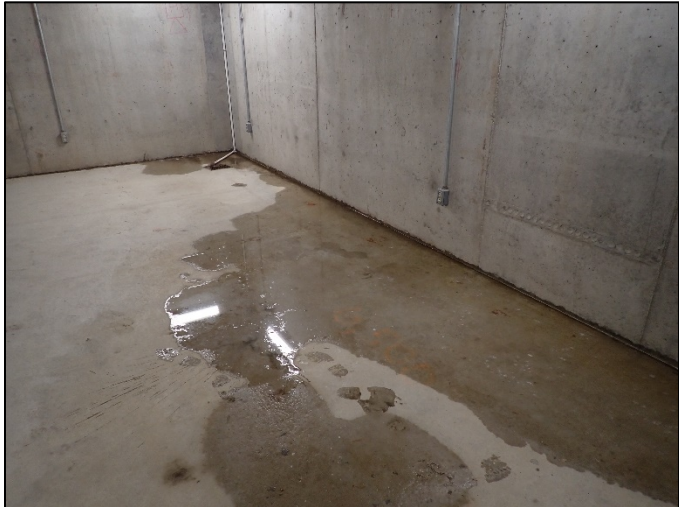
Photo B-7: Standing water along east wall in room between new electrical room and ventilation space, looking northeast

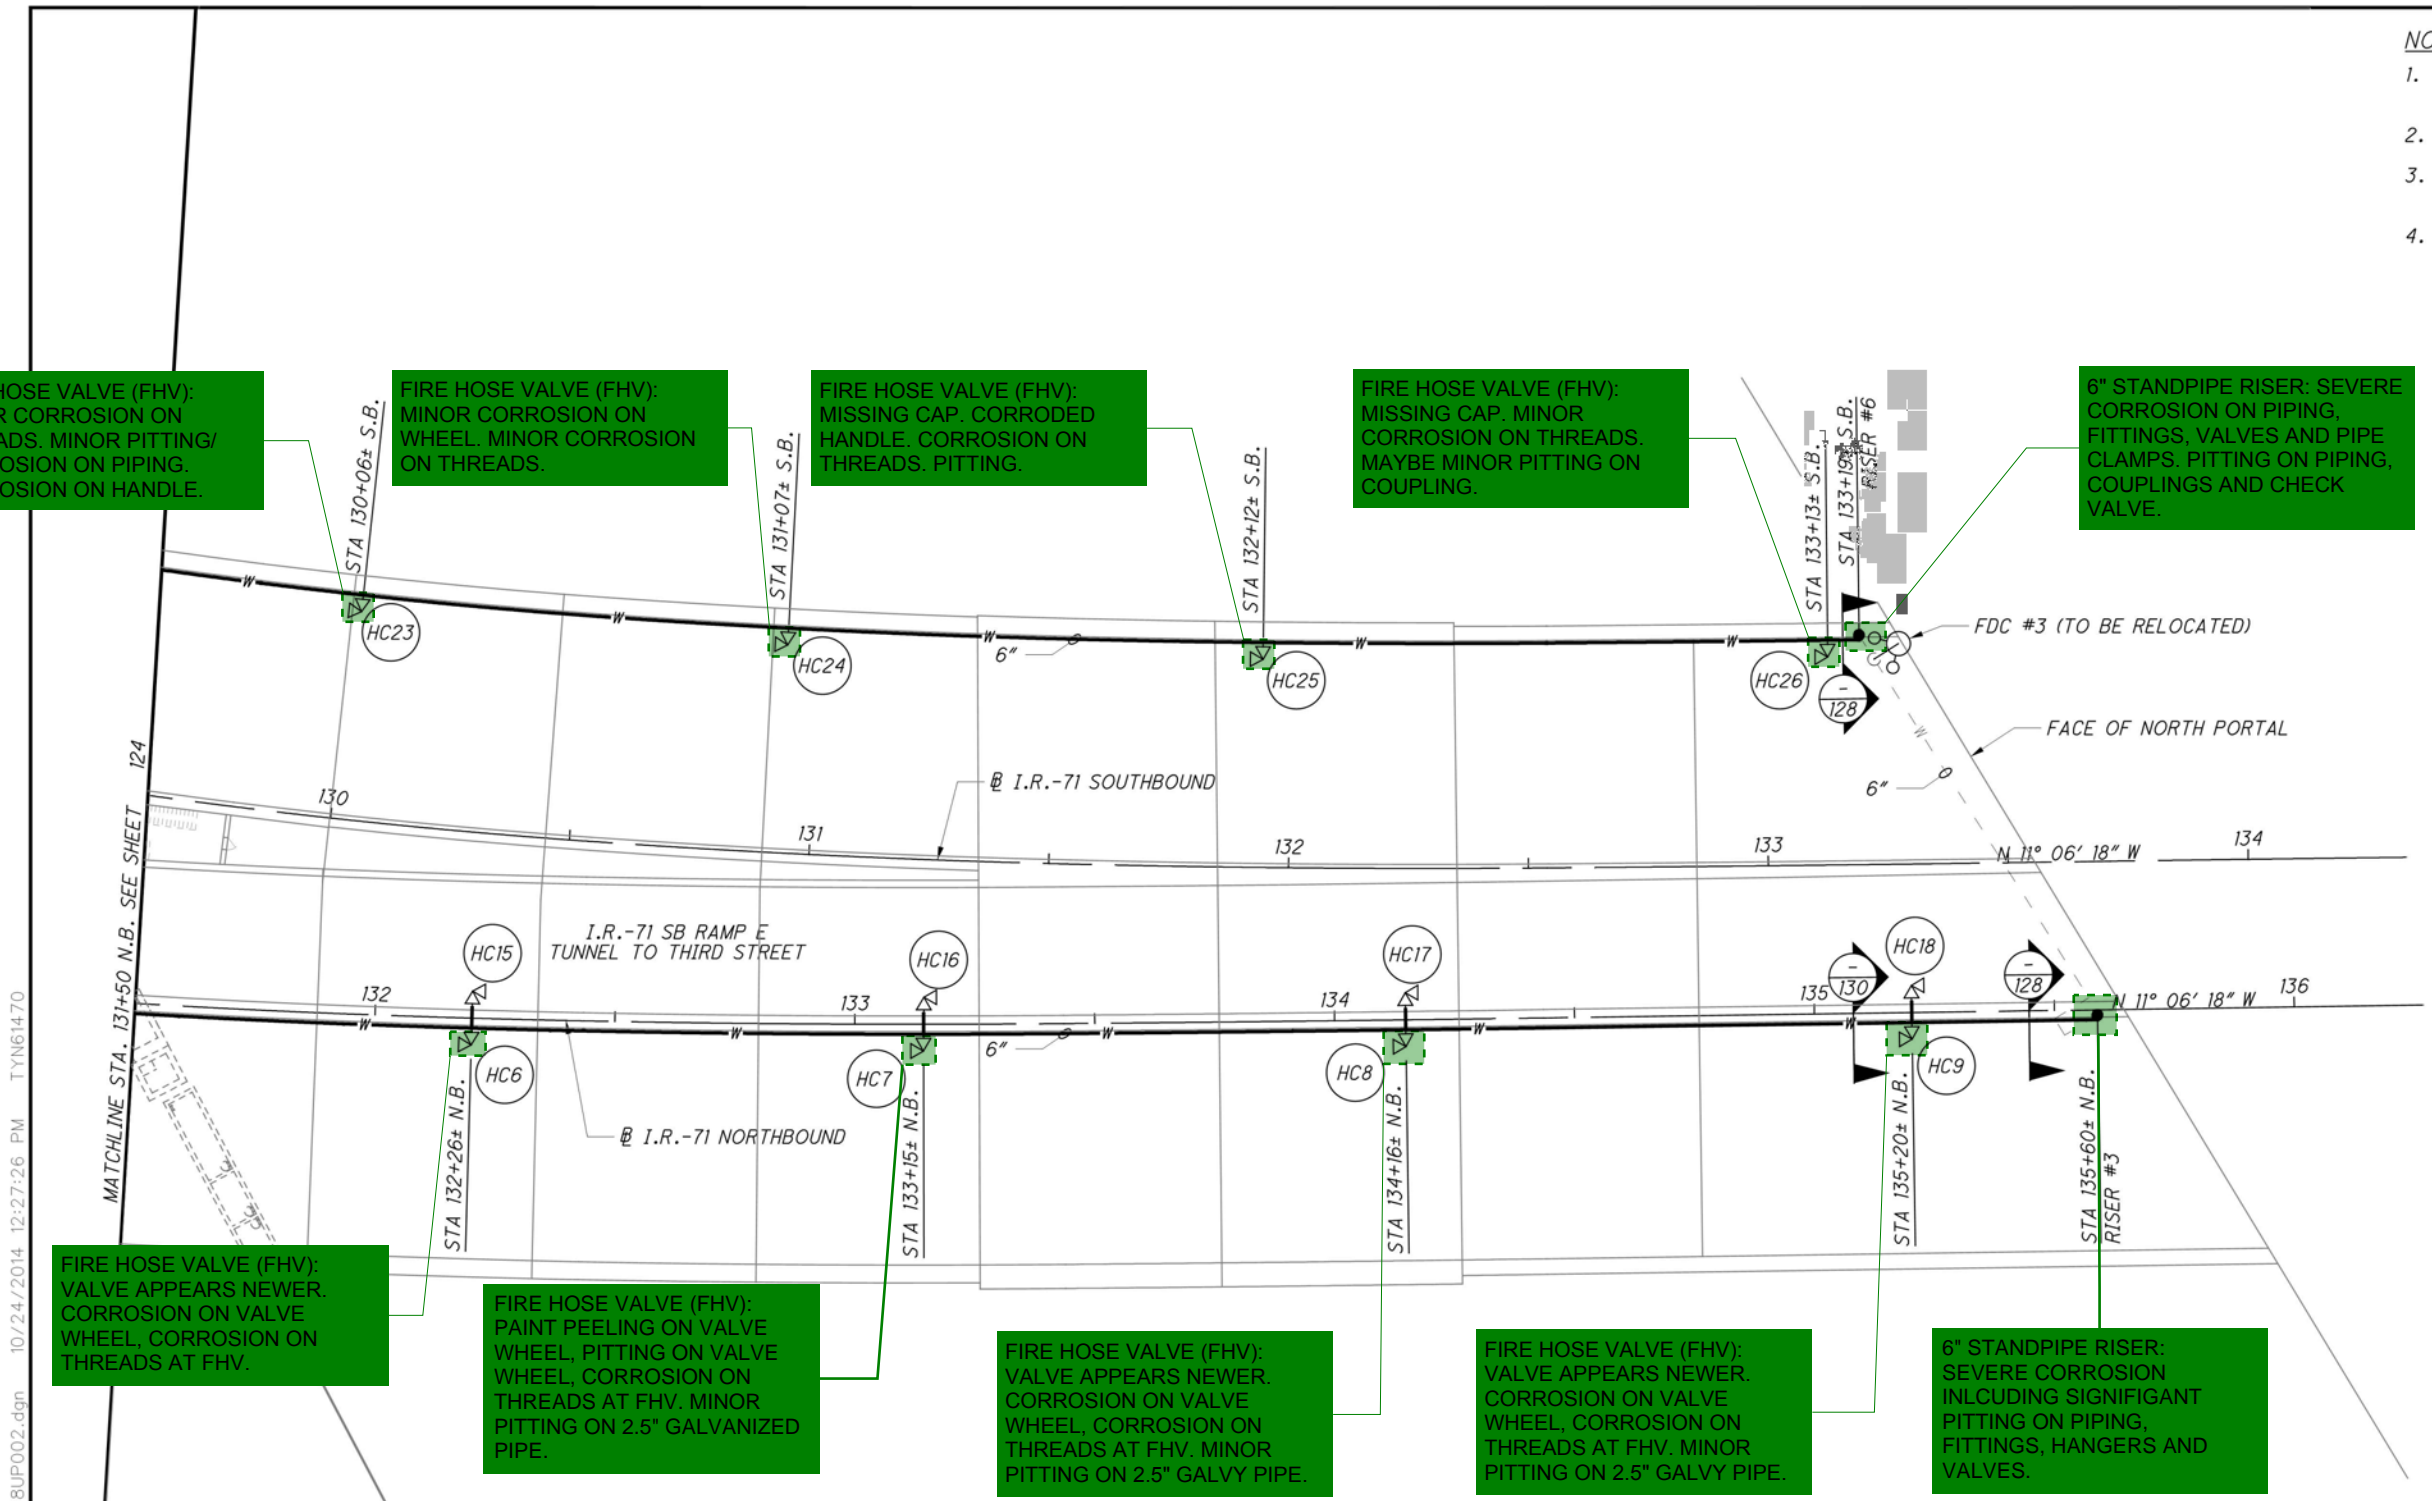
NEW WORK PLAN - STA. 131+50 N.B. TO STA. 136+50 N.B.
SCALE: 1" = 20'
