BRIDGE INSPECTION REPORT

2800152
Structure File NumberBRIDGE NUMBER **GEA 00044 0135**YEAR BUILT **1960**DIST **12**Bridge Type **112**TYPE SERVICE **5 5****LA DUE RES. 1.23 MIS 422**

SFN 2800152 Bridge GEA-44-0135

USR 44 over La Due Reservoir

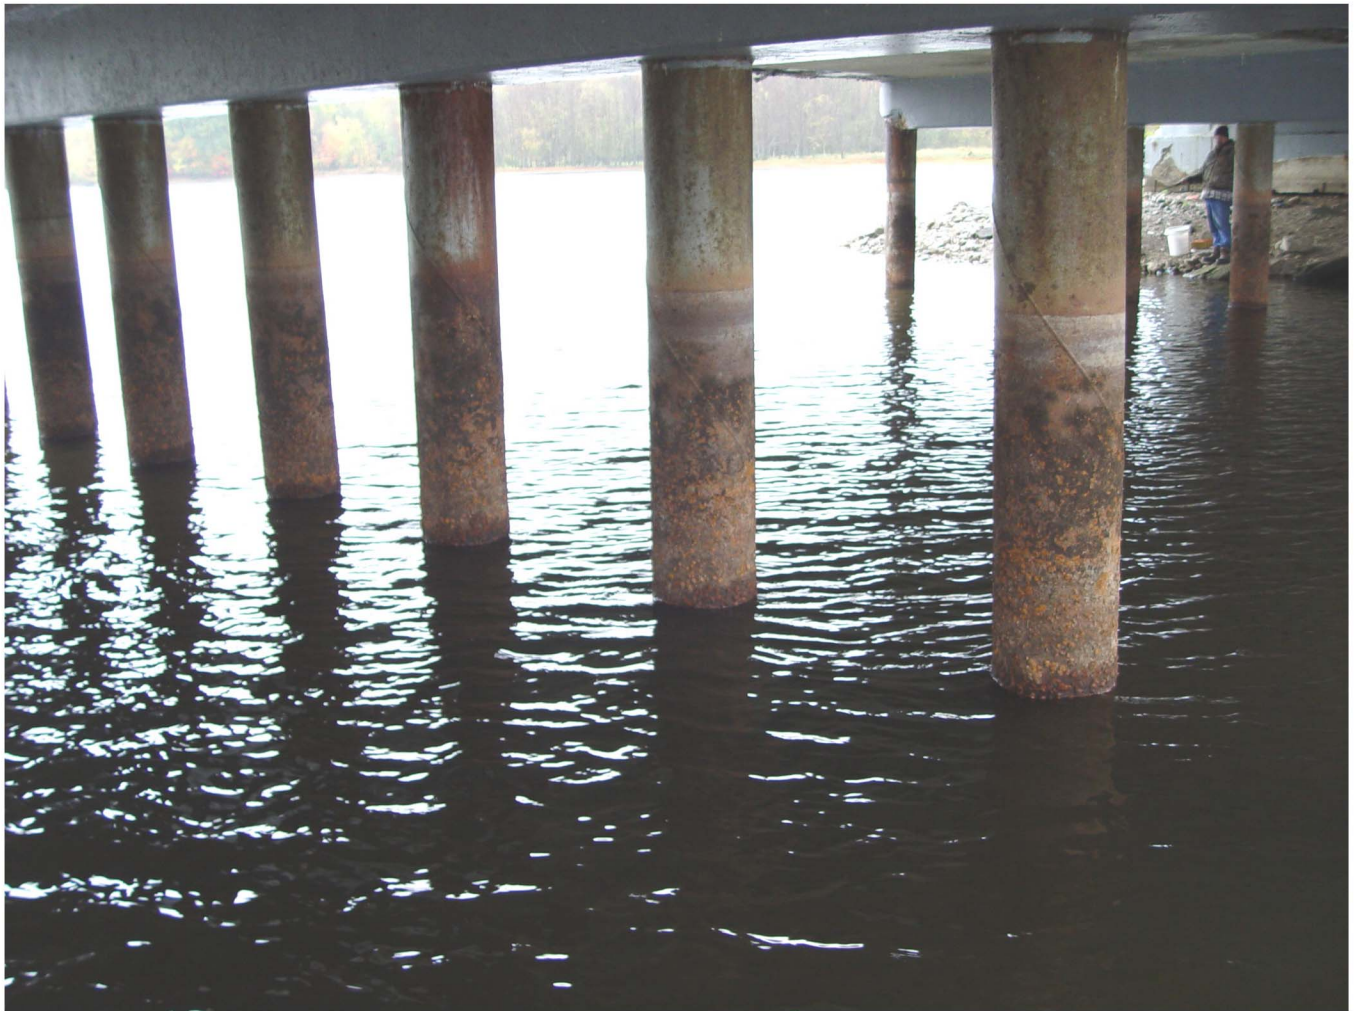
ABUTMENTS: SPALLS.
ABUTMENT SEATS: 4 SF OF SEAT LOSS AT ENDS OF ABUTMENTS.
PIERS: MINOR DELAMINATIONS OF CAPS. RUSTING SECTION LOSS OF
STEEL PIER COLUMNS NEAR WATERLINE; SEE ATTACHED PHOTO
#2 DATED 10/25/05.
SCOUR: NO SIGNIFICANT CHANGE FROM 2003 DIVER'S REPORT.
BACKWALLS: SPALLS. SOME DETERIORATED AREAS.
WINGWALLS: CRACKS. SPALLS.
SLOPE PROTECTION: UNDERMINING OF START ABUTMENT EXPOSES
PARTS OF SOME PILES TO WATER/AIR. ULTV IS
(42 INCHES, 44 LF, 1 LF); SEE ATTACHED
PHOTOS #1 AND #2 DATED 12/5/02. FINISH
ABUTMENT IS SLIGHTLY UNDERMINED NEAR LEFT
END AND BELOW CENTERLINE OF SR 44.

Photo 2. *Facing north looking at the steel pile columns of Pier 1.
Note the rusting section loss occurring at the waterline.*
