Geology and Field Reconnaissance
Portsmouth Bypass
Project SCI-823-10.13
Phase 2 – Stage I
Scioto County, Ohio

DLZ Job No. 0121-3070.03
PID 79977

November 16, 2007

**REPORT OF
GEOLOGY AND FIELD RECONNAISSANCE
FOR
PROJECT SCI-823-10.13
PHASE 2 – STAGE I
SCIOTO COUNTY, OHIO**

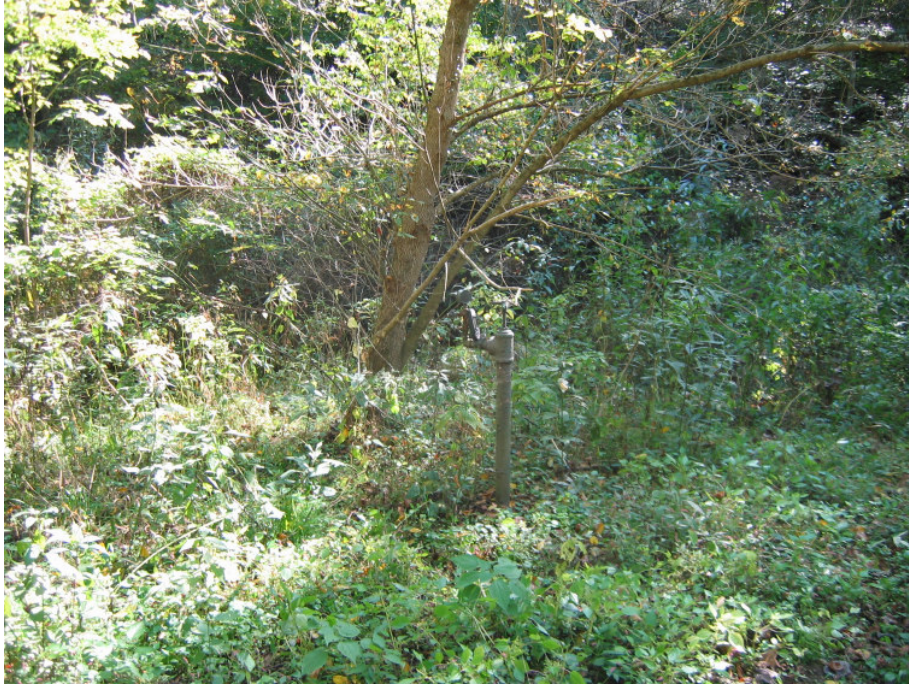
Photo 3. Previously unknown gas well 760 feet left of station 659+00.

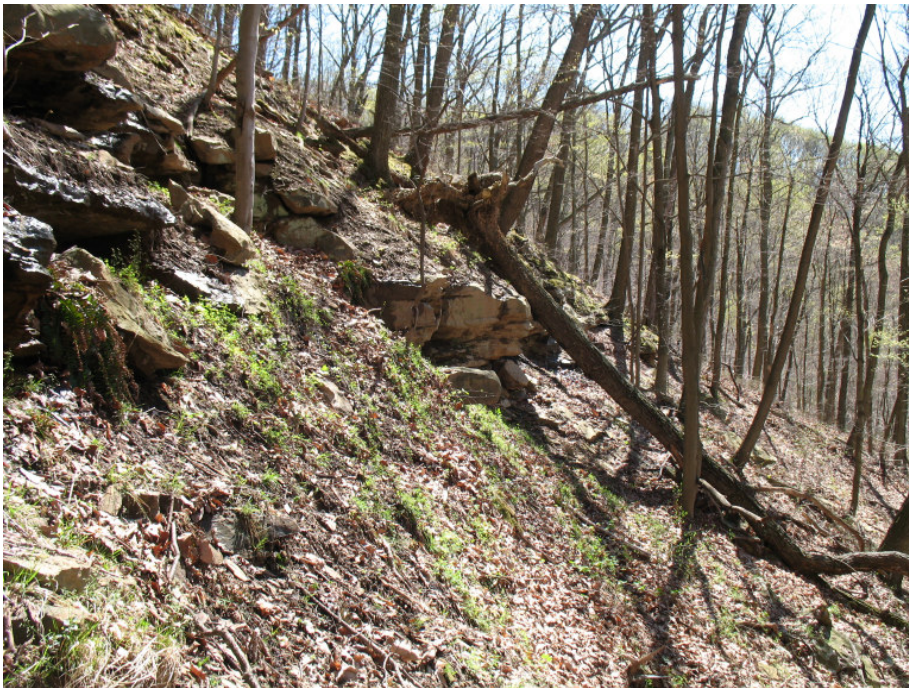
Photo 4. Bedrock exposure at Station 573+20, 420 feet right.

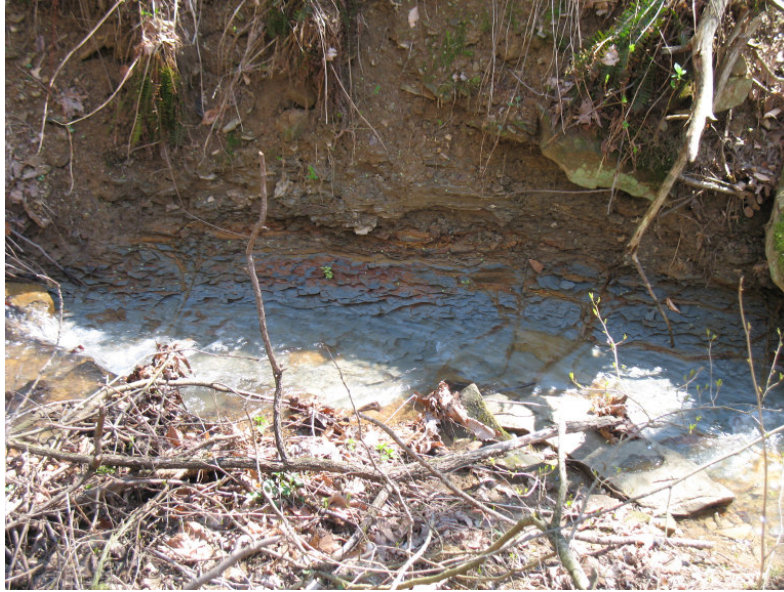
To the right of the proposed Phase 2 alignment, an 8-foot rock exposure was created during the construction of a logging road. The rock consists of weathered, massively bedded very hard, fine-grained sandstone. The cut is nearly vertical and is failing.

Photo 5. Bedrock Exposure at Station 716+95, 165 feet right.

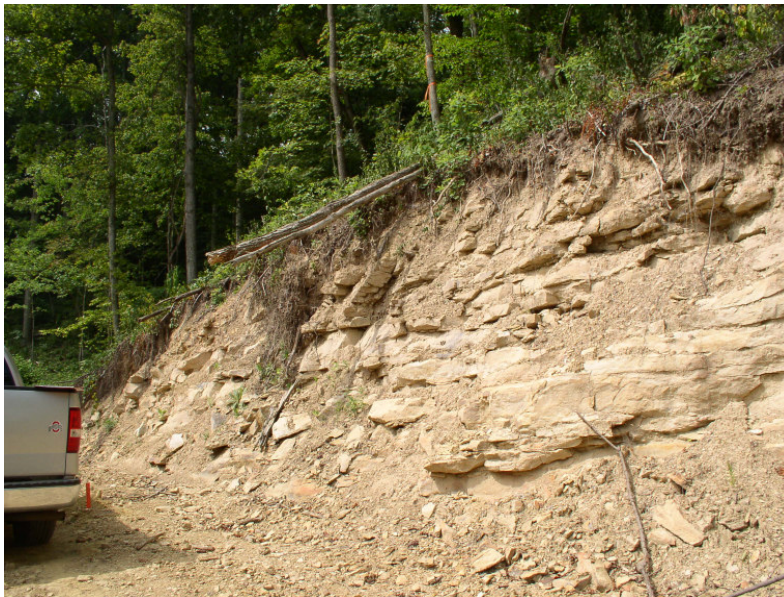
Photo 6. Bedrock exposure at station 798+50.

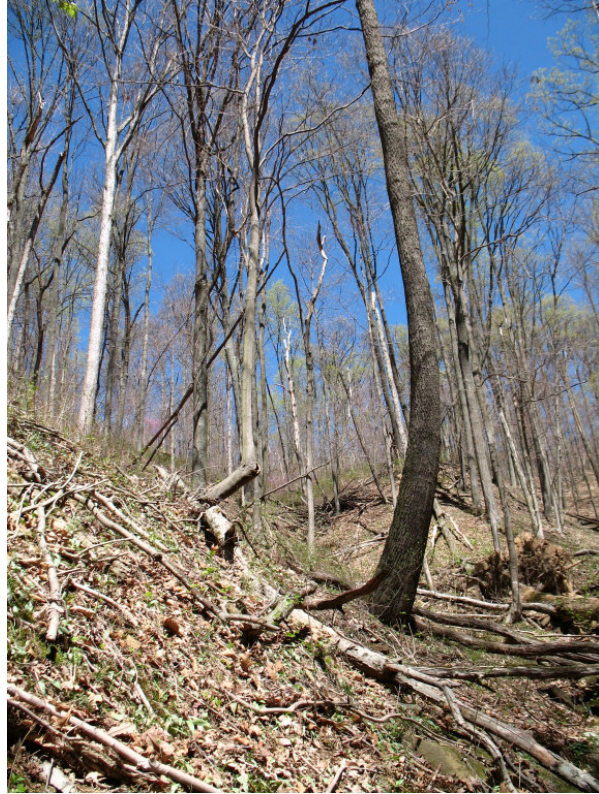
Photo 7. Indicators of slope instability, right of station 673+50.

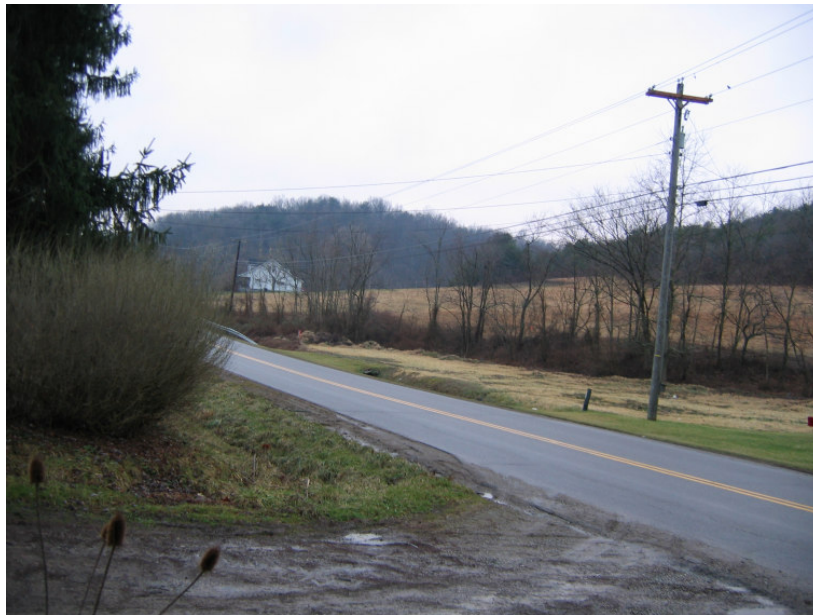
Photo 10. Lucasville-Minford Road.

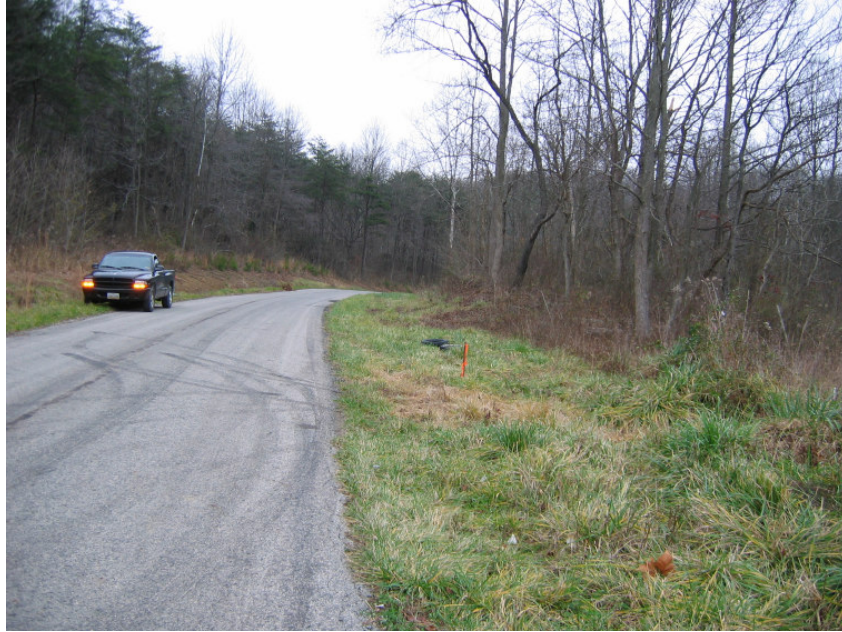
Photo 11. Morris Lane – Blue Run Road.

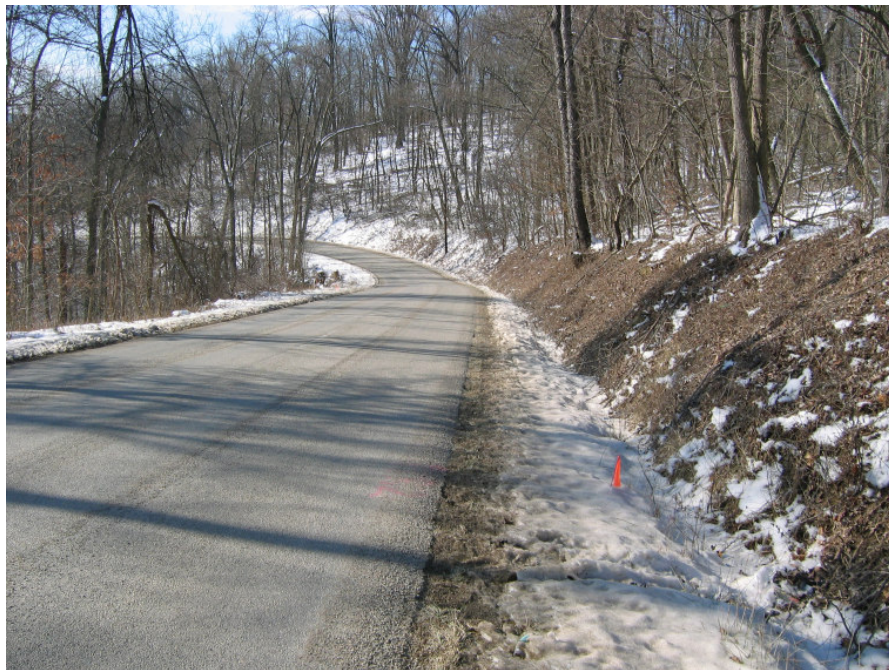
The existing pavement for Lucasville-Minford Road (CR 28), Blue Run Road, Flowers Ison Road, Morris Lane Road, Flatwood Fallen Timbers Road, and Fairground Road (CR 55) were evaluated as part of the field reconnaissance. Photos illustrating the pavement conditions of these roads are in Appendix B. All existing pavements appeared to be performing adequately, with no serious signs of deterioration or rutting. However, Blue Run Road, Flowers Ison Road, Morris Lane Road, and Flatwood Fallen Timbers Road showed minor signs of transverse cracking and raveling.

Photo 12. Flatwoods-Fallen Timbers Road

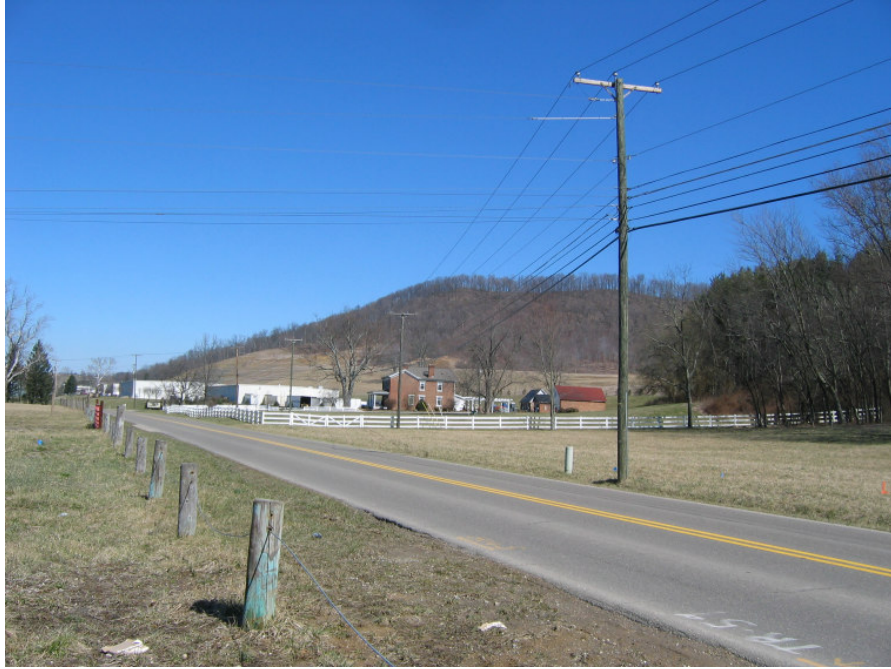
Photo 13. Fairground Road
