BRIDGE No.: HAM-71-6.75 & HAM-71-7.31	EDMONSON RD. & ROBERTSON AVE. OVER I-71
31148 DESIGN		14902
XXX PROJEC	H MM-I MM-I 1535 TO TO	GTF ≣R DD-YY

STRUCTURE REPAIR DETAILS BRIDGE No: HAM-71-6.75 EDMONSON RD. OVER I-71
SFN 3114813 DESIGN AGENCY
DESIGNER CHECKER CAH GTF REVIEWER XXX MM-DD-YY PROJECTID 115355 SUBSET TOTAL

STRUCTURE REPAIR DETAILS BRIDGE No: HAM-71-7.31 ROBERTSON AVE. OVER I-71

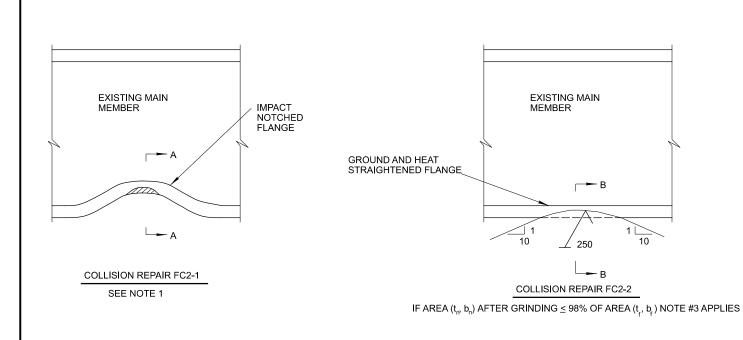
SECTION A-A SEE NOTE 1 THROUGH 4 FLANGE NOT SHOWN WITH BEND FOR CLARITY

MAIN AND SECONDARY MEMBER DAMAGE IS NOT SHOWN. FOR CLARITY SEE SECTION A-A

TABLE # 1 DAMAGED MAIN MEMBERS TO BE HEAT STRAIGHTENED												
DAMAGE AREA No. MEMBER LINE No. A PIER OR ABUT. B C D E F1 F2 G H J K											L		
1	BEAM 6	PIER 1	40.3'	41.6'	42.9'		- 0.5"	+ 0.5"

REMOVE ACCORDING TO ITEM 202-PORTIONS OF SECONDARY MEMBERS REMOVED, AS PER PLAN. REPLACE BY MATCHING EXISTING DETAIL. SEE GSD-1-96 FOR ADDITIONAL CLARIFICATION.

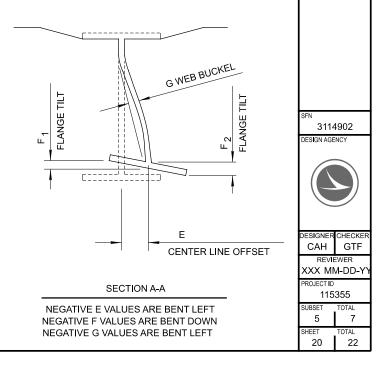
DETERMINE IF IMPACT NOTCH IS CRACKED USING MAGNETIC PARTICLE INSPECTION IF CRACK DOES NOT EXTEND THROUGH THE FLANGE. DETERMINE DEPTH OF CRACK

IF NOTCH OR PARTIAL DEPTH CRACK CAN BE REMOVED BY GRINDING ACCORDING TO SUPPLEMENTAL SPECIFICATION 849, REPAIR DAMAGED MEMBERS. PERFORM GRINDING ACCORDING TO SUPPLEMENTAL SPECIFICATION 849 AND AS ILLUSTRATED IN DETAIL FC2-2

TO SUPPLEMENTAL SPECIFICATION 849 REPAIRING DAMAGED MEMBERS, AS ILLUSTRATED IN DETAIL FC2-3. PERFORM COMPLETE PENETRATION WELDING ACCORDING TO C&MS 513.21 BY ATTACHING RUN OFF TABS AND GRIND ALL WELDED SURFACES SMOOTH

ACCORDING TO ANSI B46.1 OF 250 mil PERFORM NDT TESTING ACCORDING TO C&MS 513.25A. MAGNETIC PARTICLE TESTING WILL BE ACCEPTED IN LIEU OF RADIOGRAPHIC TESTING.
