Reference: **Geotechnical Desktop Study**  
**TP 26 NE Ohio Site 13 – MAH-11 Vacant Rest Areas (PID 122881)**  
Mahoning County, Ohio  
S&ME Project No. 24170232

Figure Desc.: Site Aerial with Reconnaissance Notes - SB and NB Parking Areas

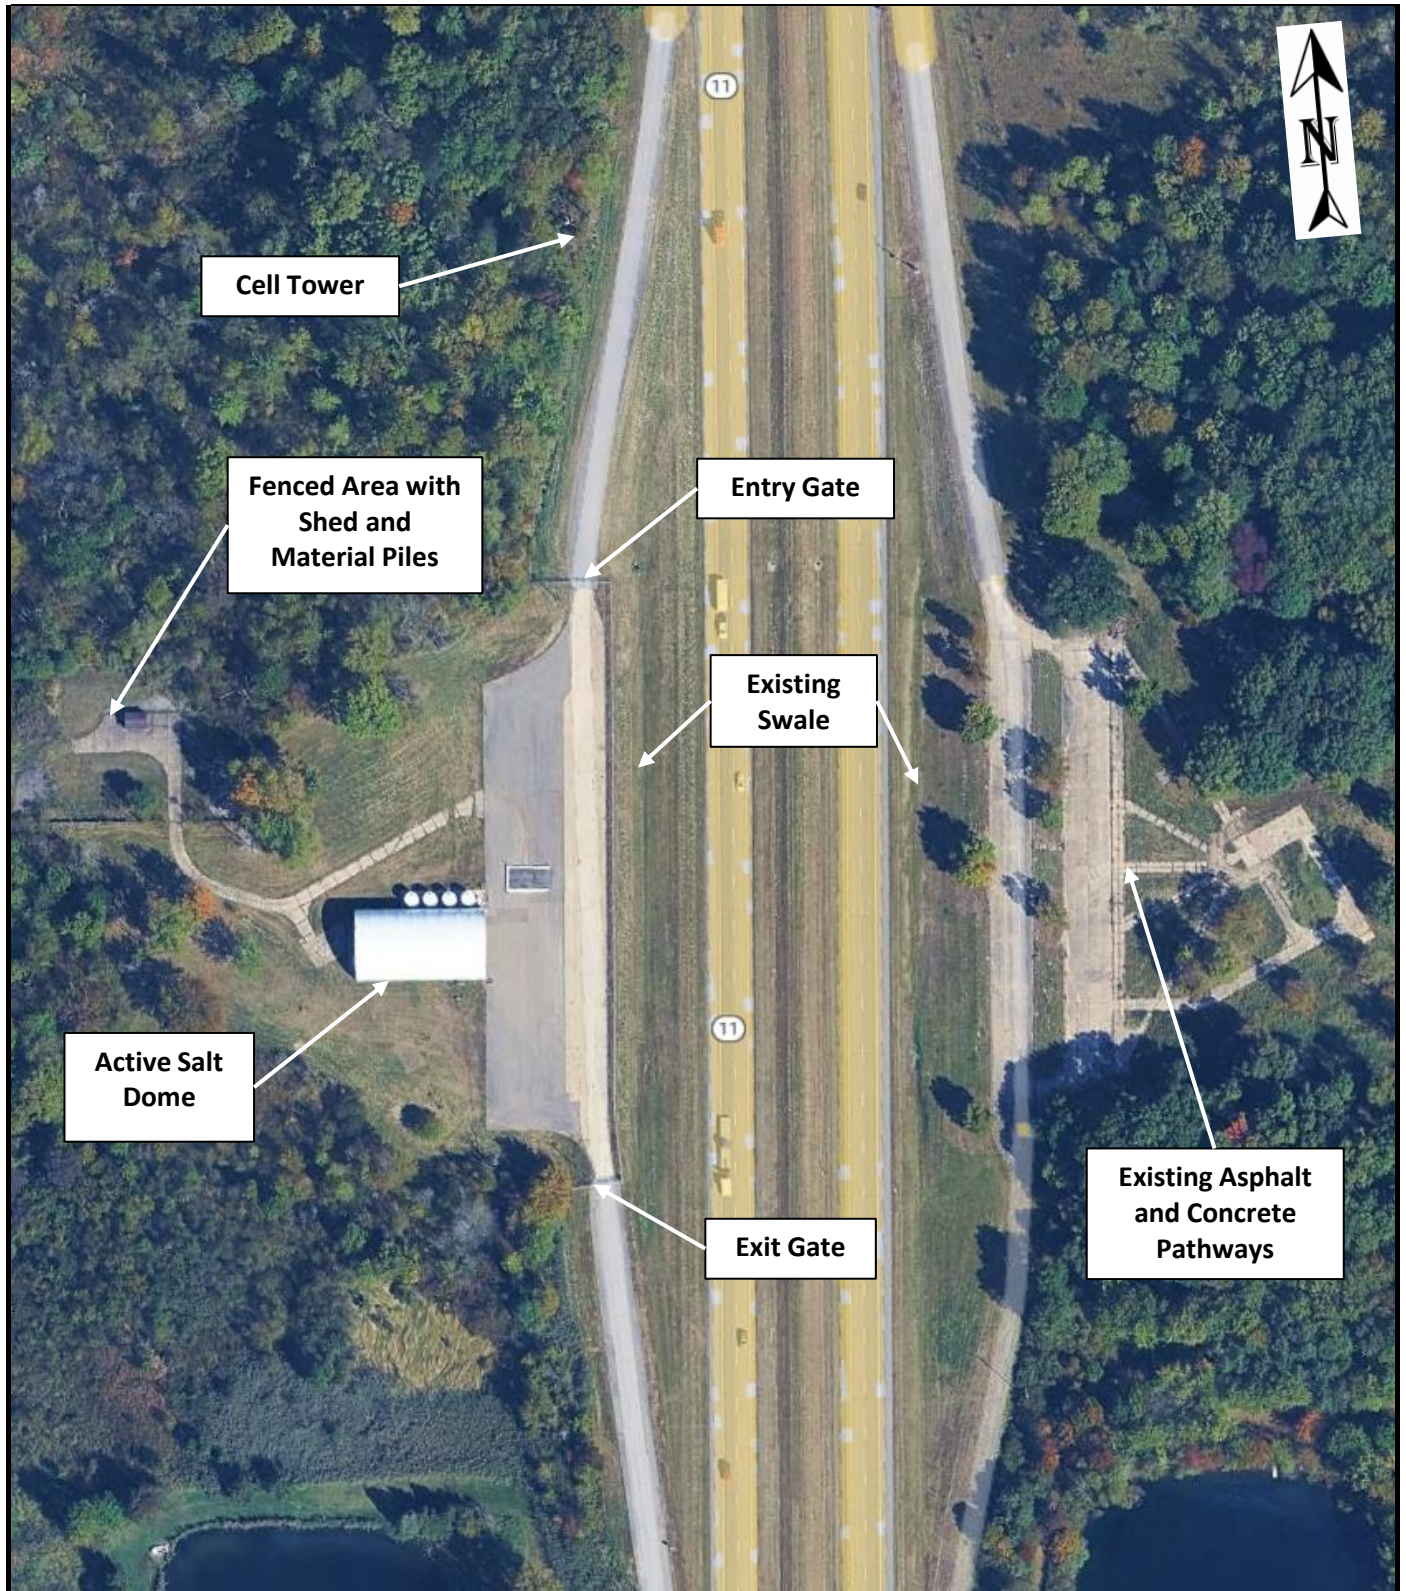
- The bottom of the existing drainage swale adjacent to the SB outside shoulder of SR 11 was roughly 10 feet below the SR 11 pavement. The bottom of the swale adjacent to the NB outside shoulder of SR 11 was roughly 3 to 4 feet below the SR 11 pavement.

- There is an active salt storage dome located in the southbound parking area.
- A fenced-in area with an empty storage shed is also located on the northwest corner of the southbound parking area. A few piles of concrete rubble were observed within this fenced-in area.

- Multiple 10-foot square concrete pads were observed throughout the grass portion of the SB parking area.
- In the NB parking area, significant areas of asphalt and concrete pavement have been left in place following the closure of the rest areas.

- Areas of possible wetlands were observed adjacent to and inside the tree lines surrounding the SB parking area. A few isolated areas of potential wetlands were noted within the wooded areas outside the NB parking area.

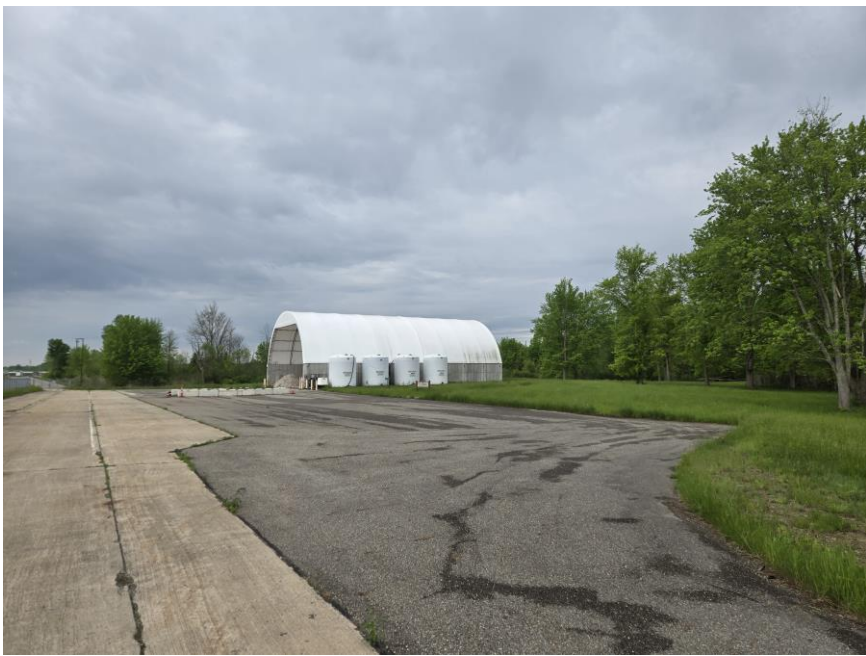
| 1 | Location / Orientation | SB Site, Just Inside North Gate, Looking South |

| | Remarks | Active salt dome, existing pavement, main site |

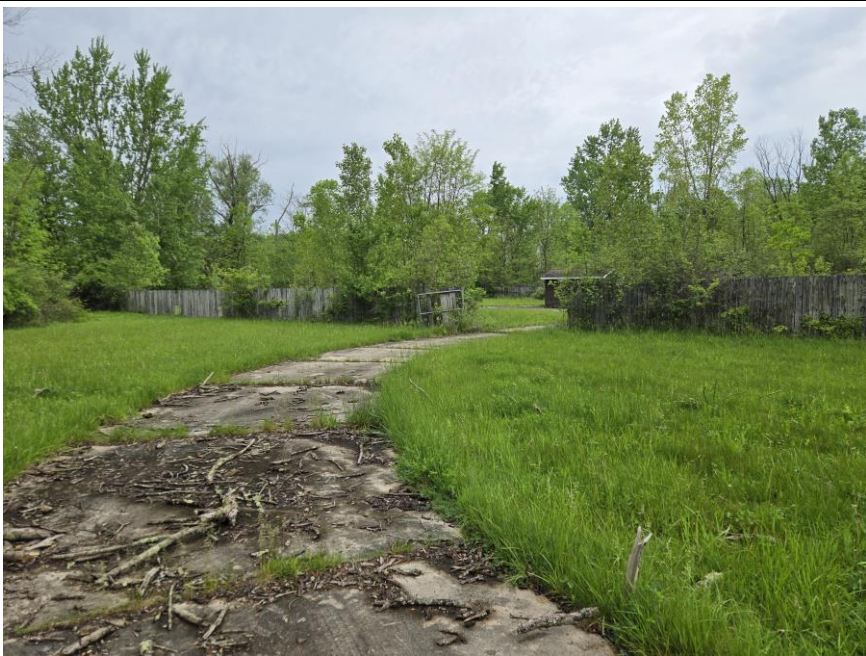
| 2 | Location / Orientation | SB Site, Near South End, Looking West |

| | Remarks | Double barrel elliptical culvert |

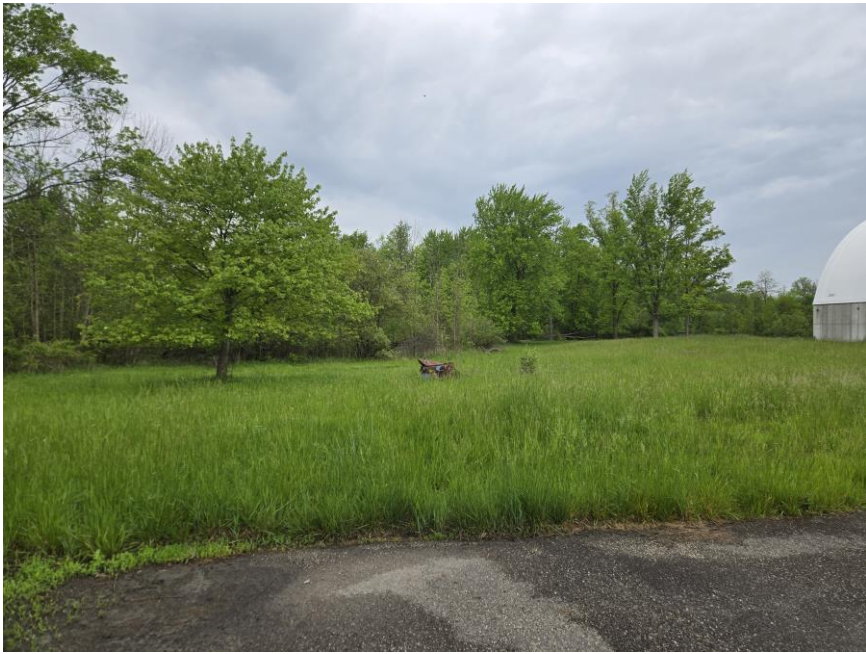
| <b>Location / Orientation</b> | | SB Site, Near South End of Parking Area, Looking West | |

| <b>Remarks</b> | | Main parking area, salt dome | |

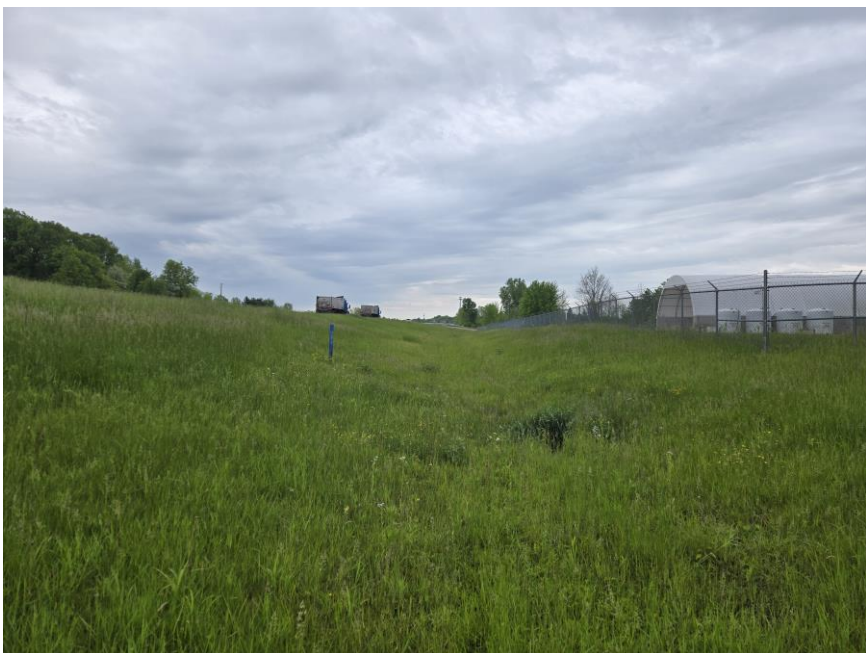
| <b>Location / Orientation</b> | | SB Site, North End of Parking Area, Looking South | |

| <b>Remarks</b> | | Swale between SR 11 and fenced, culvert | |

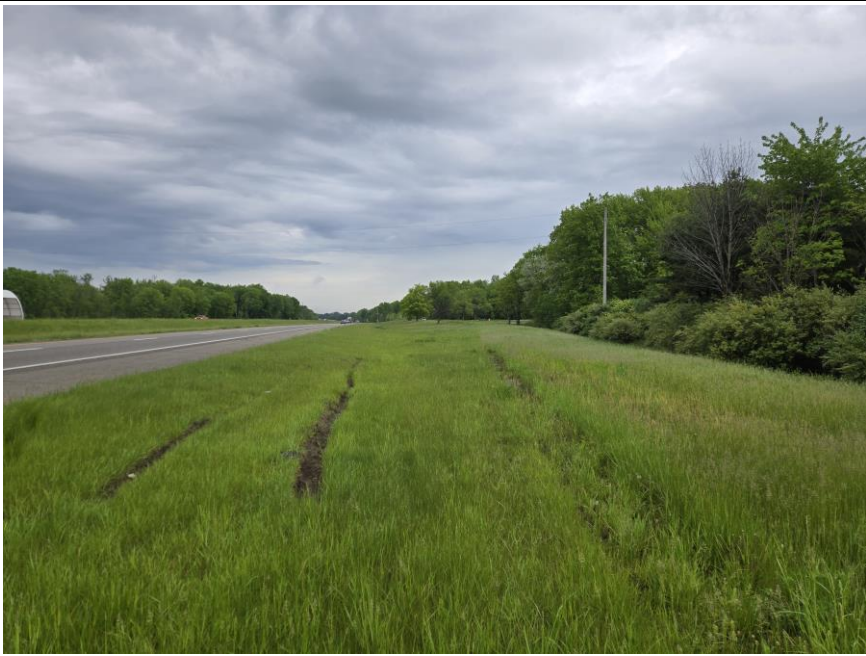
| 5 | Location / Orientation | NB Site, Near South End, Looking North |

| | Remarks | Ditch, entrance ramp, main parking area |

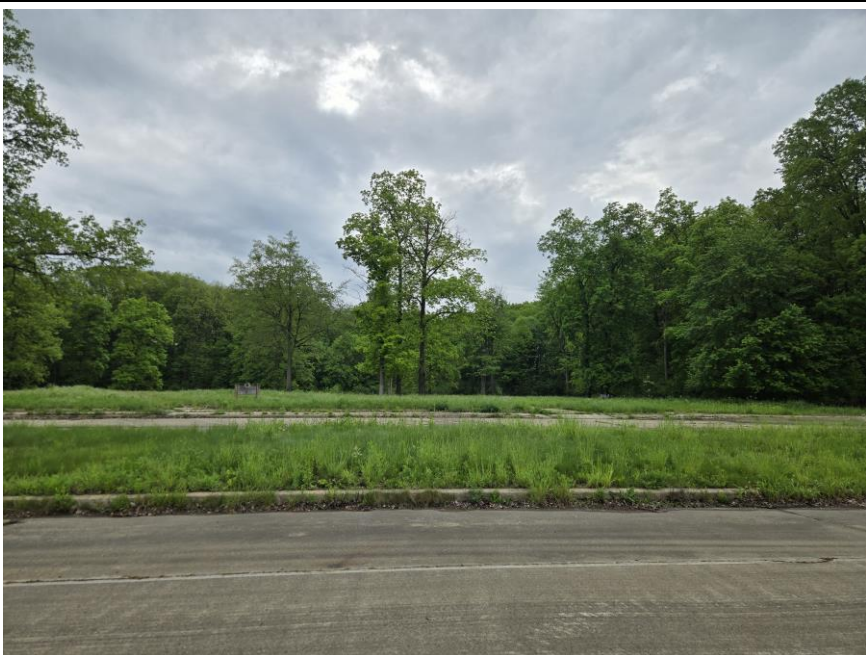
| 6 | Location / Orientation | NB Site, Near Center of Area, Looking East |

| | Remarks | Main site view, existing pavement and sidewalks |

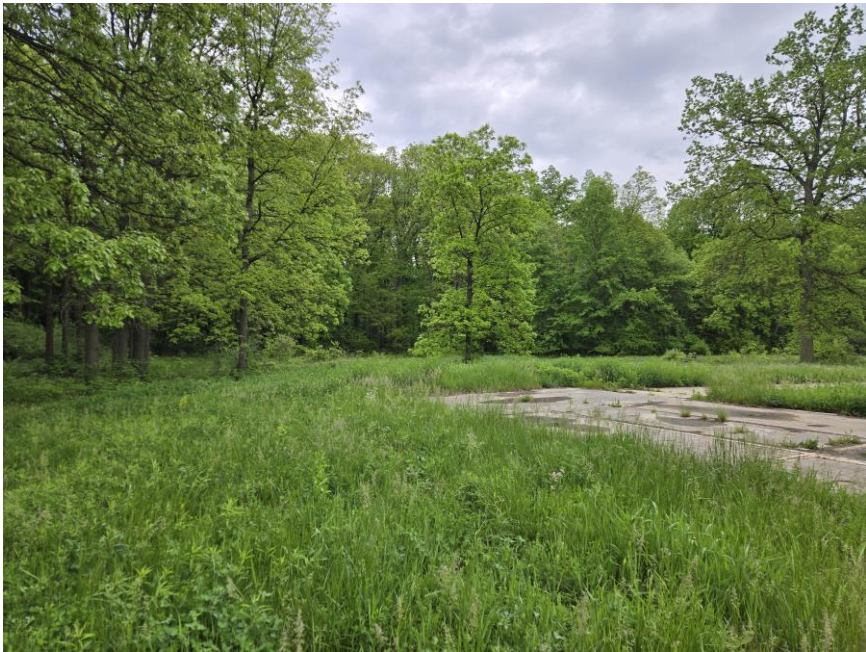
| 7 | Location / Orientation | NB Site, NE Corner of Parking Area, Looking South |

| | Remarks | Eastern portion of site, concrete pads/sidewalks |

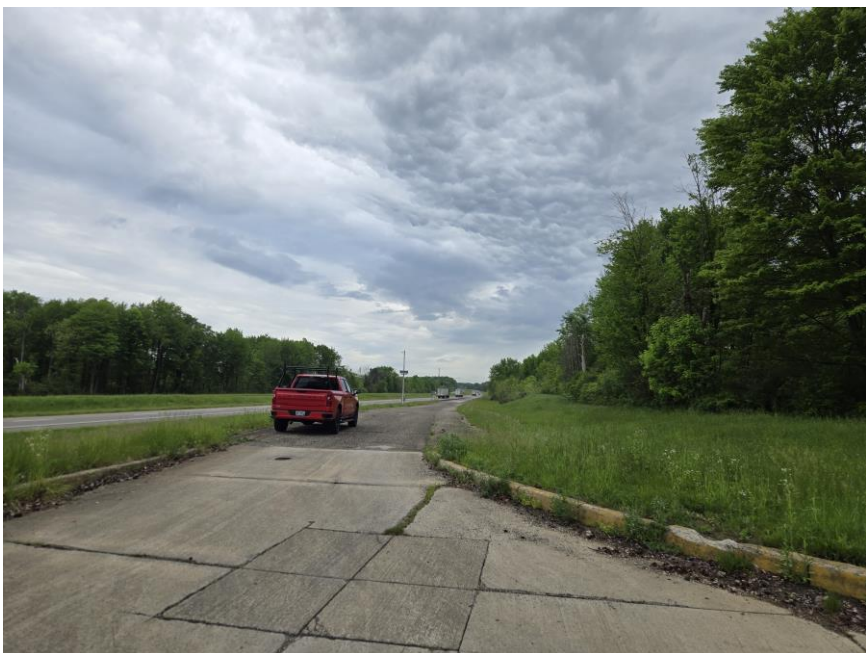
| 8 | Location / Orientation | NB Site, Near North End, Looking North |

| | Remarks | Exit ramp, existing ramp |
