Roche de Boeuf Bridge Physical Condition Report May 2026

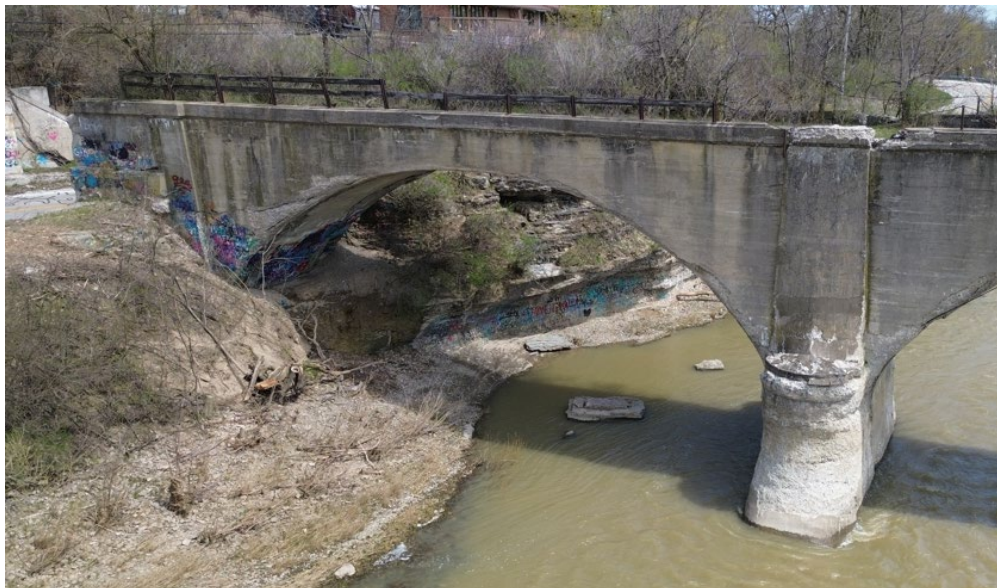
North end span (looking downstream) showing sound spandrel wall

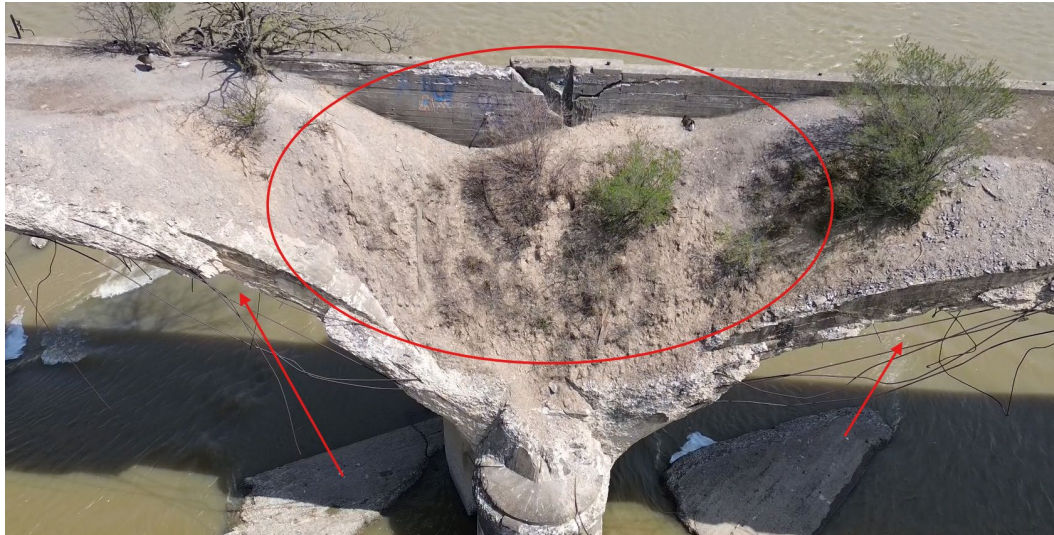
Typical condition of failed arch spandrels over piers. There are outer sections of the arch that have failed with only the rebar hanging. This condition below would justify a General Appraisal rating of a "0" if it occurred at a singular location. This issue is occurring at 50% of the pier locations.
