**GROUND PENETRATING RADAR SURVEY REPORT
HAR-US 68/SR 31 Roundabout, PID 121008
CITY OF KENTON, HARDIN COUNTY, OHIO**

Prepared For:
City of Kenton
111 E. Franklin Street
Kenton, Ohio 43326

Prepared By:
AGS, LLC
P.O. Box 70
252 N. King Street
Xenia, Ohio 45385

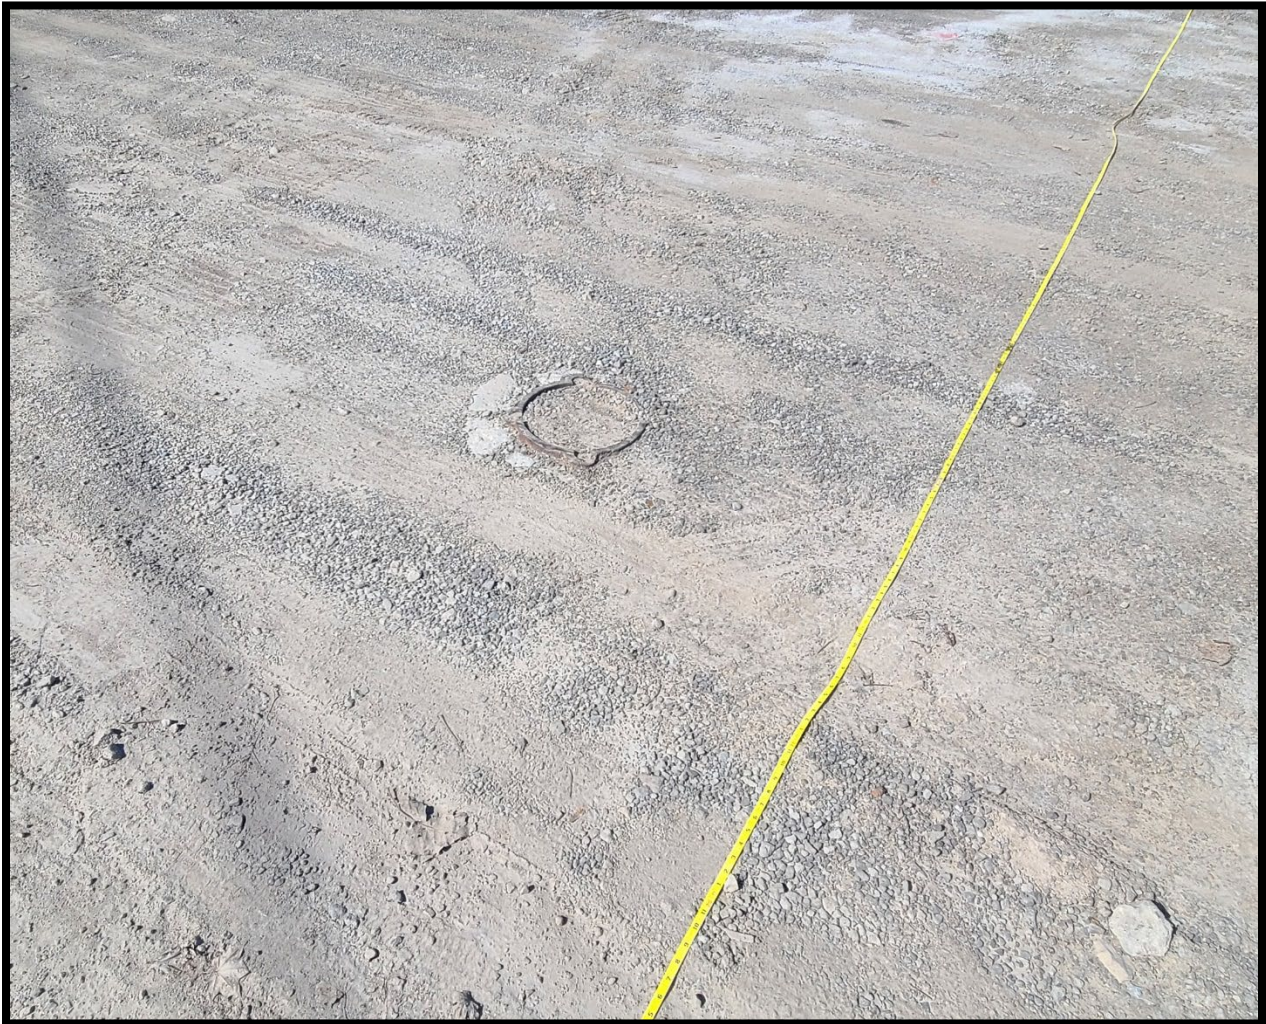
Photograph 1. Buried Hydraulic Lift Outer Casing.

During the GPR survey preparation activities, visual review of the **GPR Study Area** identified the top portion of a buried hydraulic lift outer casing is still present in the area of former service station building (see **Photograph 1**). This casing is currently flush with the ground surface and appears to be completely filled with gravel. Further, the solid steel lift piston appears to have

been removed sometime in the past. Whether or not any hydraulic liquids are still present inside the casing could not be determined based on the gravel fill materials.

An additional target of interest was identified during the preparation activities of the GPR survey. This target is the buried hydraulic lift outer casing present inside the area of the former service station building. This casing was visually identified and will require its removal prior to the construction of the road improvements in/around the **RMR Site Property**. It should be noted these type lift systems are often deeply buried and are known to have previously contained gallons of petroleum based hydraulic liquids. As such, if these liquids are still present inside the casing, the excavation/removal activities of the casing should be conducted in a manner that prevents the spillage of these liquids as the buried outer casing is removed from the ground.

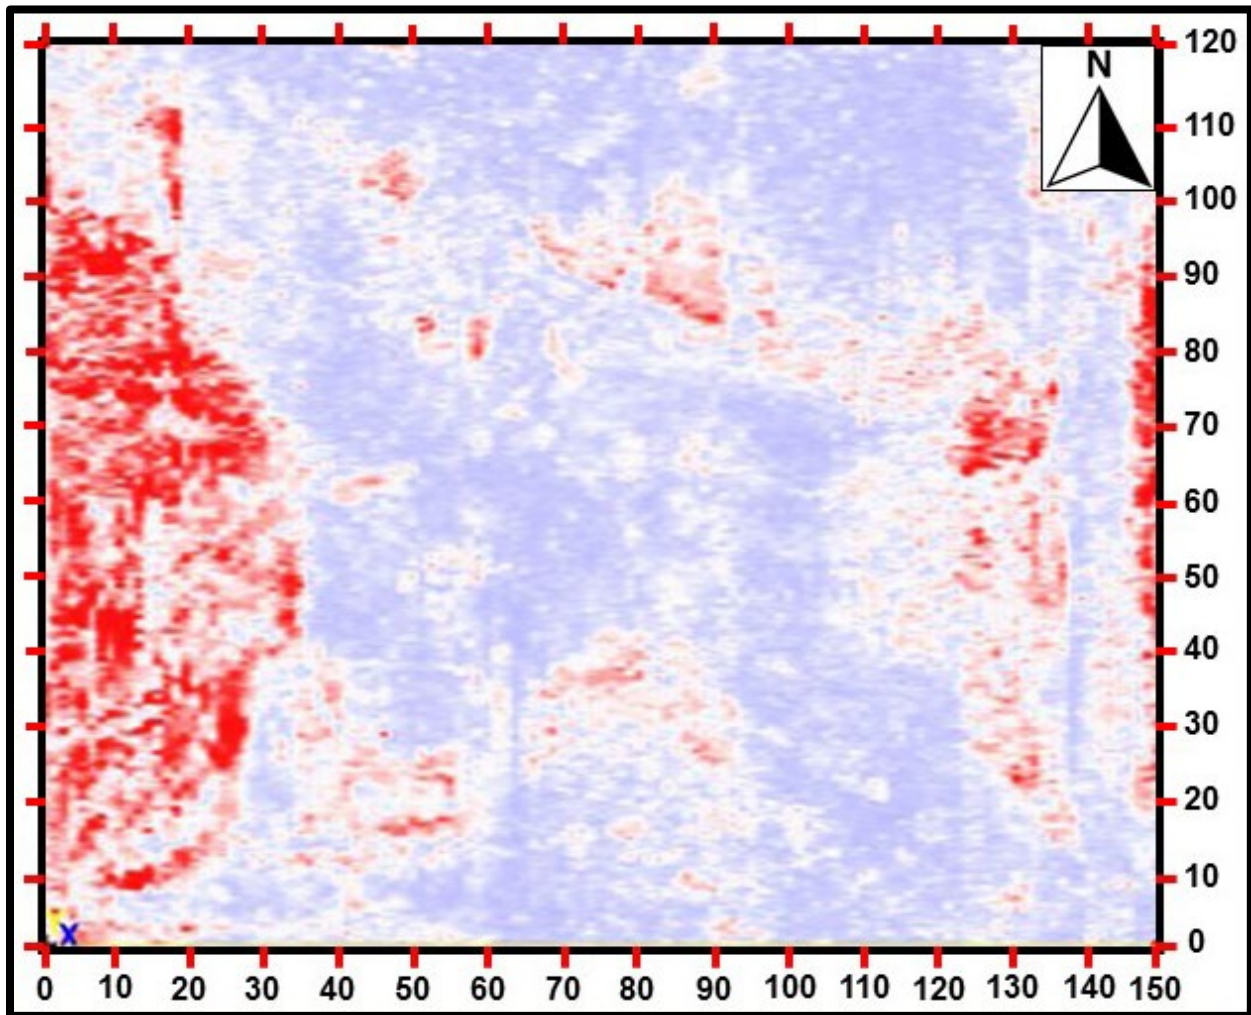
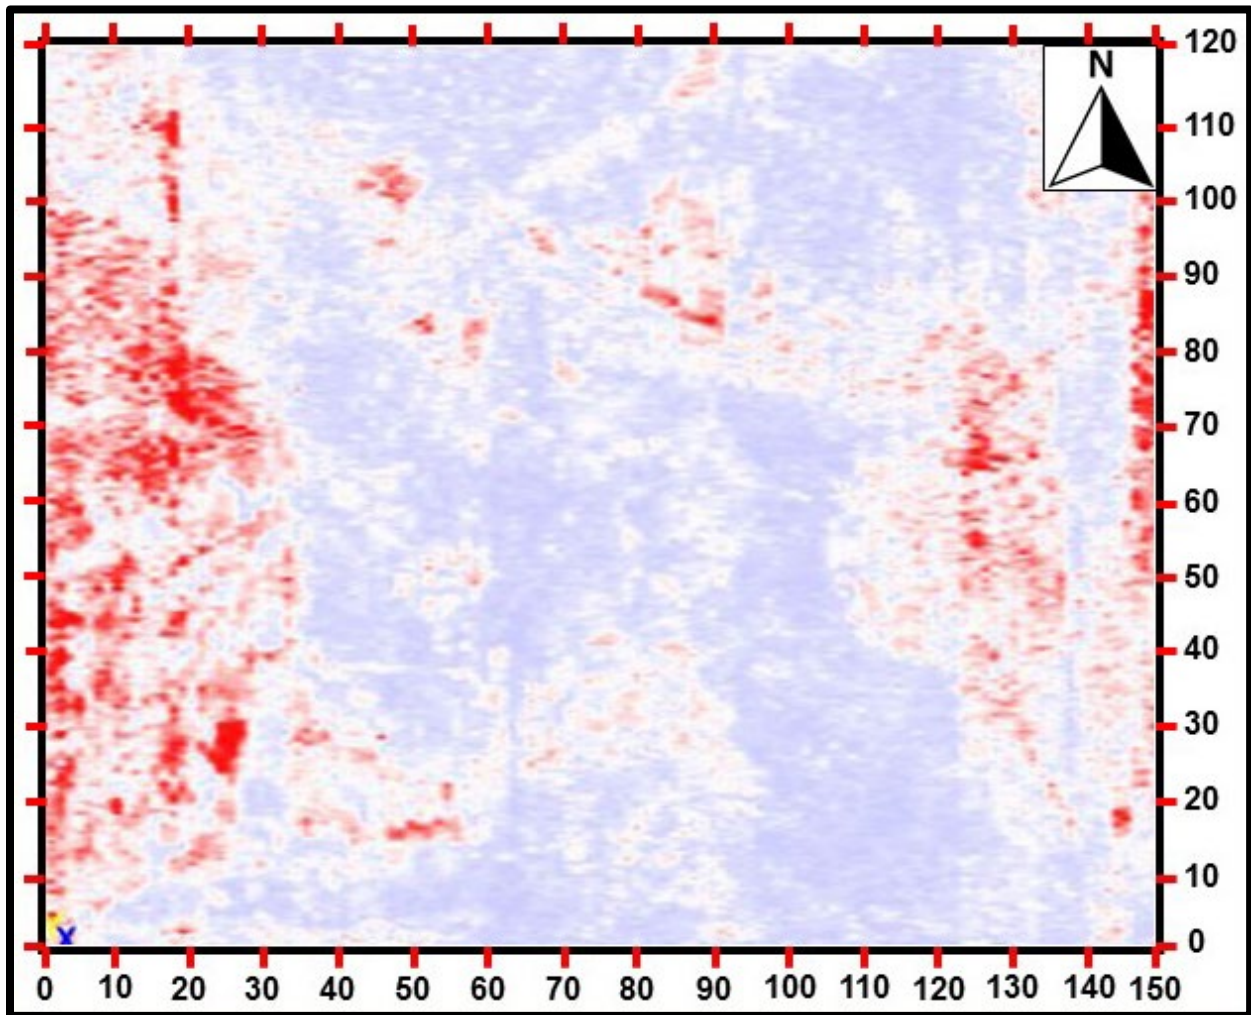
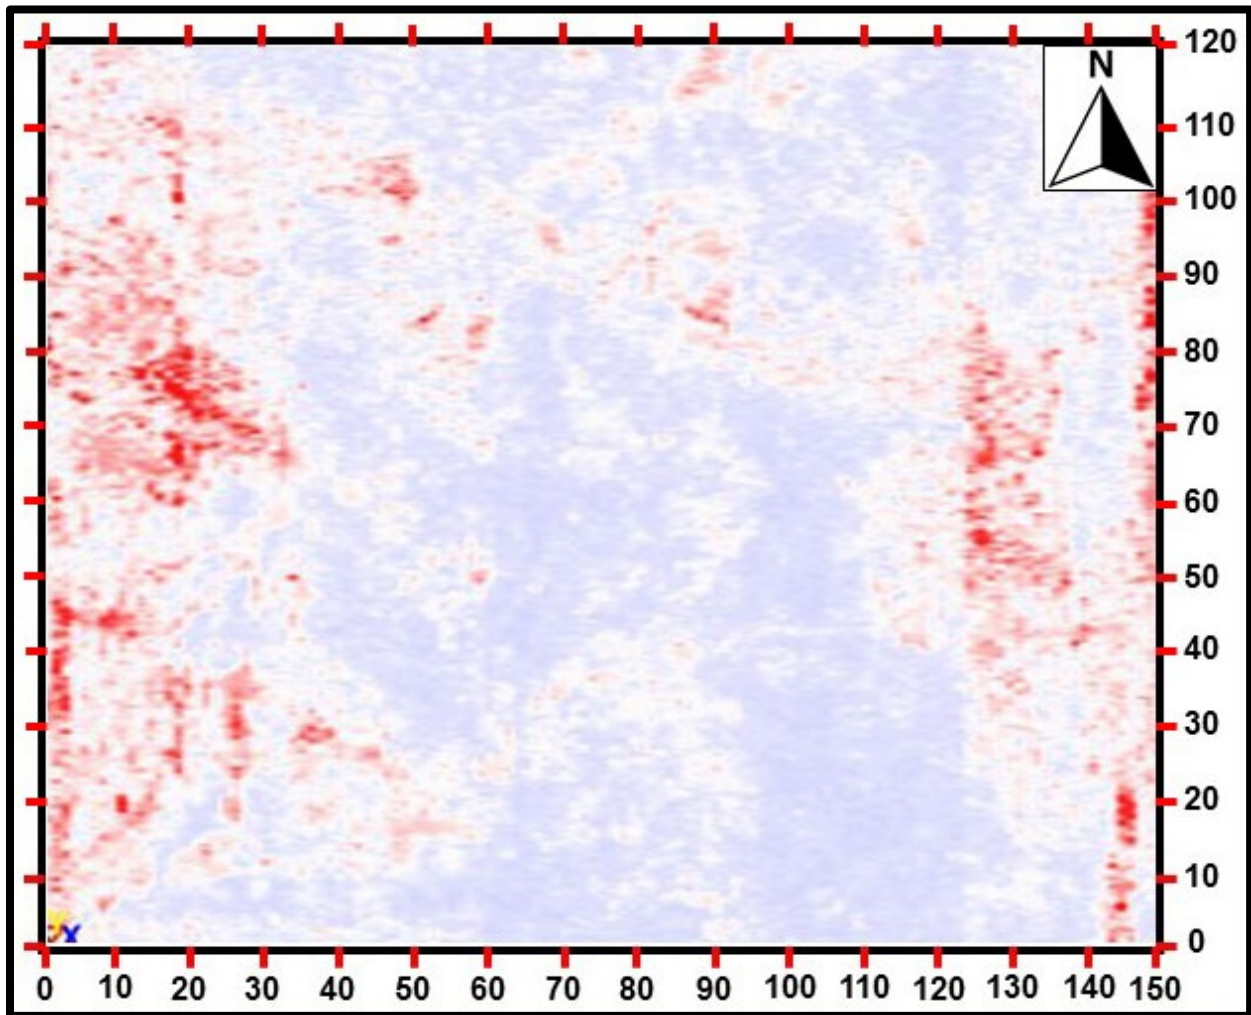
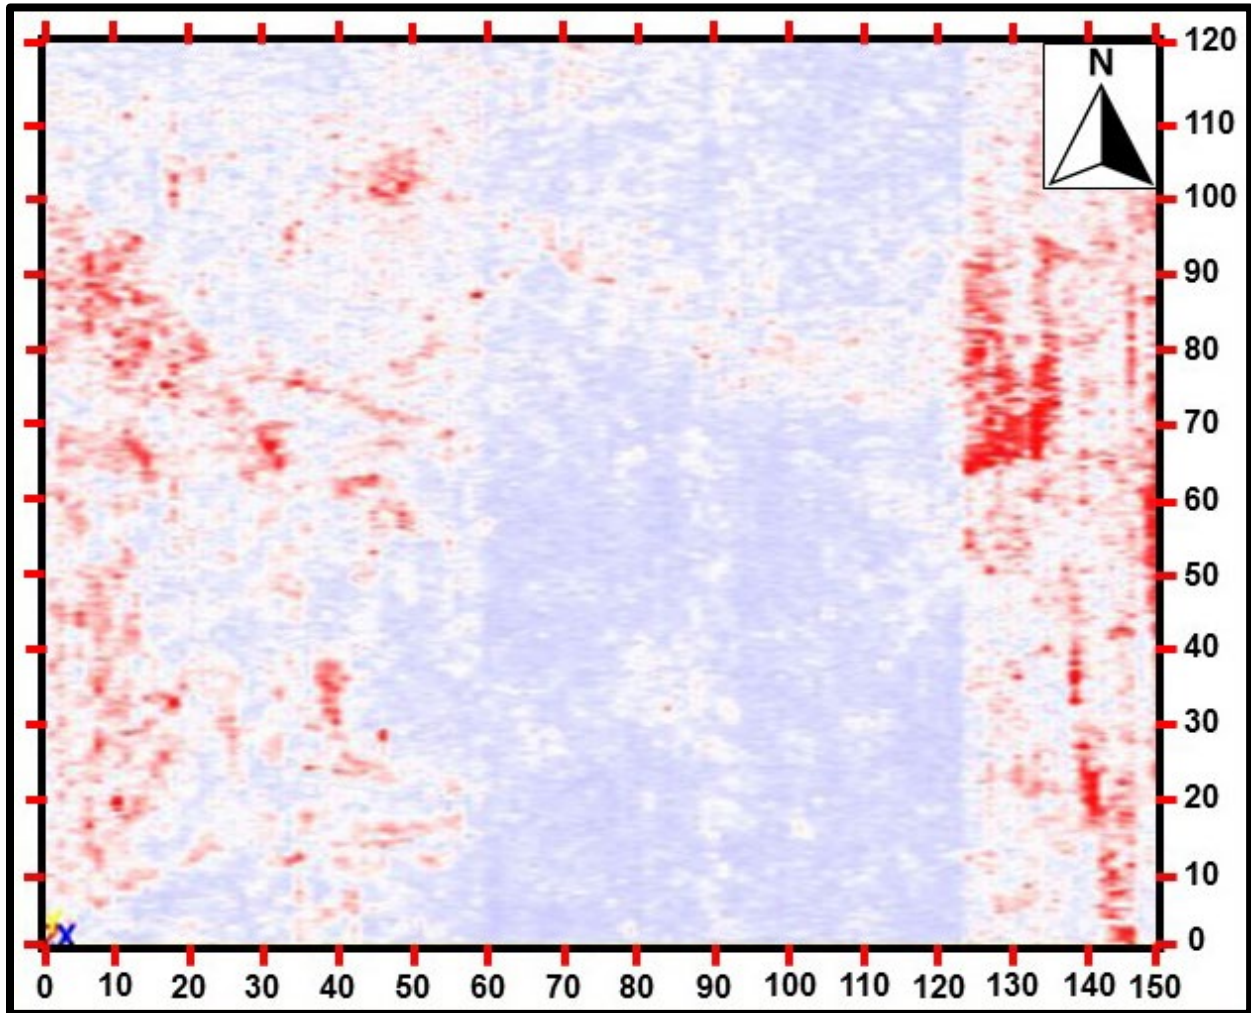
The GPR survey generated over 120 transect lines across the **GPR Study Area**. Post processing of transect line data created the 3-D block model used for the plan view slice maps. Examples of these GPR slice maps are presents in **Figures 4 to 7**.

Figure 4. Plan View Slice Map of the GPR Site Area at 1.6 feet BGS.

Figure 5. Plan View Slice Map of the GPR Site Area at 2.0 feet BGS.

Figure 6. Plan View Slice Map of the GPR Site Area at 2.3 feet BGS.

Figure 7. Plan View Slice Map of the GPR Site Area at 3.6 feet BGS.

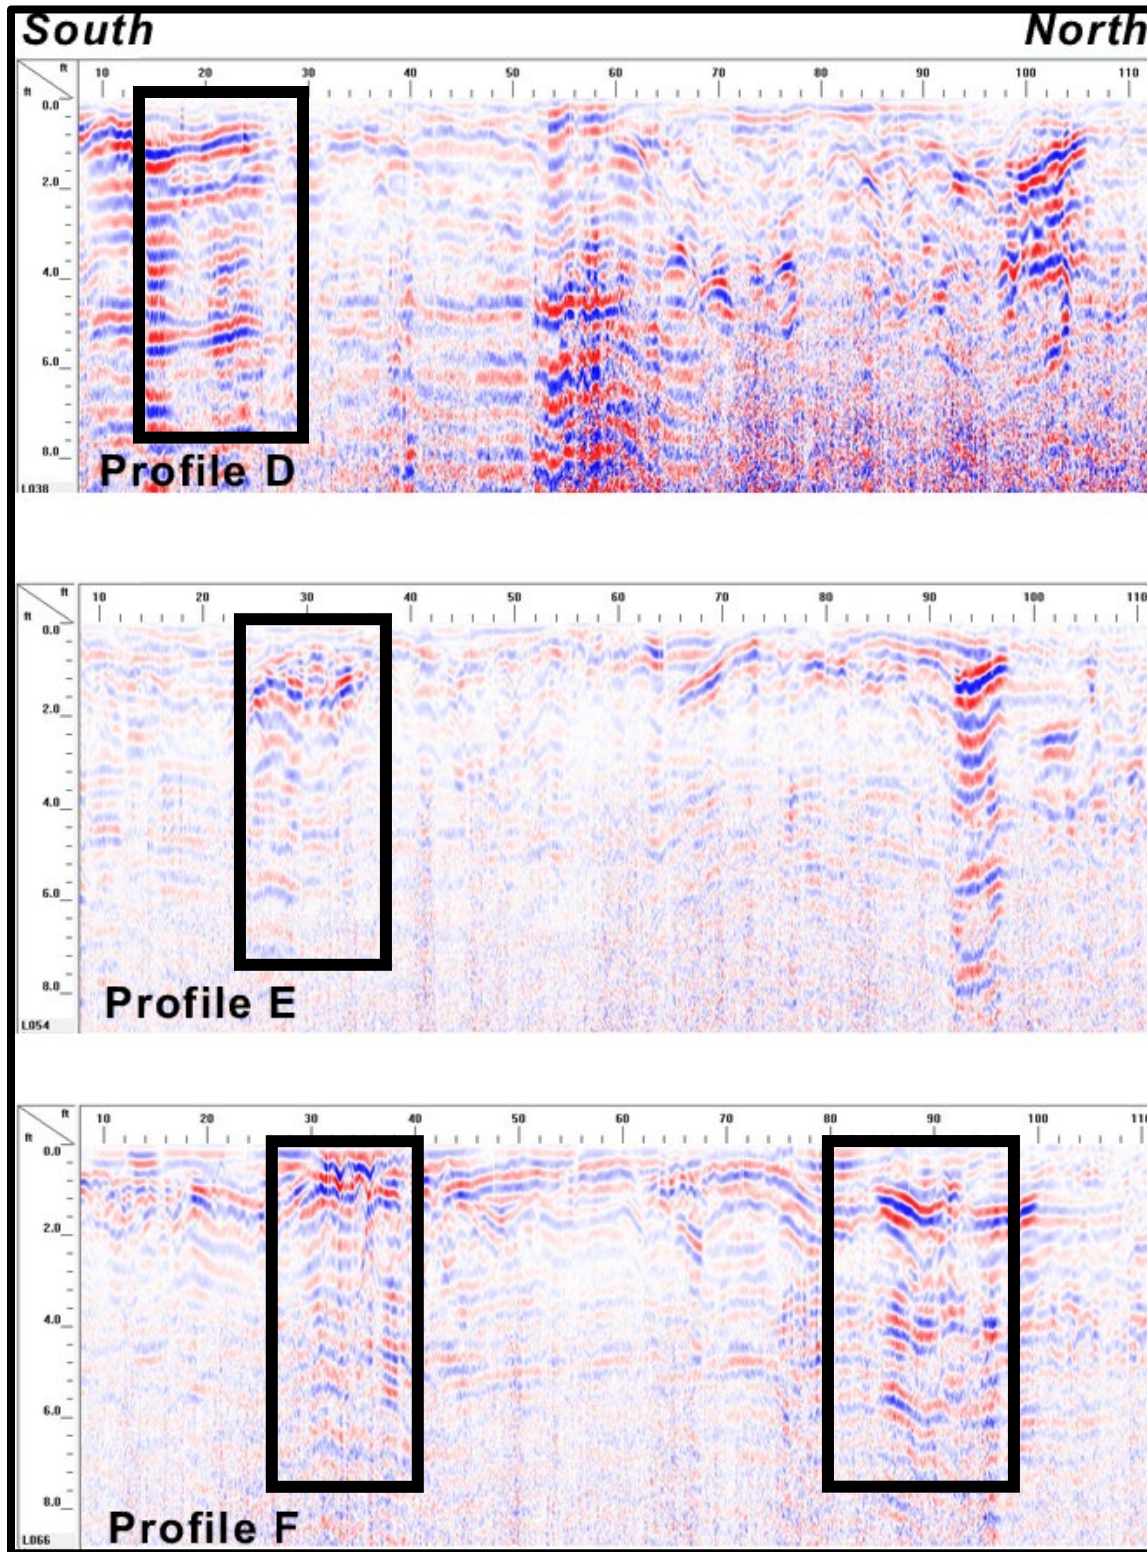
Data patterns presented in the GPR slice maps were then coupled with the Sanborn Maps and the historic Aerial Photographs presented in the **RMR Assessment Report**. Nine GPR transect lines applicable to potential targets of interest were further reviewed and are presented in **Figures 8 to 10**. These GPR transects lines are identified as Profiles A to I and illustrate subsurface anomalies (highlighted by black outlines). The depth scale (units in feet) of the GPR transect lines are present on the left side of the figures. The length (units in feet) of the GPR transects lines are present on the top. The site-specific x-coordinates and y-coordinates of the nine GPR Transects are provided in **Table 2**. The x-coordinate start at 0.0 and it is associated with the southwest corner of the **GPR Study Area**. The y-coordinate start at 0.0 and it is associated with the southeast corner of the **GPR Study Area**.

Figure 8. GPR Transect Profiles A to C Illustrating Subsurface Anomalies in Black.

Figure 9. GPR Transect Profiles D to F Illustrating Subsurface Anomalies in Black.

Figure 10. GPR Transect Profiles G to I Illustrating Subsurface Anomalies in Black.

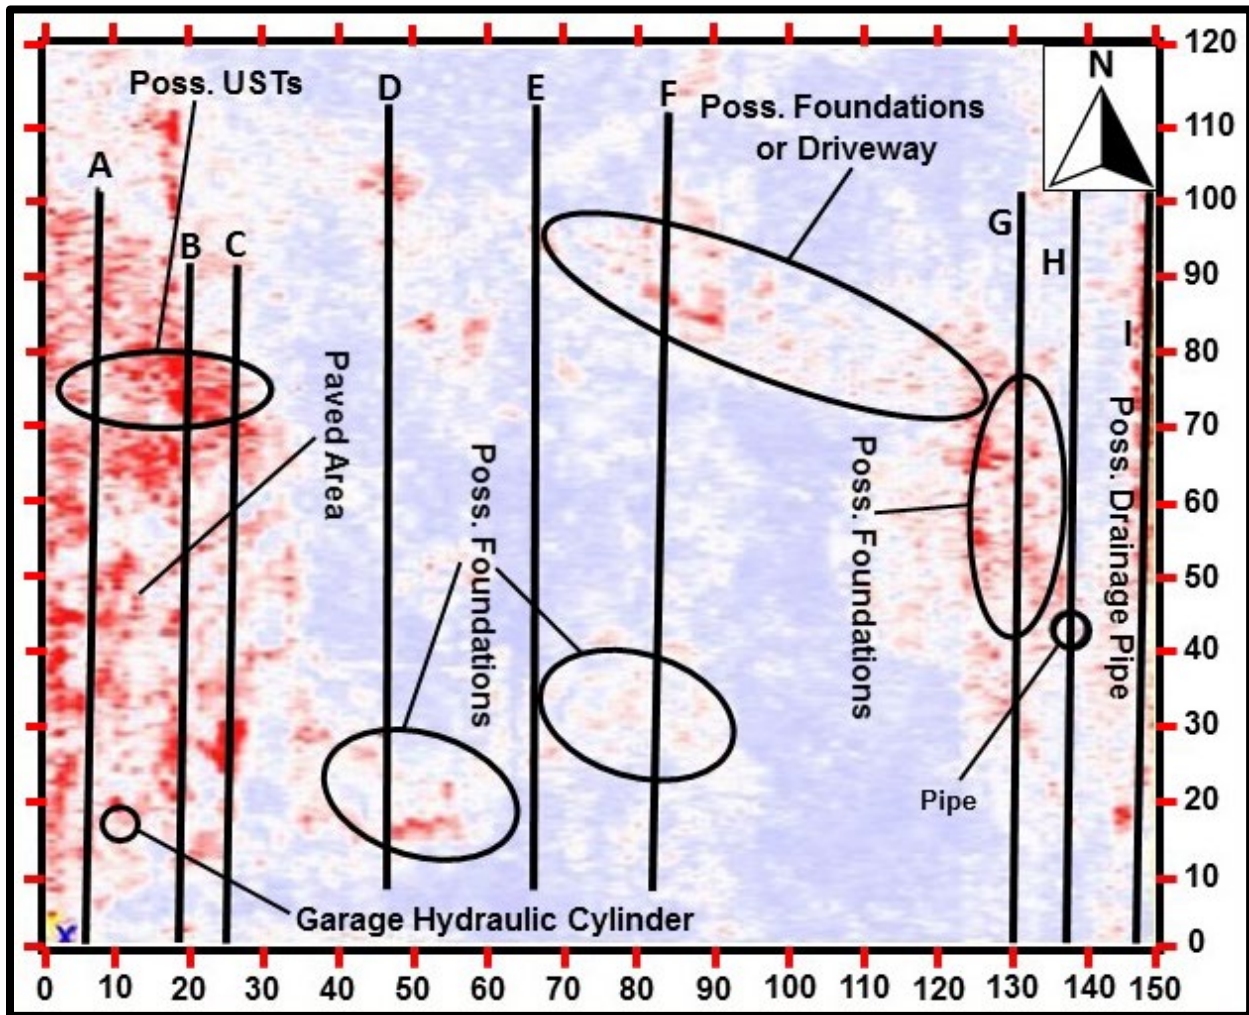
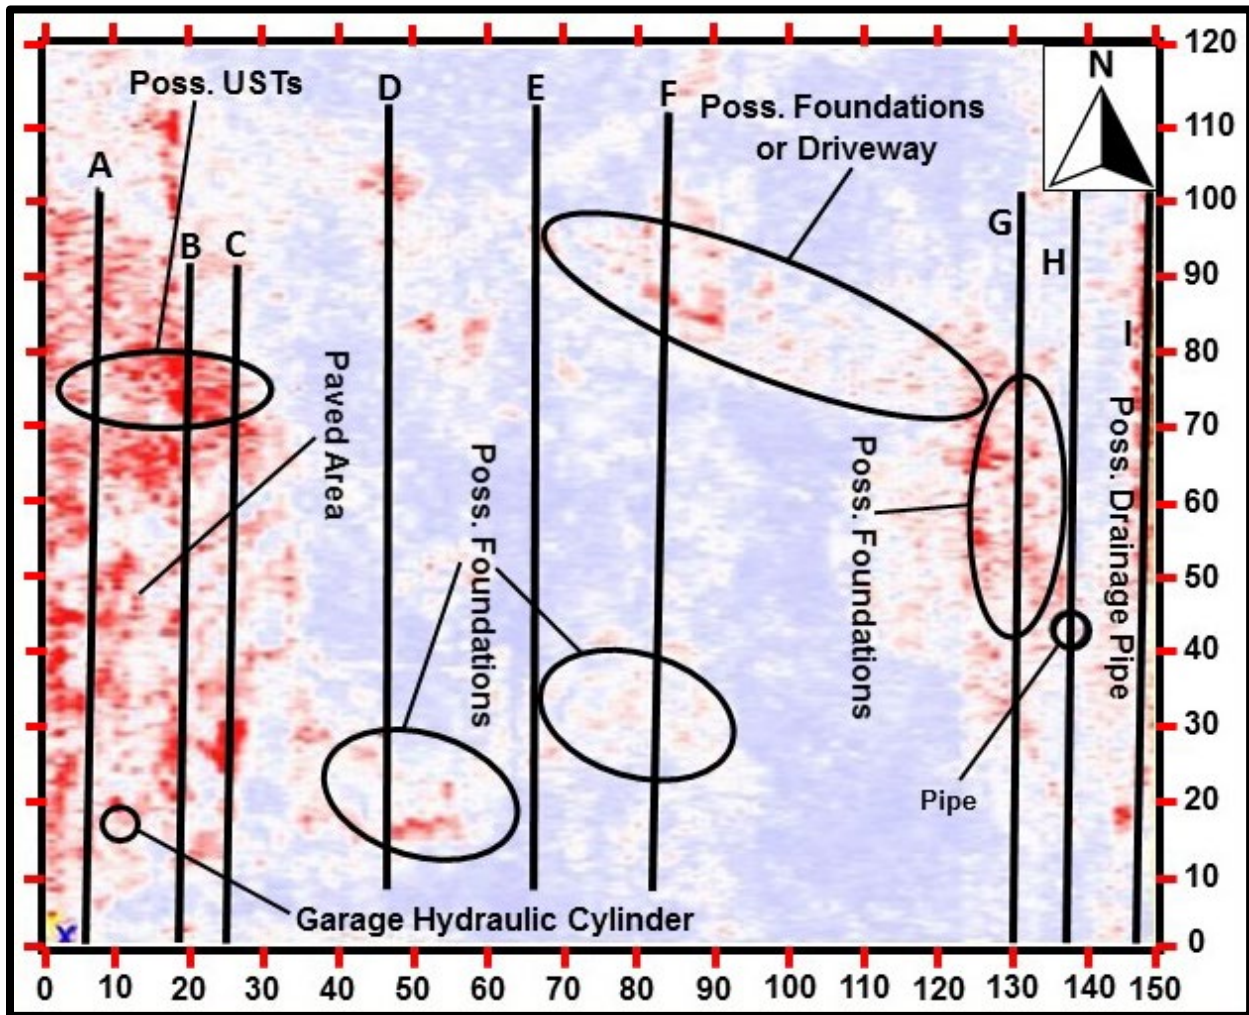
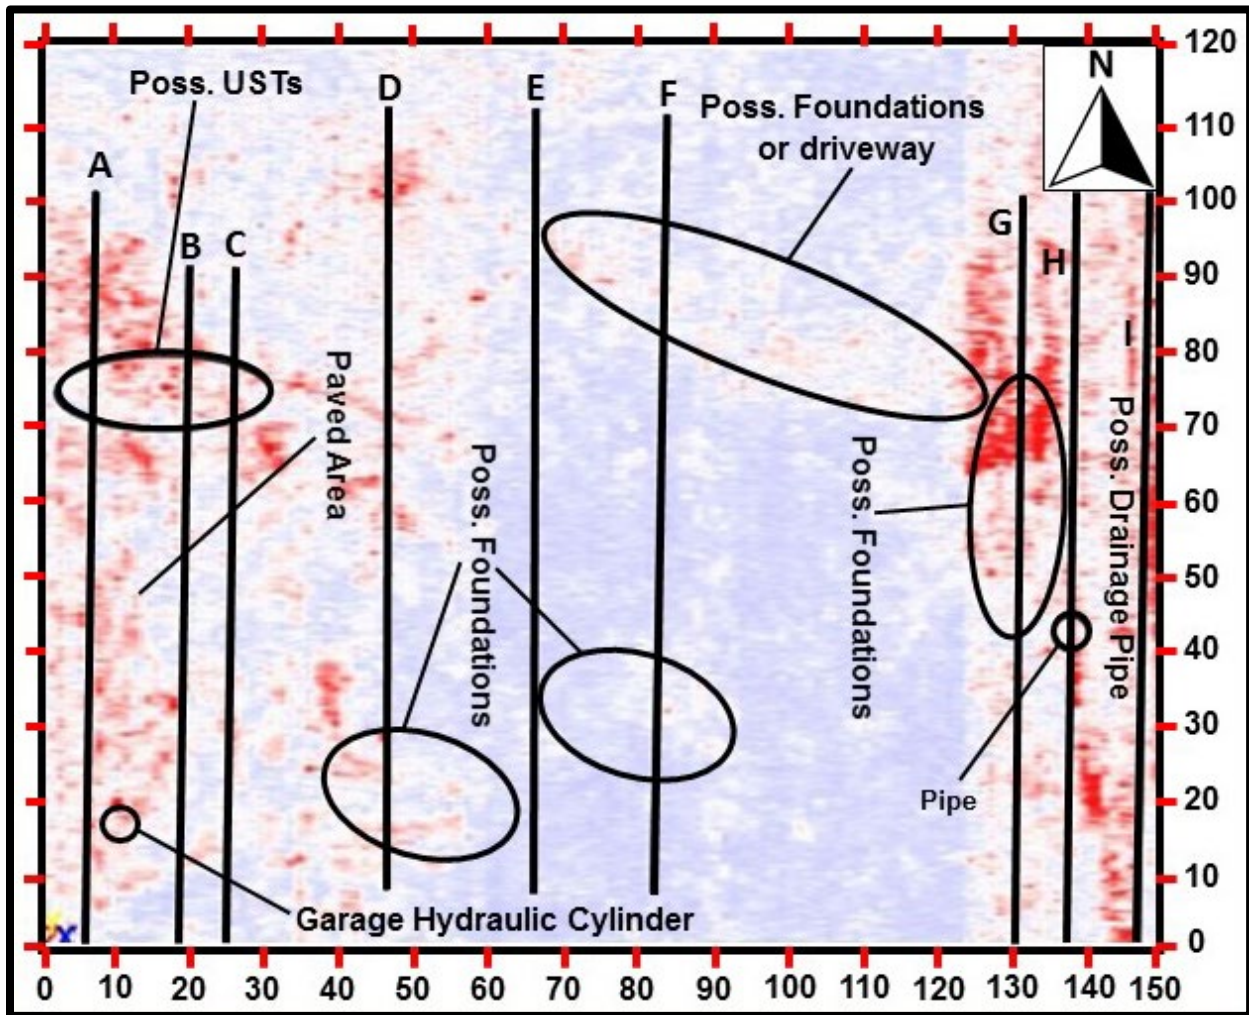
The compilation of the 3-D block model along with the selected nine transect lines are presented in **Figures 11 to 14**. **Figures 11 to 14** also include the interpretation for each of the subsurface anomalies that were identified across multiple GPR transects along with their likely source using the Sanborn Maps and the historic Aerial Photographs (see the **RMR Assessment Report**). This interpretation includes the hyperbolic reflectors associated with USTs; reflectors that represent the boundaries between different materials associated with foundations; reflectors that represent interfaces between different materials or density changes associated with former roadways; and finally flat reflectors, corresponding to the length-wise of a sewer or discharge pipe.

Figure 11. Plan View Slice Map of GPR Site Area at Depth of 1.6 feet BGS, with Transect Lines and Interpretation of Subsurface Anomalies Overlaid.

Figure 12. Plan View Slice Map of GPR Site Area at Depth of 2.0 feet BGS, with Transect Lines and Interpretation of Subsurface Anomalies Overlaid.

Figure 13. Plan View Slice Map of GPR Site Area at Depth of 2.3 feet BGS, with Transect Lines and Interpretation of Subsurface Anomalies Overlaid.

Figure 14. Plan View Slice Map of GPR Site Area at Depth of 3.6 feet BGS, with Transect Lines and Interpretation of Subsurface Anomalies Overlaid.

AGS, LLC performed a GPR survey to locate the presence/absence of USTs and related features as identified in the Sanborn maps at a former service station present in the **GPR Study Area**. In general, UST related targets of interest may still exist along the north and northwestern sides of the service station building. This includes potential USTs north of the service station and related service station infrastructure (i.e. such as a refueling island) present on the western and northwestern sides of the former service station building. Other potential GPR anomalies were identified eastward of the service station area and may reflect potential foundations, roads, utilities and sewer systems associated with the former furniture and lumber milling operations previously located in those portions of the two land parcels.

If USTs exists in the **GPR Study Area**, their existence can only be confirmed through excavation activities that are outside the scope of this GPR survey. Note: if these excavation activities confirm their existence, those UST must be removed/closed per BUSTR requirements. The only remaining issues associated with their closure should also address the fact that the current property owner of the **GPR Study Area** was not the UST Owner/Operator and that different UST closure requirements likely exist for these orphan tanks. As such, the closure requirement of the USTs should be conducted through consultation with BUSTR after their existence has been confirmed.
