**Regulated Materials Investigation for Parcel 622  
(Contract Document)**

**Innerbelt Bridge  
Construction Contract Group 1 (CCG1)**

***FINDINGS OF A REGULATED  
MATERIALS INVESTIGATION***

***The White Properties Building  
1996 West 3<sup>rd</sup> Street, Cleveland, Cuyahoga County, Ohio  
[CUY-Innerbelt CCG1 Design/PID 77332]***

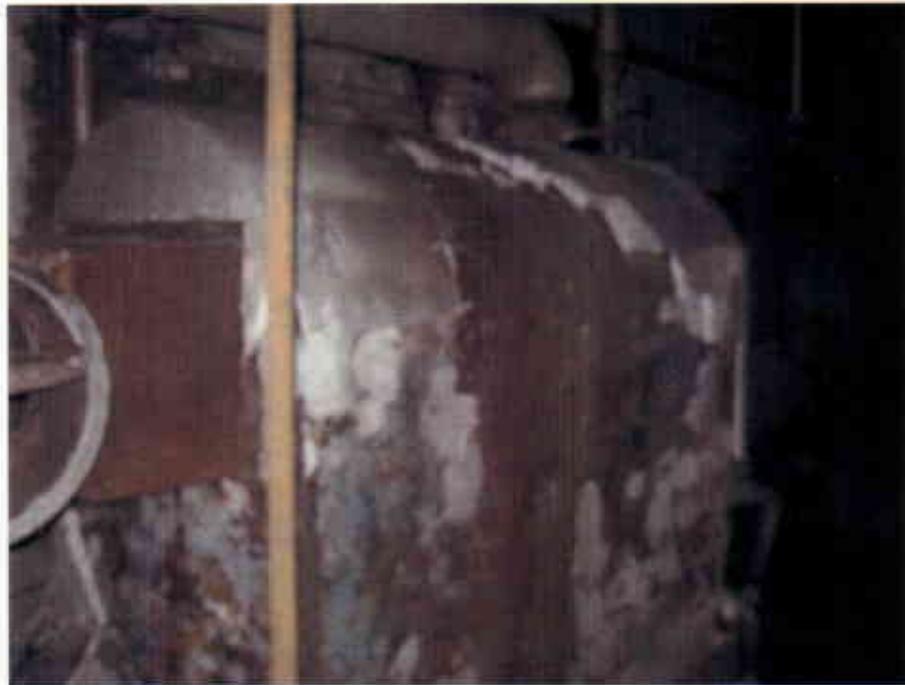
Photograph 14  
View of the First Floor Warehouse Area Boiler Room Located in the Central Portion of  
The White Properties Building, 1996 West 3<sup>rd</sup> Street, Cleveland, Ohio (CCG1 Design PID 77332)

1. Approximately 110 square feet of boiler insulation in poor condition was identified as containing 40 percent asbestos. It should be noted that the boiler room floor was contaminated with the asbestos-containing boiler insulation.
2. Approximately 2 square feet of boiler gasket rope insulation was identified as containing 80 percent asbestos.
3. Approximately 510 square feet (35 Windows) of window glazing in poor condition located on metal windows was identified as containing from a trace to 0.5 percent asbestos.
4. Approximately 180 square feet of floor tile (9-inch by 9-inch, Brown) in poor condition was identified as containing 10 percent asbestos.
5. Approximately 2 square feet of drinking fountain tar coating was assumed to contain asbestos.

2. Contract with an asbestos abatement contractor licensed in the State of Ohio to abate the asbestos-containing pipe and fitting insulation, boiler insulation and associated debris located on the floor, boiler gasket rope, window glazing identified in poor condition associated with the Two-Story Office Area, and floor tile identified in poor condition in the Warehouse of the subject building. If the assumed nonfriable asbestos-containing materials identified in good condition, become friable as a result of the demolition activities, then these materials are required to be abated prior to the demolition activities being performed.

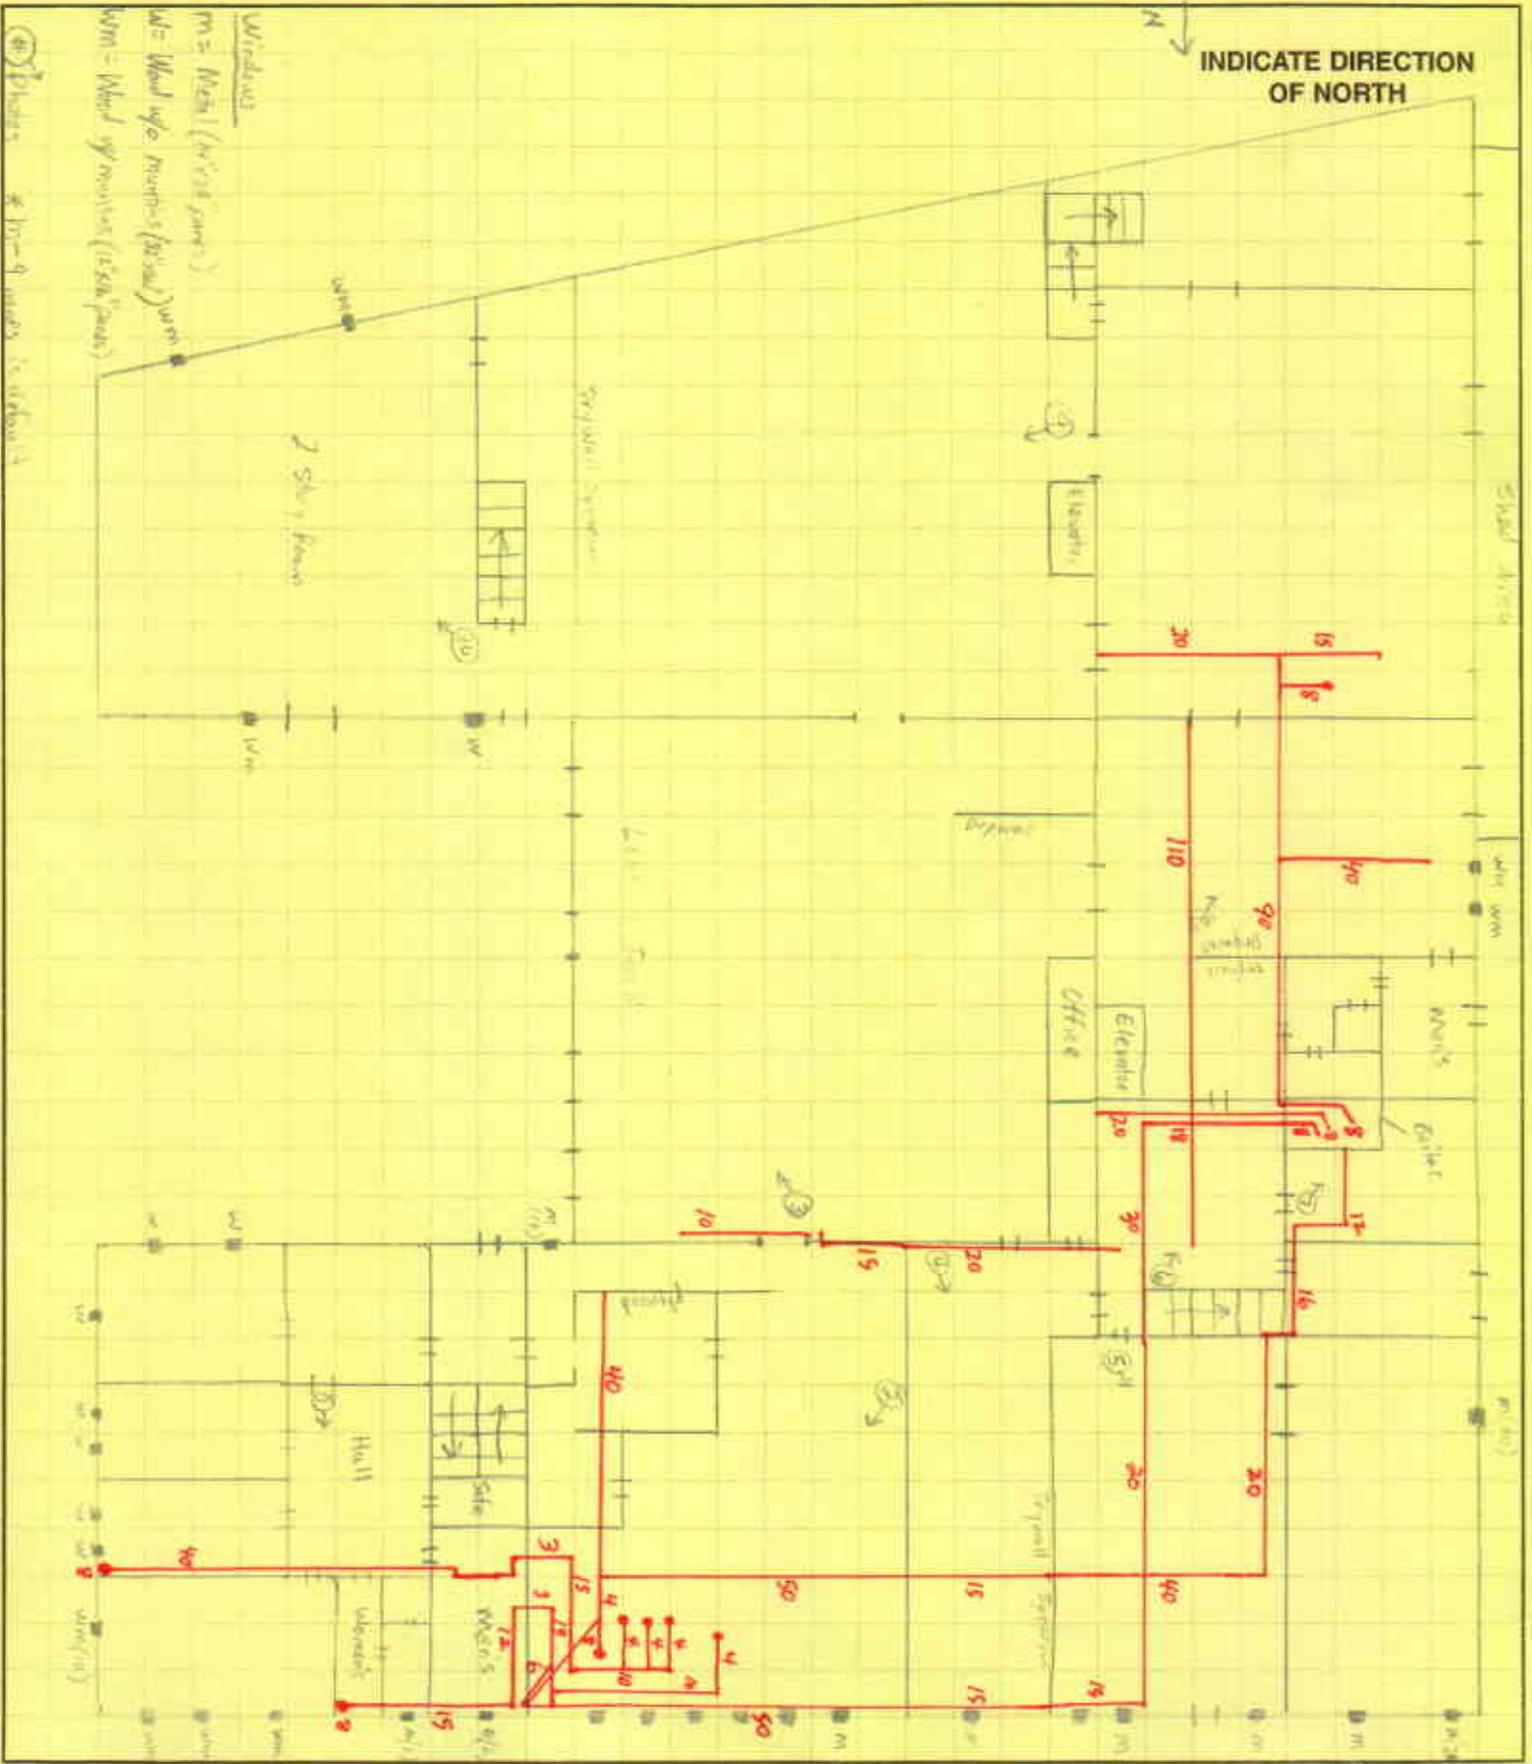
1st  
Floor

PROJECT 1776 W 3rd St (W. of Progress)  
PROJECT NO. H10002-03  
PAGE NO. \_\_\_\_\_ OF \_\_\_\_\_  
FIELD REPRESENTATIVE \_\_\_\_\_ DATE \_\_\_\_\_  
SCALE \_\_\_\_\_
