**Regulated Materials Investigation for
PPN 122-18-019
(Contract Document)**

**Innerbelt Bridge
Construction Contract Group 1 (CCG1)**

***FINDINGS OF A REGULATED
MATERIALS INVESTIGATION***

***The White Properties Building
1996 West 3rd Street, Cleveland, Cuyahoga County, Ohio
[CUY-Innerbelt CCG1 Design/PID 77332]***

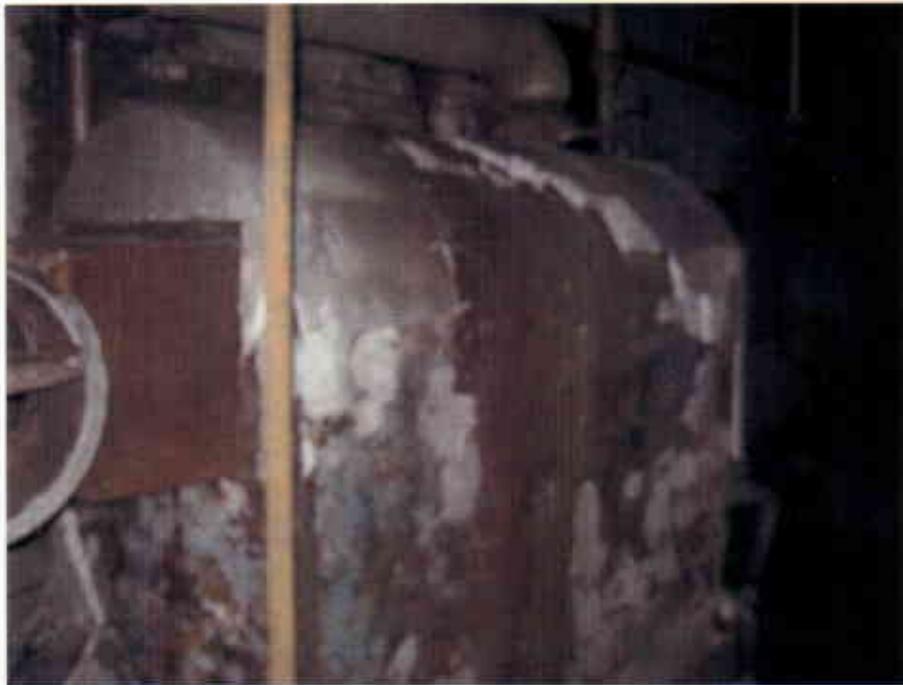
1. Approximately 110 square feet of boiler insulation in poor condition was identified as containing 40 percent asbestos. It should be noted that the boiler room floor was contaminated with the asbestos-containing boiler insulation.
2. Approximately 2 square feet of boiler gasket rope insulation was identified as containing 80 percent asbestos.
3. Approximately 510 square feet (35 Windows) of window glazing in poor condition located on metal windows was identified as containing from a trace to 0.5 percent asbestos.
4. Approximately 180 square feet of floor tile (9-inch by 9-inch, Brown) in poor condition was identified as containing 10 percent asbestos.
5. Approximately 2 square feet of drinking fountain tar coating was assumed to contain asbestos.

Photograph 14
View of the First Floor Warehouse Area Boiler Room Located in the Central Portion of
The White Properties Building, 1996 West 3rd Street, Cleveland, Ohio (CCG1 Design PID 77332)

2. Contract with an asbestos abatement contractor licensed in the State of Ohio to abate the asbestos-containing pipe and fitting insulation, boiler insulation and associated debris located on the floor, boiler gasket rope, window glazing identified in poor condition associated with the Two-Story Office Area, and floor tile identified in poor condition in the Warehouse of the subject building. If the assumed nonfriable asbestos-containing materials identified in good condition, become friable as a result of the demolition activities, then these materials are required to be abated prior to the demolition activities being performed.
