SFN: 4800303

City-Rte SLM: LUC-002-1862

### **Bridge Identification:**

**Fracture Critical Inspection Plan:**

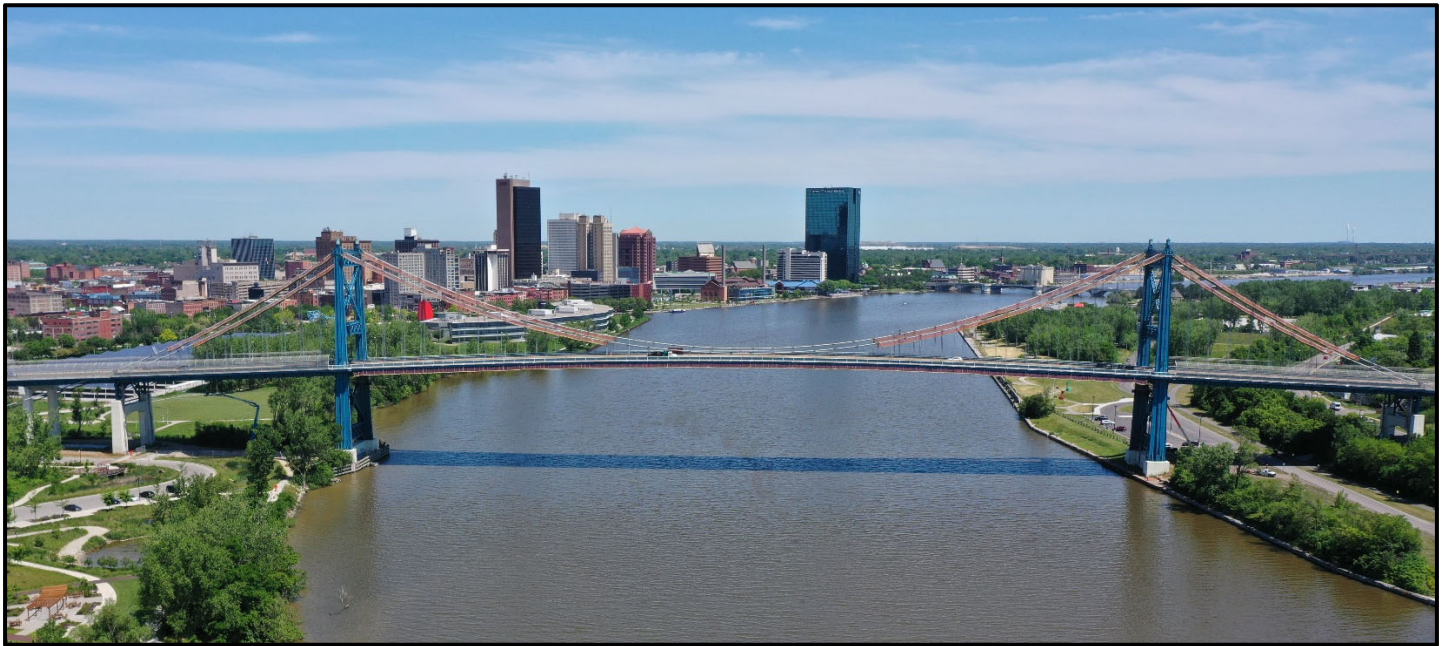
*Photo 1 - Elevation View, Looking North*

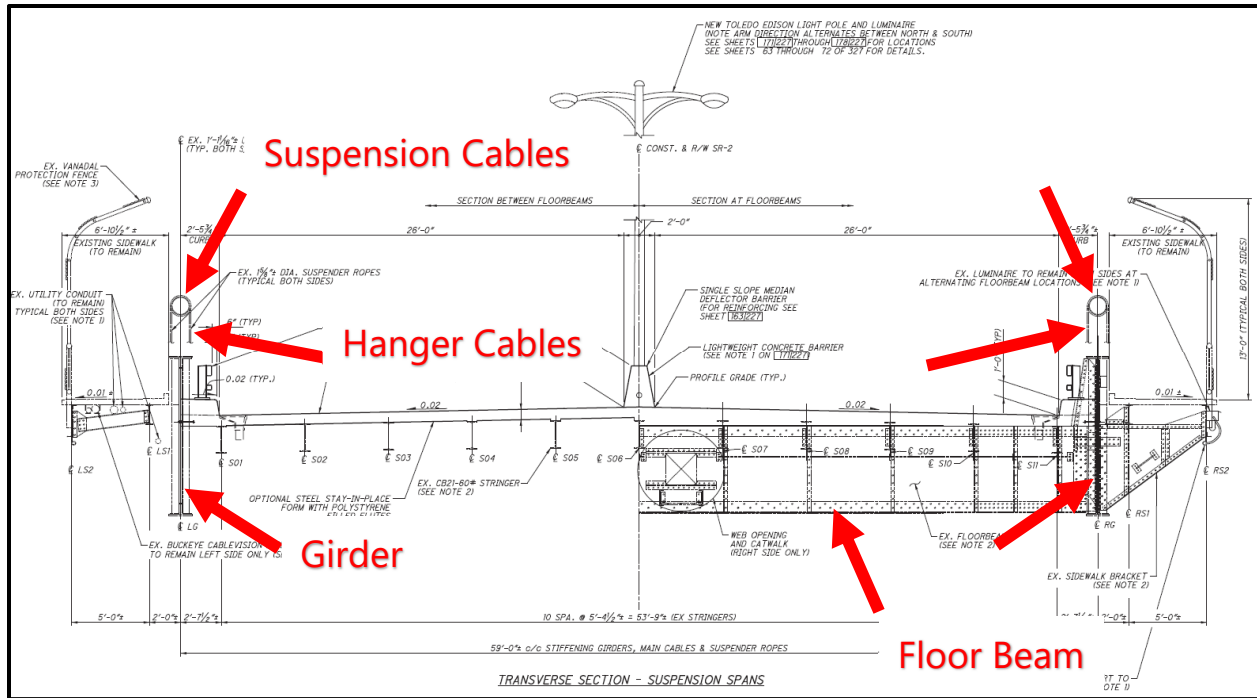
The structure consists of three unique superstructure types: three continuous suspension spans, fourteen two-girder approach spans, and thirteen multi-beam/girder approach spans. The suspension span and two-girder superstructure types both contain Fracture Critical Members, identified with red arrows in the Figures below.

Figure 2 - Suspension Span Typical Section

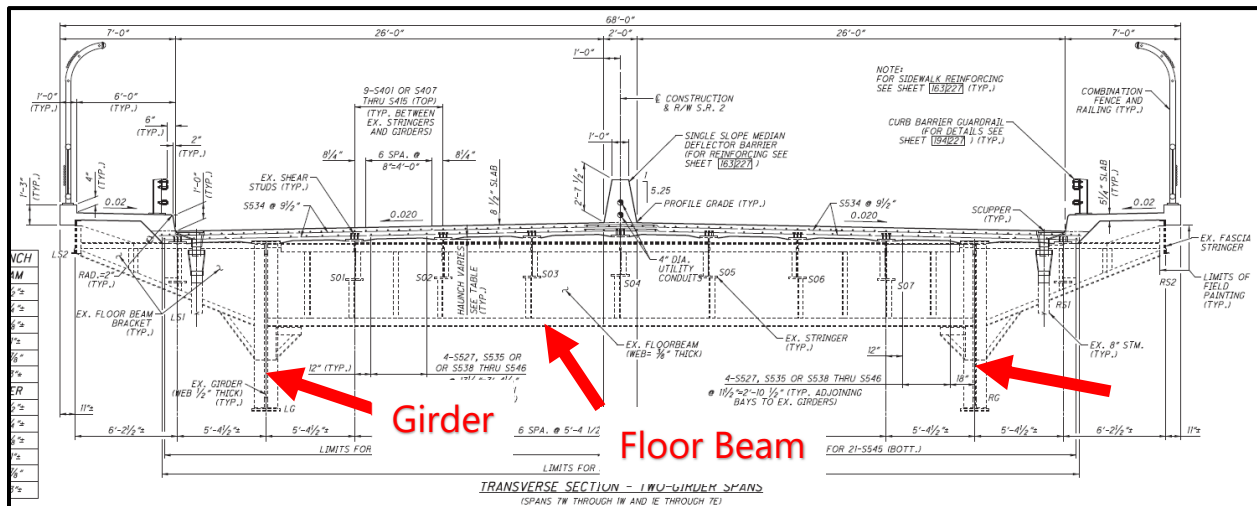
Figure 3 - Two-Girder Span Typical Section

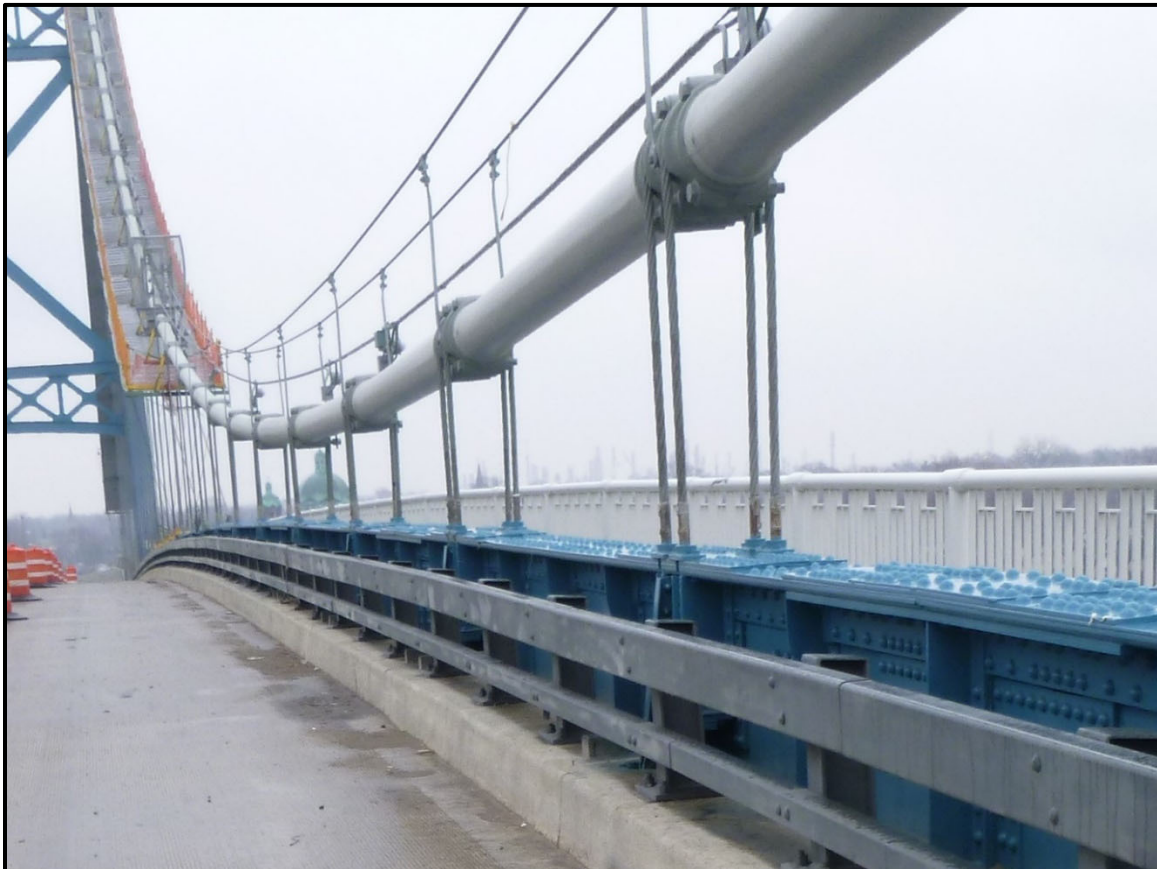
**Main Suspension Cables:** The main cables of the Anthony Wayne Bridge are made up of 19 strands of 186 galvanized steel wires each. The tension cables run from the anchorage houses at each end through the backstays, side spans, and the main suspension span.

Photo 2 - Main Suspension Cables near Midspan

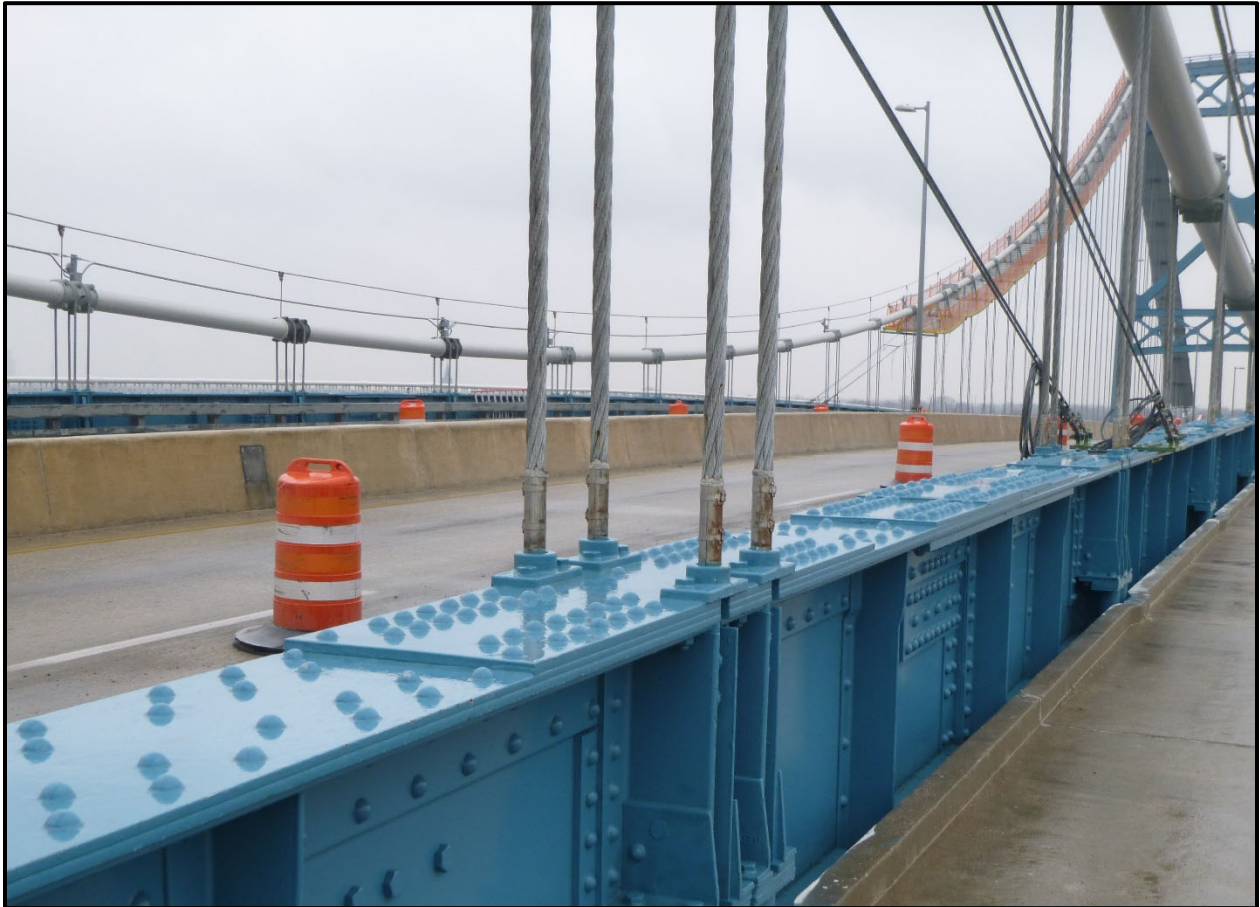
**Secondary Hanger Cables:** The suspenders consist of two wire ropes, or suspender cables, looped over the main cables, providing four components to carry each panel load. Special attention should be given to the hanger-girder connection to ensure load transfer.

*Photo 3 - Hanger Cable - Suspension Girder Connection*

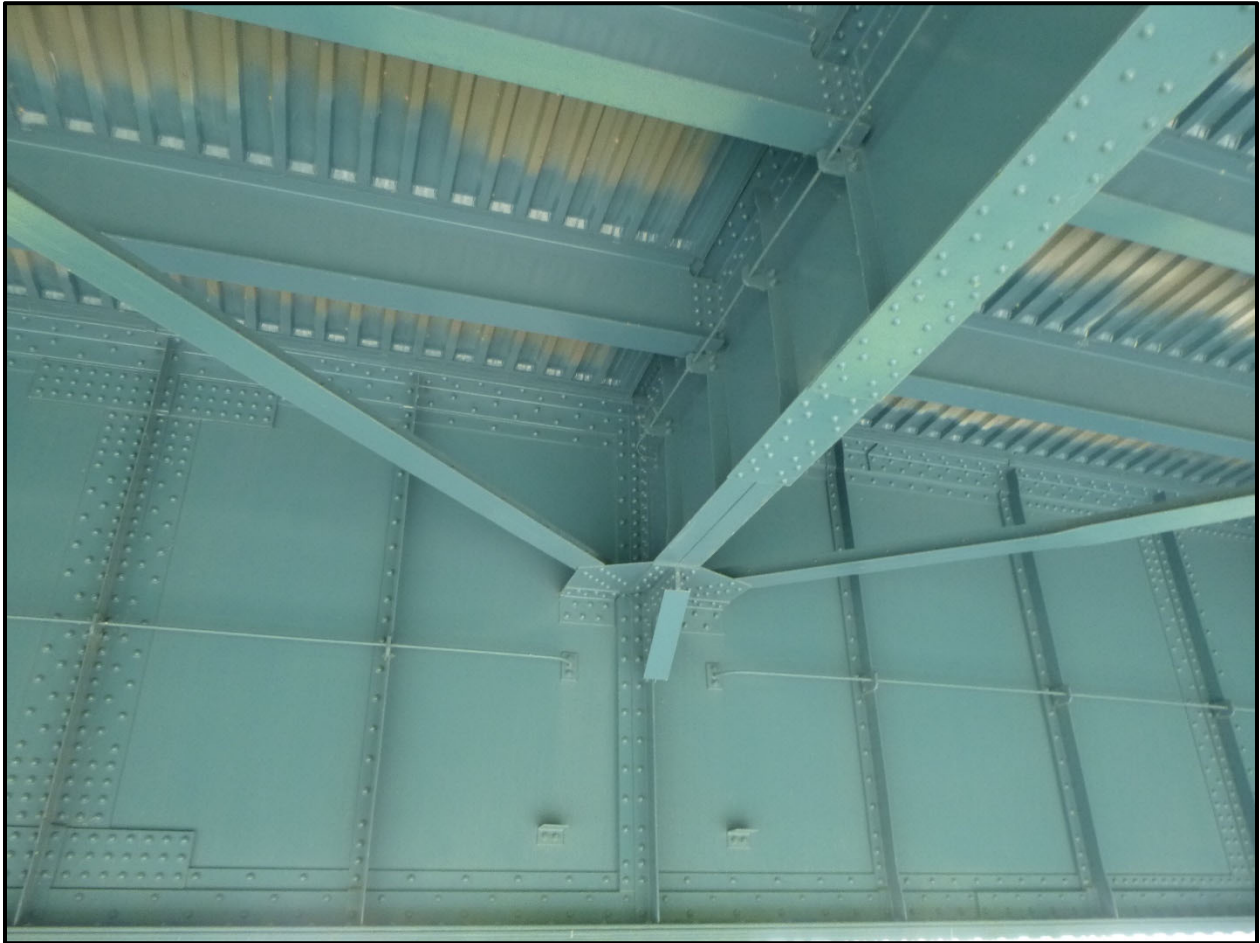
**2-Girder System Girders – Approach Spans:** Located in Spans 7W through 1W and Spans 1E through 7E, the single-span riveted, built-up girders support a floor beam/stringer floor system. Special attention should be given to the bottom flange tension zones near midspan.

*Photo 5 - Approach Span Girder*

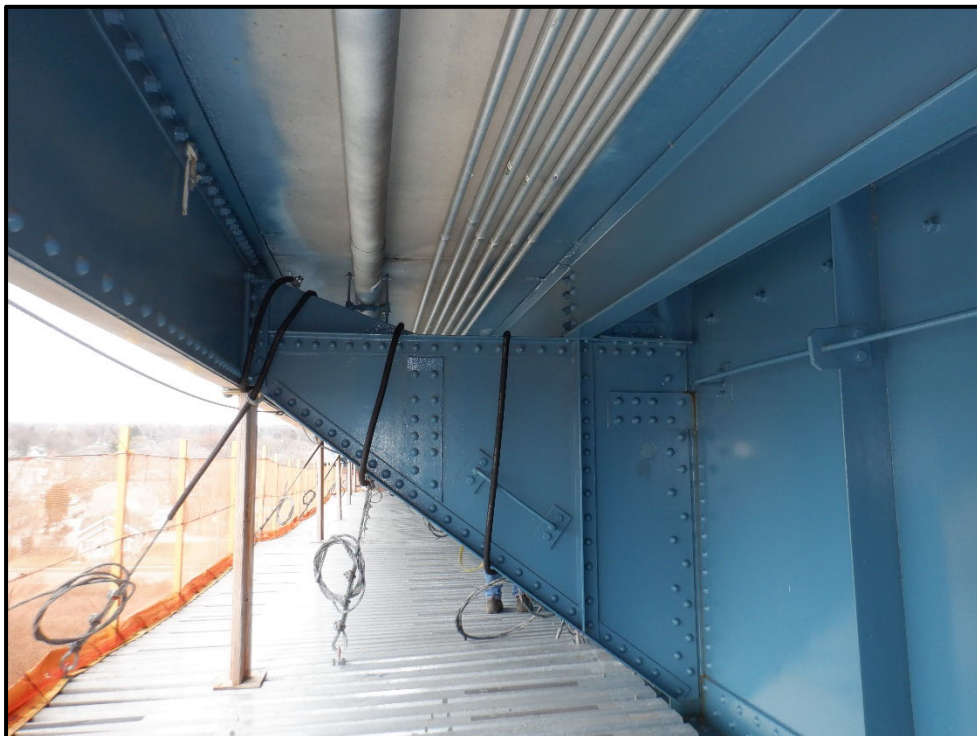
**Floor Beams:** The riveted, built-up girders frame into the girder webs and cantilever beyond the girders to support the sidewalks. Tension zones include the bottom flange between girders and the top flange cantilever supporting the sidewalks.

*Photo 7 - Floor Beam Cantilever Supporting the Sidewalk*
