O.D.O.T. DISTRICT 2 SURVEY OFFICE (USE ONLY)

REFERENCE NO. 11 A

ROUTE SR 109

TYPE MONUMENT RR SPK IN WOOD HUB

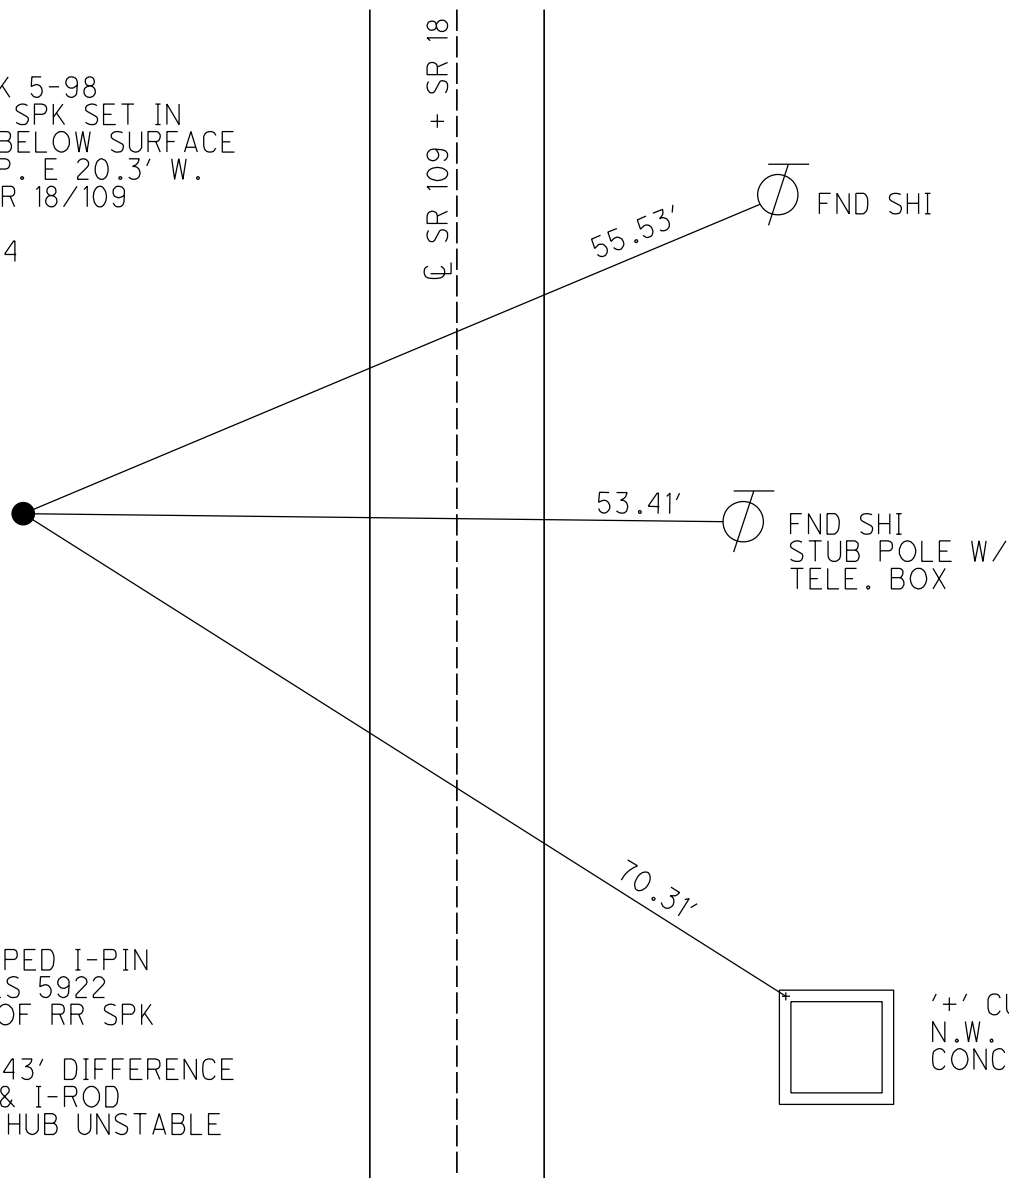
SHEET 18 OF 25

~~ON SURFACE~~ - BELOW 2"

OFFSET Q PAVEMENT 20.3' LT : ~~RT~~

RECORD:  
FND SM RR SPK 5-98  
FND SMALL RR SPK SET IN  
WOOD HUB 2" BELOW SURFACE  
10' W OF W E.P. E 20.3' W.  
OF Q PVMT. SR 18/109

D.N.F. - 10/4/24

NOTE:  
ALSO FND CAPPED I-PIN  
STAMPED # RLS 5922  
3.5" TO N.E. OF RR SPK

THERE IS A 0.43' DIFFERENCE  
BETWEEN SPK & I-ROD  
SMALL SPK IN HUB UNSTABLE

'+' CUT ON  
N.W. COR.  
CONC. CB

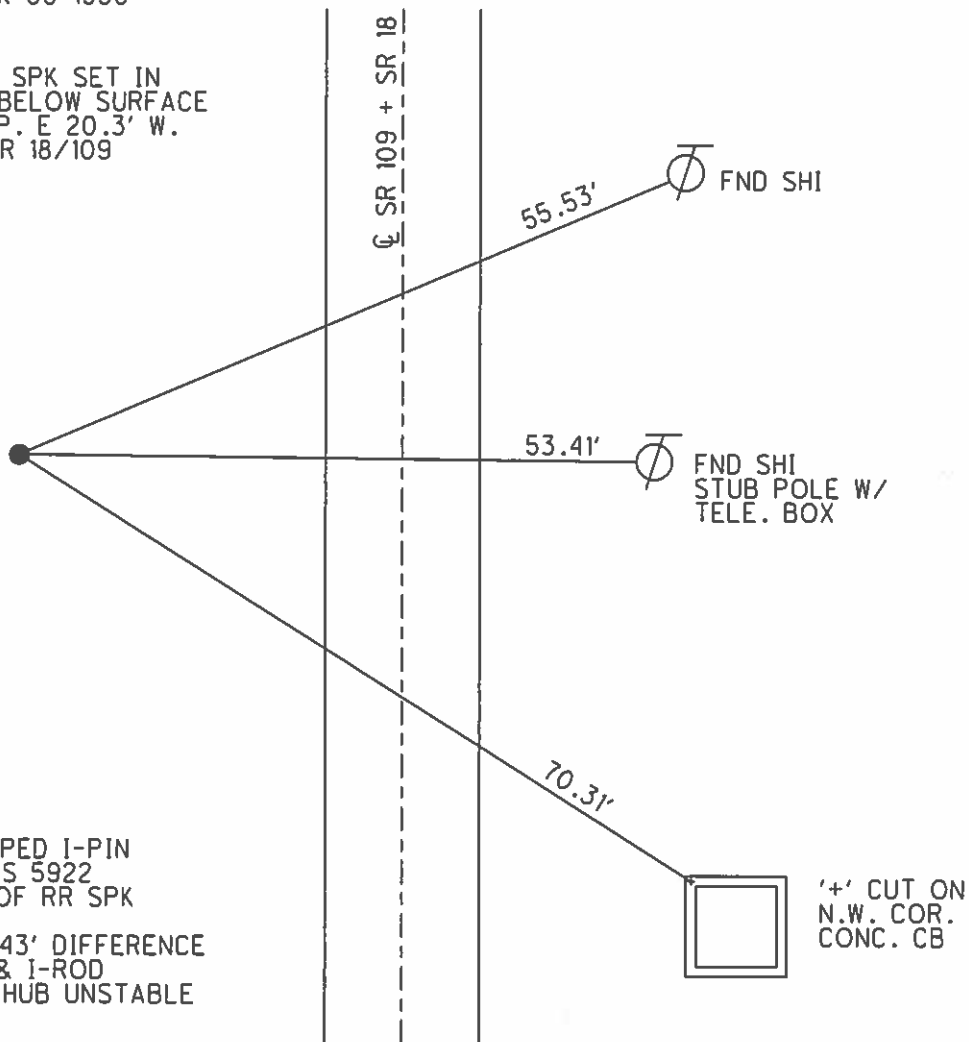
TYPE MONUMENT RR SPK IN WOOD HUB

~~ON SURFACE~~ - BELOW 2"

LEFT - ~~PAV'T~~ - RIGHT 20.3'

REC:  
FND SMALL RR SPK SET IN  
WOOD HUB 2" BELOW SURFACE  
10' W OF W E.P. E 20.3' W.  
OF C PVMT. SR 18/109

NOTE:  
ALSO FND CAPPED I-PIN  
STAMPED # RLS 5922  
3.5" TO N.E. OF RR SPK

THERE IS A 0.43' DIFFERENCE  
BETWEEN SPK & I-ROD  
SMALL SPK IN HUB UNSTABLE

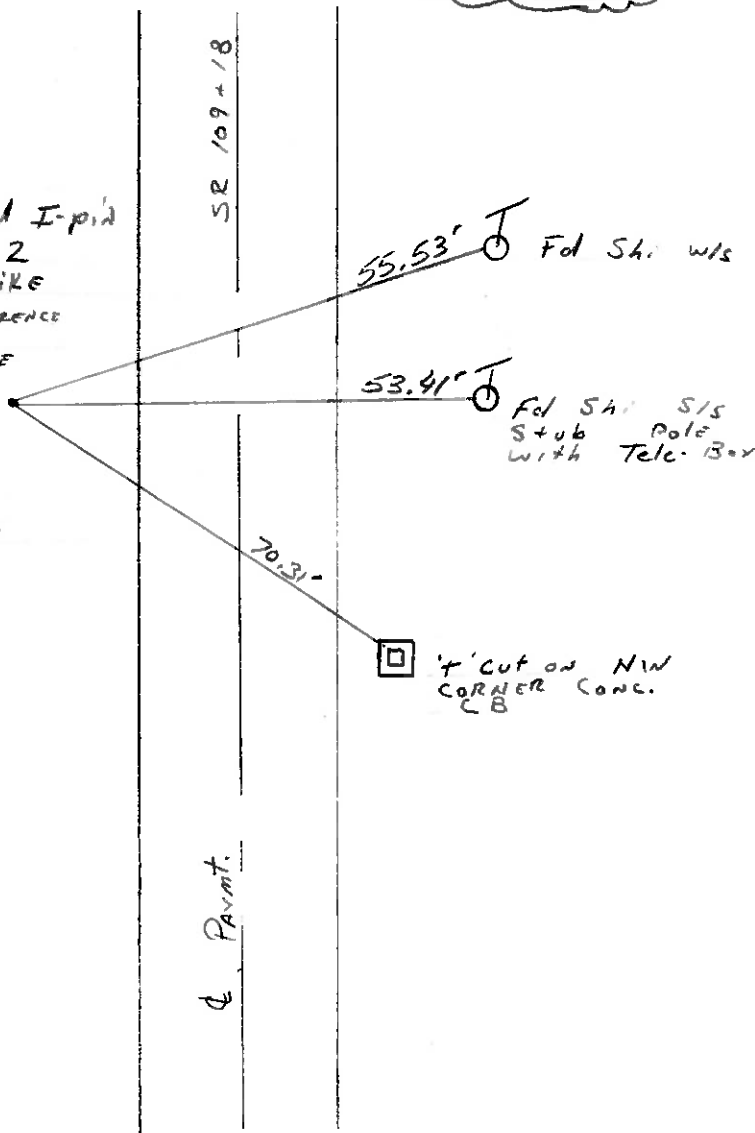
TYPE MONUMENT Sm. RR spike in wood hub

~~ON SURFACE~~ - BELOW 2" Below

LEFT- & PAV'T. ~~RIGHT~~ 20.3' W of E

10' ETO W EDGE PAVEMENT

S.L.M. 17 + 229 SLM (MEASURED STA 565+27)

Also Found capped I-pin  
stamped \*RLS 5922  
3.5" to N.E. of RR spike

\* THERE IS A 0.43' DIFFERENCE  
BETWEEN SPIKE & I-ROD  
- Small SPIKE IN HUB IS UNSTABLE

Find, Small RR SPIKE SET IN  
WOOD HUB 2" Below SURFACE  
10' W. OF W. E.P. & 20.3' W.  
OF & Pavt. SR 18/109

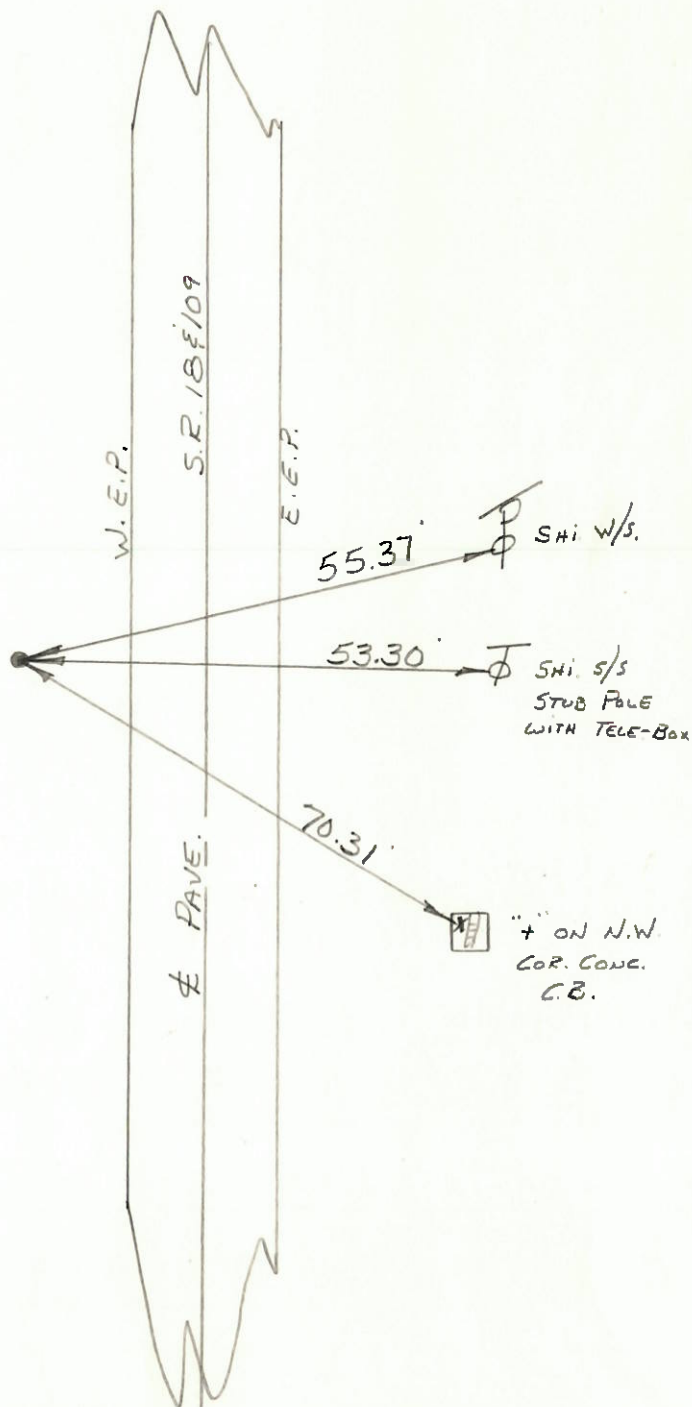
FD. SMALL R.R. SPK. SET  
IN WOOD HUB 2"  
BELOW SURFACE  
10' WEST OF WEST. E.P. &  
20.3' WEST OF & PAVE.  
S.R. 18/109

S.L.M. STA. 565+02±

MEASURED  
STA. 565+27
