ERI -6 – 2893
Substructure Monumentation
and
Monitoring

ERI - 6 - 2893
SUBSTRUCTURE MONUMENTATION
THREADED ROD LOCATIONS

ERI - 6 - 2893
SUBSTRUCTURE MONITORING
MONUMENTS

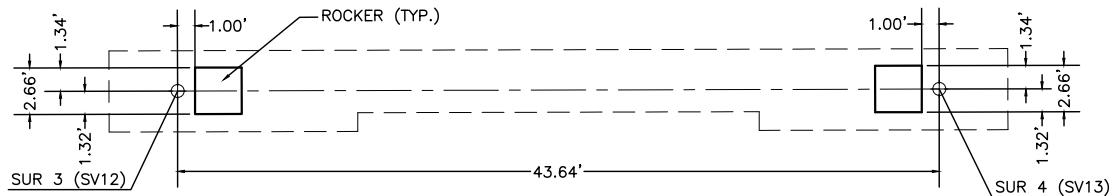
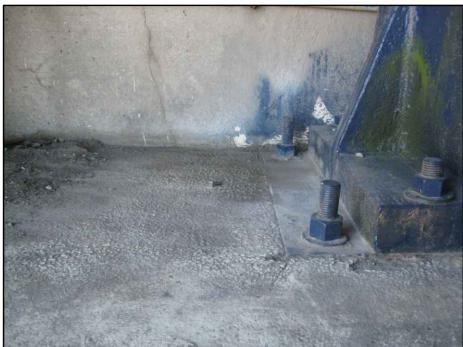
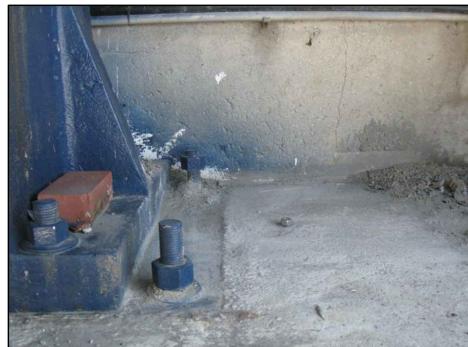
FORWARD ABUTMENT

Four threaded rods were set in the abutments, establishing two survey points on each abutment referenced to the centerline of the bearings.

SUR 3 – 5/8” threaded rod set in bridge seat (SV12)

SUR 4 – 5/8” threaded rod set in bridge seat (SV13)

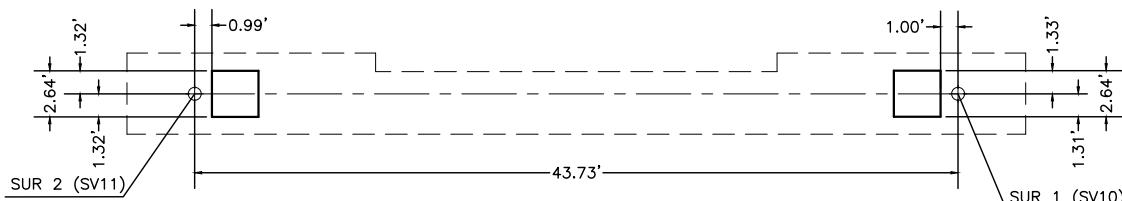
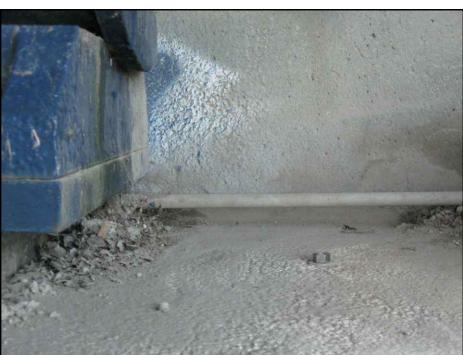
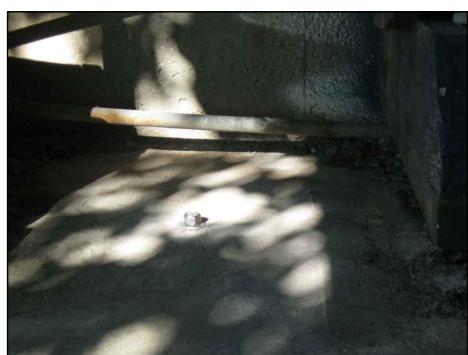
REAR ABUTMENT

SUR 1 – 5/8” threaded rod set in bridge seat (SV10)

SUR 2 – 5/8” threaded rod set in bridge seat (SV11)

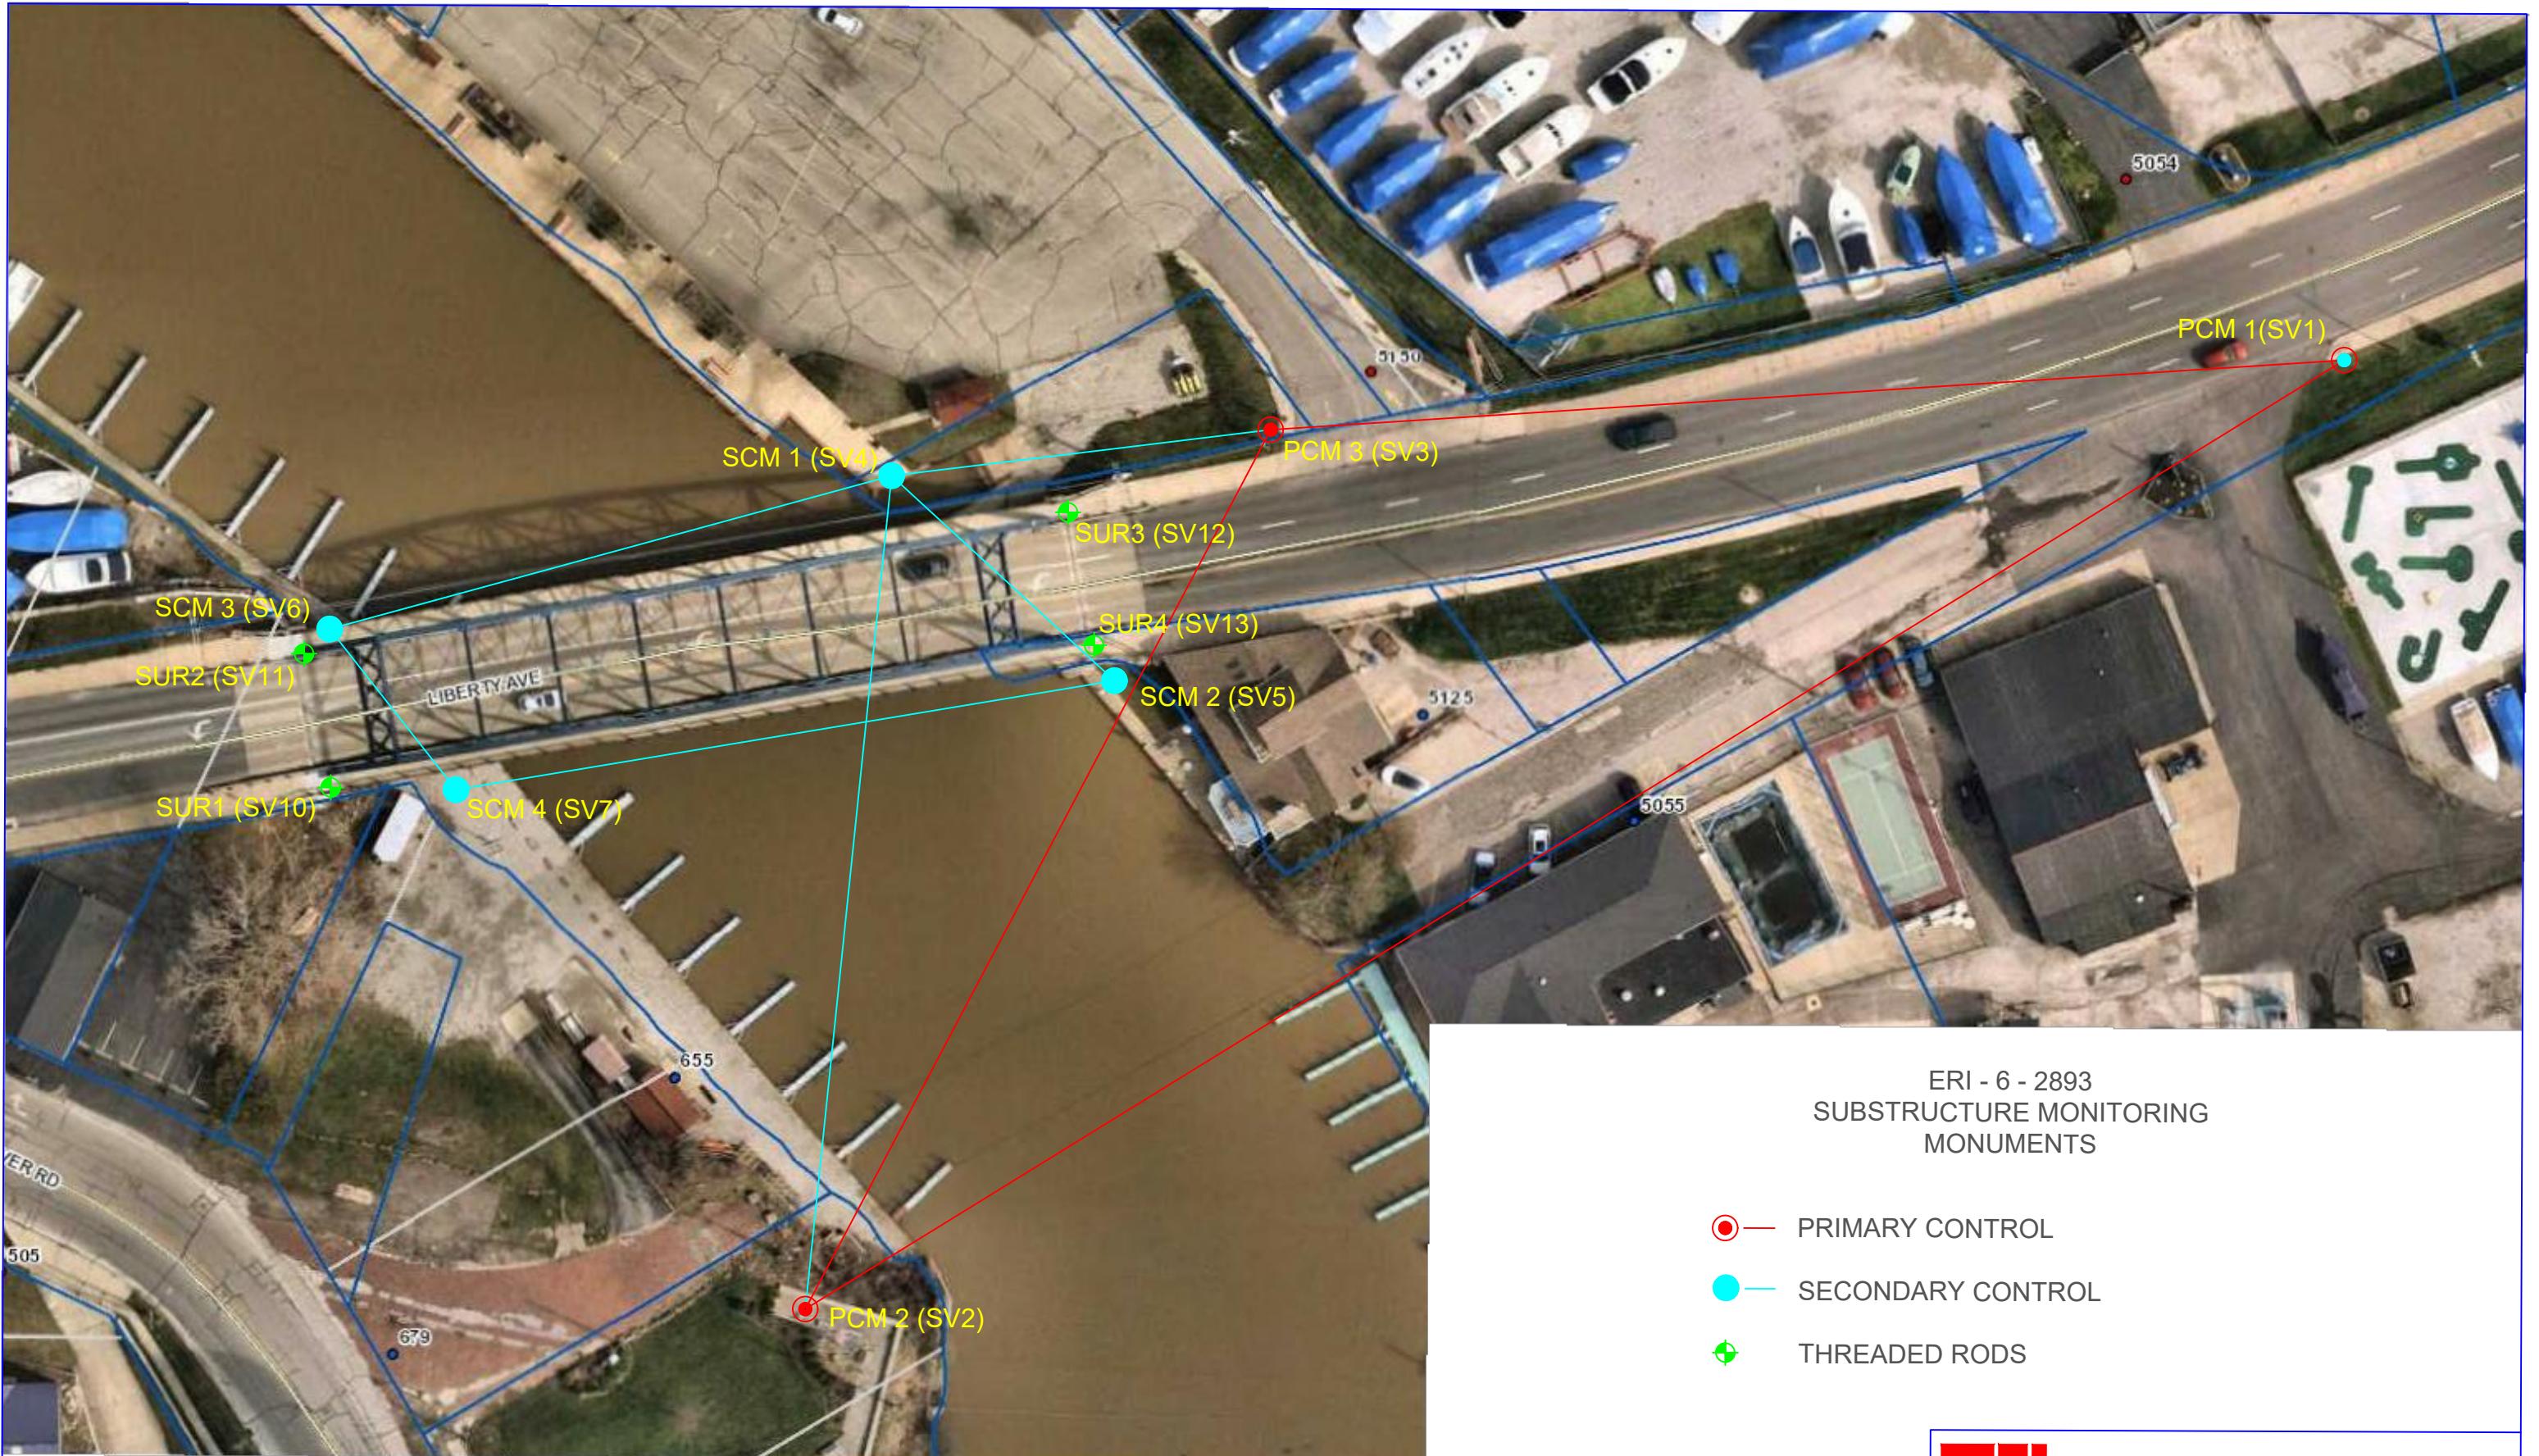
Four secondary control monuments (two 5/8" rebar with cap, one survey marker spike, and one MAG nail) were established under the bridge to observe the threaded rods from two locations.

Three primary control monuments (two 40" X 3/4" rebar with cap and one survey marker spike) were established outside the area of possible movement. Local benchmarks were established.

- PRIMARY CONTROL
- SECONDARY CONTROL
- THREADED RODS
