Abbreviated Safety Study

DEL-23-18.00-18.30

May 2013

This study analyzes US23 from section mile 18.00 to 18.30. This section of road appears on ODOT's 2011 listing of rural non-freeway high crash locations, and it is rated #44 in the State. The purpose of this report is to study this location and analyze the crashes to determine what, if any, actions can be taken to reduce the high percentage of fixed object and animal crashes that have occurred in the study area.

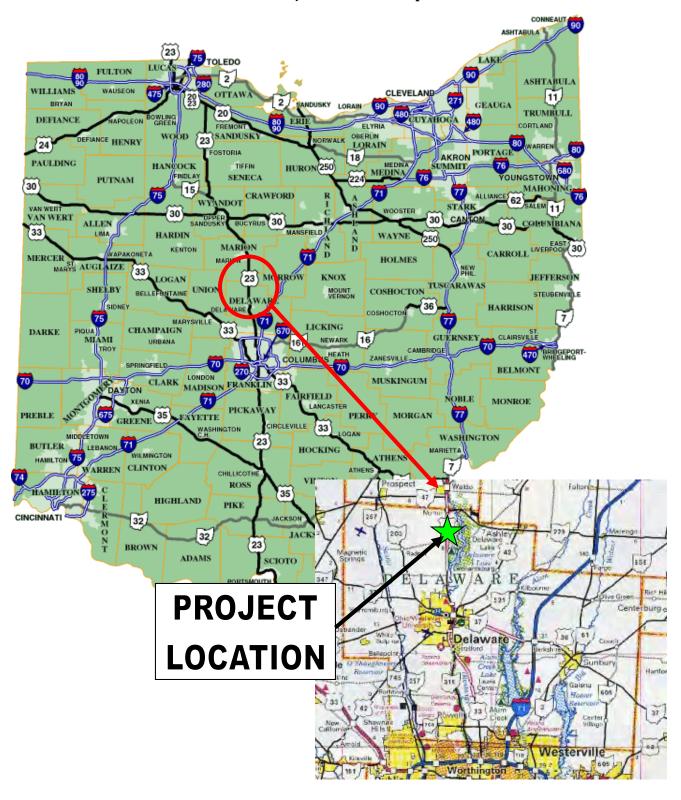
FIGURE 1 Project Location Map

BPS staff conducted a field review on January 5, 2013; the Photolog is included in **Appendix A**. BPS staff observed the study area section and collected information regarding the existing conditions. The section under study, log point 18.00 to 18.30, begins at 1,700 feet south of the US23/Irwin Road intersection and extends north to 100 feet south of the US23/Irwin Road intersection. This 0.30-mile section of US23 is located in rural Delaware County, Ohio, approximately four miles north of the City of Delaware (**see Figure 1**, pg. 8).

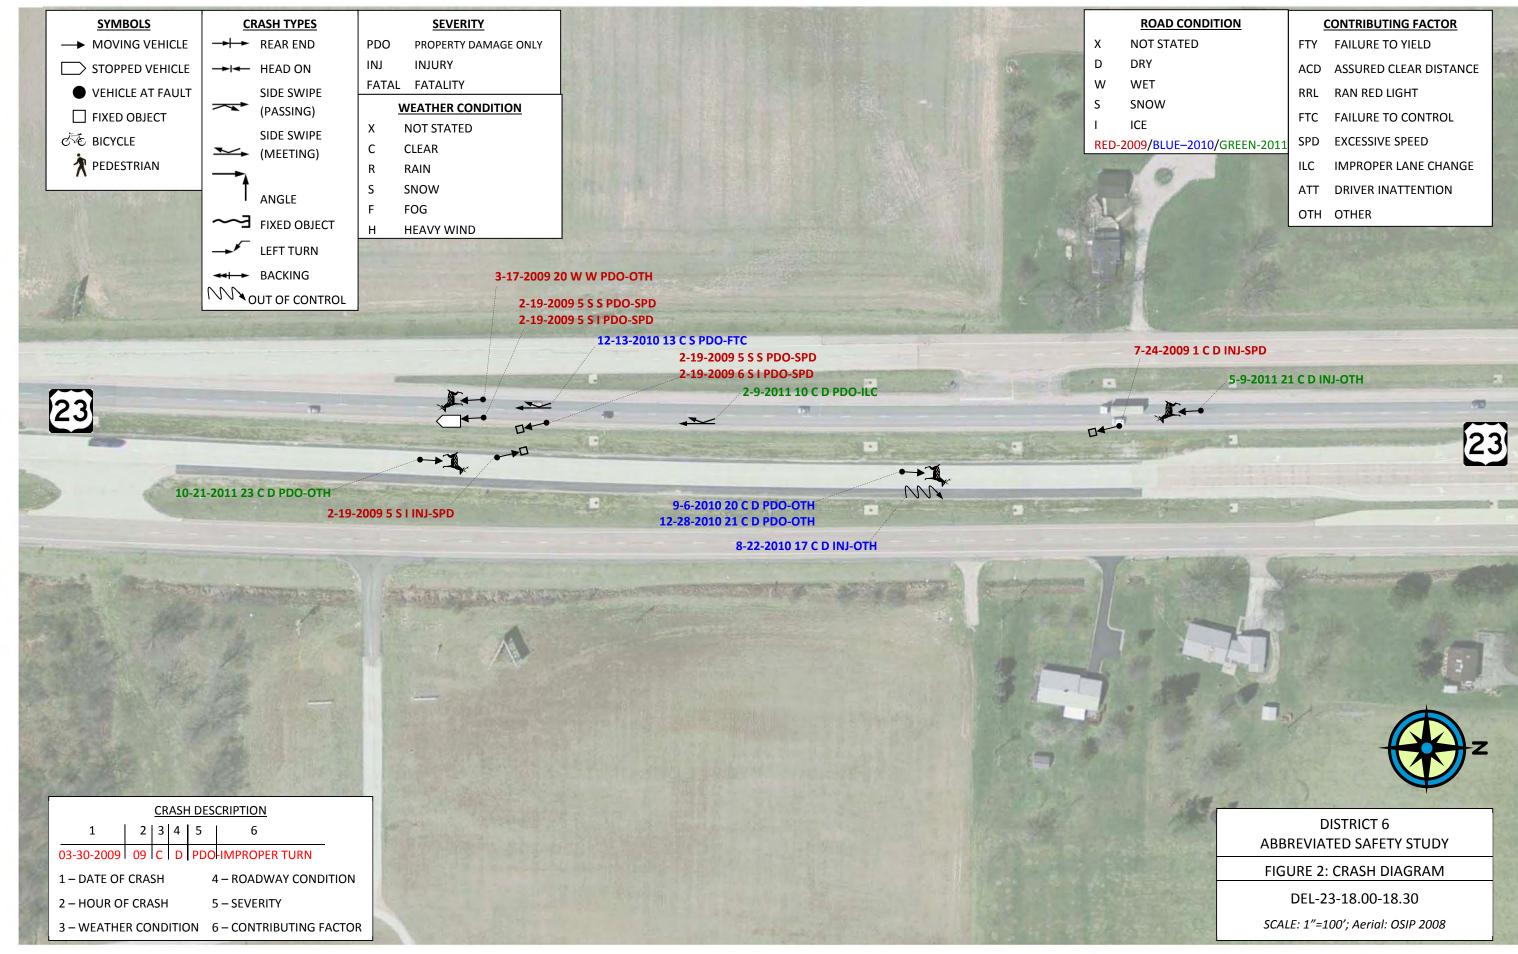
Crash reports from January 1, 2009 through December 31, 2011 were obtained. During this three-year period, a total of 15 crashes were originally logged within the study limits with a crash rate of 1.79 crashes per million vehicle miles traveled. As mentioned above after reviewing the OH-1 reports, one of these crashes was actually located outside the study area on a different roadway (US 36). **Figure 2** (pg. 9) includes the crash diagram which shows the approximate locations of these 14 crashes.

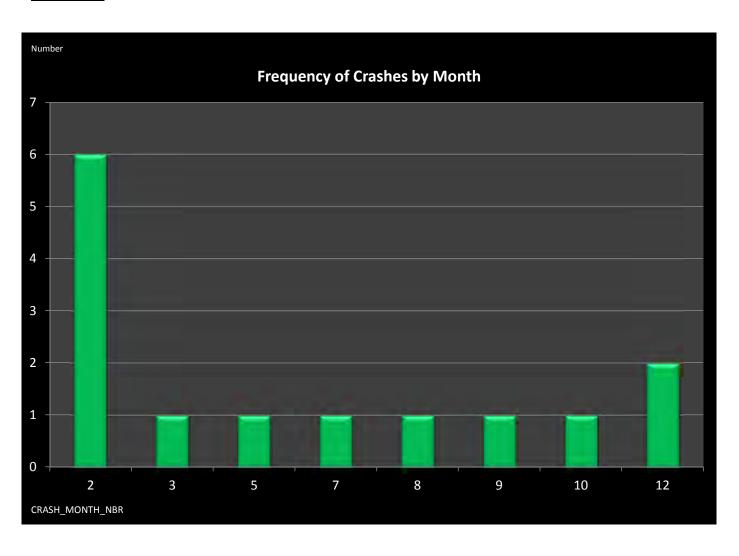
Frequency of Crashes by Hour

HOUR OF DAY	Number	%
1:00	1	7.14%
5:00	4	28.57%
6:00	1	7.14%
10:00	1	7.14%
13:00	1	7.14%
17:00	1	7.14%
20:00	2	14.29%
21:00	2	14.29%
23:00	1	7.14%
Grand Total	14	100.00%

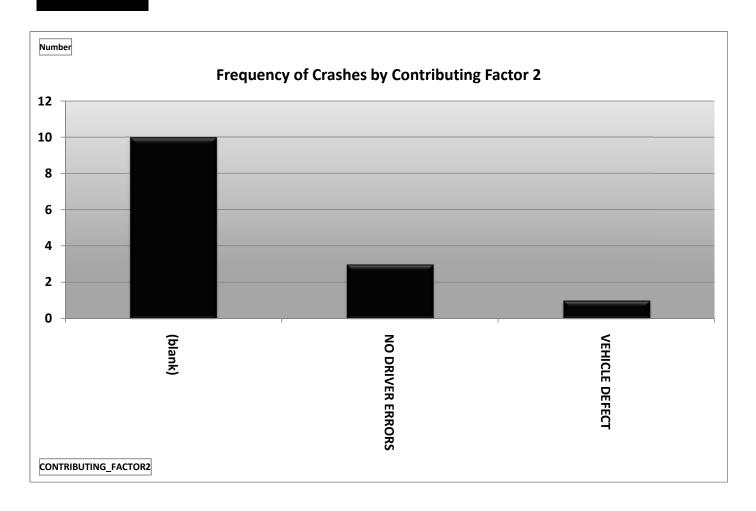
Frequency of Crashes by Contributing Factor 1

CONTRIBUTING FACTOR	Number	%
EXCESSIVE SPEED	6	42.86%
NO DRIVER ERRORS	5	35.71%
FAILURE TO CONTROL	1	7.14%
OTHER DRIVER ERROR	1	7.14%
IMPROPER LANE CHANGE	1	7.14%
Grand Total	14	100.00%

Overall, most crashes did occur in the dark with no lights (79%), and excessive speed was the most listed contributing factor (43%), followed by no driver errors (36%). The excessive speed was related to the crashes that occurred in slick roadway conditions and in the dark, and the no driver errors were related to the animal crashes. No crashes appeared to be a result of the merging (southbound) and diverging (northbound) of the inside and outside sets of lanes. In addition, once the crashes from the single crash event in 2009 were analyzed separately, the only crash pattern that emerged was a relatively high percentage of animal crashes occurring at night in the project area.

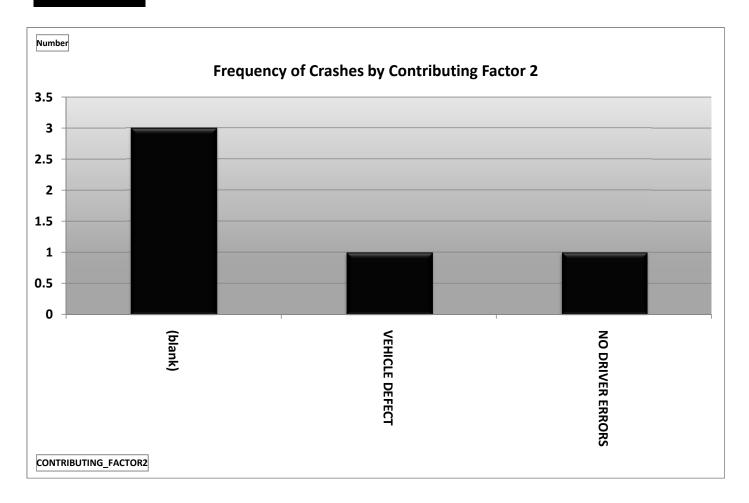
Frequency of Crashes by Contributing Factor 1

CONTRIBUTING_FACTOR1	Number	%
EXCESSIVE SPEED	5	100.0%
Grand Total	5	100.0%

A total of five crashes in 2009 occurred during a single crash event. Most (80%) were property damage only, and all occurred at the same time in the early morning, between 5:00 AM and 6:00 AM. It was dark, snowing, and the road was covered with ice and snow. All vehicles were cited for excessive speed.

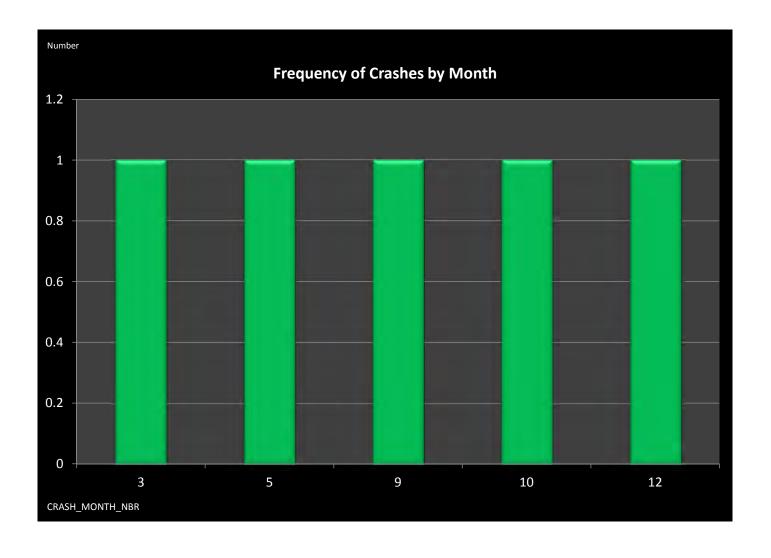
Frequency of Crashes by Hour

HOUR_OF_DAY	Number	%
20	2	40.0%
21	2	40.0%
23	1	20.0%
Grand Total	5	100.0%

A total of five crashes in three years were deer-involved. Most (80%) were property damage only, and all occurred at night, between 8:00 PM and 11:00 PM. It was dark, and only one crash occurred on wet pavement. No fault was assigned to the drivers.
