CUY-90-9.09 SAFETY STUDY

INTERSTATE 90 AT WARREN ROAD (CR 66)

INTERSTATE 90 AT W. 140TH STREET (CR 232)

JUNE 30, 2018

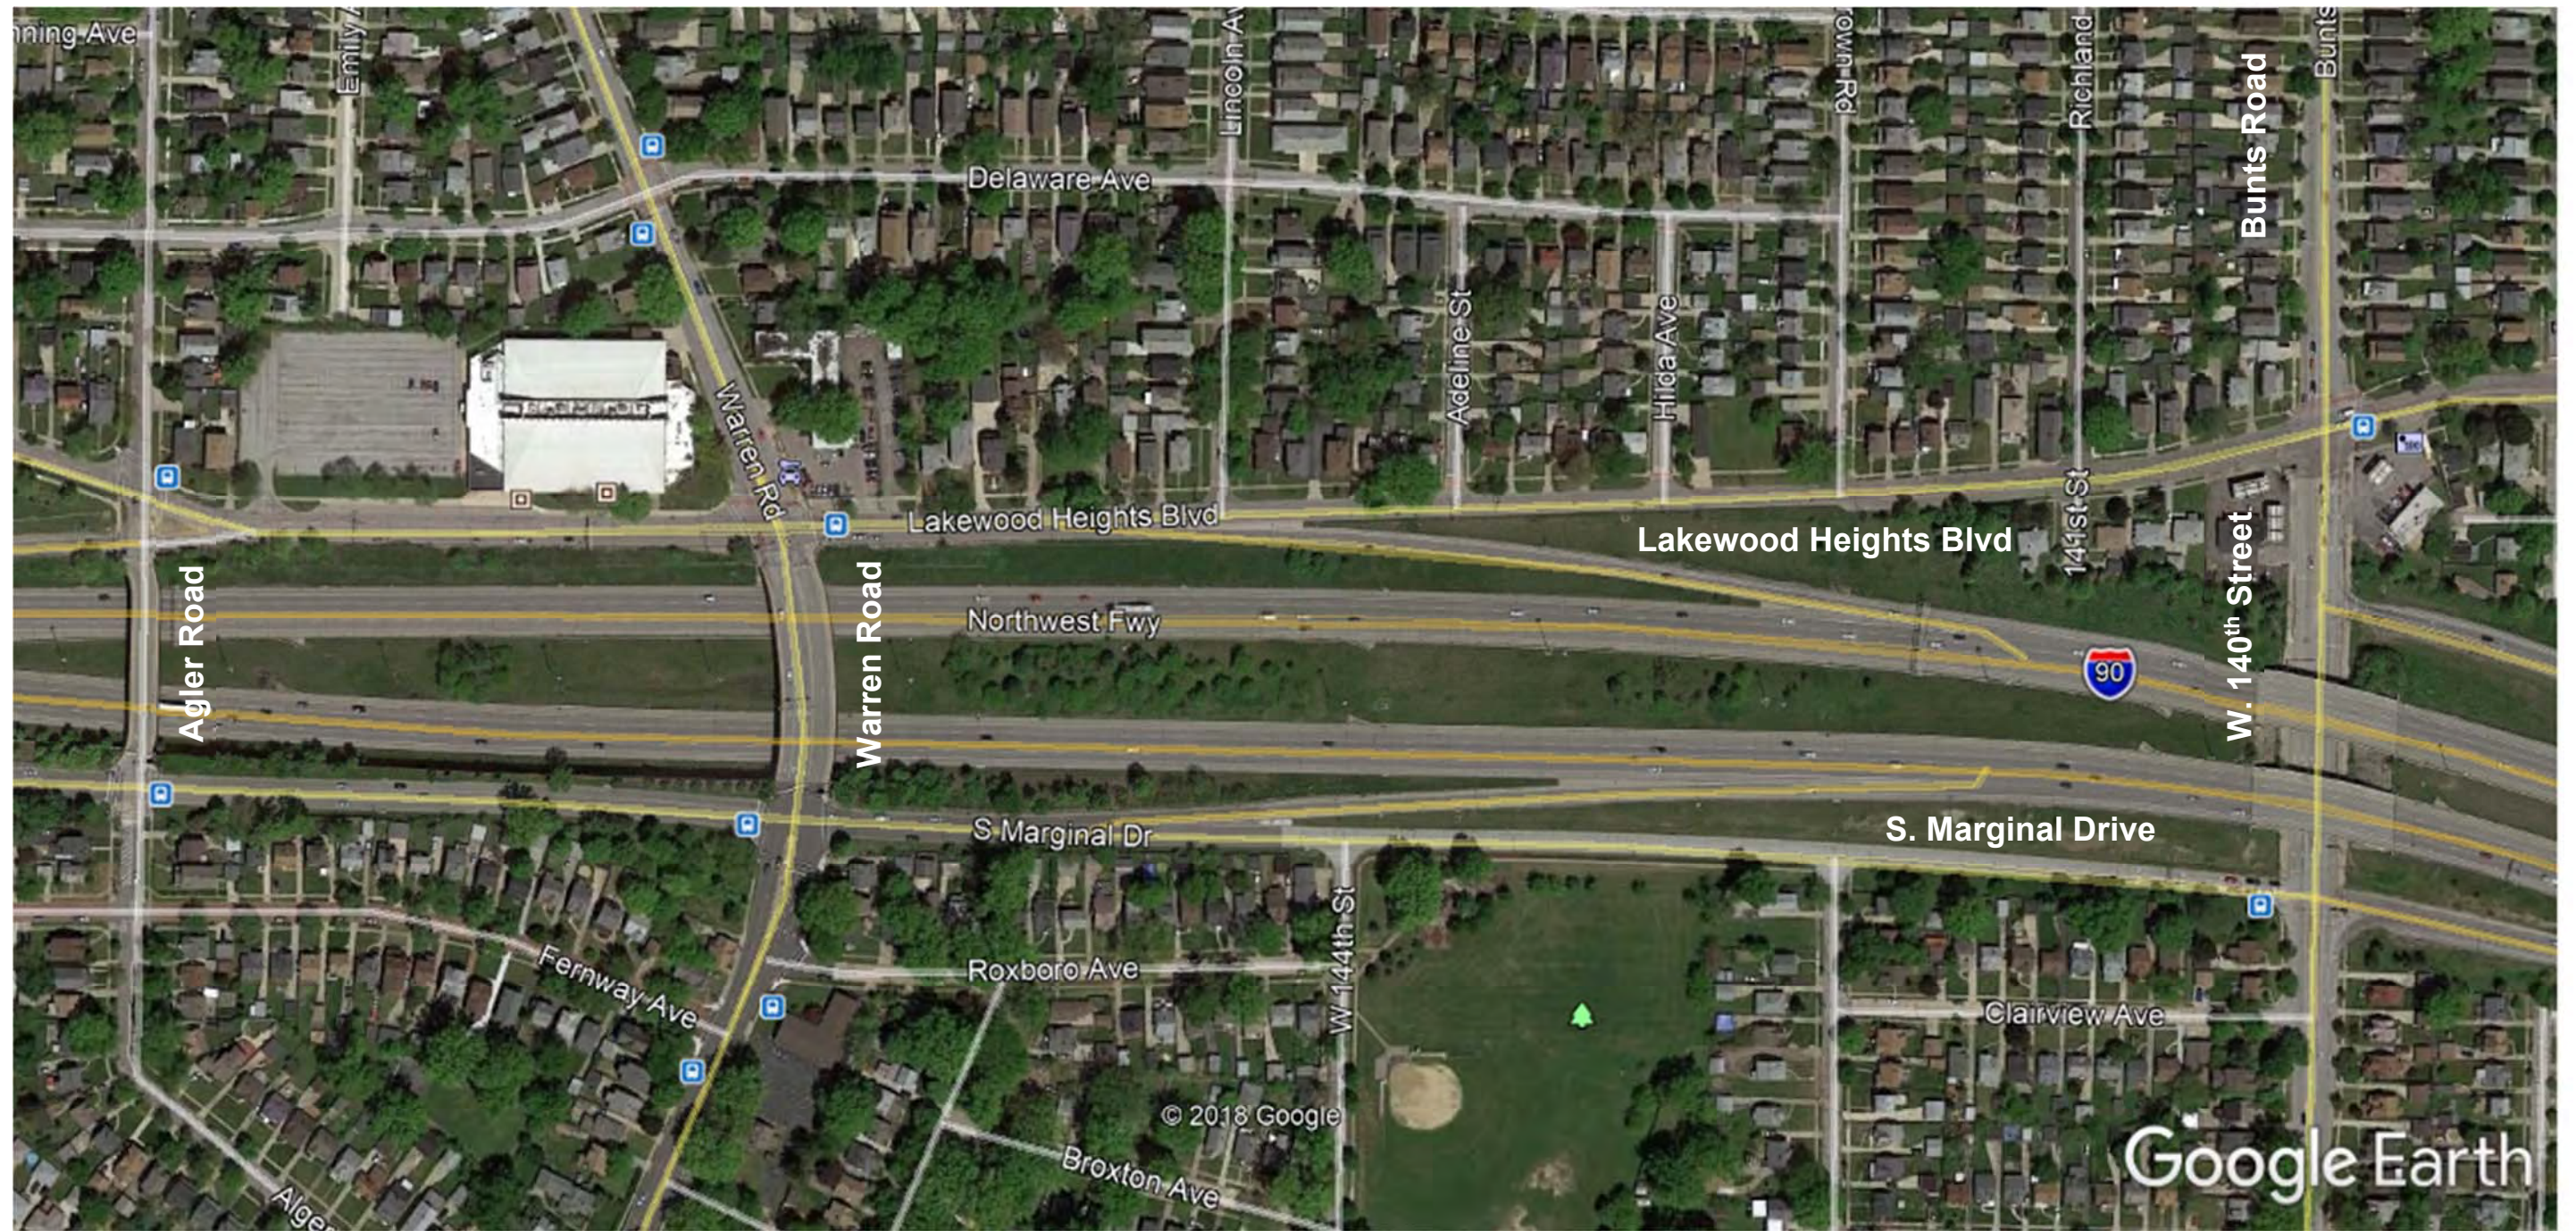
FIGURE 1: STUDY AREA

The purpose of this study is to evaluate the existing safety performance and to identify potential countermeasures to reduce crashes at two interchanges on I-90 west of downtown Cleveland in Cuyahoga, County. **Figure 1** is an aerial photo of the study area.

Existing roadway conditions are summarized in **Table 1** and shown graphically in **Figure 1**.

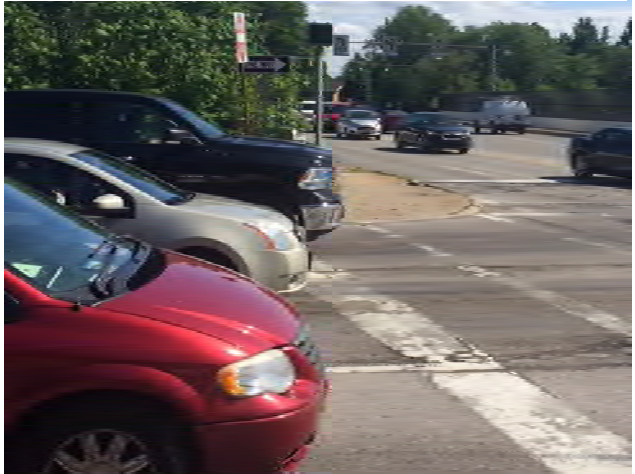
PHOTO 1A: WB LAKEWOOD HEIGHTS BLVD AT WARREN RD – SIGHT DISTANCE

- The lane configuration on the westbound approach is L-T, T, T-R. Three (3) signal heads are provided for the multi-lane approach. Overhead lane use signs with sign lighting is located 180 feet from the stop line. Vegetation blocks visibility of the signs.

5. Relocate the overhead lane use signs for the westbound approach from 180 feet to 325 feet from the intersection. Replace signs and remove sign lighting.

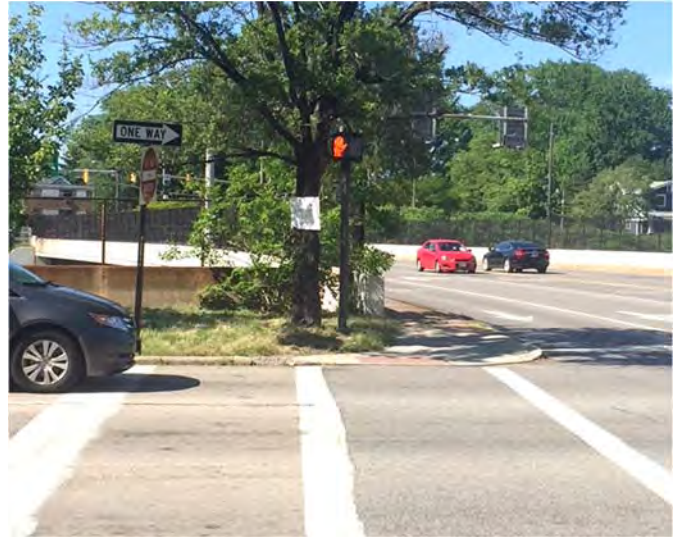
PHOTO 2A: EB MARGINAL DRIVE AT WARREN ROAD – SIGHT DISTANCE

- Vegetation blocks visibility of destination signs on the eastbound approach (220 ft in advance of stop line). Vegetation also blocks visibility of the overhead guide sign for the EB I-90 entrance ramp downstream of the intersection.

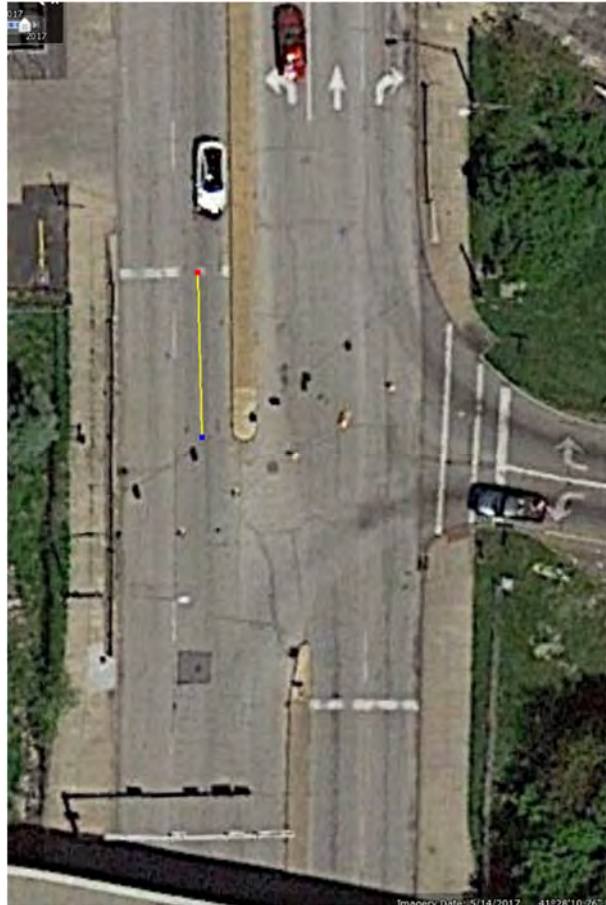
FIGURE 2: W. 140TH STREET AT WB I-90 EXIT RAMP INTERSECTION

- A lane imbalance occurs on the northbound approach due to the percentage of vehicles destined to Bunts Road (north). The curb lane through the interchange area becomes an exclusive right turn lane at Lakewood Heights Boulevard and W. 140th Street/ Bunts Road.

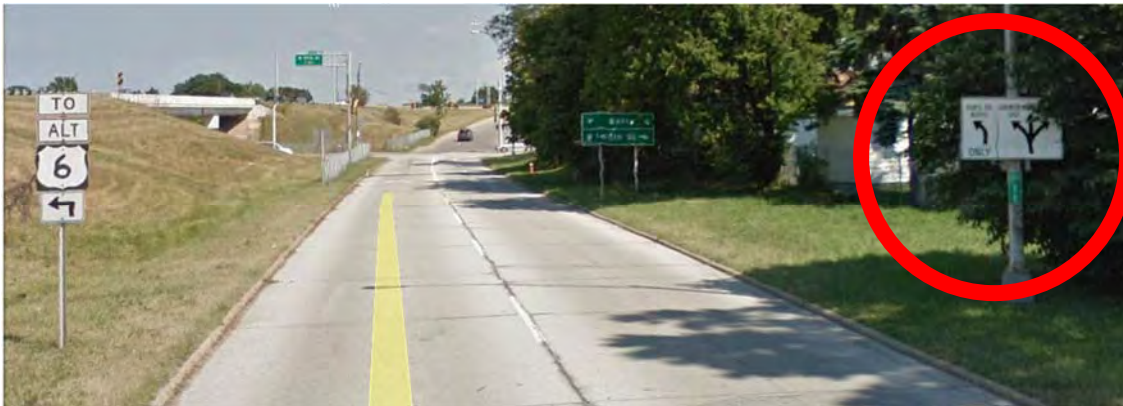
PHOTO 3: EB S. MARGINAL DRIVE APPROACH TO W. 140TH STREET

- The eastbound approach has an exclusive left turn lane (L, L-TH-R) that differs from other intersections on the S. Marginal Road and on Lakewood Heights Boulevard corridors. The left most curb lane is a shared lane at the previous 2 signalized intersections on S. Marginal Road. The eastbound S. Marginal Drive approach at W. 140th Street does not have overhead lane use signs to communicate this change of lane use. One ground mounted lane use sign exists 350 feet in advance of the intersection on the right side of the roadway. See **Photo 3**.

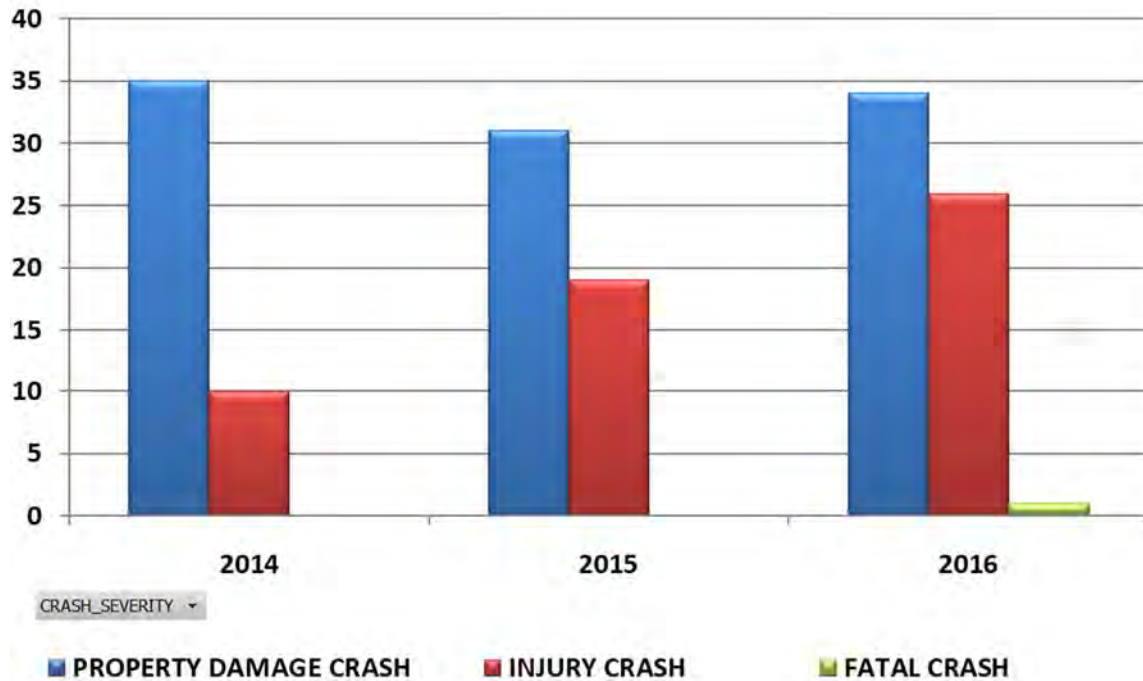
FIGURE 5: FREQUENCY OF CRASHES BY YEAR AND SEVERITY

Angle crashes typically correlate to higher injury rates. While the injury rate for the 3-year period is slightly above statewide averages, the injury rate continues to increase each year as shown in **Figure 5**. Injury crashes comprise 43% of all crashes in 2016.

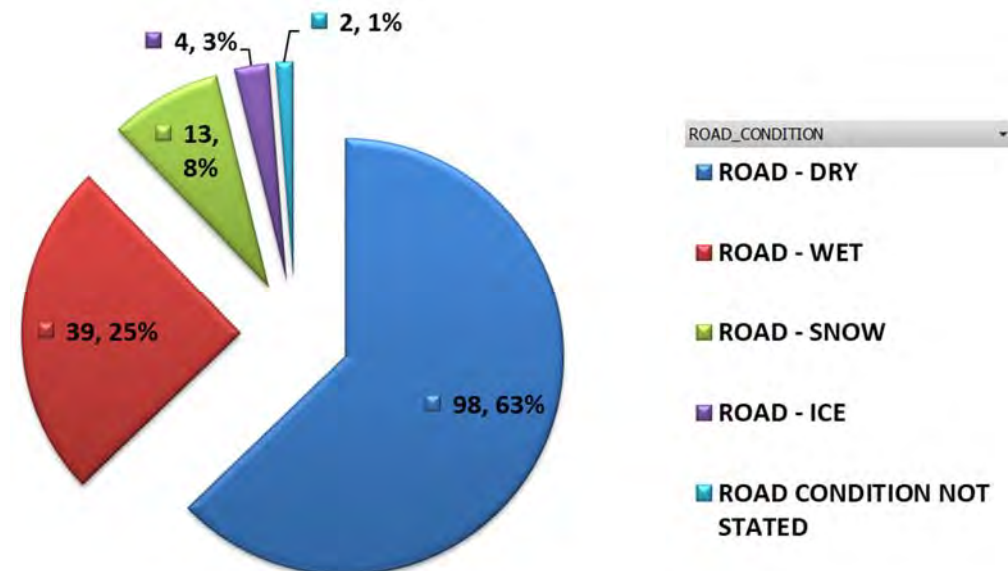
FIGURE 6: FREQUENCY OF CRASHES BY ROAD CONDITION

Wet crashes (39 crashes or 25%) and snow crashes (13 crashes or 8%) are above statewide average crash rates of 19.4% and 6.1%, respectively as shown in **Figure 6**. Countermeasures should also improve existing pavement conditions.

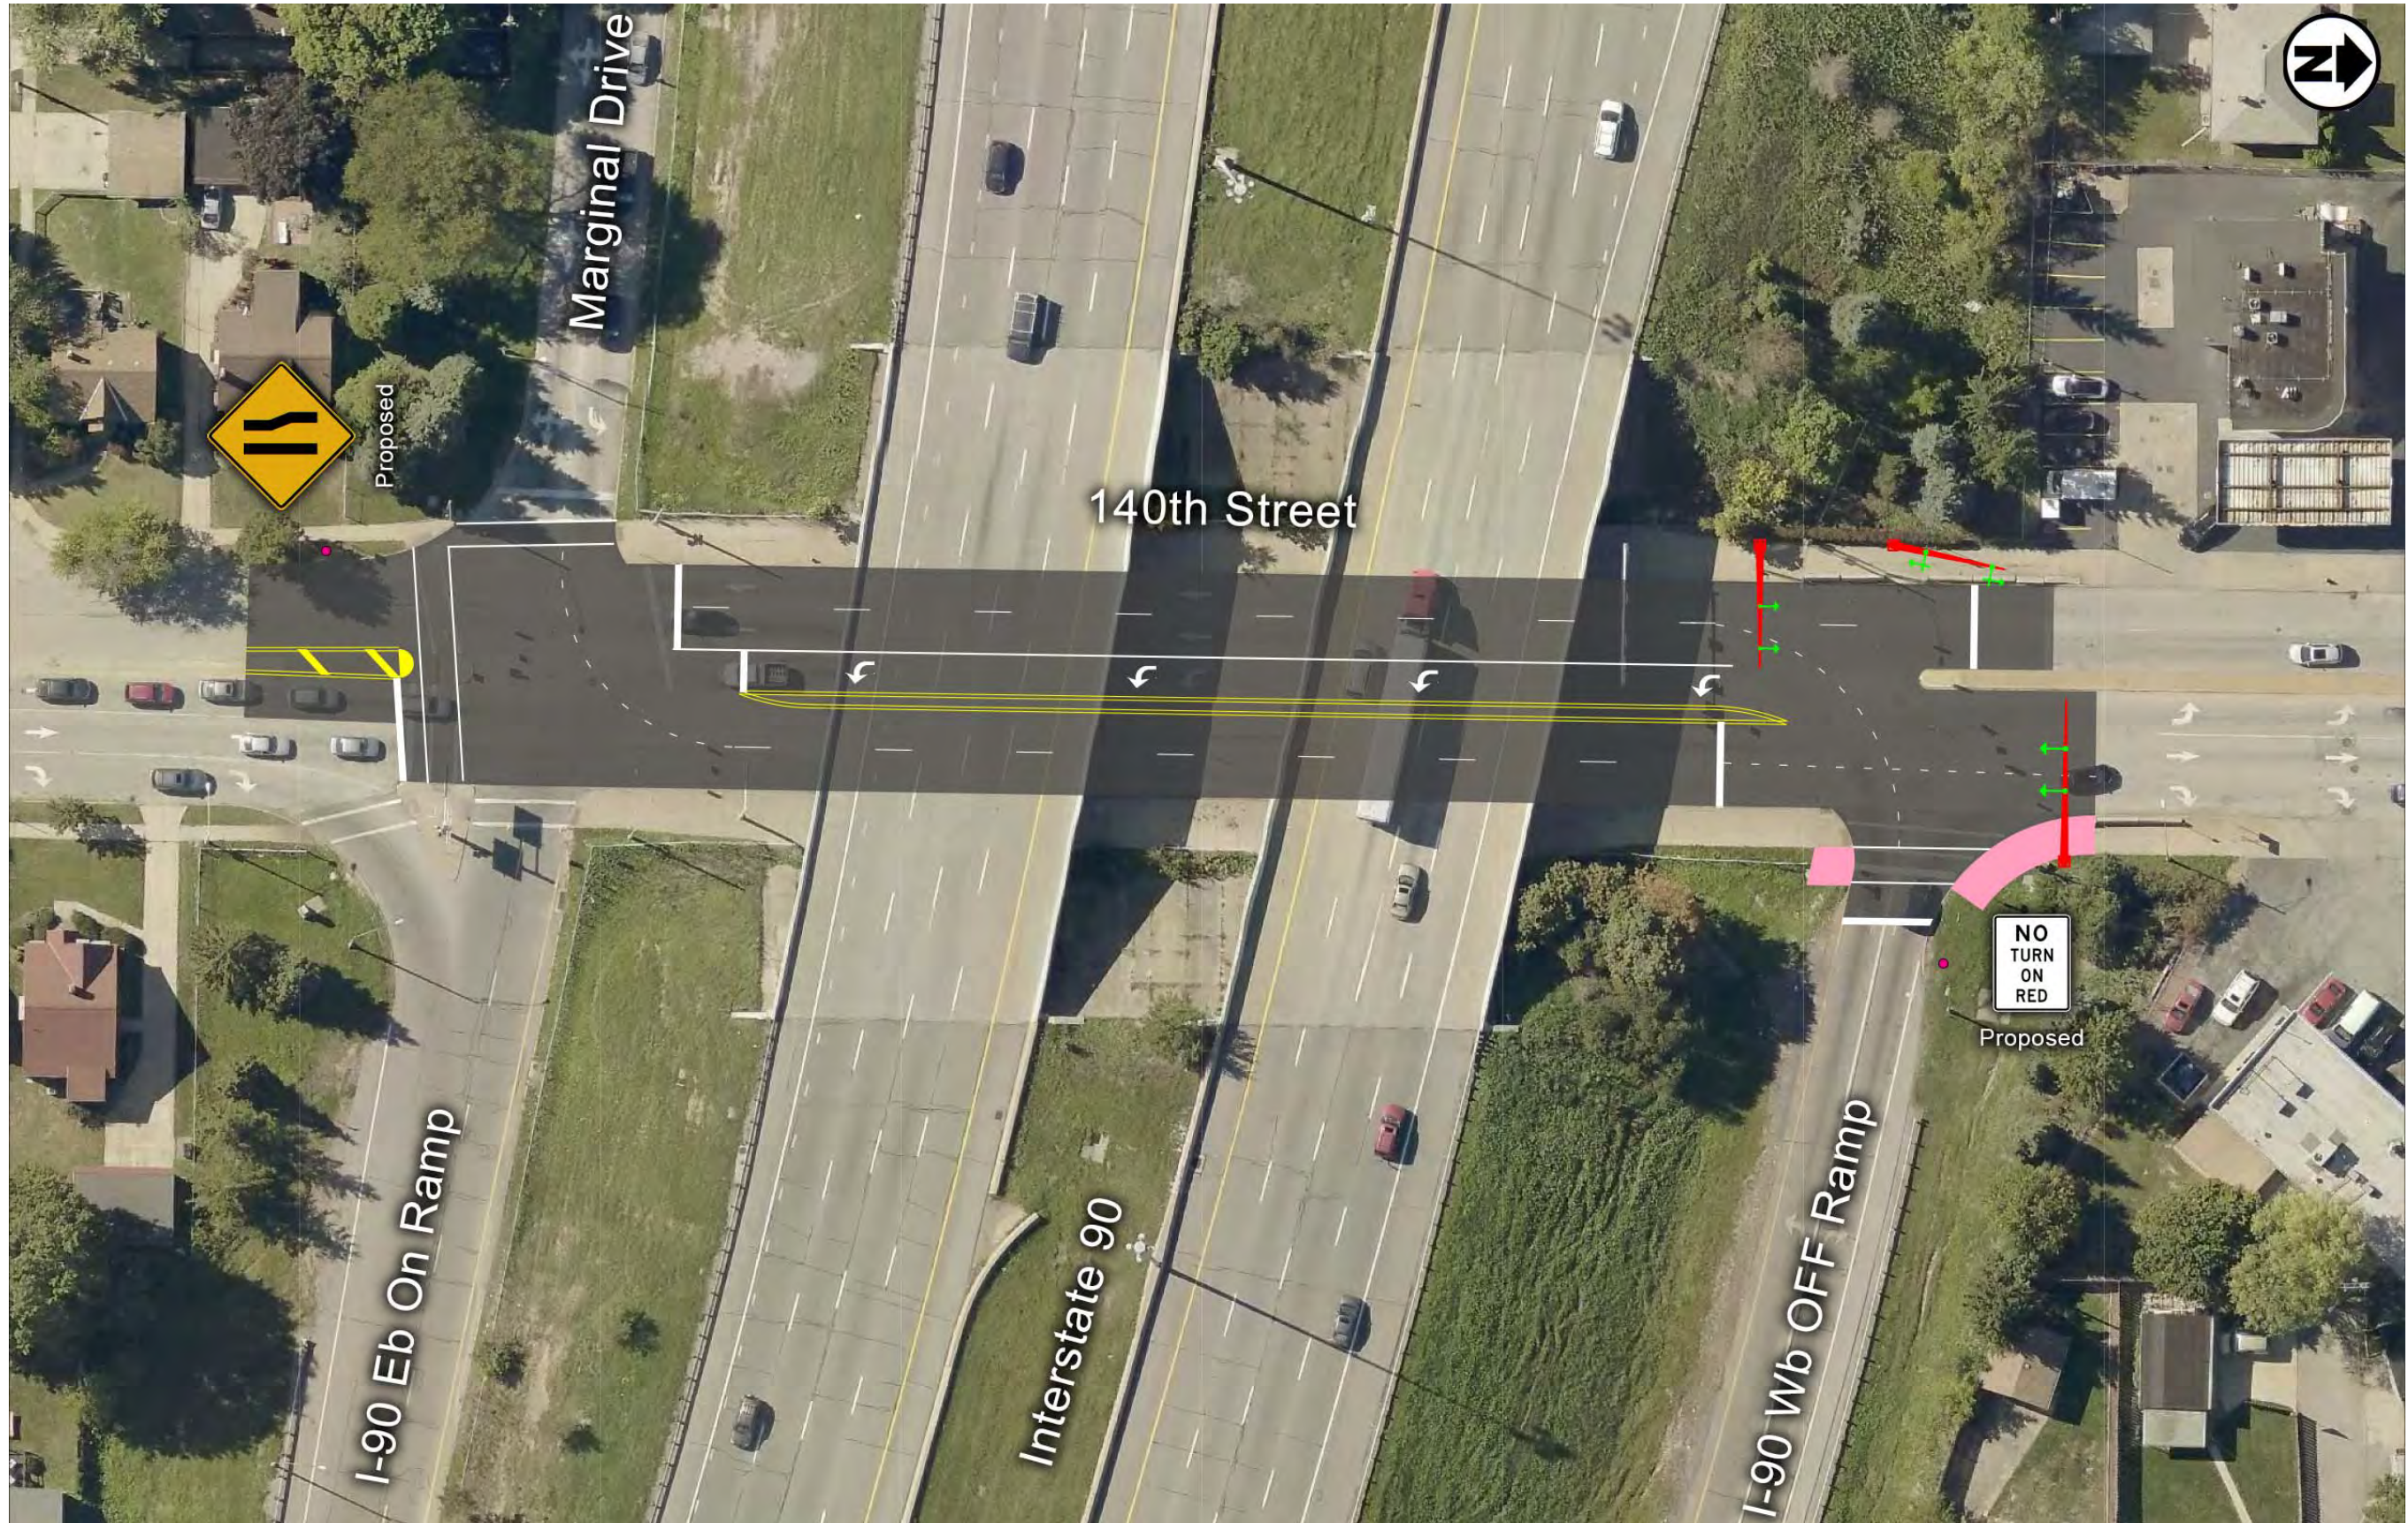
FIGURE 7B: CONCEPTUAL PLAN (W. 140TH STREET)

8. Remove raised median on W. 140th Street between the WB I-90 Exit Ramp and the S. Marginal Road intersection. Removal of the median will improve the lane widths of the receiving lanes of eastbound left turning traffic.
9. Add dotted line having a 60 ft radius to improve the turning radius of the eastbound dual left turn movement. Setback stop lines on the southbound W. 140th Street approach. Vehicles already stop in advance of the stop lines on the W. 140th Street approach to avoid crashes with eastbound left turning vehicles.

10. Install sign support for overhead lane use signs on the eastbound approach 400 feet from the intersection.
11. Remove raised median south of the intersection.
12. Add Right Lane Ends sign to SW quadrant of the intersection to provide advance warning of the lane merge 125 feet south of the intersection.
13. Consider the use of the Flashing Yellow Arrow (FYA) sequence for the lagging left turn phase (southbound approach). See **Appendix D** for more information.

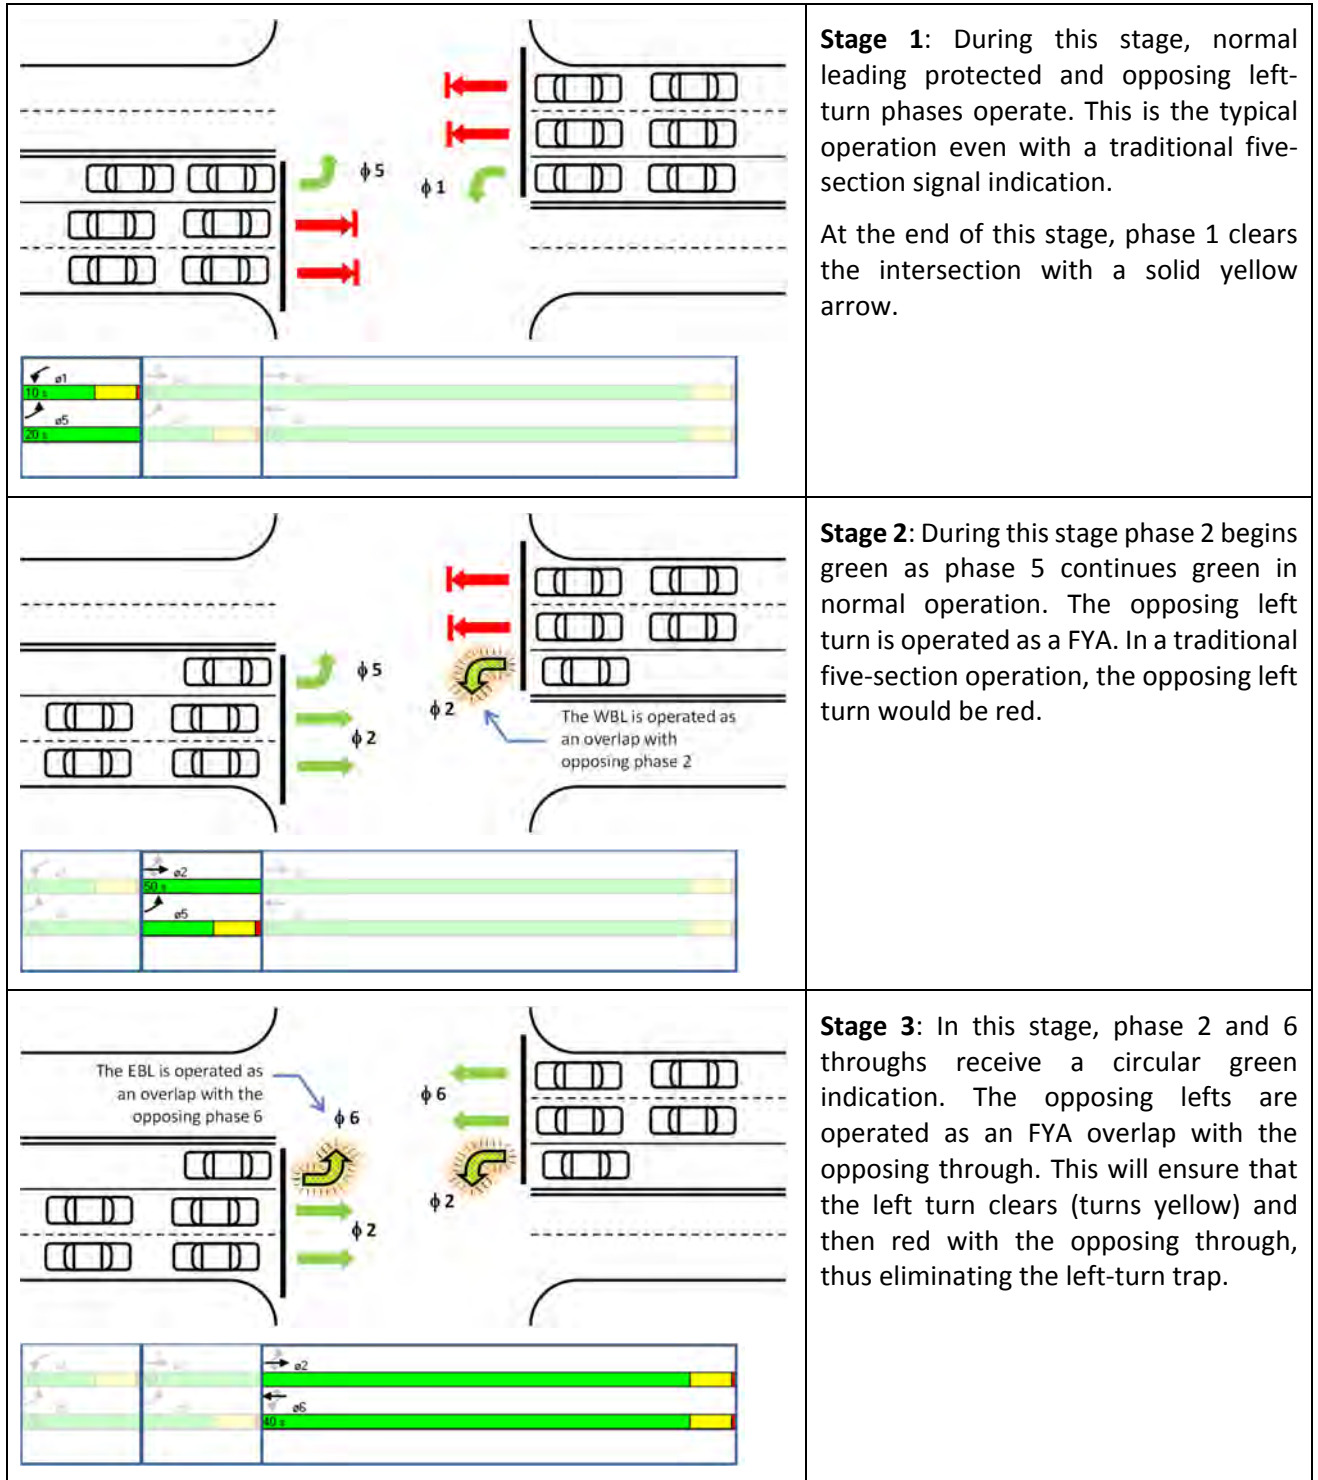
Exhibit 3 FYA to Eliminate Left-Turn Trap

Exhibit 3 illustrates the signal operation of the FYA even under the “soft-trap” condition and how this can be eliminated.

Note: The soft-trap occurs when opposing through movements have different clearance times and permissive lefts are allowed. In this case, one direction sees the solid yellow ball indication while the opposing through is still green. As with the left turn trap, the left turn that sees the yellow indications assumes the opposing through see the yellow at the same time. This is not as critical as a full left turn trap, yet it can be problematic. As noted, the FYA eliminates this situation since the flashing left is tied to the opposing through phase.

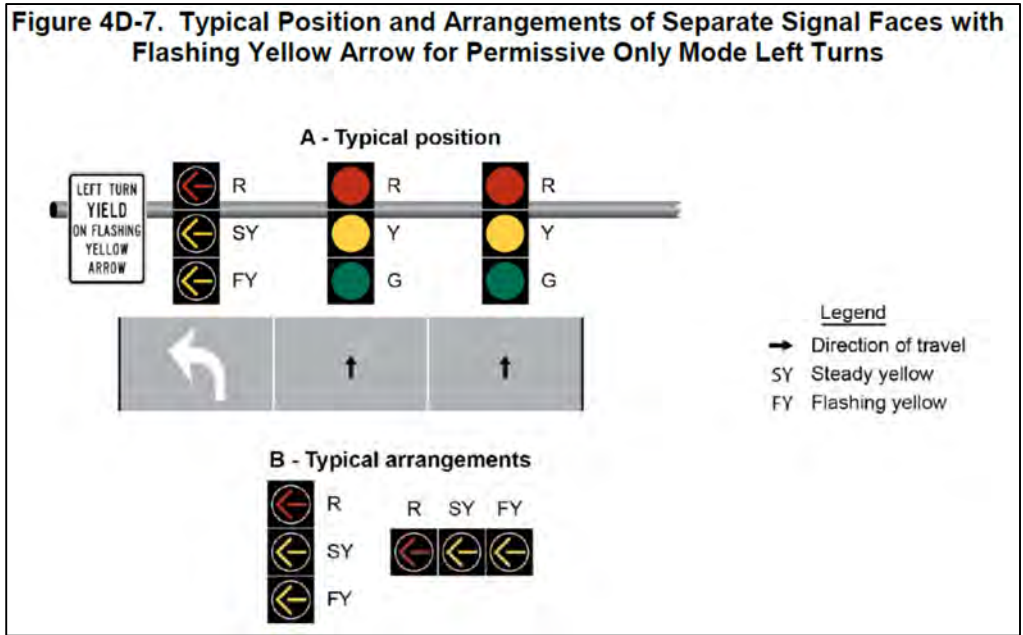
Exhibit 4 OMUTCD FYA Position for Permissive-Only Mode

In accordance with Section 4D.13 of the OMUTCD, the FYA signal head shall be positioned between the extension of the left-hand and right-hand edges of the exclusive turn lane. NCHRP Report 493 recommended this type of configuration since it was rated higher in terms of safety, drivers’ perception, and operations. **Exhibit 4** is Figure 4D-7 from the MUTCD. This is for the typical position and arrangement of separate signal faces using FYA for permissive-only left turns.
