August 16, 2018

**Subject: Asbestos Survey of the CAR 00043 23470 Bridge (SFN #1000969/ PID 106764) State Route 43 & State Route 183 over Big Sandy Creek in Carroll County, Ohio (L&A 18-0272)**

**Bulk Sample Diagram**

**Inventory Bridge Number:** CAR 00043 23470

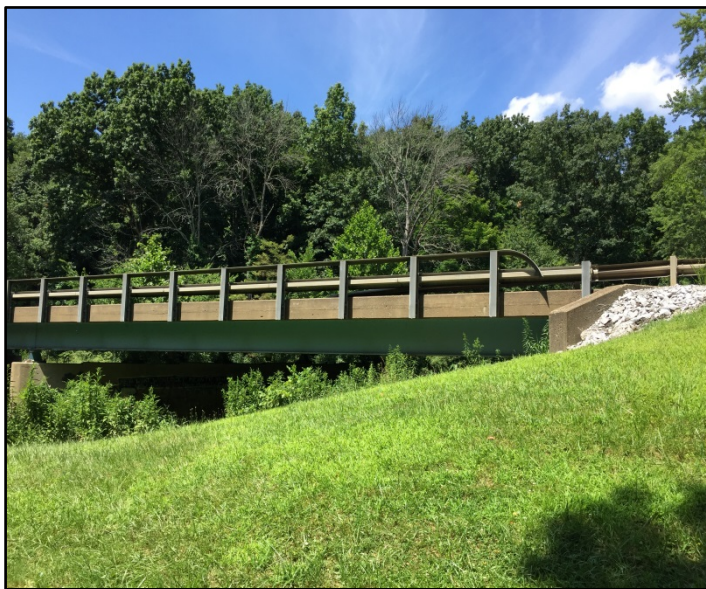
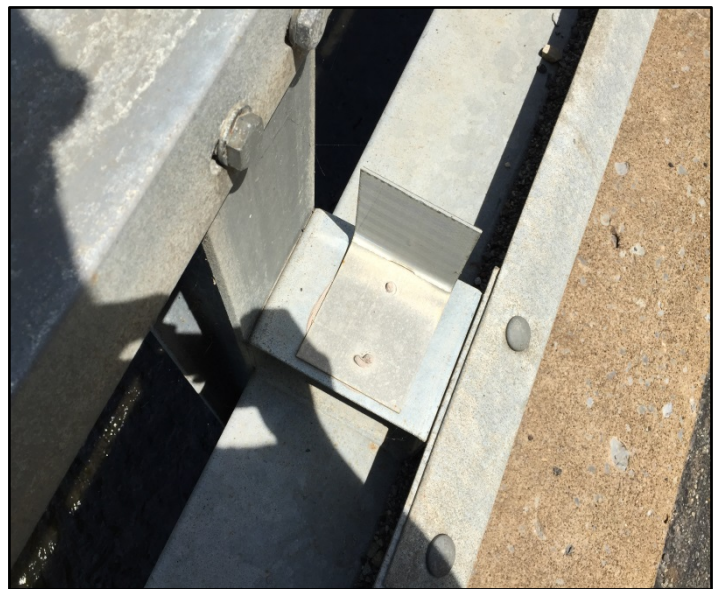
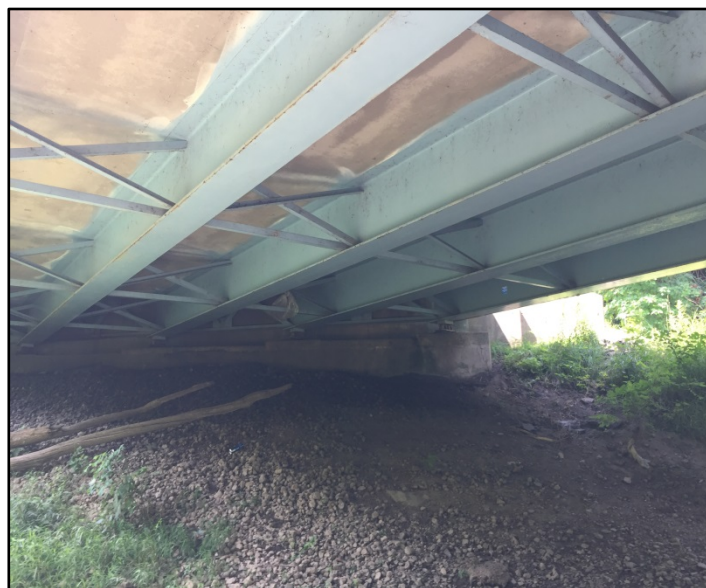
The materials suspected of being asbestos-containing identified during the survey are presented in Table 1 along with an indication of their friability. A bulk sample location diagram can be found in Appendix C.

Sample #	Sample Description and Location	Asbestos %
1	Reflector Caulking – North Side, Middle	No Asbestos Detected
2	Reflector Caulking – North Side, East End	No Asbestos Detected
3	Reflector Caulking – South Side, Middle	No Asbestos Detected
4	Blue Paint – North Side, West End	No Asbestos Detected
5	Blue Paint – West End, Middle	No Asbestos Detected
6	Blue Paint – East End, North Side	No Asbestos Detected
7	Road Tar Patching – West End, North Side	No Asbestos Detected
8	Road Tar Patching – East End, North Side	No Asbestos Detected
9	Road Tar Patching – East End, South Side	No Asbestos Detected
