**EXPANSION JOINT REPAIR DETAILS**

**ABUTMENT SLAB DRAINAGE DETAILS**

RICHLAND ENGINEERING LIMITED 29 NORTH PARK STREET MANSFIELD, OHIO 44902	
DATE	8/2020
REVIEWED	DLR
DESIGNED	BLN
DRAWN	JLS
CHECKED	dnt
STRUCTURE FILE NUMBER	1814028
ABUTMENT REPAIR DETAILS - LOCATION 5	
BRIDGE NO. CUY-480-0126	
CHRISTMAN DRIVE PEDESTRIAN BRIDGE OVER IR 480	
D12-BH-FY2021(A) MISC	PID No. 103162
5	6
62	96

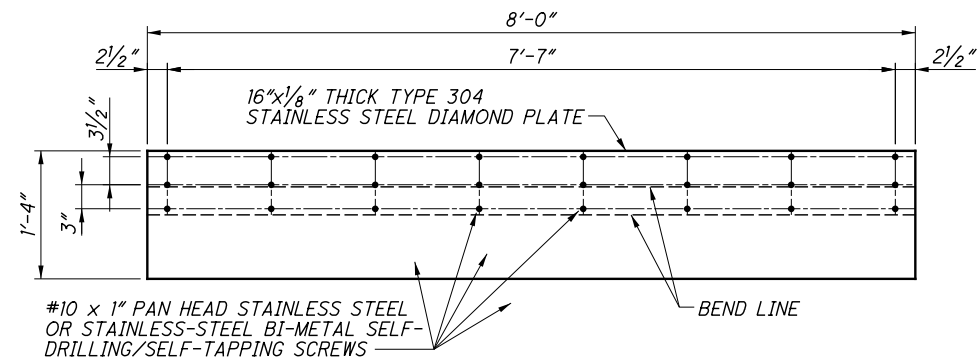
**DIAMOND PLATE DETAIL**

PAYMENT FOR THIS ITEM SHALL BE PER EACH. PAYMENT SHALL BE MADE UNDER ITEM 516 - STRUCTURAL JOINT OR JOINT SEALER, MISC.: ADDING DIAMOND PLATE COVER TO JOINT.

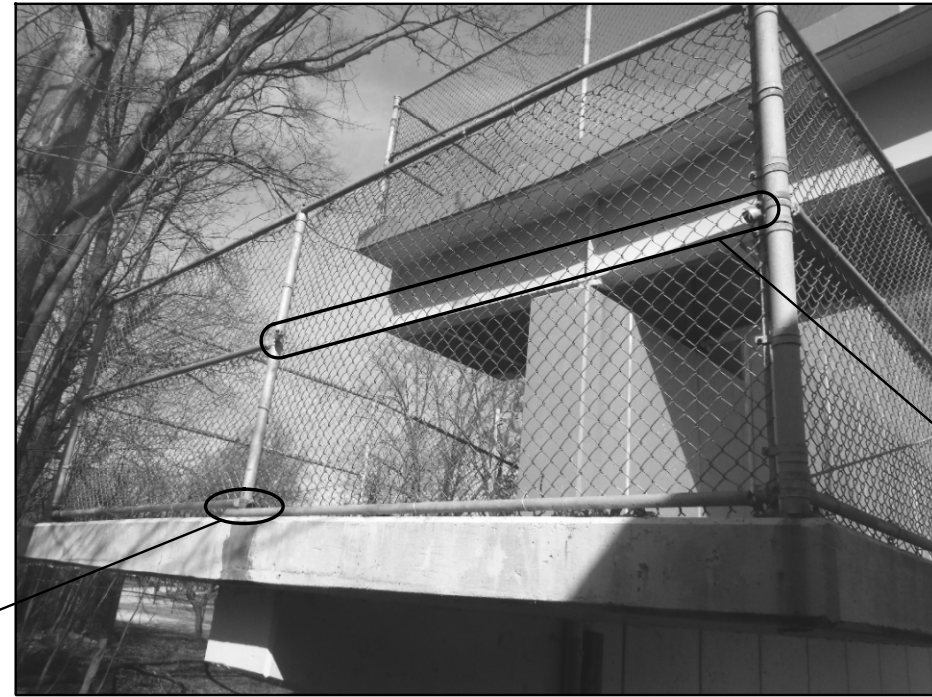
**NORTH ABUTMENT FENCE REPAIR**

PAYMENT FOR THIS ITEM SHALL BE PER EACH. PAYMENT SHALL BE MADE UNDER ITEM 607 - FENCE, MISC.: REPAIR DAMAGED FENCE ON NORTH ABUTMENT LANDING.
