HZW
Environmental
Consultants

***Subject: CUY-BH-FY2023 (B) Misc - PID 105909, Asbestos Survey
CUY – 6-0.420, US-6 Bridge over the Rocky River, SFN 1801074
HZW Project No. H21034***

***Report of Findings of an Asbestos Survey Conducted of the US-6 Bridge over the Rocky River
Located in Lakewood, Cuyahoga County, Ohio***

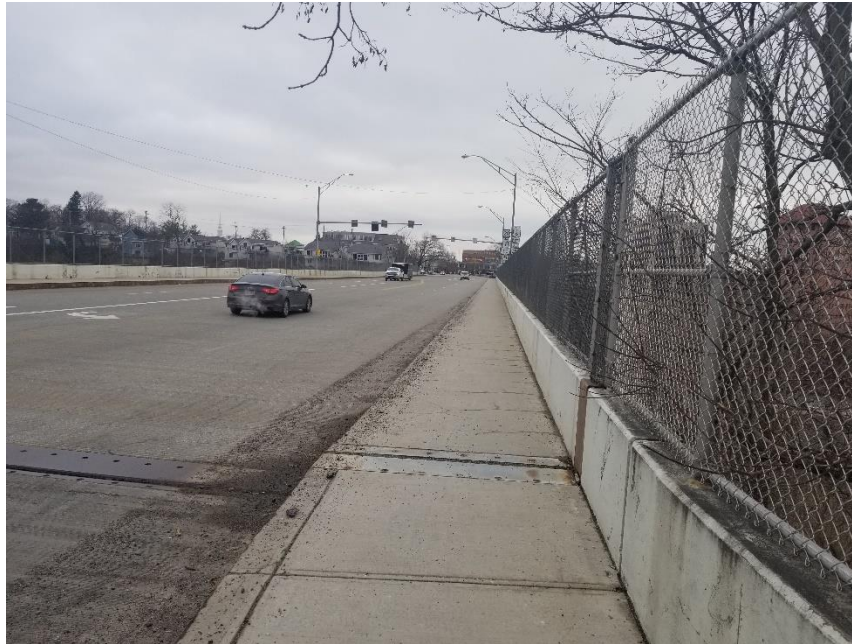
Photograph 01

View Looking West at the Top of the US-6 Bridge over the Rocky River,
Lakewood, Cuyahoga County, Ohio

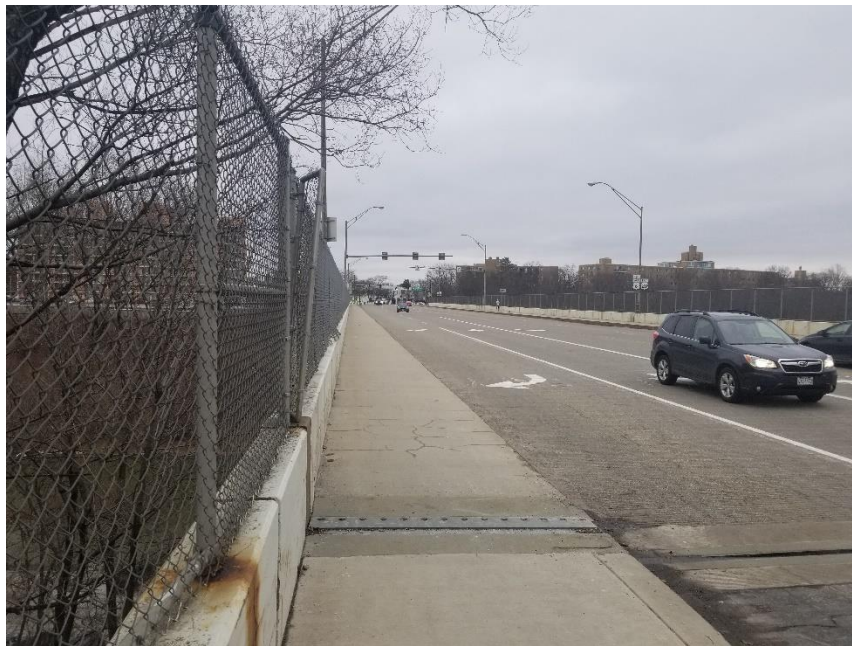
Photograph 02

View Looking East at the Top of the US-6 Bridge over the Rocky River,
Lakewood, Cuyahoga County, Ohio

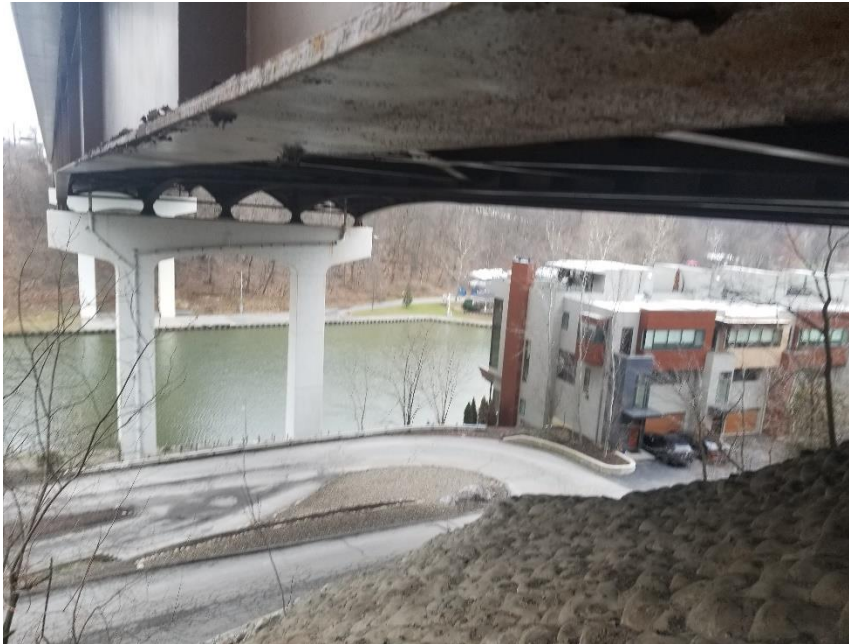
Photograph 03

View Looking Southeast at the Underside of the US-6 Bridge over the Rocky River,
Lakewood, Cuyahoga County, Ohio

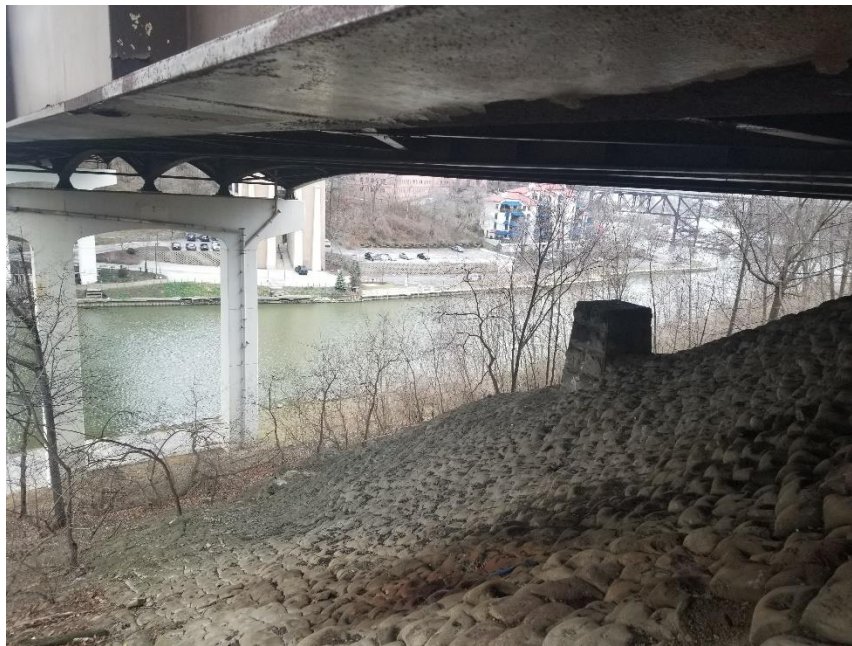
Photograph 04

View Looking Northwest at the Underside of the US-6 Bridge over the Rocky River,
Lakewood, Cuyahoga County, Ohio

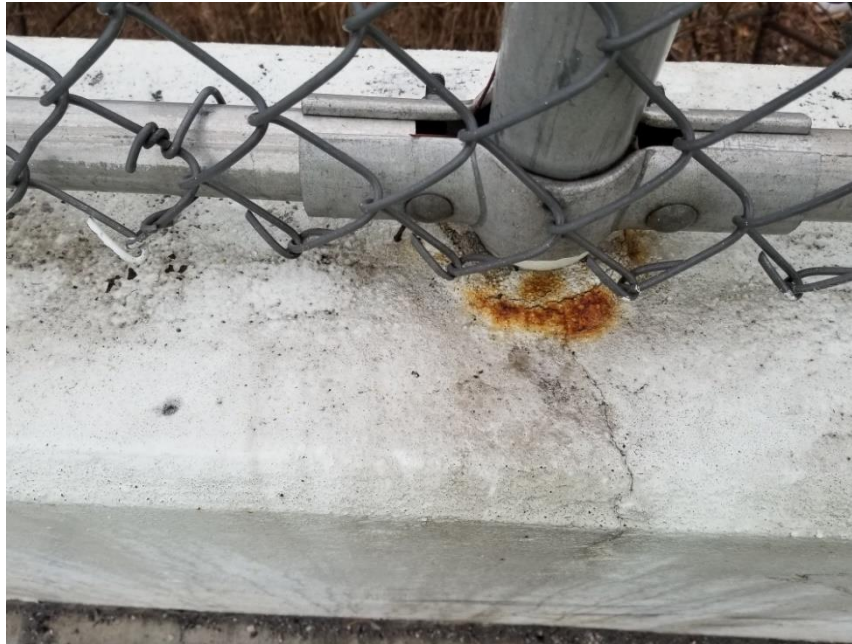
Photograph 05

View Looking at Fence Connection to Concrete at the US-6 Bridge over the Rocky River,
Lakewood, Cuyahoga County, Ohio

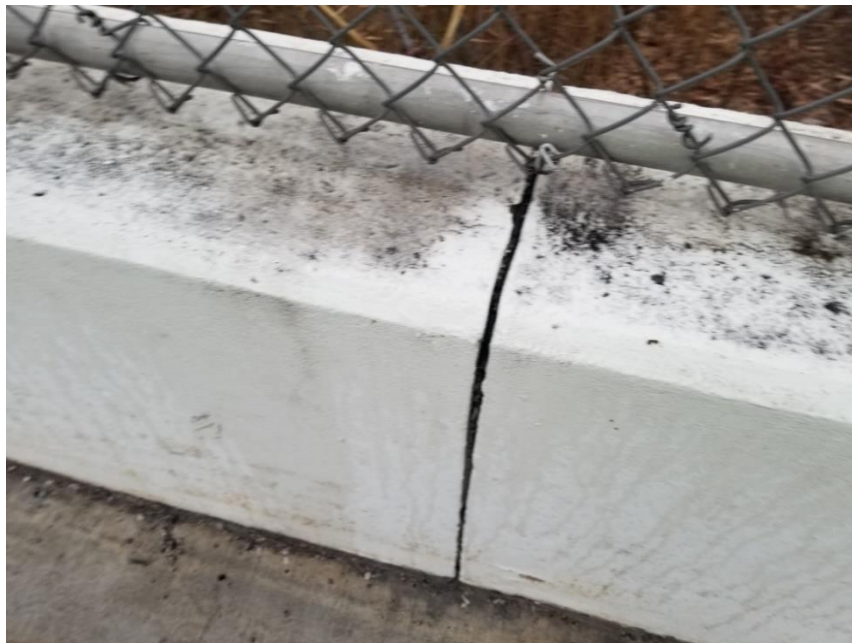
Photograph 06

HA	Suspect Material/Condition	Location	Sample No.	Asbestos Content (Percent)	Quantity of ACM Identified
A	Foam Gasket - Black Fair Condition	Topside of Bridge: Between Parapet Wall Slabs	01	ND	NA
			02	ND	
B	Tar and Fiberglass Pipe Insulation – 30-inch Diameter, Black – Similar to Item No. 5 Above for Construction Plan Review Fair Condition	Underside of Bridge, North End	03	20	640 ln.ft.
			04	20	
C	Tar and Cloth Pipe Insulation – 8-inch Diameter – Similar to Item No. 4 Above for Construction Plan Review Fair Condition	Underside of Bridge, North End	05	ND	NA
			06	ND

View Looking at Parapet Wall Gasket at the US-6 Bridge over the Rocky River,
Lakewood, Cuyahoga County, Ohio

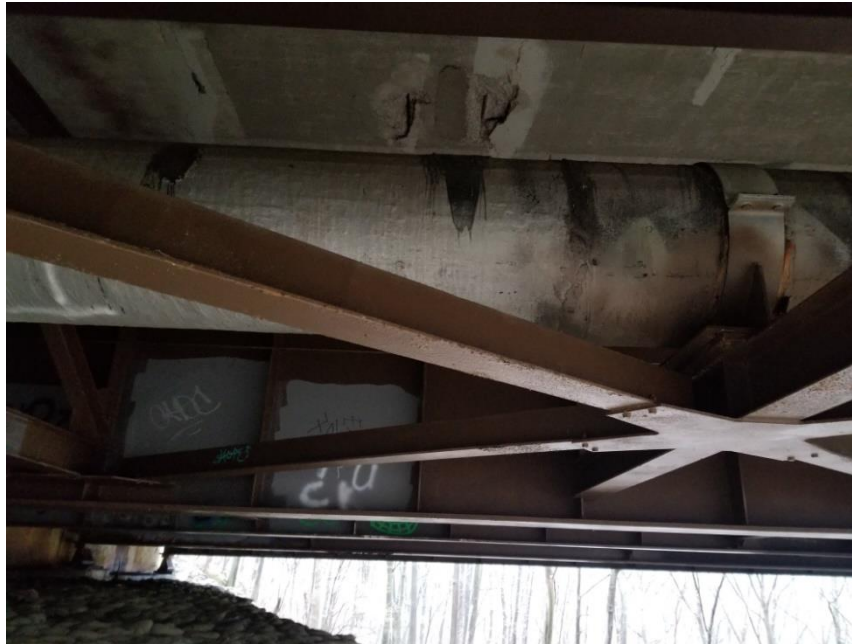
Photograph 07

View Looking at a 30-inch Diameter Tar and Fiberglass Covered Pipe Located on the North End on the Underside of the US-6 Bridge over the Rocky River, Lakewood, Cuyahoga County, Ohio

Black Felt
03	03-1		Black Felt	20% Chrysotile	
04	04-1		Black Felt	20% Chrysotile

1. Notify any outside contractor(s), prior to them working on the subject bridge, of the presence of the asbestos-containing tar and fiberglass pipe insulation located on a 30-inch water main. In addition, the suspect building materials identified during the construction plan review and not identified during the physical inspection may still be present on the structure; hence outside contractor(s) should be notified that these suspect building materials may be present on the bridge structure.

2. If renovation activities have the potential to disturb the asbestos-containing tar and fiberglass pipe insulation located on the 30-inch water main identified at the subject bridge, then a licensed asbestos abatement contractor should be retained to abate this material prior to it being disturbed.

4. If the asbestos-containing tar and fiberglass pipe insulation located on the 30-inch water main is to remain in place, implement an operations and maintenance (O&M) program whereby this material is continually evaluated and maintained by trained personnel.

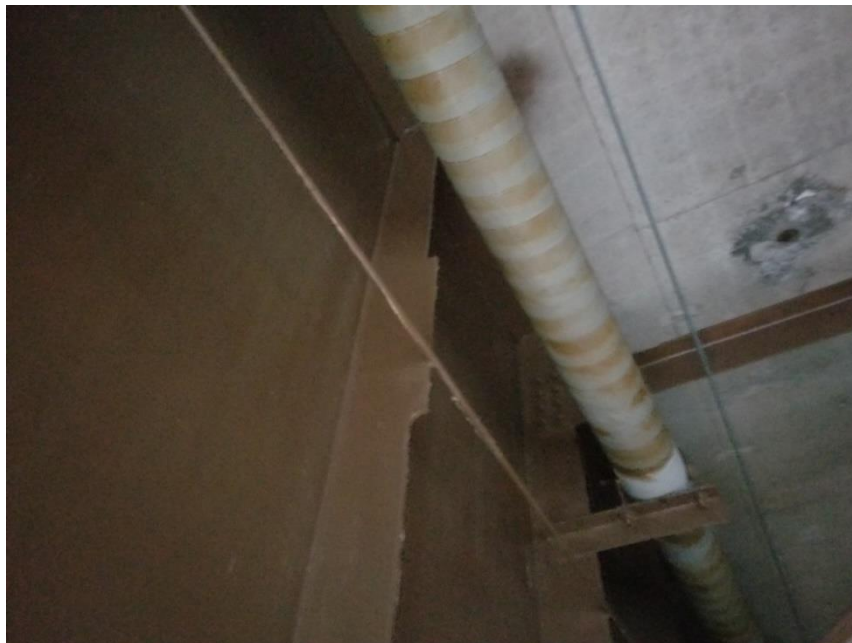
Photograph 08

View Looking at an 8-Inch Diameter Tar and Cloth Covered Pipe Located on the North End on the Underside of the US-6 Bridge over the Rocky River, Lakewood, Cuyahoga County, Ohio

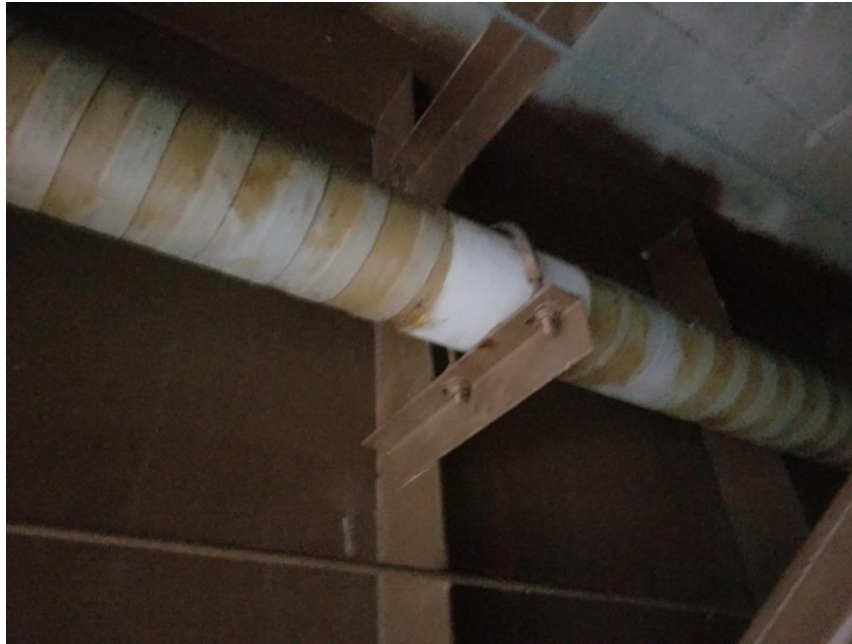
Photograph 09

HA	Suspect Material/Condition	Location	Sample No.	Asbestos Content (Percent)	Quantity of ACM Identified
D	Pipe Hanger Pad – Associated with HA-C Fair Condition	Underside of Bridge, North End	07	ND	NA
			08	ND

View Looking at a Hanger Pad on an 8-Inch Diameter Tar and Cloth Covered Pipe Located on the North End on the Underside of the US-6 Bridge over the Rocky River, Lakewood, Cuyahoga County, Ohio

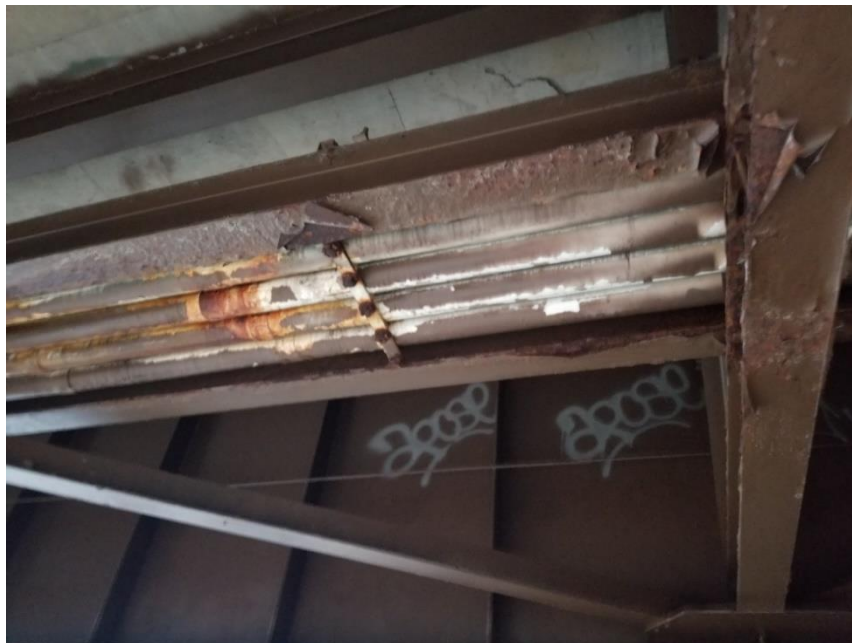
Photograph 10

During the physical inspection of the bridge, HZW located three (3) of the six (6) suspect materials identified during the construction plan review. These suspect materials consisted of the 12-inch gas main, the 30-inch water main and the bank of 16 Ameritech ducts. Suspect material associated with the 12-inch gas main and 30-inch water main was sampled as part of the physical inspection. The 16 Ameritech ducts were identified during the physical inspection as being comprised of plastic.

View Looking at Six (6) 12-inch Plastic Pipes Located on the Underside of the US-6 Bridge over the Rocky River, Lakewood, Cuyahoga County, Ohio
