Subject: *CUY-BH-FY2023 (B) Misc - PID 105909, Asbestos Survey
CUY – 90-29.070, Interstate 90 Bridge over State Route 175 (East 260th Street), SFN 1809008
HZW Project No. H21034*

Report of Findings of an Asbestos Survey Conducted of the Interstate 90 Bridge over State Route 175 (East 260th Street) Located in Euclid, Cuyahoga County, Ohio

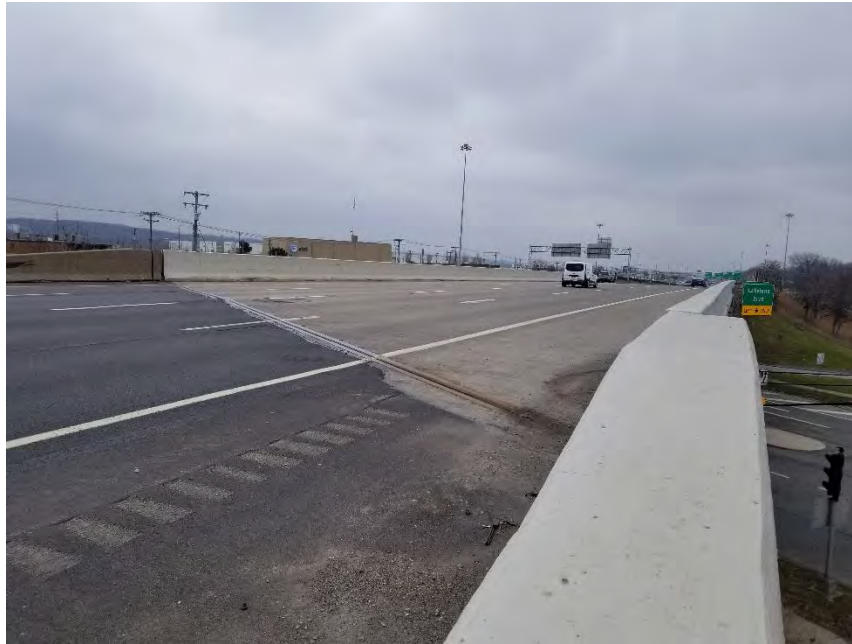
Photograph 01

View Looking West at the Top of the Interstate 90 Bridge over State Route 175 (East 260th Street), Euclid, Cuyahoga County, Ohio

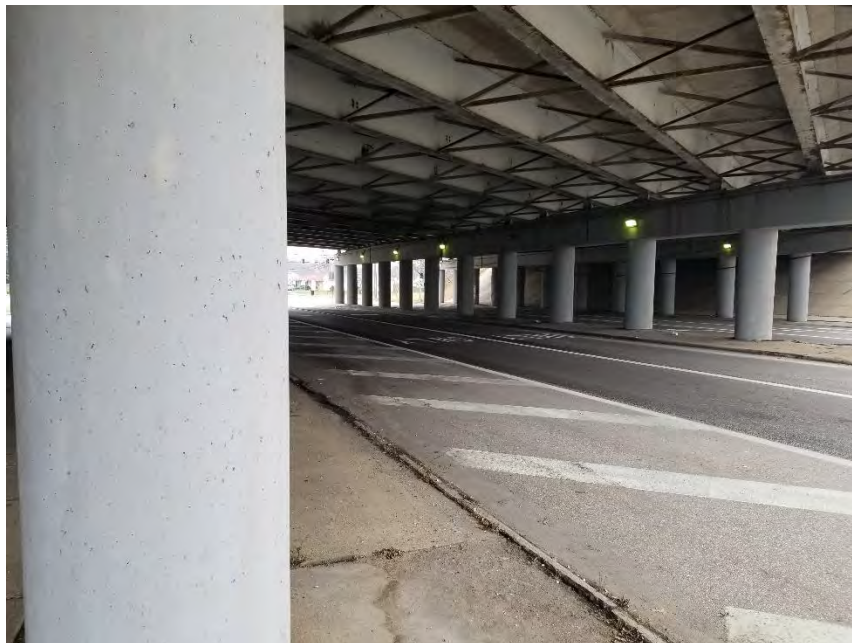
Photograph 02

View Looking Southwest at the Underside of the Interstate 90 Bridge over State Route 175 (East 260th Street), Euclid, Cuyahoga County, Ohio

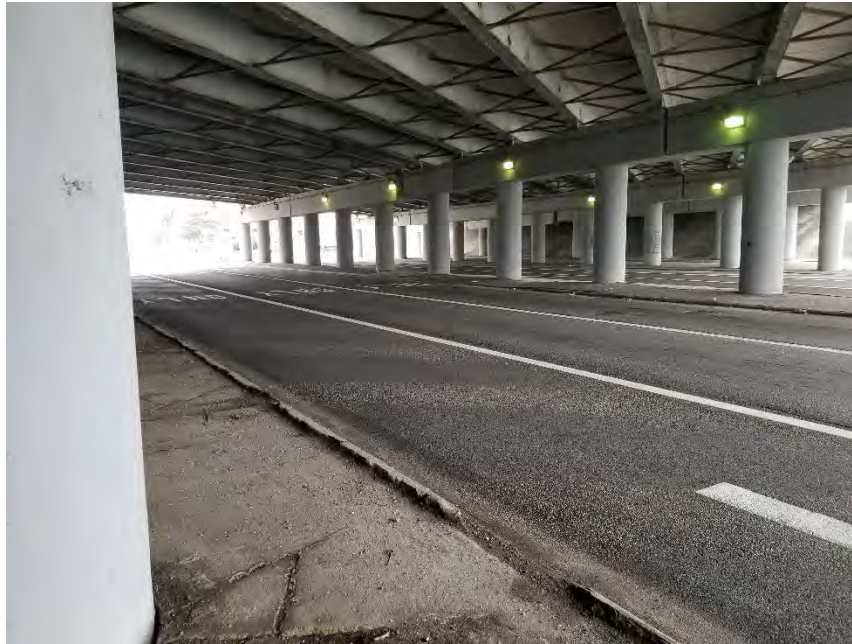
Photograph 03

View Looking Northeast at the Underside of the Interstate 90 Bridge over State Route 175 (East 260th Street), Euclid, Cuyahoga County, Ohio

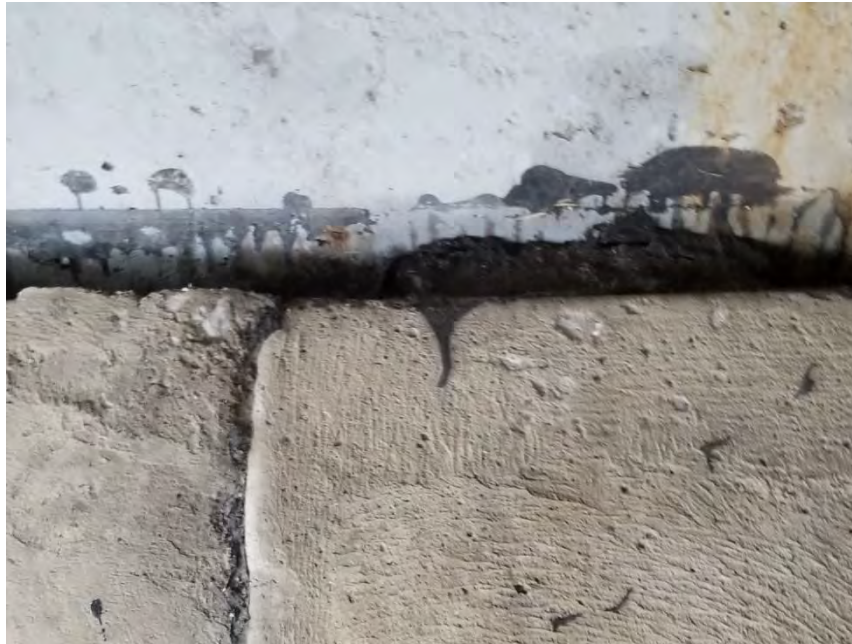
Photograph 05

View Looking at the 6-inch Gasket at the Abutment Wall and Slope on the Underside of the Interstate 90 Bridge over State Route 175 (East 260th Street), Euclid, Cuyahoga County, Ohio

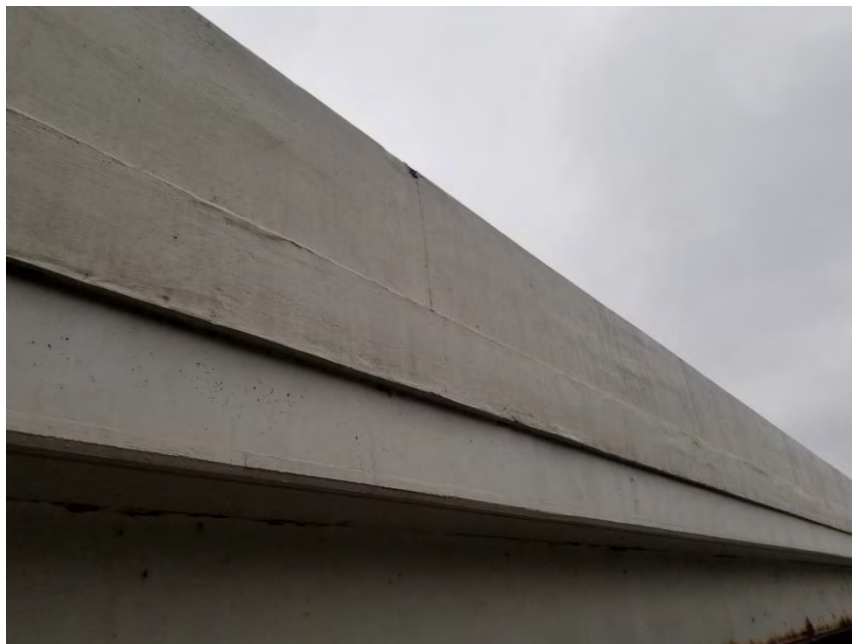
Photograph 06

During the physical inspection of the bridge, only one (1) suspect material was identified during the construction plan review. This suspect material consisted of the 1-inch gray sponge rubber preformed expansion joint filler and was sampled as part of the physical inspection.

View Looking at Gray Foam Gasket Located in a Parapet Crack on the Top Side of the Interstate 90 Bridge over State Route 175 (East 260th Street), Euclid, Cuyahoga County, Ohio
