HZW
Environmental
Consultants

Subject: Report of Findings of an Asbestos Survey Conducted of the East 98th Street Bridge over Interstate 480 Located in Garfield Heights, Cuyahoga County, Ohio (CUY-480-19.550, SFN 1812556) (HZW Project No. H19336)

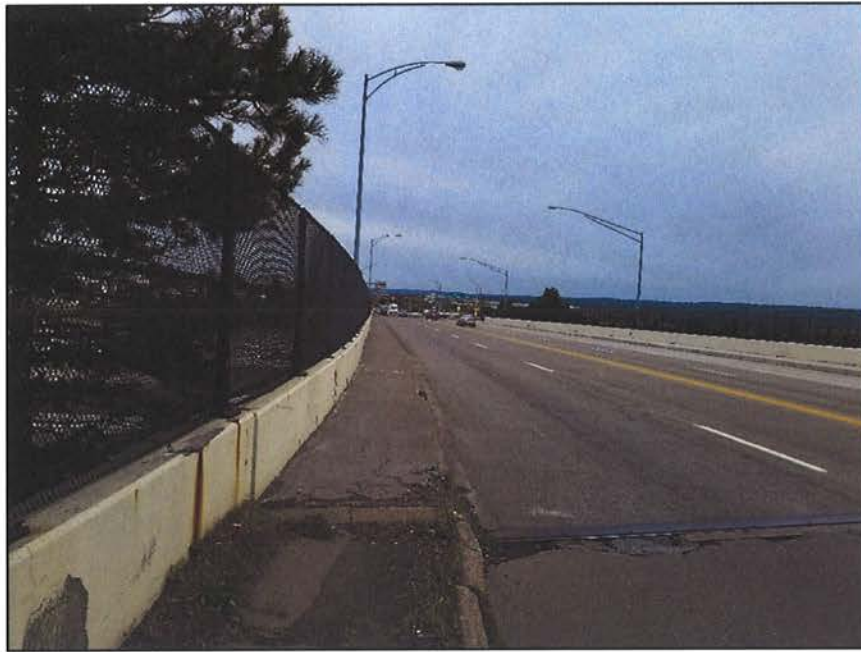
Photograph 01

View Looking South at the Top of the East 98th Street Bridge over Interstate 480,
Garfield Heights, Cuyahoga County, Ohio

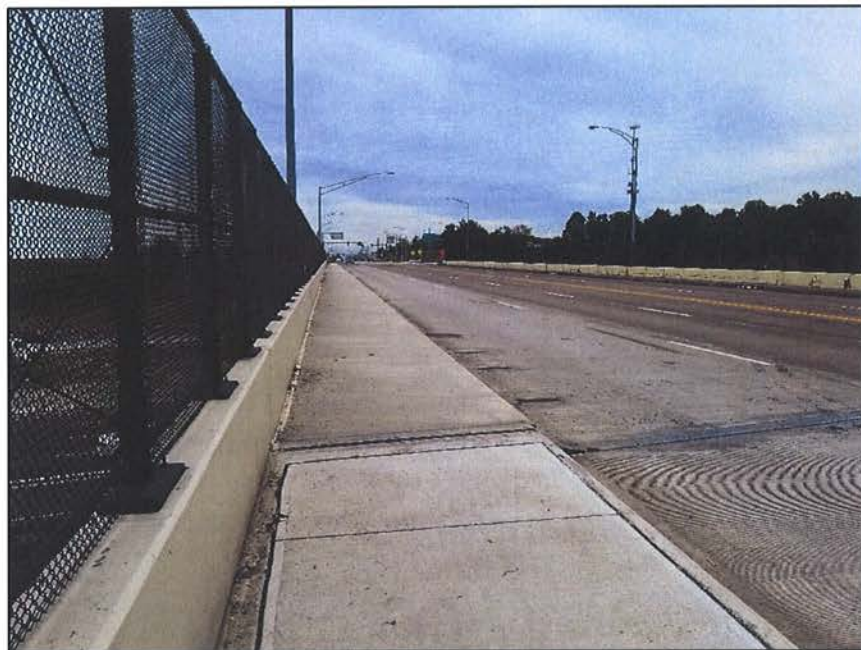
Photograph 02

View Looking North at the Top of the East 98th Street Bridge over Interstate 480,
Garfield Heights, Cuyahoga County, Ohio

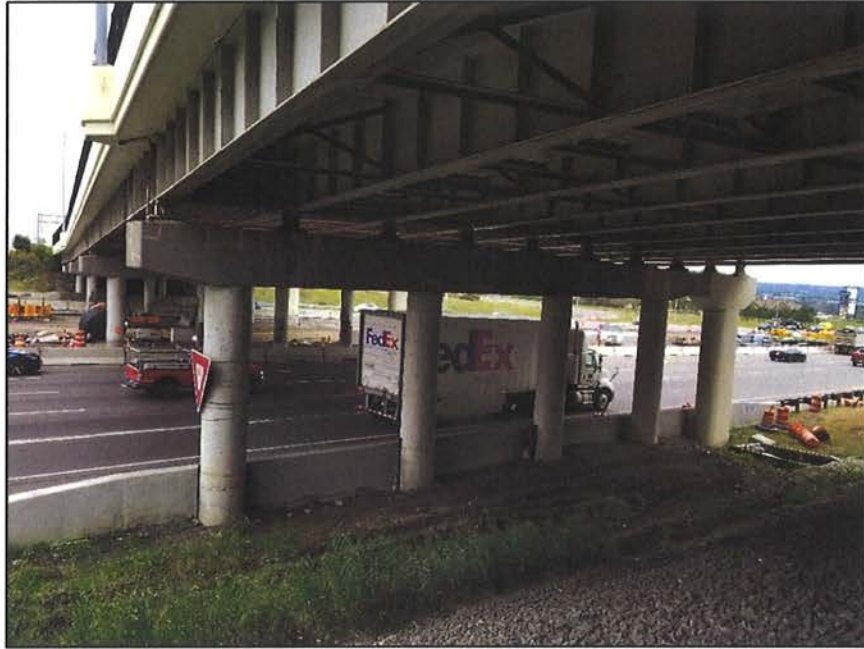
Photograph 03

View Looking Southwest at the Underside of the East 98th Street Bridge over Interstate 480, Garfield Heights, Cuyahoga County, Ohio

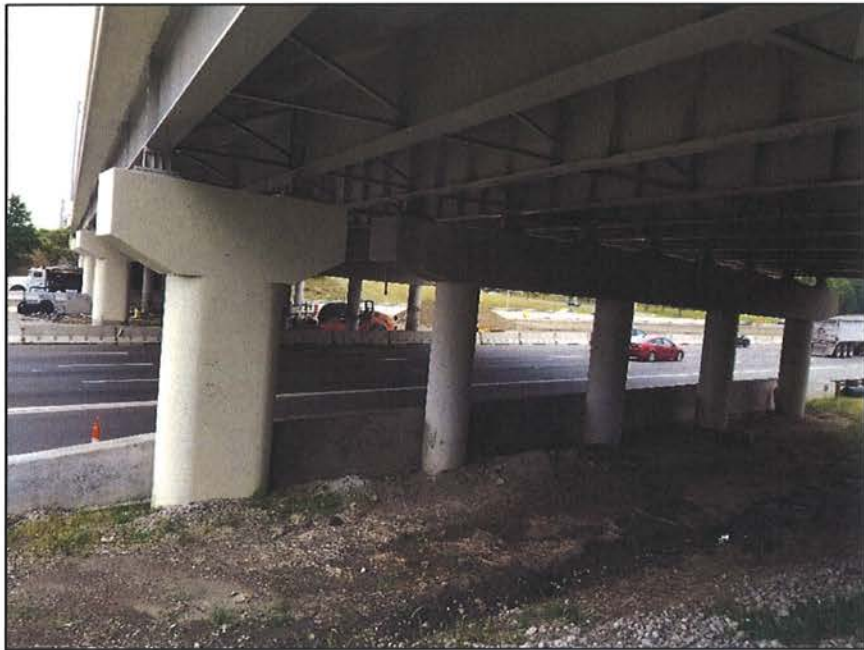
Photograph 04

View Looking Northeast at the Underside of the East 98th Street Bridge over Interstate 480, Garfield Heights, Cuyahoga County, Ohio

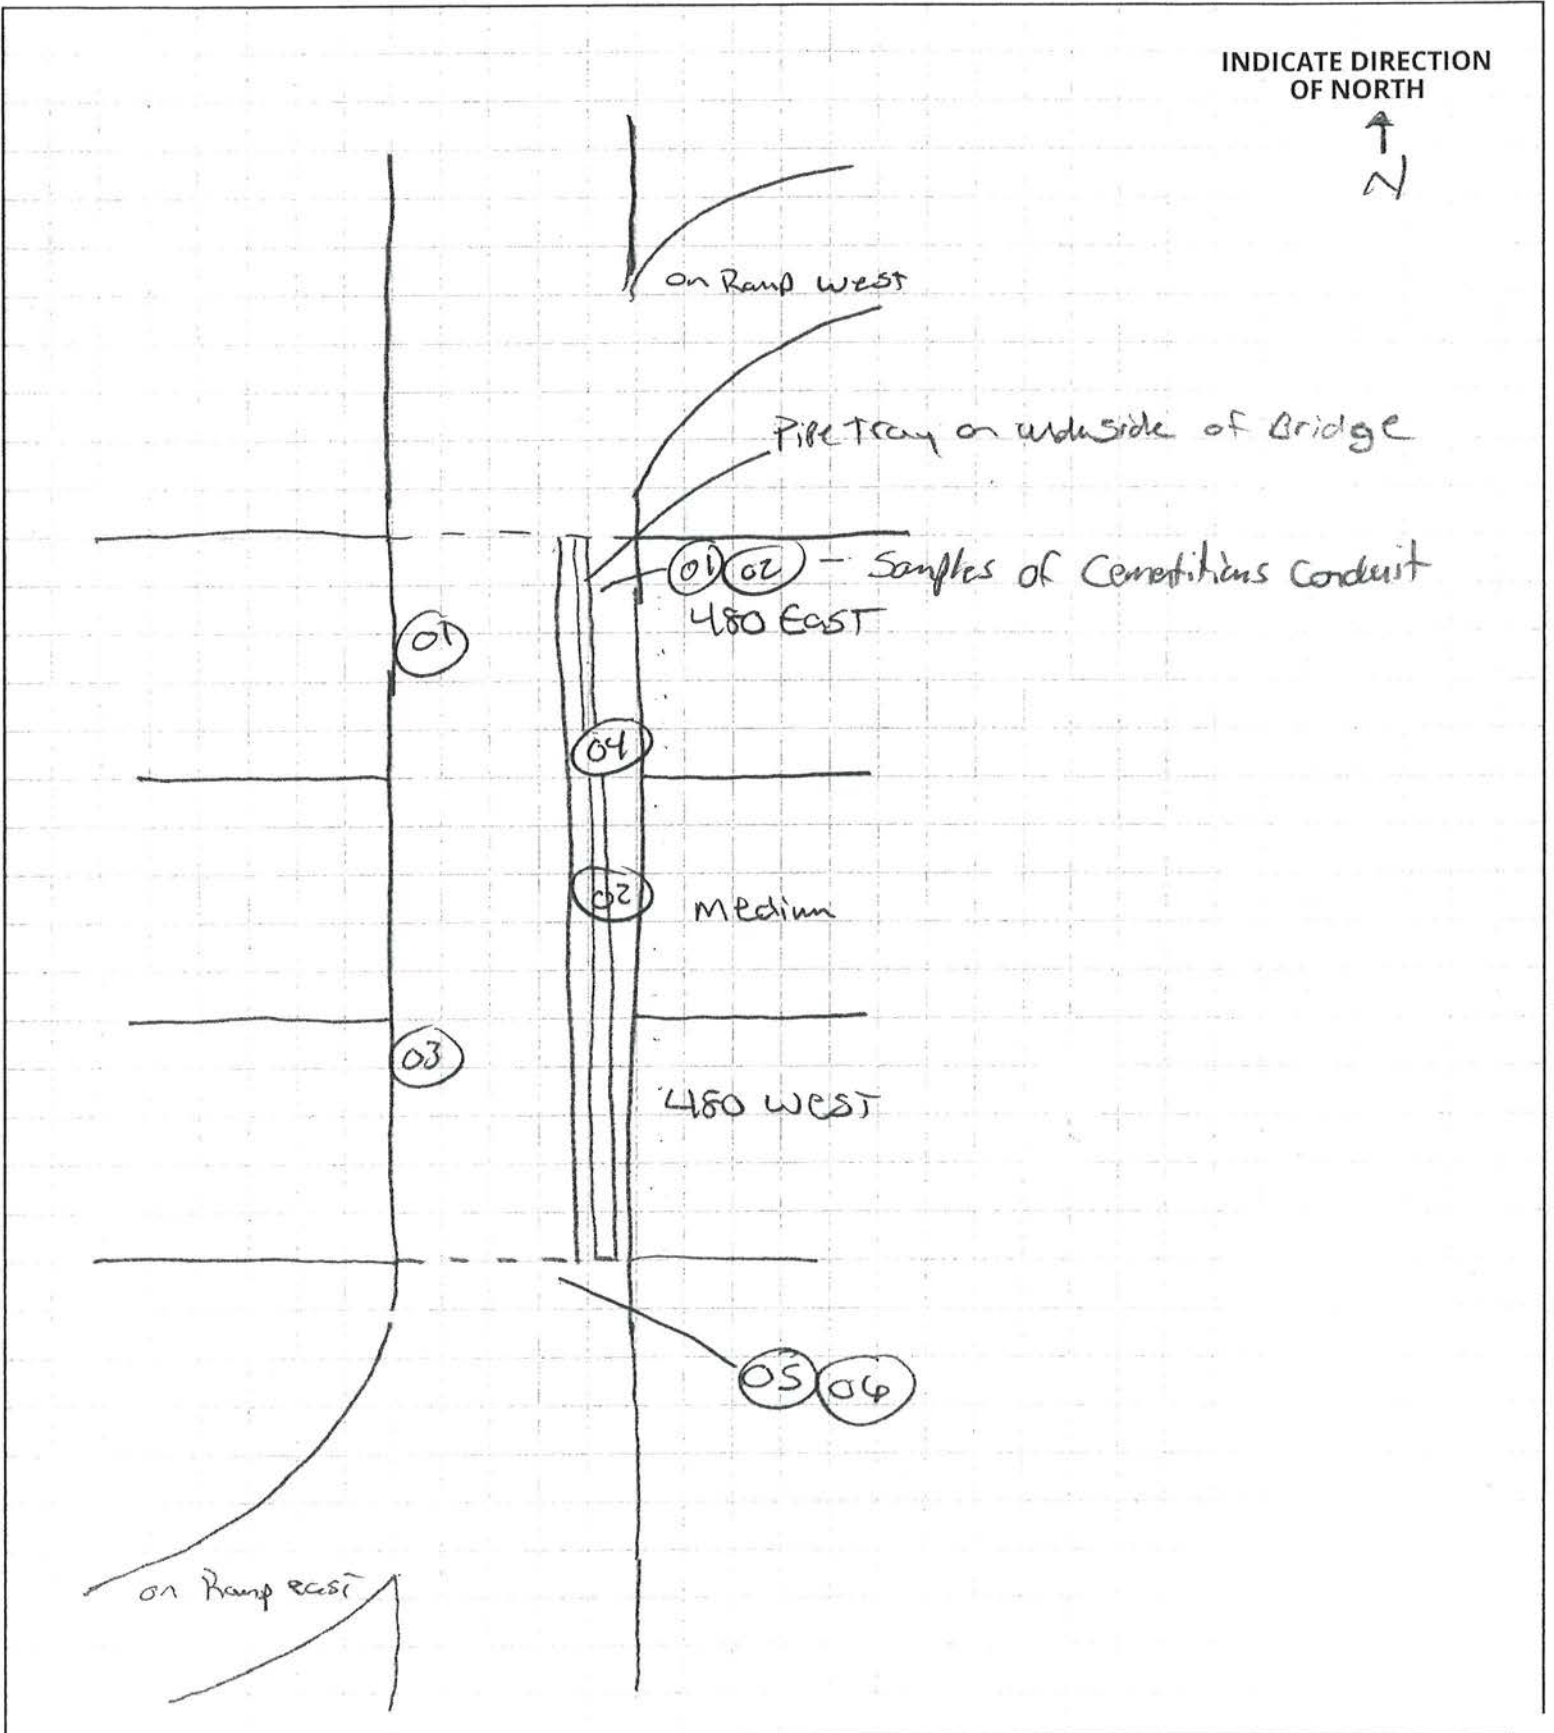
- SITE SKETCH OF BRIDGE

ID	Suspect Material/Condition	Location	Sample No.	Asbestos Content (Percent)	Quantity of ACM Identified
A	Caulk - Black Fair Condition	Topside of Bridge: Parapet Wall Fence Base	01	ND	NA
			02	ND	
B	Foam Gasket – Gray Fair Condition	Topside of Bridge: Between Parapet Wall Slabs	03	ND	NA
			04	ND	
C	Fibrous Column Wrap Fair Condition	Underside of Bridge: At Base of North End Columns	05	ND	NA
			06	ND	
D	Cementitious Conduit – 6-inch diameter Fair Condition	Underside of Bridge: Running Length of Bridge on East Side	01	20	1,062 ln.ft. (3 Conduits)
			02	NA

1. Notify any outside contractor(s), prior to them working on the subject bridge, of the presence of the asbestos-containing cementitious conduit. In addition, even though not identified on the bridge structure during the physical inspection, the suspect building materials identified during the construction plan review may still be present on the structure; hence outside contractor(s) should be notified that these suspect building materials may be present on the bridge structure.
2. If renovation activities have the potential to disturb the asbestos-containing cementitious conduit identified at the subject bridge, then a licensed asbestos abatement contractor should be retained to abate this material prior to it being disturbed.

4. If the asbestos-containing cementitious conduit is to remain in place, implement an operations and maintenance (O&M) program whereby this material is continually evaluated and maintained by trained personnel.
