**Reference: Final Subsurface Exploration Report for HAN-75-14.39
Bridge No. HAN-68-1585 over Proposed Lima Avenue
Findlay, Hancock County, Ohio
PID No. 87005
PGI Project No. G13011G**

**FINAL
SUBSURFACE EXPLORATION REPORT
FOR HAN-75-14.39
BRIDGE NO. HAN-68-1585 OVER PROPOSED LIMA AVENUE**

**HANCOCK COUNTY, OHIO
PGI PROJECT NO. G13011G
PID NO. 87005**

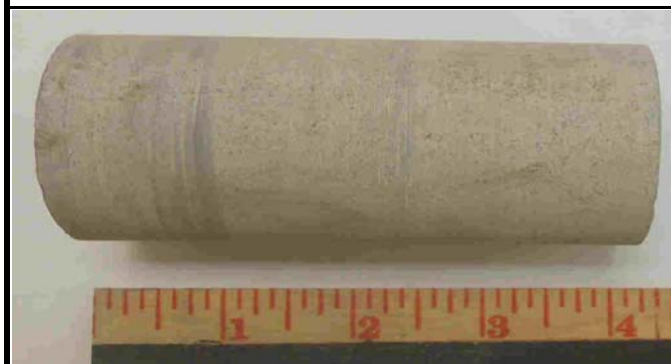
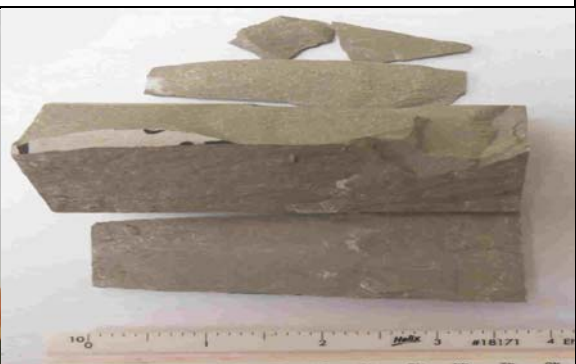
FORMATION	TYMOCHTEE / GREENFIELD GROUP
DESCRIPTION	DOLOMITE, LIGHT GRAY, MODERATELY TO SLIGHTLY WEATHERED, STRONG, VERY THIN TO THIN BEDDED, JOINTED, HIGHLY TO MODERATELY FRACTURED, FEW ANGULAR FRACTURES, APERTURE WIDTH TIGHT TO NARROW, SLIGHTLY TO VERY ROUGH

MEASUREMENT	LENGTH (INCH)	DIAMETER (INCH)	LENGTH/DIAMETER	
1	3.915	1.965		1.99
				CORRECTION FACTOR
2	3.930	1.970		1.00
				AREA (SQ. INCH)
3	3.915	1.985		3.058
				MASS (GRAMS)
AVERAGE	3.920	1.973		520.87
				UNIT WEIGHT (LBS/FT ³)
				165.51

MAXIMUM LOAD (LBS)	44160
COMPRESSIVE STRENGTH (PSI)	14427
TIME OF TEST (MINUTES)	3:10
LOADING DIRECTION	PERPENDICULAR TO BEDDING
TECHNICIAN	FBUSHER

BEFORE TESTING

AFTER FAILURE

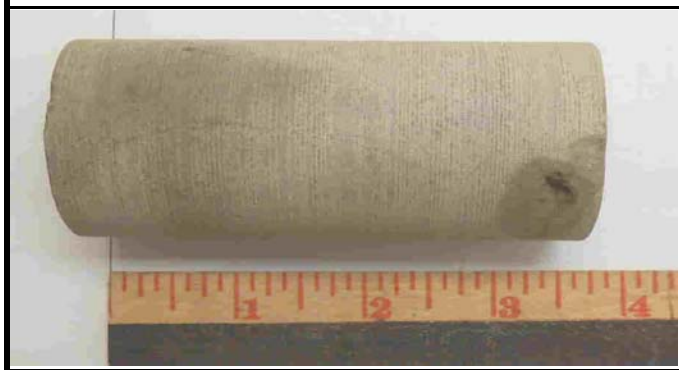
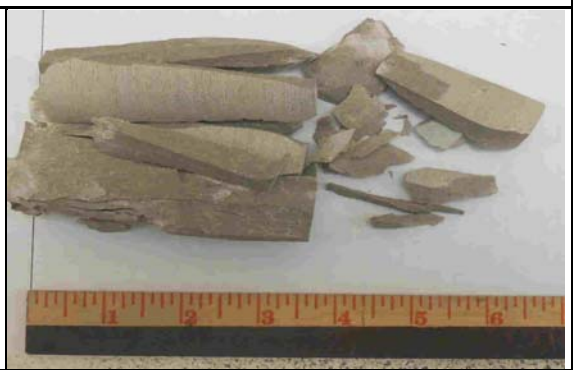
FORMATION	TYMOCHTEE / GREENFIELD GROUP
DESCRIPTION	DOLOMITE, LIGHT GRAY, MODERATELY TO SLIGHTLY WEATHERED, STRONG, VERY THIN TO THIN BEDDED, JOINTED, HIGHLY TO MODERATELY FRACTURED, FEW ANGULAR FRACTURES, APERTURE WIDTH TIGHT TO NARROW, SLIGHTLY TO VERY ROUGH

MEASUREMENT	LENGTH (INCH)	DIAMETER (INCH)	LENGTH/DIAMETER	1.82
1	3.593	2.023	CORRECTION FACTOR	1.01
2	3.576	2.022	AREA (SQ. INCH)	3.215
3	3.857	2.025	MASS (GRAMS)	514.17
AVERAGE	3.675	2.023	UNIT WEIGHT (LBS/FT ³)	165.75

MAXIMUM LOAD (LBS)	48120
COMPRESSIVE STRENGTH (PSI)	14787
TIME OF TEST (MINUTES)	3:00
LOADING DIRECTION	PERPENDICULAR TO BEDDING
TECHNICIAN	FBUSHER

BEFORE TESTING

AFTER FAILURE

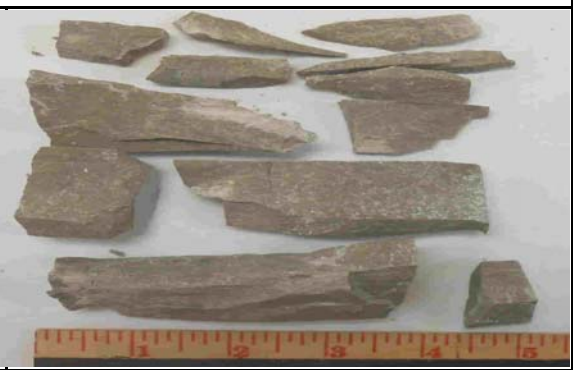
FORMATION	TYMOCHTEE / GREENFIELD GROUP
DESCRIPTION	DOLOMITE, LIGHT GRAY, MODERATELY TO SLIGHTLY WEATHERED, STRONG, VERY THIN TO THIN BEDDED, JOINTED, HIGHLY TO MODERATELY FRACTURED, FEW ANGULAR FRACTURES, APERTURE WIDTH TIGHT TO NARROW, SLIGHTLY TO VERY ROUGH

MEASUREMENT	LENGTH (INCH)	DIAMETER (INCH)		LENGTH/DIAMETER	1.92
1	3.945	2.052		CORRECTION FACTOR	1.00
2	3.935	2.045		AREA (SQ. INCH)	3.296
3	3.934	2.049		MASS (GRAMS)	564.17
AVERAGE	3.938	2.049		UNIT WEIGHT (LBS/FT ³)	165.57

MAXIMUM LOAD (LBS)	45649
COMPRESSIVE STRENGTH (PSI)	13781
TIME OF TEST (MINUTES)	3:20
LOADING DIRECTION	PERPENDICULAR TO BEDDING
TECHNICIAN	FBUSHER

BEFORE TESTING

AFTER FAILURE

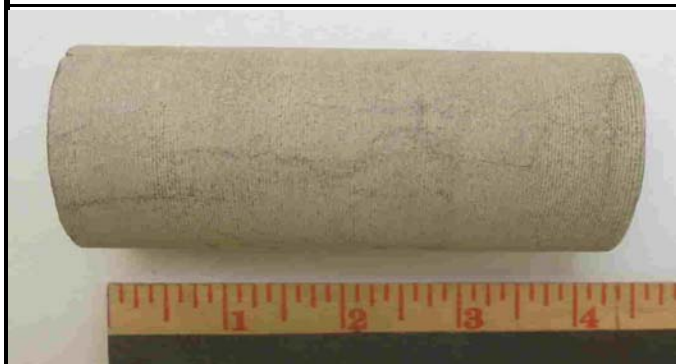
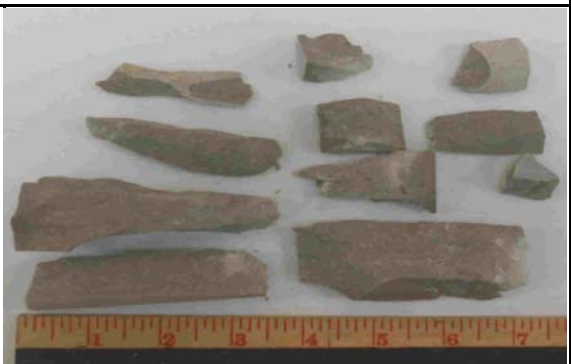
FORMATION	TYMOCHTEE / GREENFIELD GROUP
DESCRIPTION	DOLOMITE, LIGHT GRAY, SLIGHTLY WEATHERED, STRONG, THIN BEDDED, JOINTED, FRACTURED TO MODERATELY FRACTURED, FEW ANGULAR FRACTURES, APERTURE WIDTH TIGHT TO NARROW, SLIGHTLY TO VERY ROUGH

MEASUREMENT	LENGTH (INCH)	DIAMETER (INCH)	LENGTH/DIAMETER	
1	4.013	2.043		1.97
				CORRECTION FACTOR 1.00
2	4.031	2.039		AREA (SQ. INCH) 3.269
3	4.028	2.038		MASS (GRAMS) 585.77
AVERAGE	4.024	2.040		UNIT WEIGHT (LBS/FT ³) 169.67

MAXIMUM LOAD (LBS)	64288
COMPRESSIVE STRENGTH (PSI)	19636
TIME OF TEST (MINUTES)	3:10
LOADING DIRECTION	PERPENDICULAR TO BEDDING
TECHNICIAN	FBUSHER

BEFORE TESTING

AFTER FAILURE

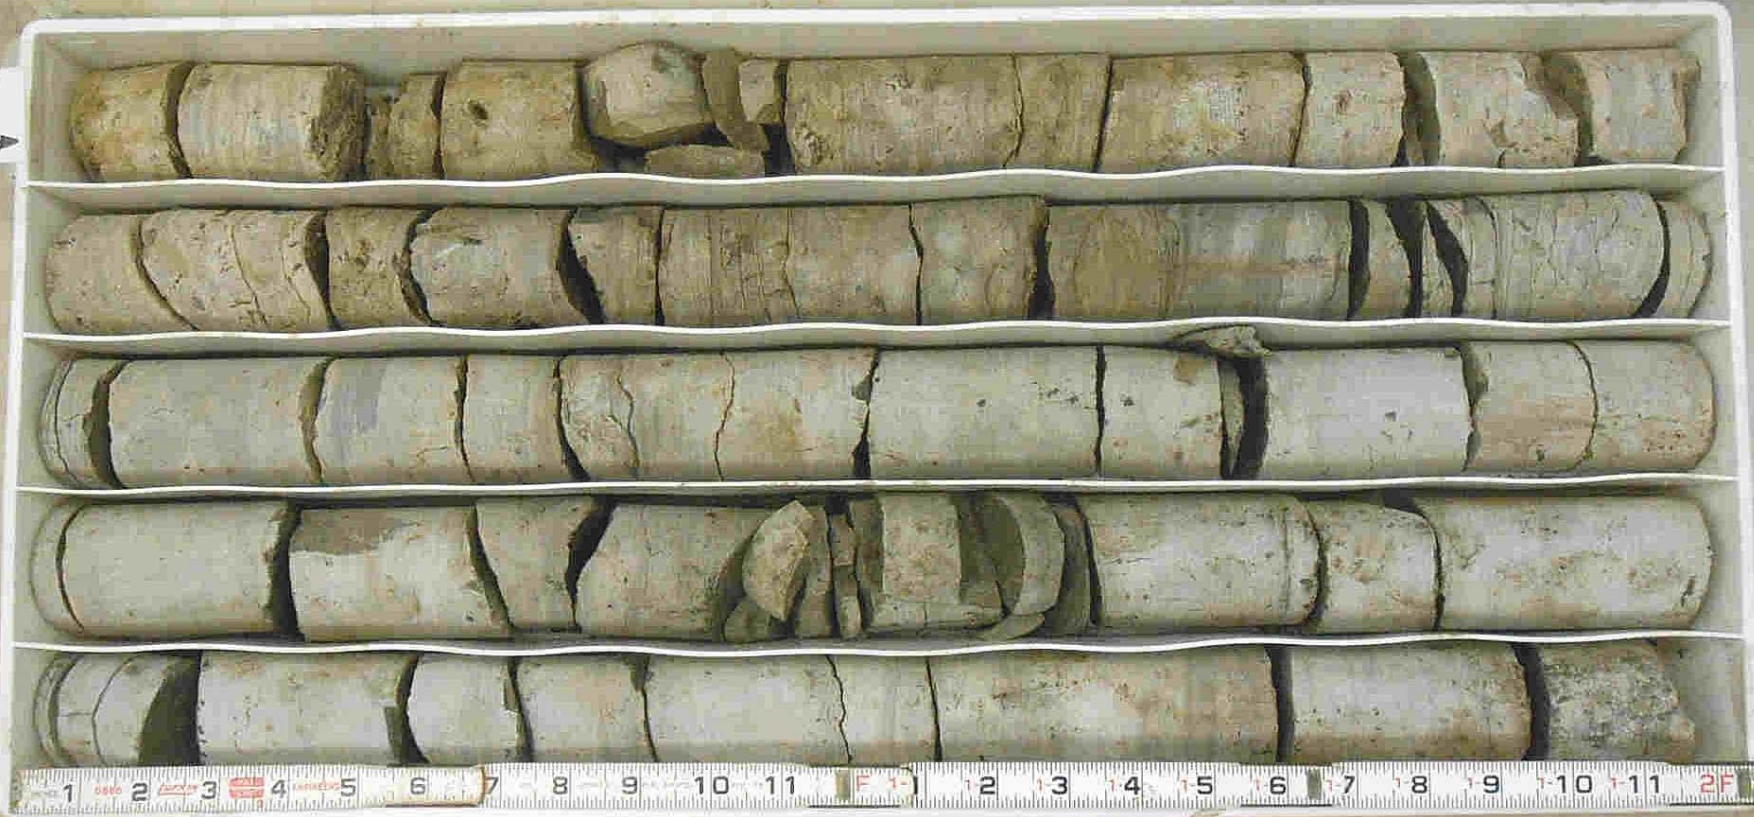
TOP OF
RUN 1
→

BOTTOM
RUN 1
←

COMPANY: PGI
PROJECT: HAN-75-14.39
BRIDGE NO.: HAN-68-1585 over Proposed Lima Ave.
BORING: B-083-0-13 BOX 1/1
DATE of CORING: 7/29/13
RUN-1: 4.0' - 14.0'
REC: 100% RQD: 38%
