**Reference: Final Structure Foundation Exploration Report for HAN-75-14.39
Bridge No. HAN-68-1668 over US 68 Ramp A and Norfolk Southern Railroad
Findlay, Hancock County, Ohio
ODOT PID No. 87005 and PGI Project No. G13011G**

**FINAL
STRUCTURE FOUNDATION EXPLORATION REPORT
FOR HAN-75-14.39
BRIDGE NO. HAN-68-1668 OVER US 68 RAMP A &
NORFOLK SOUTHERN RAILROAD**

**HANCOCK COUNTY, OHIO
ODOT PID NO. 87005 AND PGI PROJECT NO. G13011G**

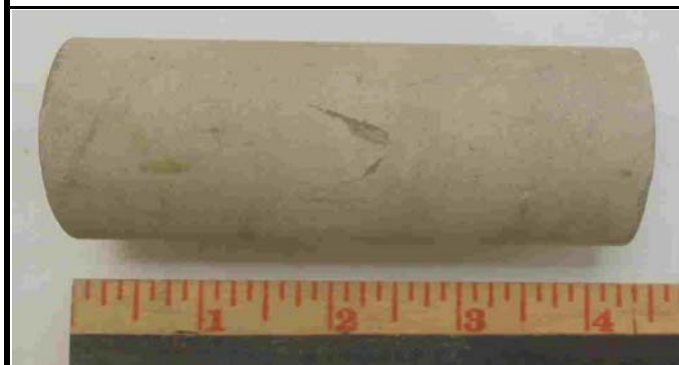
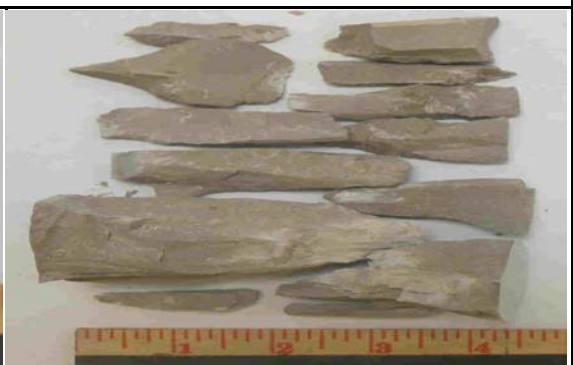
MEASUREMENT	LENGTH (INCH)	DIAMETER (INCH)		LENGTH/DIAMETER	2.04
1	4.005	1.960		CORRECTION FACTOR	1.00
2	4.011	1.964		AREA (SQ. INCH)	3.033
3	4.009	1.971		MASS (GRAMS)	536.15
AVERAGE	4.008	1.965		UNIT WEIGHT (LBS/FT ³)	168.03

MAXIMUM LOAD (LBS)	52632
COMPRESSIVE STRENGTH (PSI)	17355
TIME OF TEST (MINUTES)	2:40
LOADING DIRECTION	PERPENDICULAR TO BEDDING
TECHNICIAN	F. BUSER

BEFORE TESTING

AFTER FAILURE

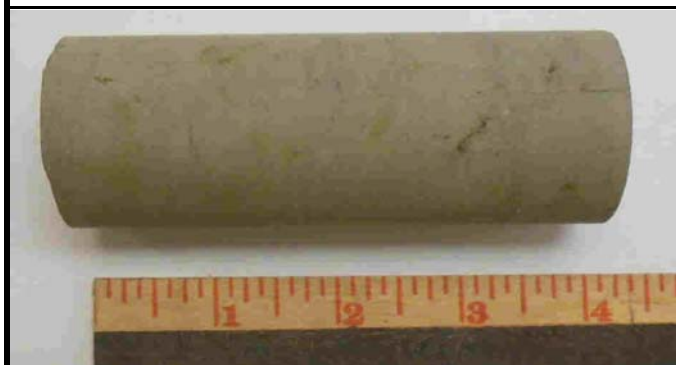
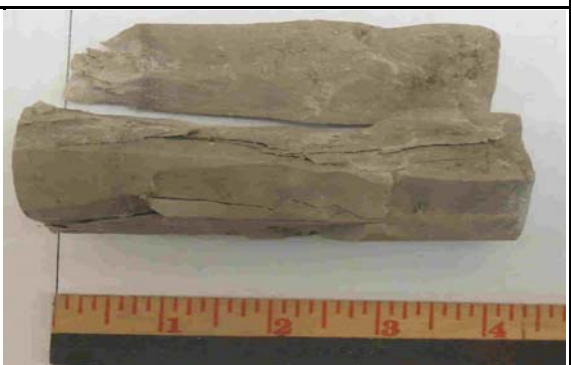
MEASUREMENT	LENGTH (INCH)	DIAMETER (INCH)	LENGTH/DIAMETER	
1	4.011	1.965		2.04
2	4.017	1.958		1.00
3	4.019	1.977		3.038
AVERAGE	4.016	1.967		531.94
				UNIT WEIGHT (LBS/FT ³)
				166.12

MAXIMUM LOAD (LBS)	32276
COMPRESSIVE STRENGTH (PSI)	10625
TIME OF TEST (MINUTES)	3.32
LOADING DIRECTION	PERPENDICULAR TO BEDDING
TECHNICIAN	F. BUSER

BEFORE TESTING

AFTER FAILURE

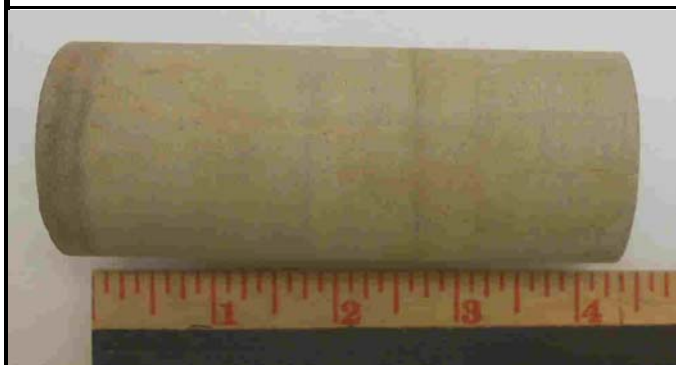
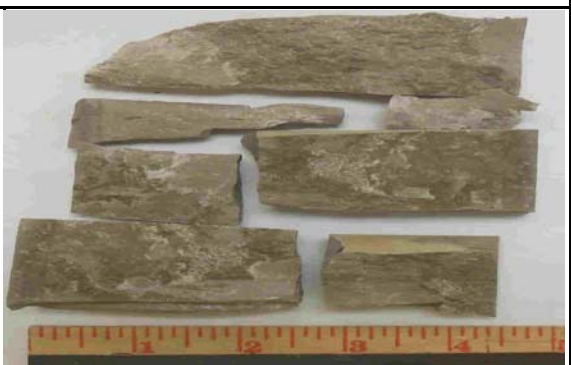
MEASUREMENT	LENGTH (INCH)	DIAMETER (INCH)	LENGTH/DIAMETER	
1	4.053	1.955		2.07
				CORRECTION FACTOR 1.00
2	4.055	1.950		AREA (SQ. INCH) 2.999
3	4.055	1.957		MASS (GRAMS) 546.28
AVERAGE	4.054	1.954		UNIT WEIGHT (LBS/FT ³) 171.17

MAXIMUM LOAD (LBS)	38071
COMPRESSIVE STRENGTH (PSI)	12696
TIME OF TEST (MINUTES)	3.32
LOADING DIRECTION	PERPENDICULAR TO BEDDING
TECHNICIAN	F. BUSER

BEFORE TESTING

AFTER FAILURE

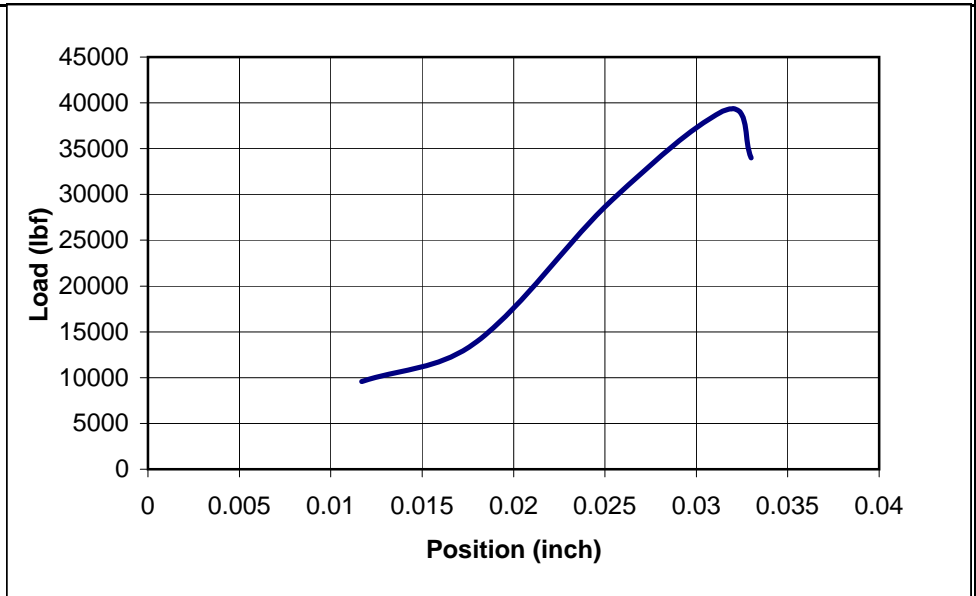
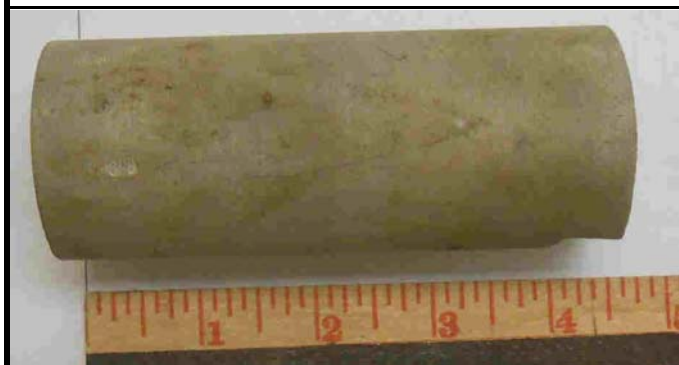
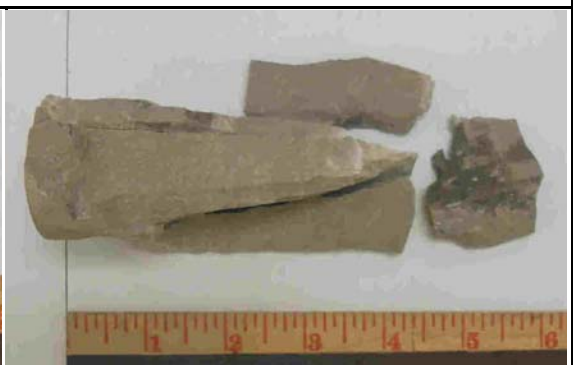
MEASUREMENT	LENGTH (INCH)	DIAMETER (INCH)	LENGTH/DIAMETER	
1	4.362	1.942		2.26
				CORRECTION FACTOR
2	4.358	1.939		1.00
				AREA (SQ. INCH)
3	4.460	1.940		2.957
				MASS (GRAMS)
AVERAGE	4.393	1.940		571.16
				UNIT WEIGHT (LBS/FT ³)
				167.49

MAXIMUM LOAD (LBS)	39281
COMPRESSIVE STRENGTH (PSI)	13284
TIME OF TEST (MINUTES)	3:10
LOADING DIRECTION	PERPENDICULAR TO BEDDING
TECHNICIAN	F. BUSER

BEFORE TESTING

AFTER FAILURE

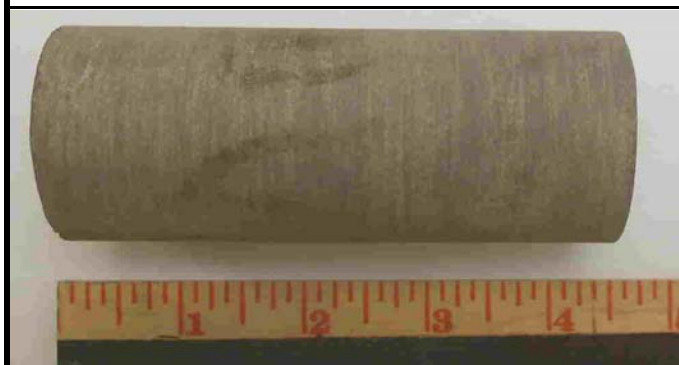
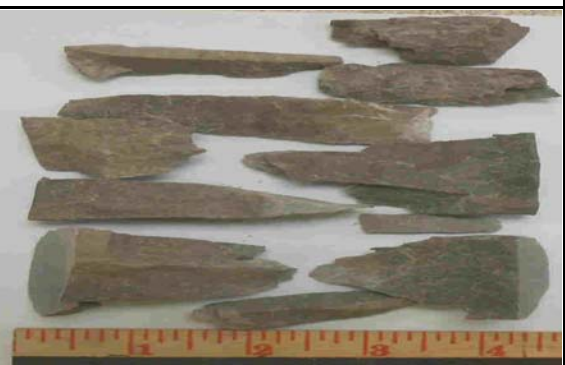
MEASUREMENT	LENGTH (INCH)	DIAMETER (INCH)	LENGTH/DIAMETER	
1	4.029	1.959		2.05
				CORRECTION FACTOR
2	4.010	1.964		1.00
				AREA (SQ. INCH)
3	4.016	1.967		3.027
				MASS (GRAMS)
AVERAGE	4.018	1.963		543.92
				UNIT WEIGHT (LBS/FT ³)
				170.33

MAXIMUM LOAD (LBS)	76835
COMPRESSIVE STRENGTH (PSI)	25379
TIME OF TEST (MINUTES)	3:10
LOADING DIRECTION	PERPENDICULAR TO BEDDING
TECHNICIAN	F. BUSER

BEFORE TESTING

AFTER FAILURE

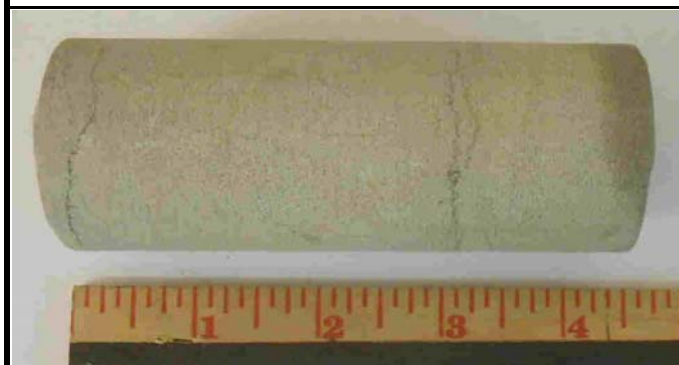
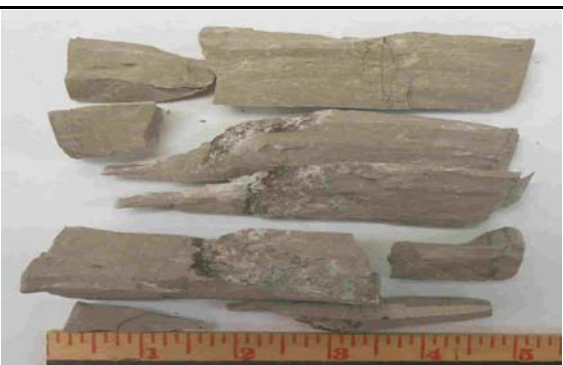
MEASUREMENT	LENGTH (INCH)	DIAMETER (INCH)	LENGTH/DIAMETER	
1	4.150	2.039		2.03
2	4.139	2.045		1.00
3	4.140	2.040		3.273
AVERAGE	4.143	2.041		585.86
				UNIT WEIGHT (LBS/FT ³)
				164.60

MAXIMUM LOAD (LBS)	46313
COMPRESSIVE STRENGTH (PSI)	14151
TIME OF TEST (MINUTES)	2:40
LOADING DIRECTION	PERPENDICULAR TO BEDDING
TECHNICIAN	F. BUSER

BEFORE TESTING

AFTER FAILURE

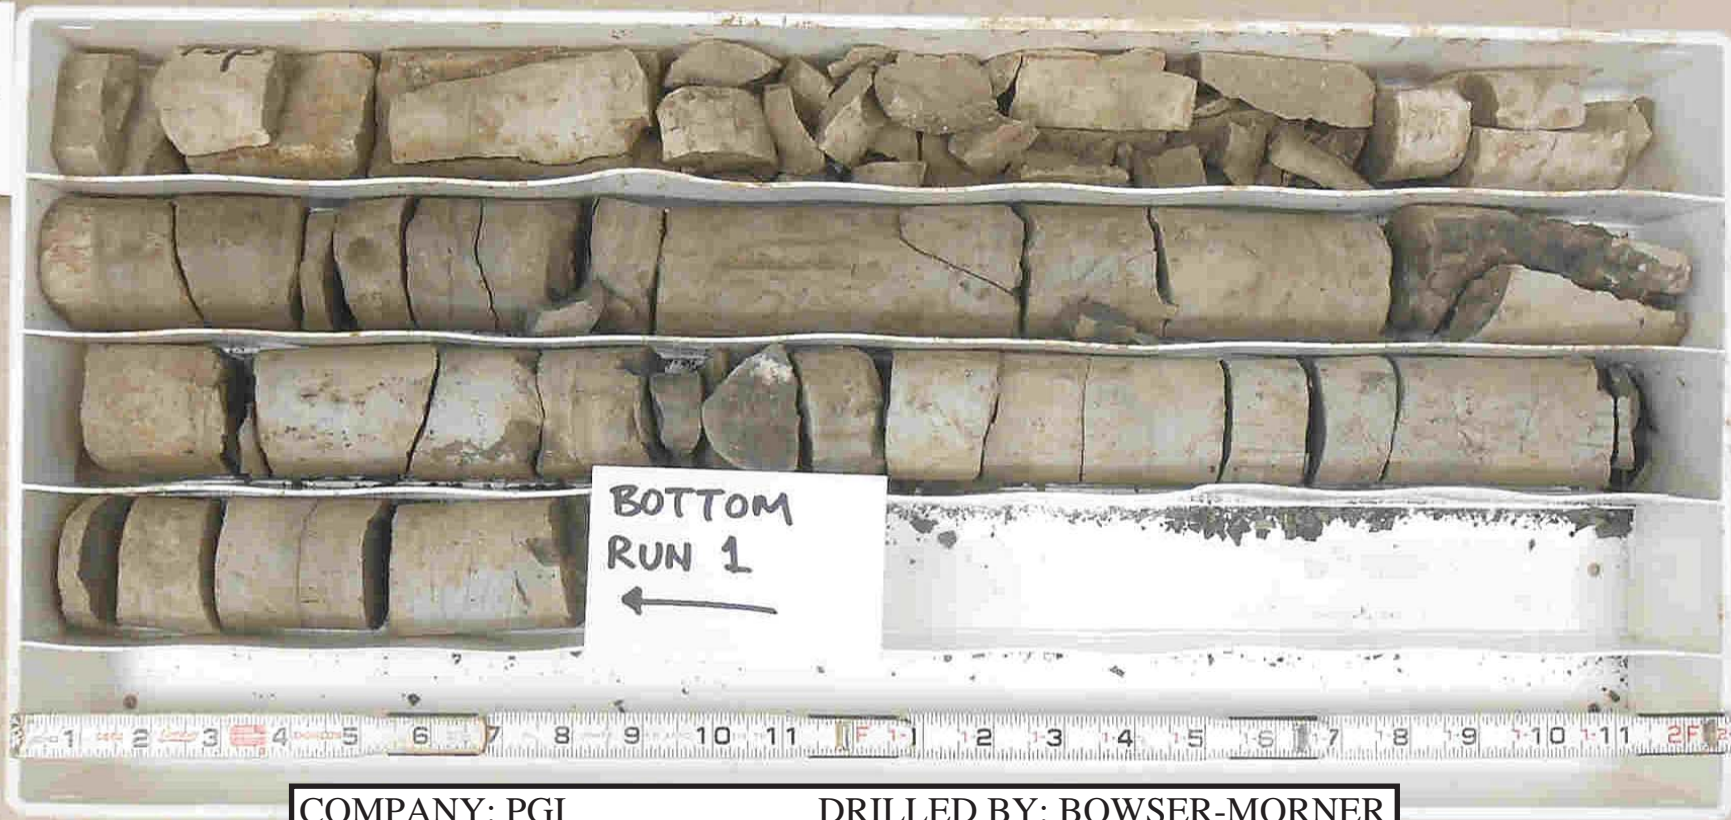
COMPANY: PGI DRILLED BY: BOWSER-MORNER
PROJECT: HAN-75-14.39
BRIDGE NO.: HAN-68-1668 over US 68 RAMP A & NS RAILROAD
BORING: B-126-0-13 BOX 1/2
DATE of CORING: 7/22/13
RUN-1: 7.5' - 14.0'
REC: 100% RQD: 10%

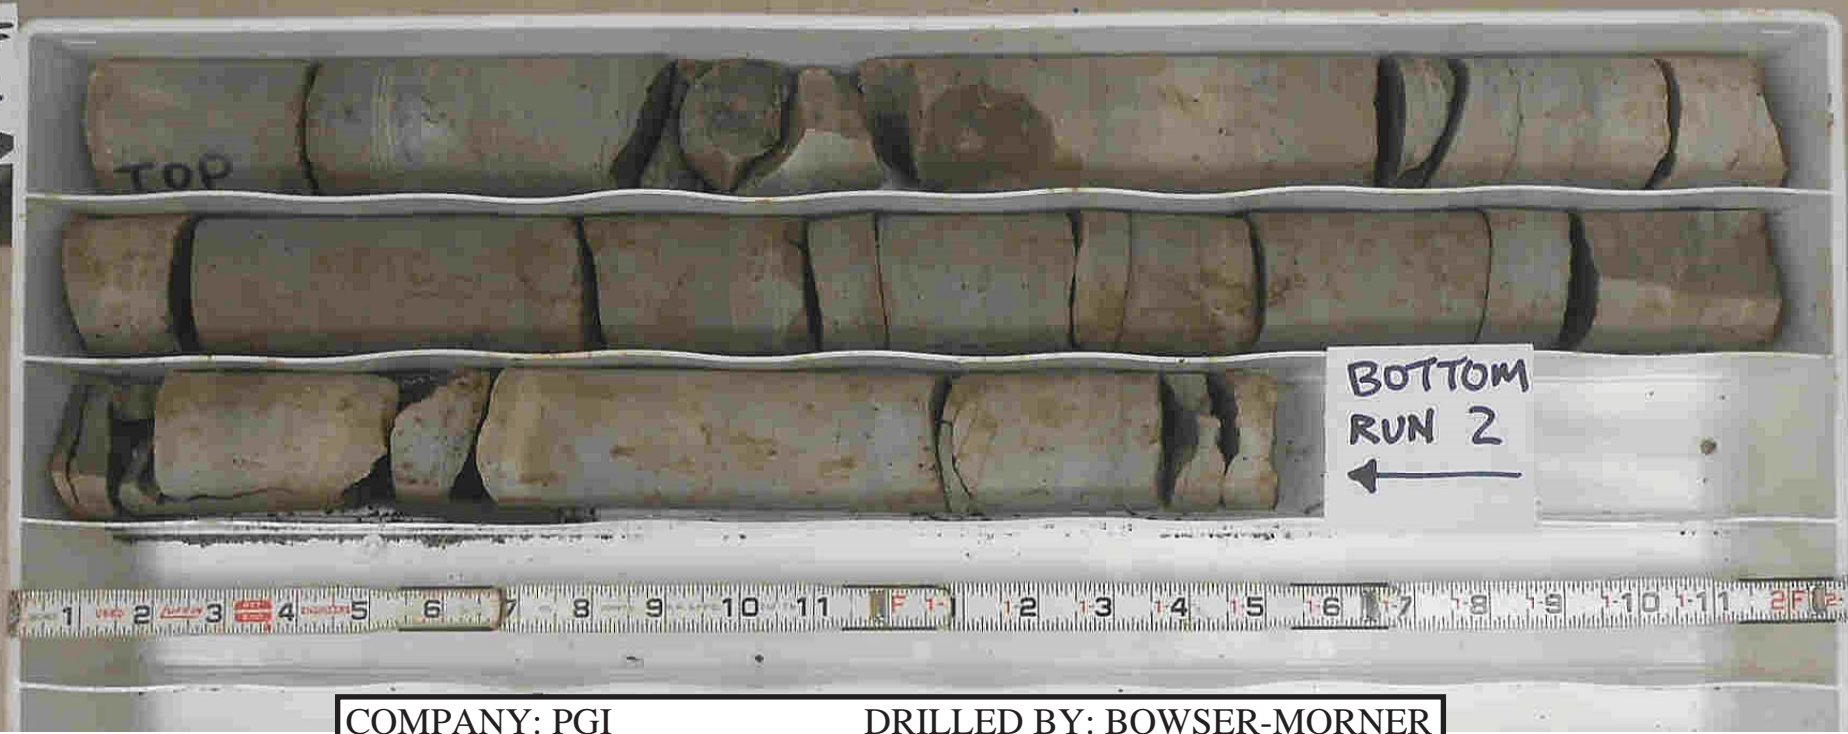
COMPANY: PGI DRILLED BY: BOWSER-MORNER
PROJECT: HAN-75-14.39
BRIDGE NO.: HAN-68-1668 over US 68 RAMP A & NS RAILROAD
BORING: B-126-0-13 BOX 2/2
DATE of CORING: 7/22/13
RUN-2: 14.0' - 19.0'
REC: 100% RQD: 43%

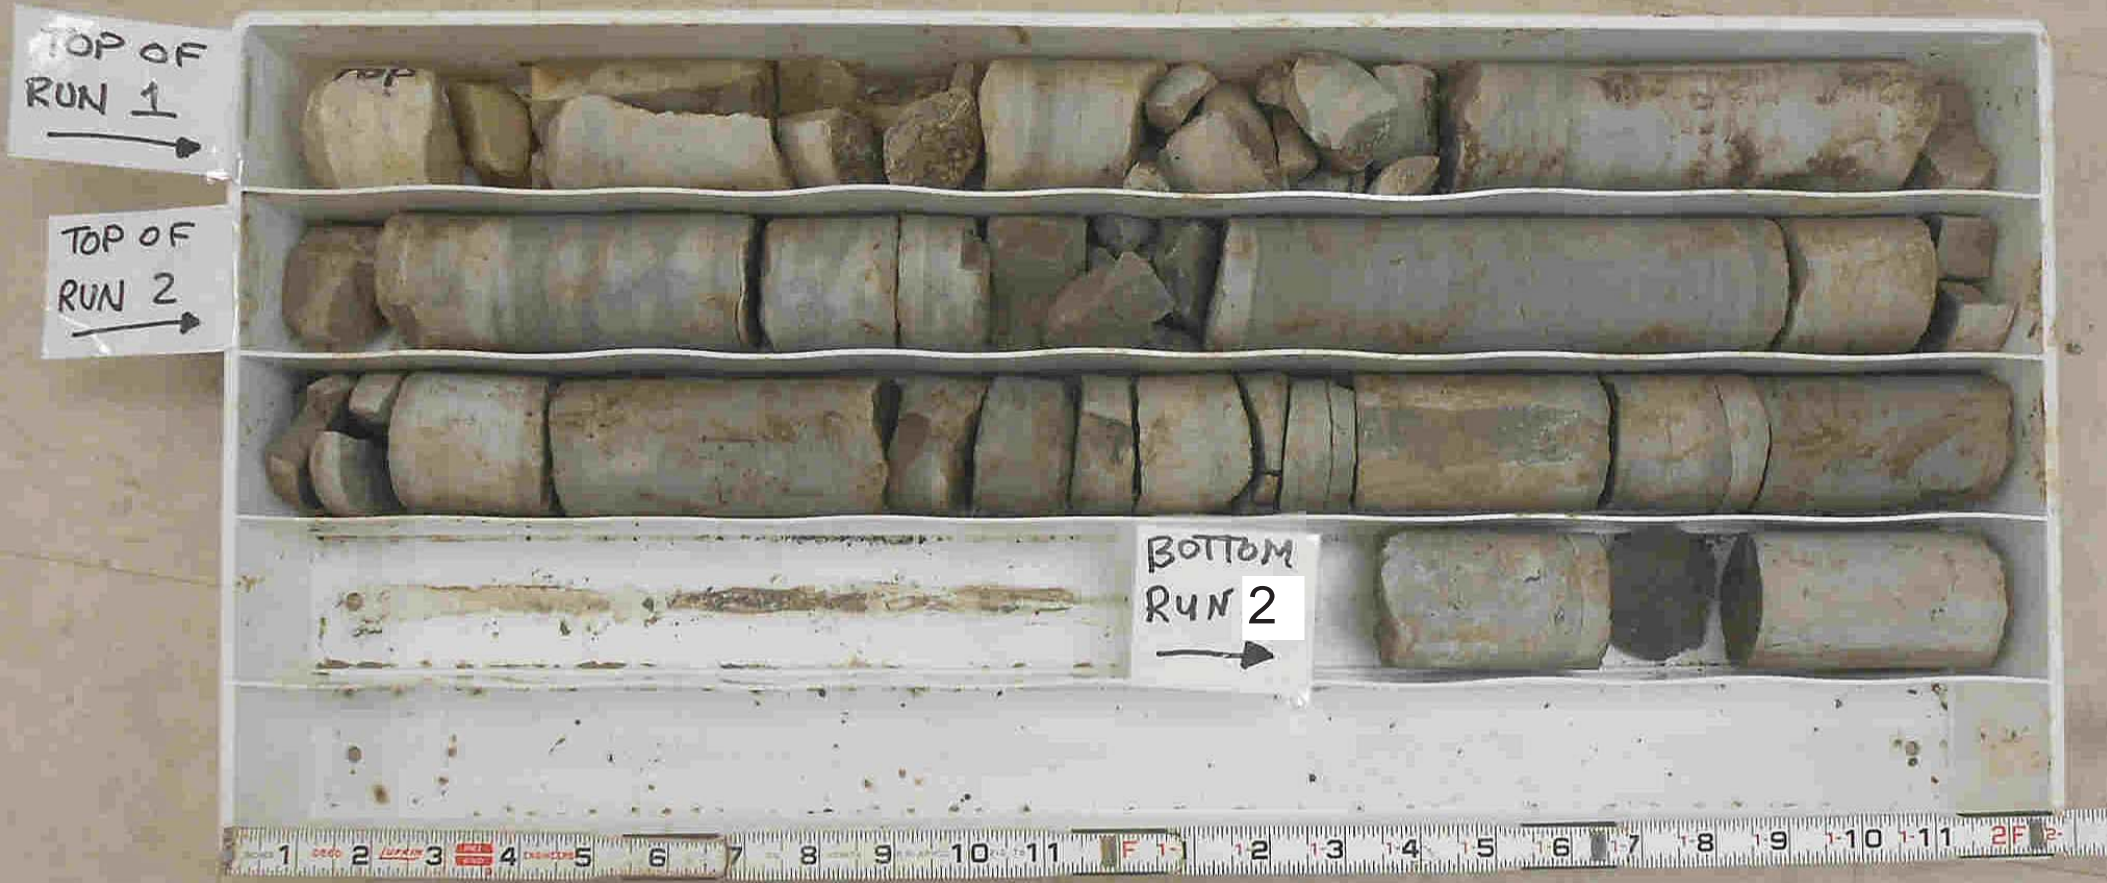
COMPANY: PGI	DRILLED BY: BOWSER-MORNER
PROJECT: HAN-75-14.39	
BRIDGE NO.: HAN-68-1668 over US 68 RAMP A & NS RAILROAD	
BORING: B-128-0-13 BOX 1/3	
DATE of CORING: 7/22/13	
RUN-1: 7.5' - 9.5'	RUN-2: 9.5' - 14.0'
REC: 100% RQD: 30%	REC: 100% RQD: 37%

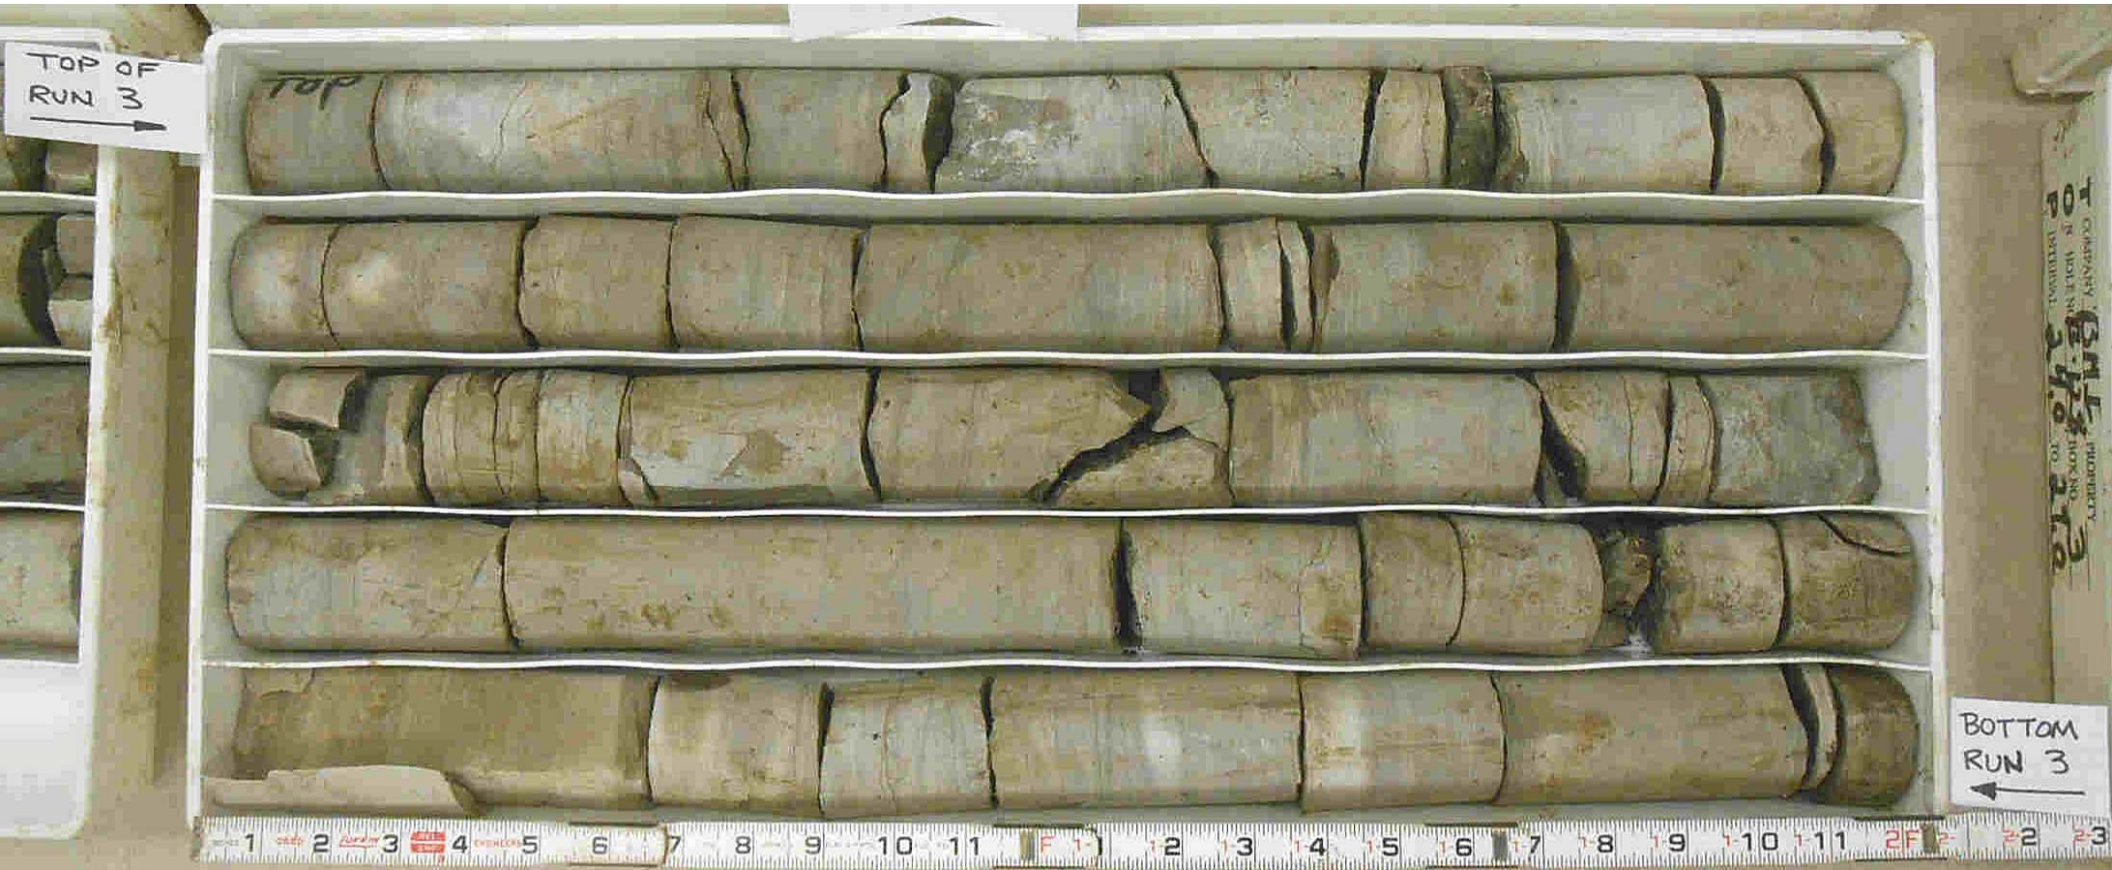
COMPANY: PGI DRILLED BY: BOWSER-MORNER
PROJECT: HAN-75-14.39
BRIDGE NO.: HAN-68-1668 over US 68 RAMP A & NS RAILROAD
BORING: B-128-0-13 BOX 2/3
DATE of CORING: 7/22/13
RUN-3: 14.0' - 24.0'
REC: 100% RQD: 60%

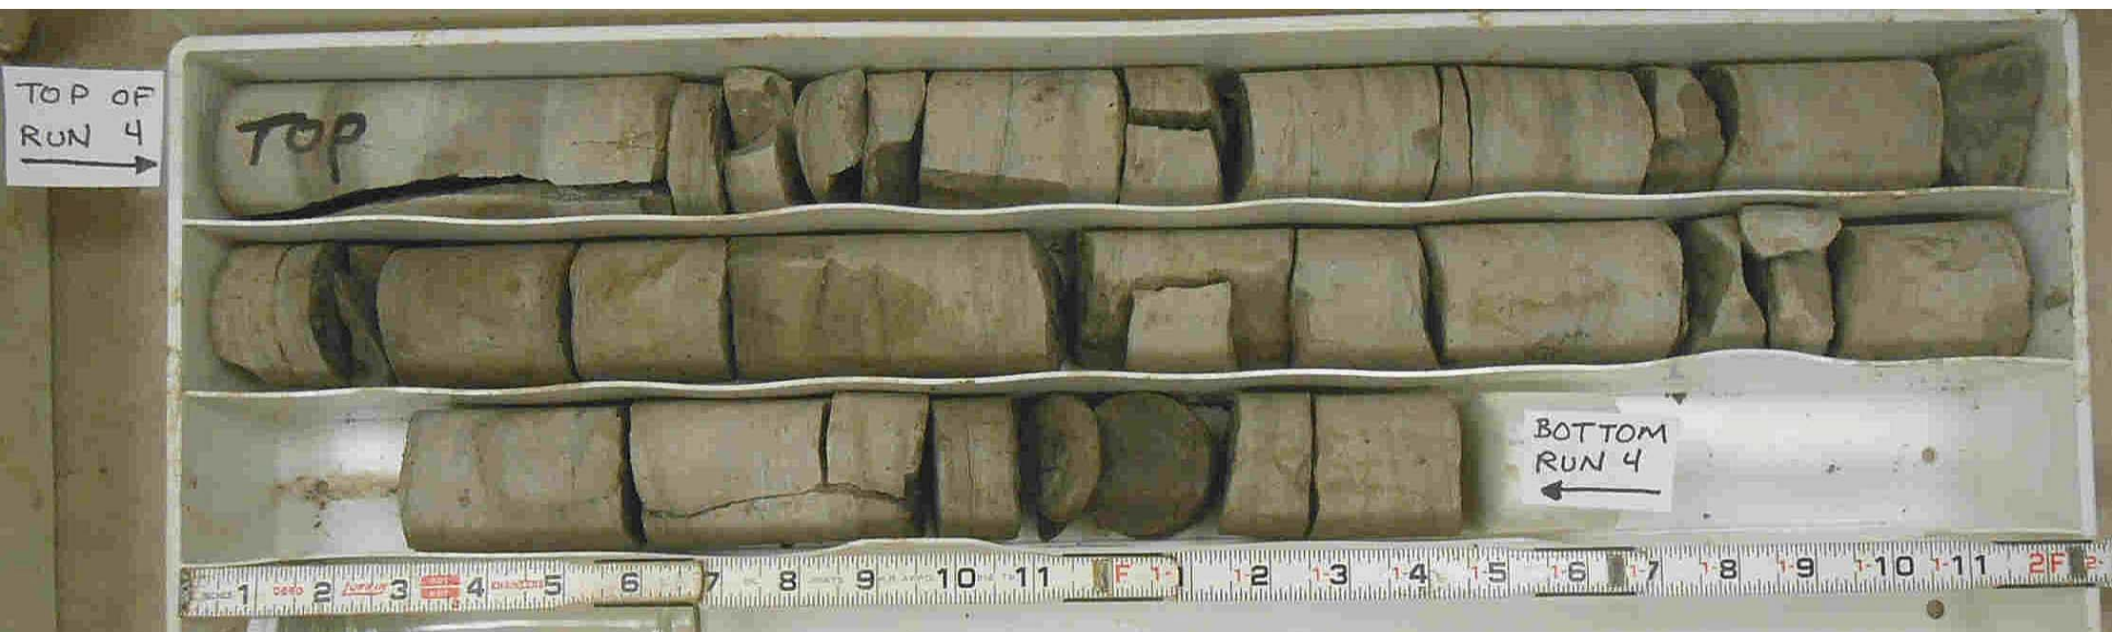
COMPANY: PGI DRILLED BY: BOWSER-MORNER
PROJECT: HAN-75-14.39
BRIDGE NO.: HAN-68-1668 over US 68 RAMP A & NS RAILROAD
BORING: B-128-0-13 BOX 3/3
DATE of CORING: 7/22/13
RUN-4: 24.0' - 29.0'
REC: 100% RQD: 6%

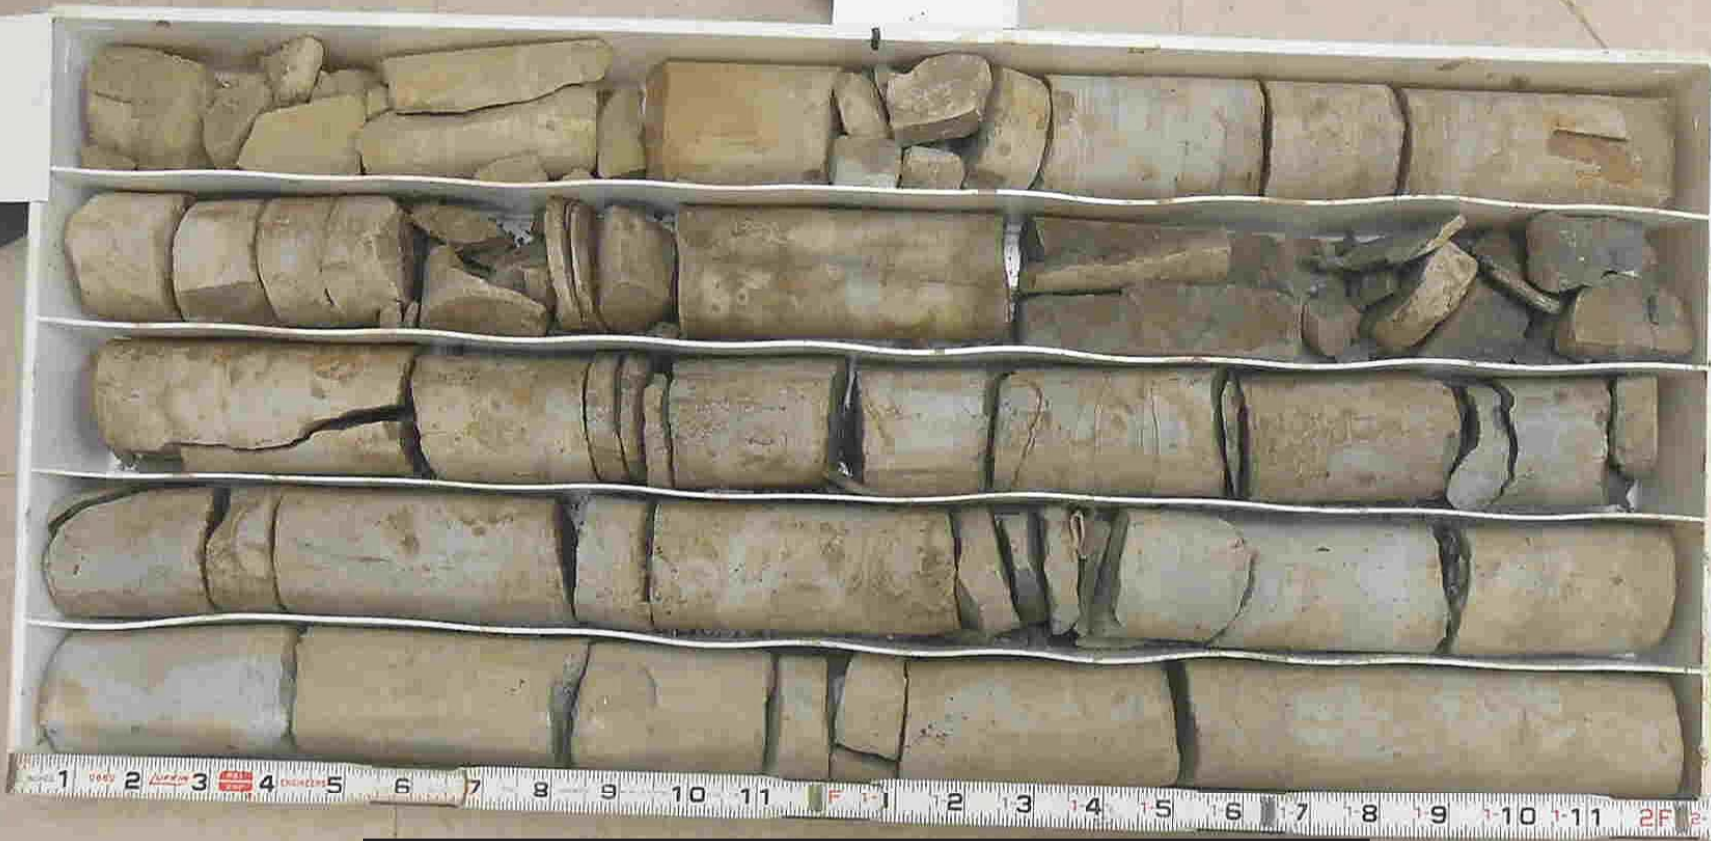
COMPANY: PGI	DRILLED BY: BOWSER-MORNER
PROJECT: HAN-75-14.39	
BRIDGE NO.: HAN-68-1668 over US 68 RAMP A & NS RAILROAD	
BORING: B-129-0-13 BOX 1/2	
DATE of CORING: 7/17/13	
RUN-1: 7.0' - 8.0'	RUN-2: 8.0' - 17.0'
REC: 96% RQD: 0%	REC: 69% RQD: 33%

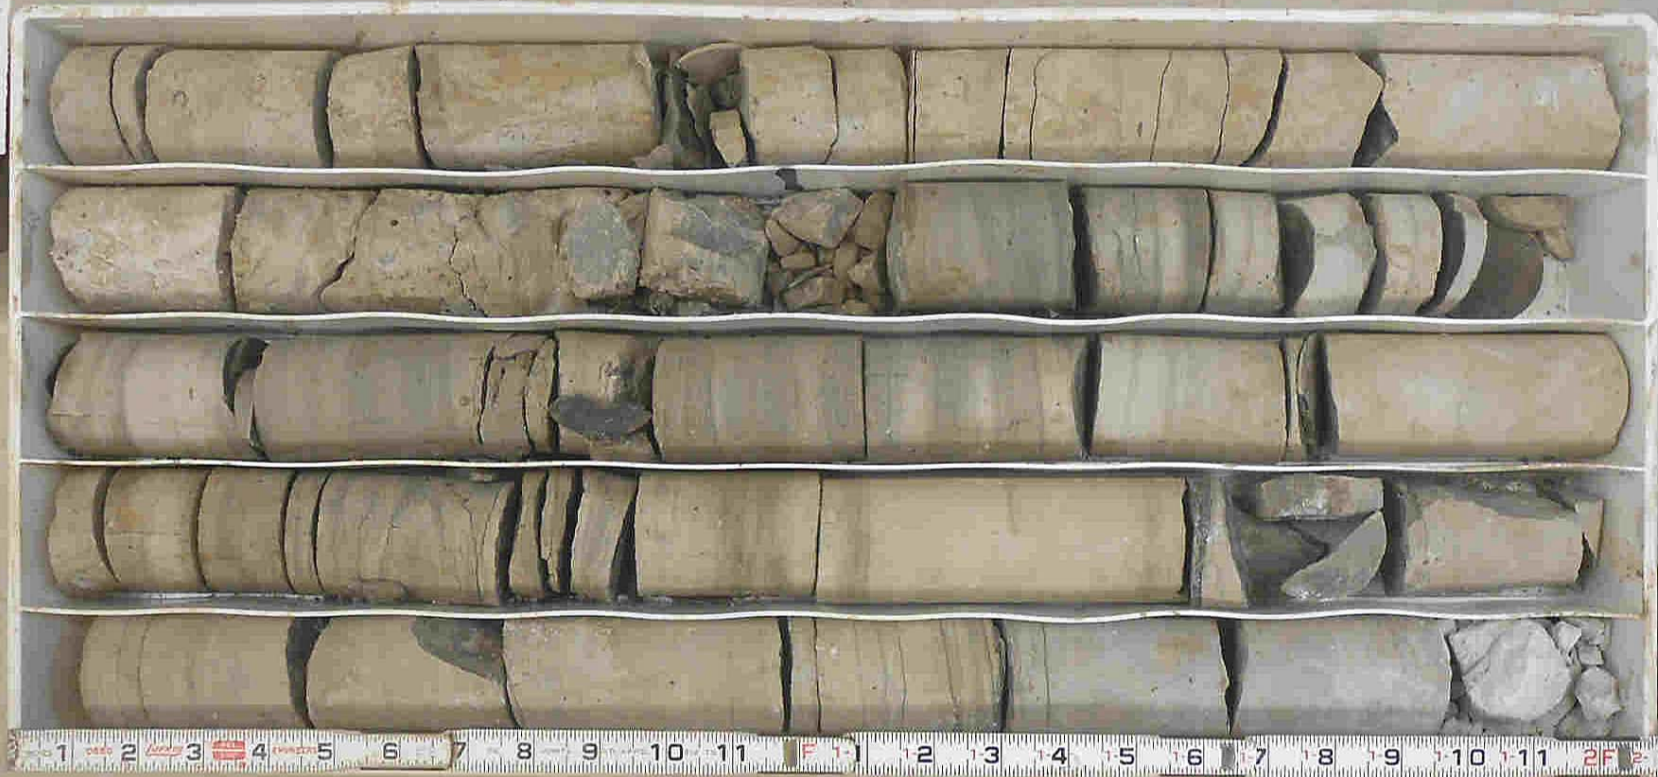
COMPANY: PGI
PROJECT: HAN-75-14.39
BRIDGE NO.: HAN-68-1668 over US 68 RAMP A & NS RAILROAD
BORING: B-129-0-13 BOX 2/2
DATE of CORING: 7/17/13
RUN-3 17.0' - 19.0'
REC: 100% RQD: 38%
RUN-4: 19.0' - 27.0'
REC: 83% RQD: 50%

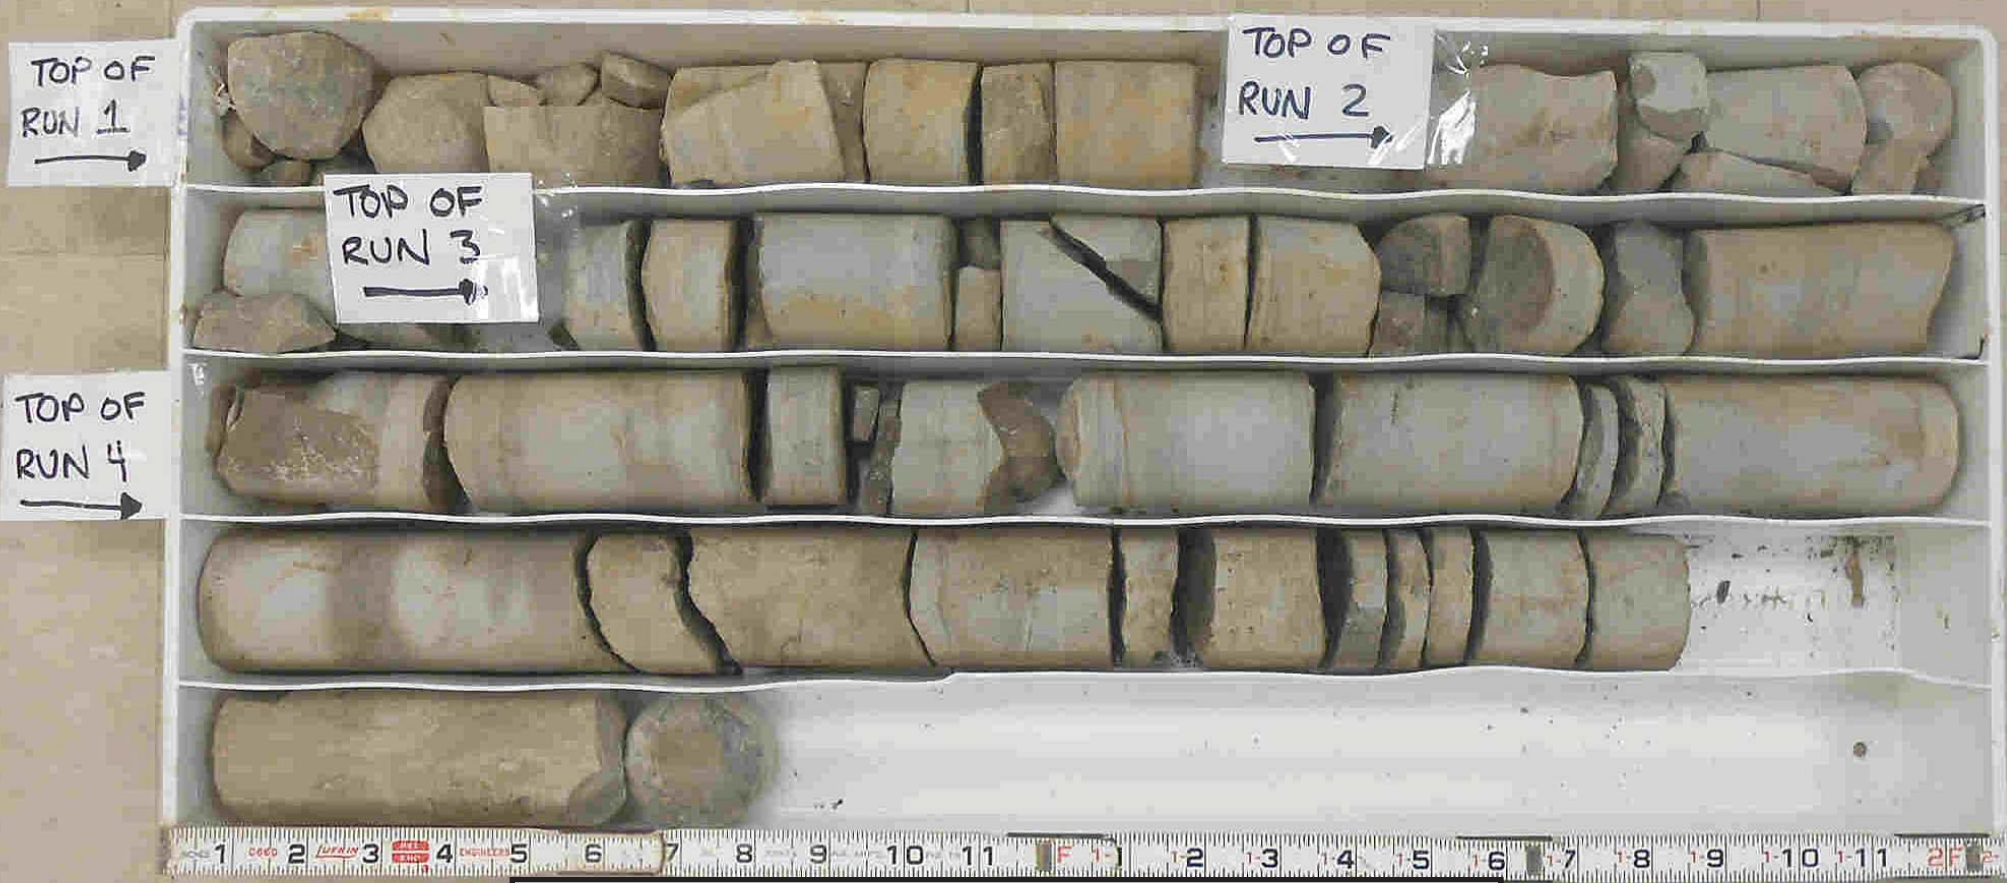
COMPANY: PGI	DRILLED BY: BOWSER-MORNER
PROJECT: HAN-75-14.39	
BRIDGE NO.: HAN-68-1668 over US 68 RAMP A & NS RAILROAD	
BORING: B-130-0-13 BOX 1/1	
DATE of CORING: 7/18/13	
RUN-1: 6.0' - 7.2'	RUN-2: 7.2' - 8.3'
REC: 97% RQD: 0%	REC: 98% RQD: 0%
RUN -3: 8.3' - 9.9'	RUN -4: 9.9' - 14.0'
REC: 100% RQD: 0%	REC: 100% RQD: 63%

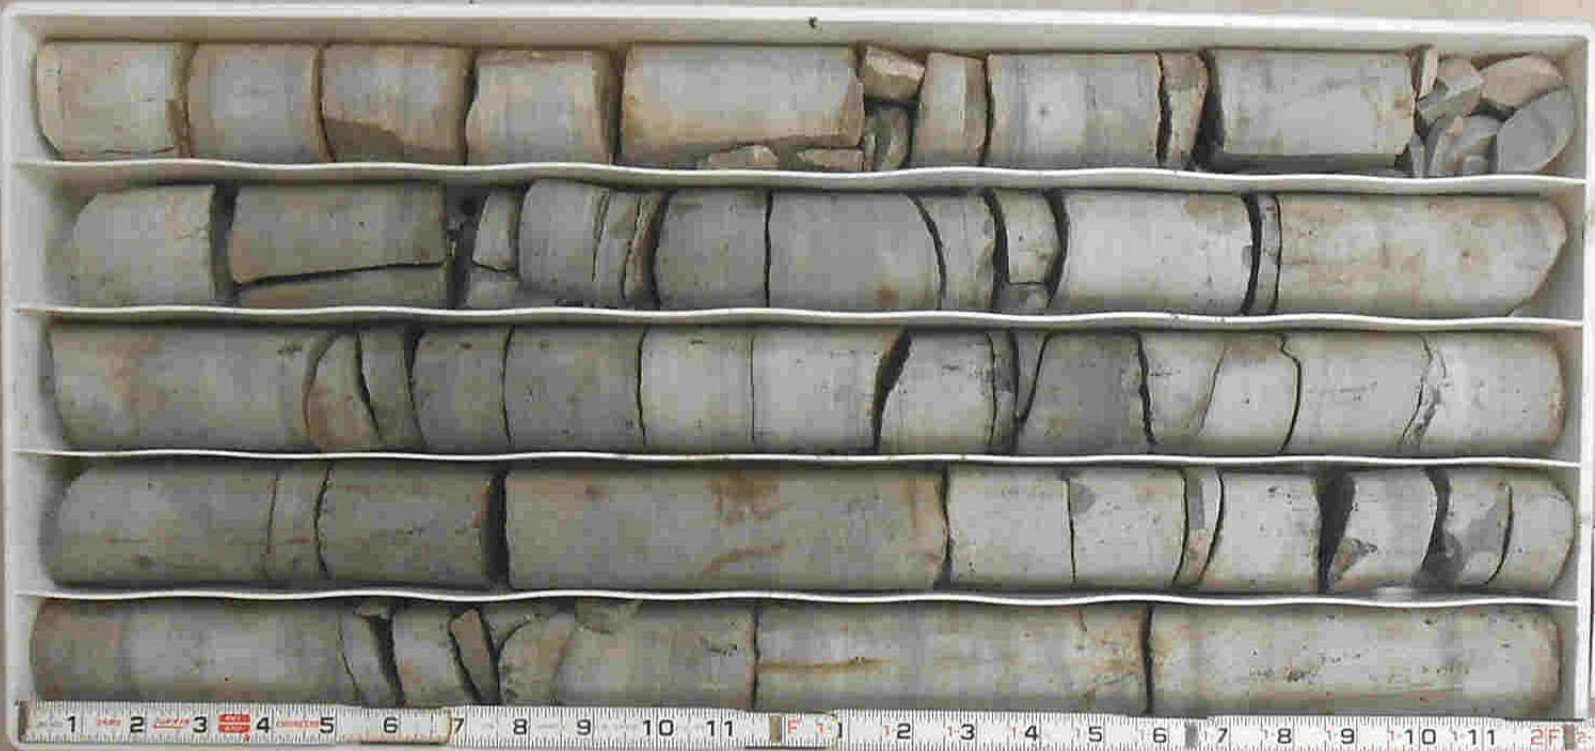
COMPANY: PGI DRILLED BY: BOWSER-MORNER
PROJECT: HAN-75-14.39
BRIDGE NO.: HAN-68-1668 over US 68 RAMP A & NS RAILROAD
BORING: B-131-0-13 BOX 1/1
DATE of CORING: 8/16/13
RUN-1: 14.0' - 24.0'
REC: 100% RQD: 60%

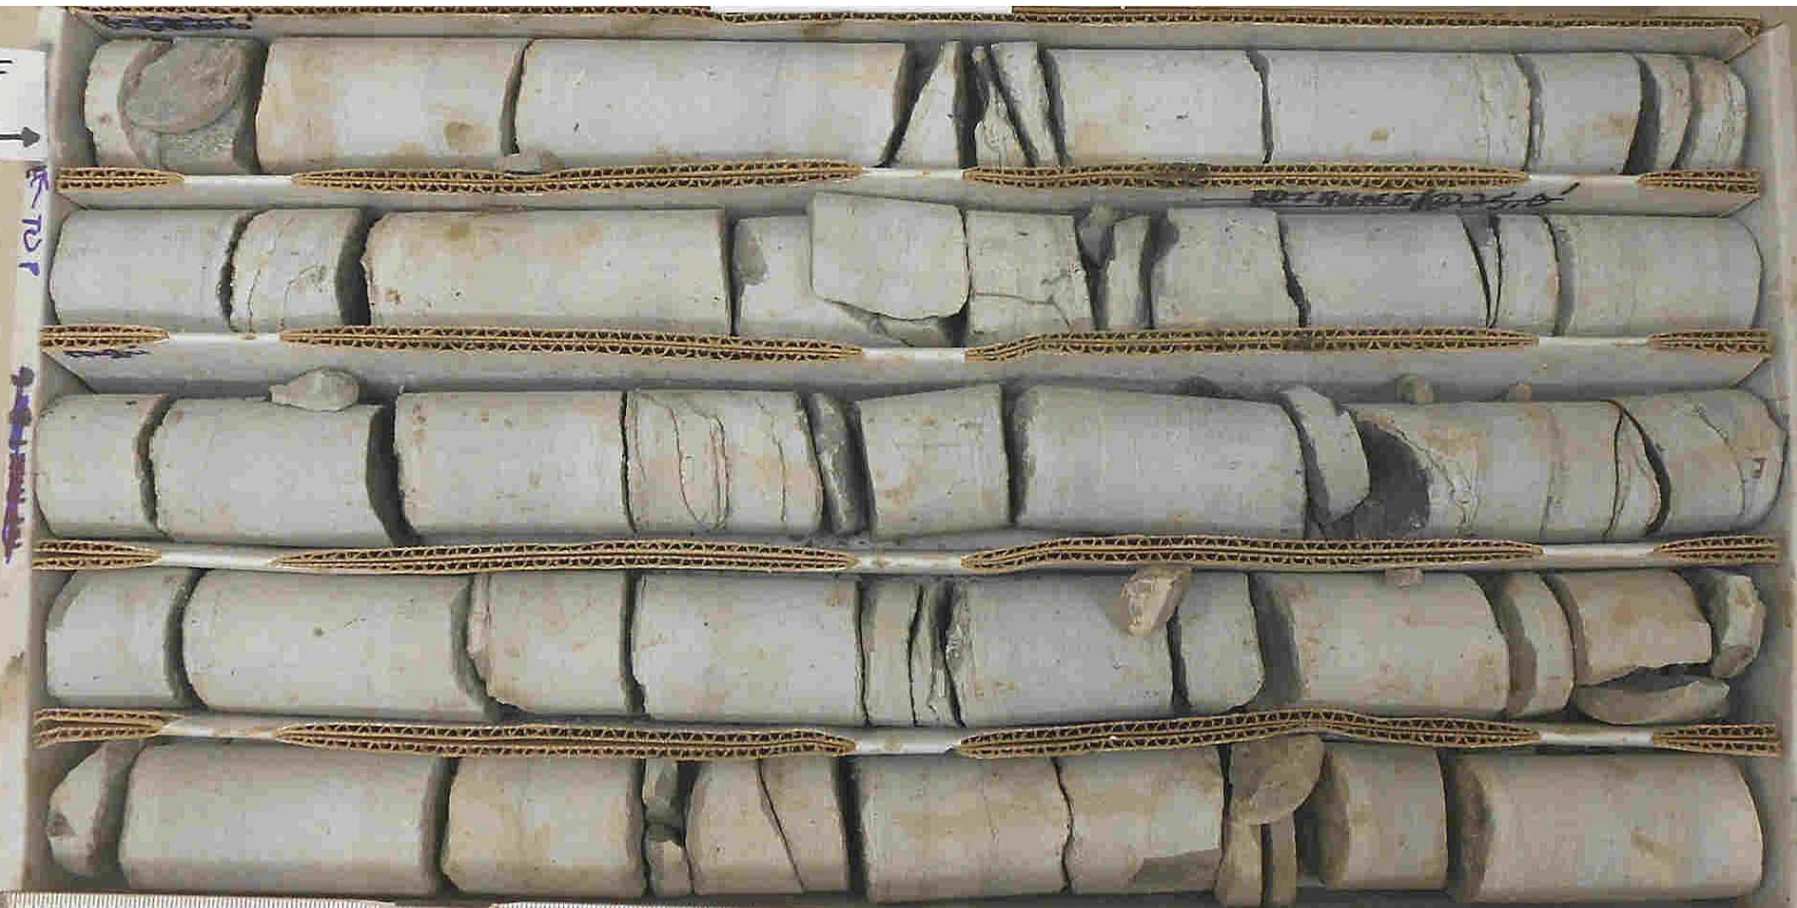
COMPANY: PGI
PROJECT: HAN-75-14.39
BRIDGE NO.: HAN-68-1668 over US 68 RAMP A & NS RAILROAD
BORING: B-131-1-13 BOX 1/2
DATE of CORING: 6/25/13
RUN-1: 9.0' - 19.0'
REC: 100% RQD: 30%

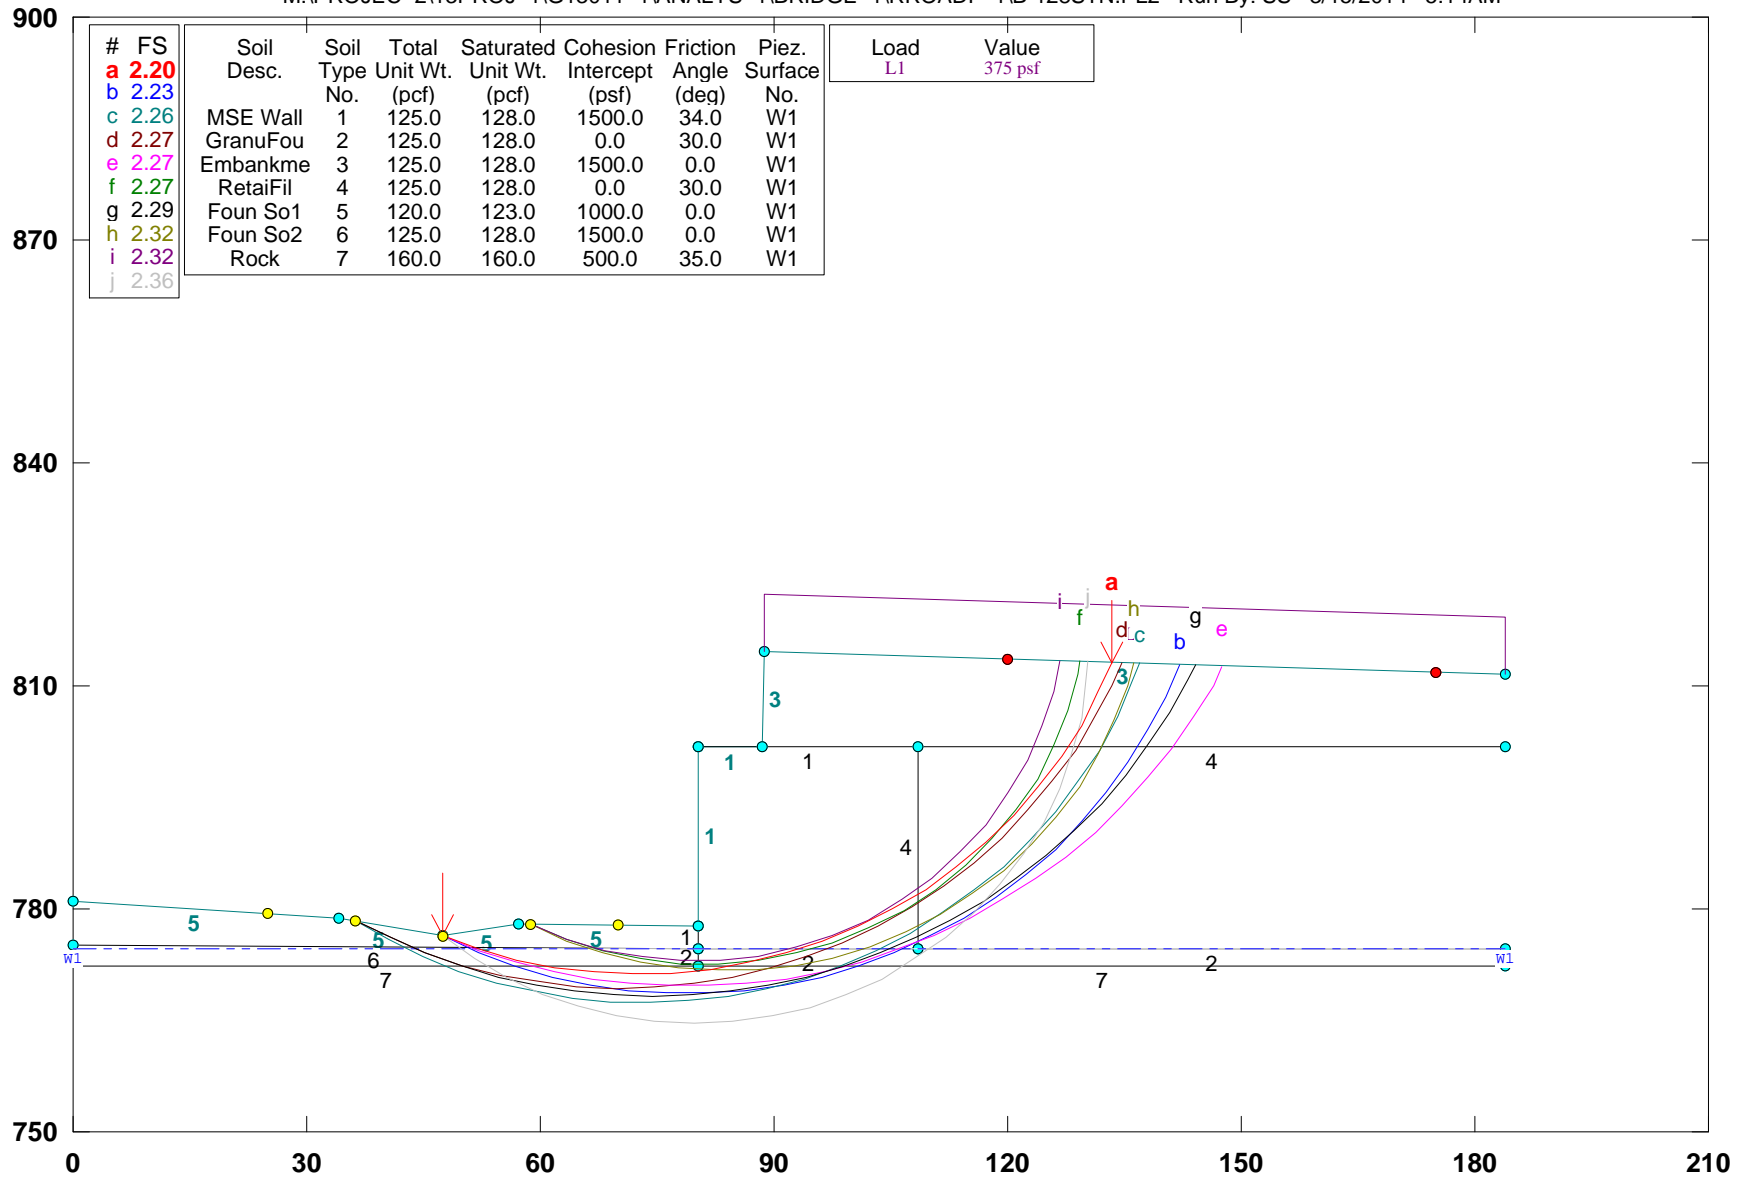
HAN-75-14.39-Bridge No. HAN-68-1668-ForwMSE Wall, Global Stability Analysis-ST

GSTABL7 v.2 FSmin=2.20

Safety Factors Are Calculated By The Modified Bishop Method

Global stability analyses were performed using the GSTABL7 with STEDwin, version 2.0 program that was developed by Mr. Garry H. Gregory, P.E. to estimate the Factor of Safety for the proposed MSE Walls. The foundation soil profiles below the proposed MSE Walls were estimated from information obtained from the test borings. The phreatic surface was assumed as top of bedrock. For slope stability

analysis, shear strength soil parameters used in this analysis were obtained from the laboratory tests performed on the undisturbed soil samples obtained from the ramp test borings and from our experience with similar types of soils. Trial failure surfaces were generated using the method of slices for short term and long-term stability. The Modified Bishop Method of slices was used to generate circular trial failure surfaces. Table 6.2.3 summarizes the safety factors for the short term and long term stability of the proposed MSE Walls. Based on this slope stability analysis, the calculated Safety Factors for both short term and long term meet the required Safety Factors specified in the ODOT Embankment Checklist. Slope analyses critical failure circles are included in Appendix B.
