**Ground Penetrating Radar
Roadway Pavement Joint
& Bridge Deck Evaluation**

HUR-20-10.76 (SLM 10.76 to 16.20)

Rii Project: N-19-011

July 26, 2019

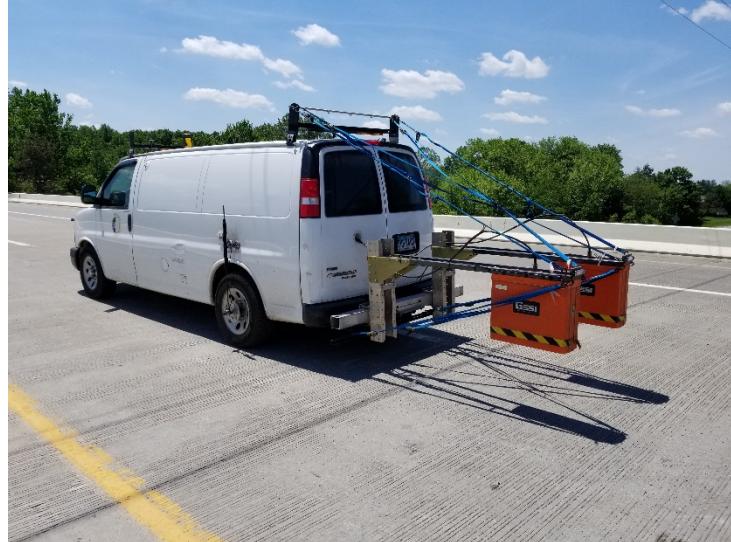
Figure 1. GPR system used during data collection

The type of GPR system used during this project utilizes the non-contact horn antenna with a center frequency of 1 GHz, which is suspended 19 inches over the surface of the pavement and which can perform surveys at highway speed. This system has the advantage of providing near-surface information, and under typical conditions, the depth of signal penetration reaches 24 inches. The GPR system used during data collection is shown in Figure 1. It is equipped with:

- GSSI SIR-30 radar system (Control Unit) and two 1 GHz air-launched antennas attached to the rear of the van on an adjustable mounting system
- Corrsys-Datron DMI wheel pulse encoder for accurate survey length measurements
- Trimble GPS system PROXH
- A three camera alignment system for accurate survey width measurements
- A workstation inside the van for the operator during data collection
- An Inverter Generator
- Several hazard lights that comply with state and federal standards for this type of survey
 - Rear facing arrow sticks lights
 - Top mounted strobe light
 - Safety light at end of mounting system

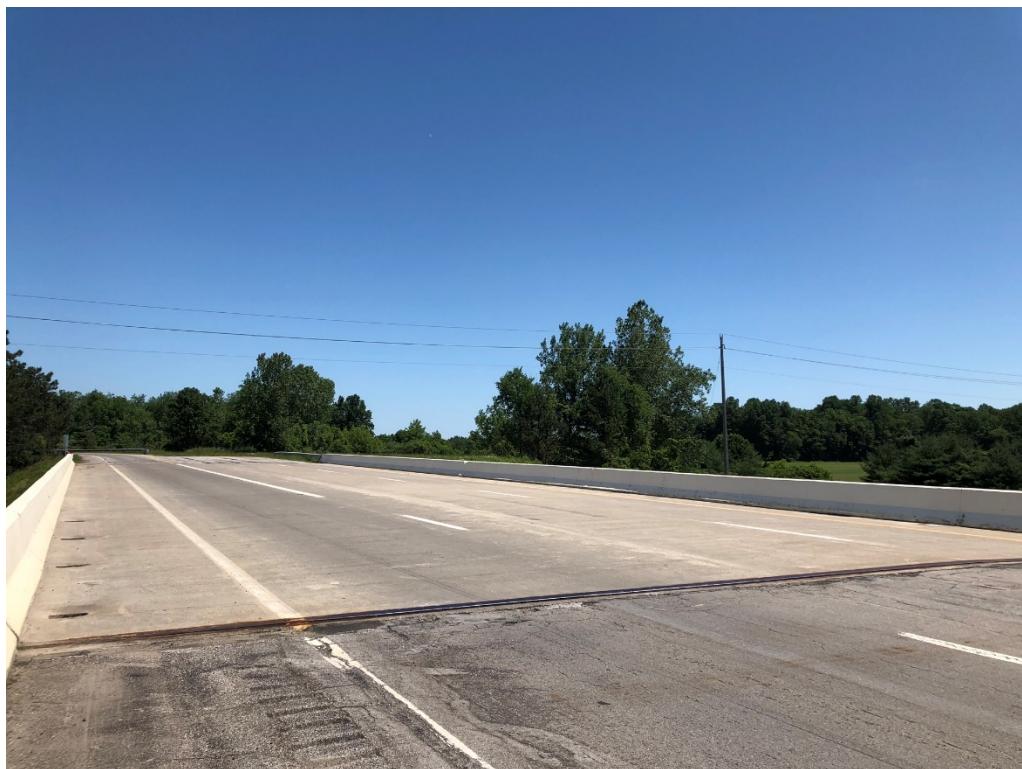
Picture 1

- Pictures
- 1: Overall
 - 2: Joint
 - 3: Delamination
 - 4: Cracking and small patches
 - 5: Cracking
 - 6: Joint
 - 7-8: Scaling

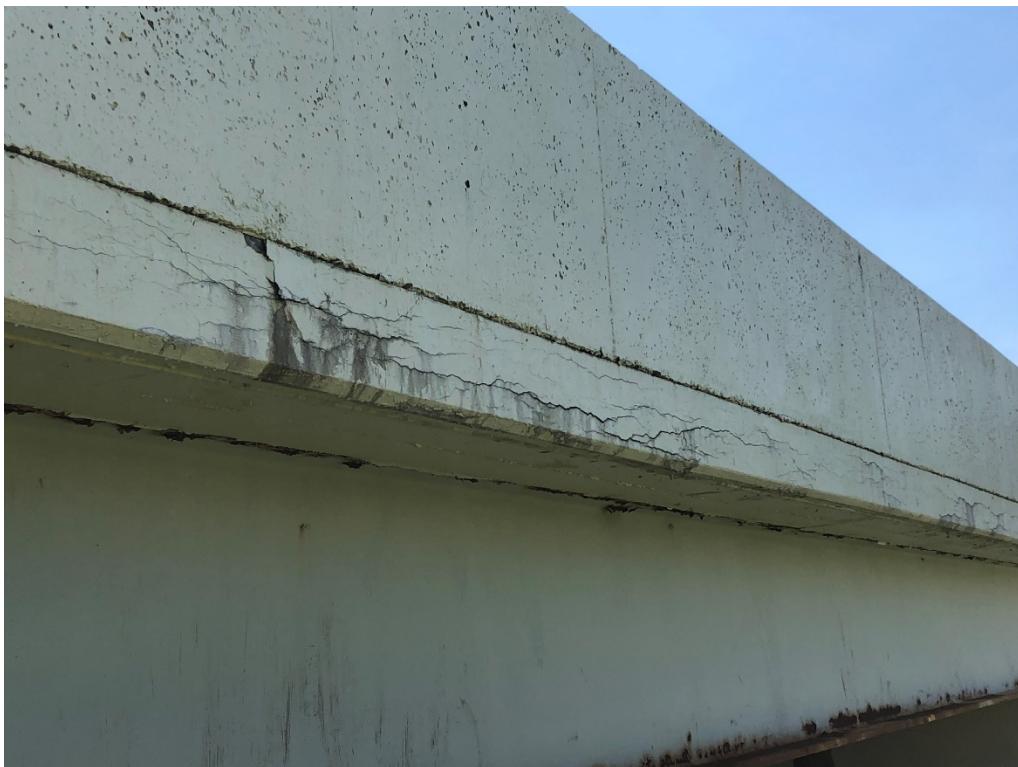
Picture 9

- Pictures
- 9: Cracking
 - 10: Patching
 - 11-14: Spalling and exposed rebar
 - 15: Cracking and efflorescence

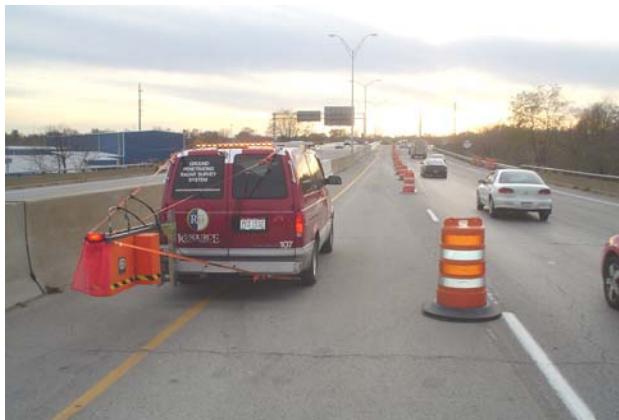
Dual-Polarization Methodology

Two van-mounted antenna data collection methodologies are generally used. The single-polarization methodology utilizes two air-launched horn antennas (1000 MHz) mounted on booms so that the antennas scan on two different paths. It is probably the most common method of GPR bridge deck evaluation. It has been around the longest and provides good, overall results. The antennas are deployed at an orientation where they are sensitive to the reinforcing steel placed in the transverse directions within the deck. The single-polarization method using two antennas has the advantage of covering more deck surface in a single day. The method provides fairly accurate deterioration quantity assessments that can be used to help decide identify locations that can best confirm that corrosion is taking place in predicted areas. The dual-polarization method uses two 1 GHz antennas mounted-in-line, so that one antenna is more sensitive to the transverse steel and the other to the longitudinal steel of the top mat

rebar. The subtraction of the two signals generates a higher resolution data output. Planar effects caused by thin overlays, undesirable artifacts which cannot be removed by the single-polarization technique are removed using this method. The dual-polarization method is the most practical method for all purposes GPR work, which accurately predicts degree, extent, and location of deteriorated regions within the deck.

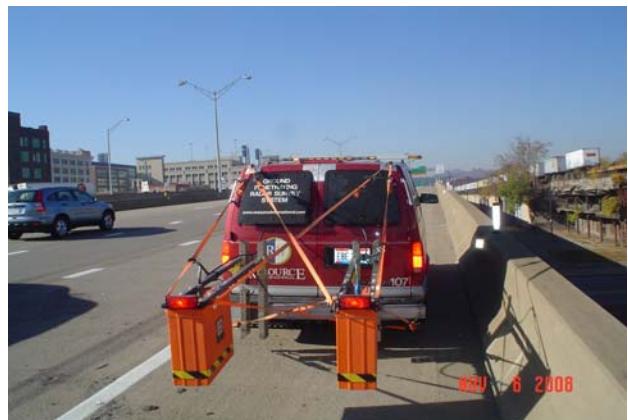
Single-Polarization Methodology

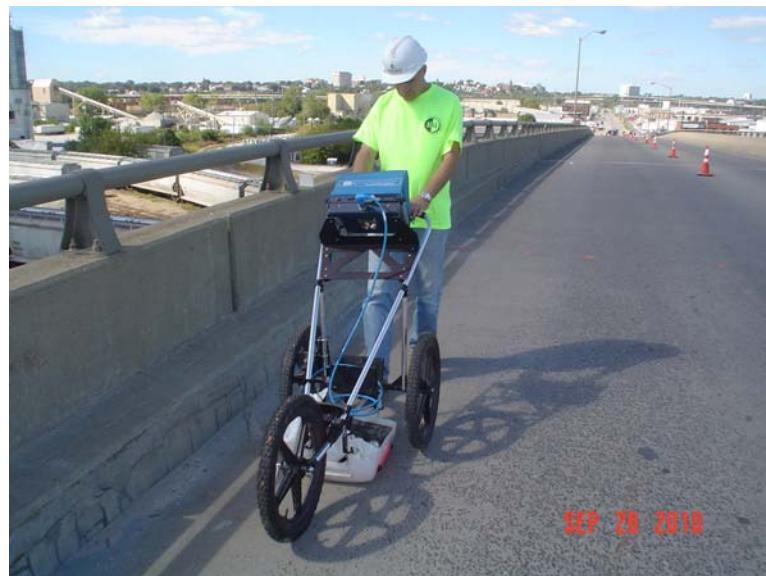
A ground-coupled method uses a higher resolution antenna with a center frequency of 1.5 GHz or greater. It provides highly accurate GPR survey results. However its slower data collection speed necessitates lane closures making it less attractive in congested areas and on Network-level projects where several bridges have to be surveyed in a short period of time and at low cost. This method is economical as a project-level evaluation tool on short bridges and in rural areas with limited traffic so that lane closures are not necessary.

Ground-Coupled Methodology
