**LANDSLIDE EXPLORATION  
MED-18-13.54  
MEDINA COUNTY, OHIO  
PID#: 92953**

**NEAS PROJECT 15-0091**

**March 8, 2017**

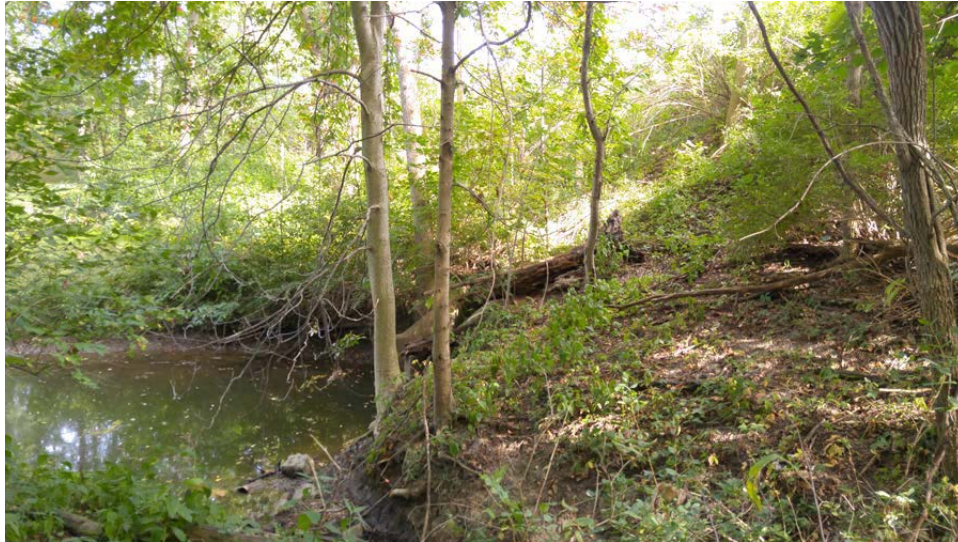
Photograph 1: Embankment at historical landslide near Sta 127+00

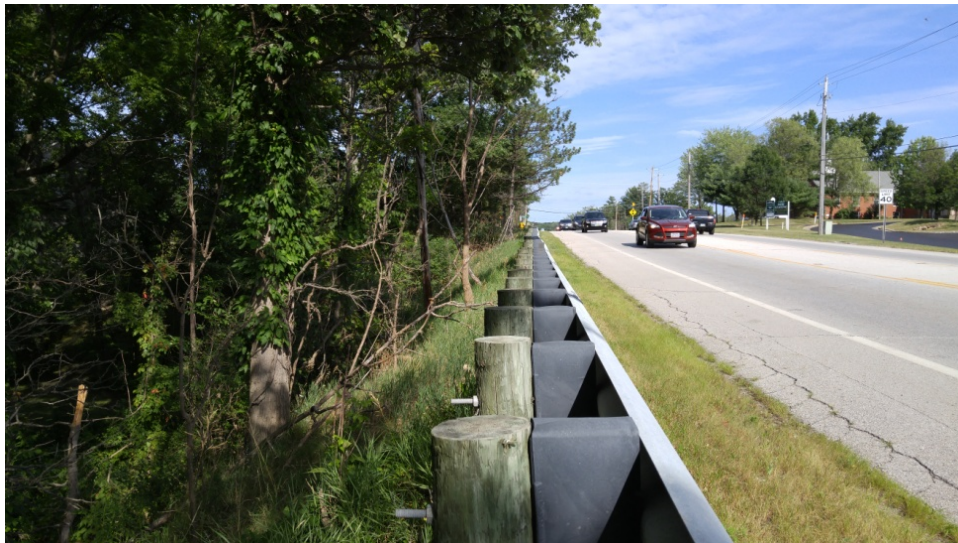
Photograph 2: Guardrail at historical landslide near Sta 127+00

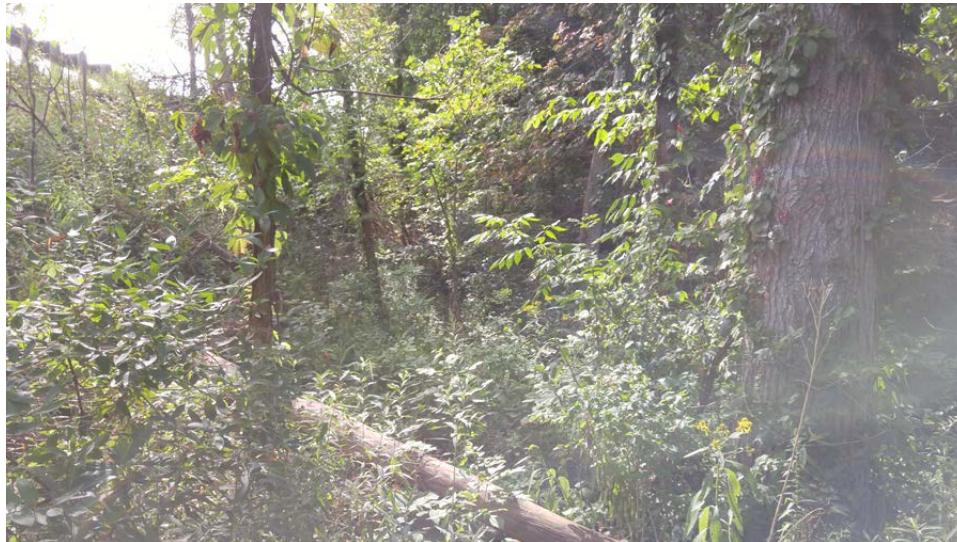
slanted slightly more upslope (Photograph 3). Several sources of water flow into and out of this area, including 2 culverts, a lake, the roadway, and potential overflow of the pond, making high water levels during heavy rainfall extremely likely.

Photograph 3: Tree alignments at historical landslide near Sta 127+00

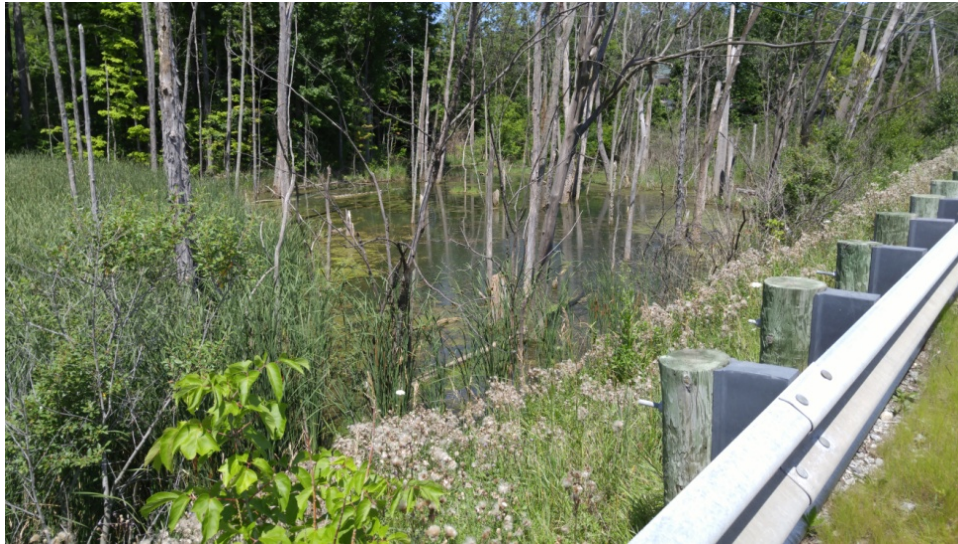
This location at Station 166+00 is adjacent to a swamp (Photograph 4) and on a steep, grass and weed covered embankment of greater than 1.5:1 slope in several places (Photograph 5). A thick wooded area is located between the bottom of the embankment and the swamp. The guardrail shows no signs of slope movement (it also appears to be relatively new), however a telephone pole is leaning significantly downslope (Photograph 6). Water is conveyed to and from the swamp by 2 culverts, runoff from the roadway, and runoff from a large empty lot to the north. The lot appears to send very large quantities of water into the swamp area, causing a massive eroded channel connecting the two locations (Photograph 7). The swamp appeared to have lower water levels than usual, as a large dry area to the north was covered in deposits from the swamp with very little growth occurring (Photograph 8).

Photograph 4: Swamp at historical landslide near Sta 166+00

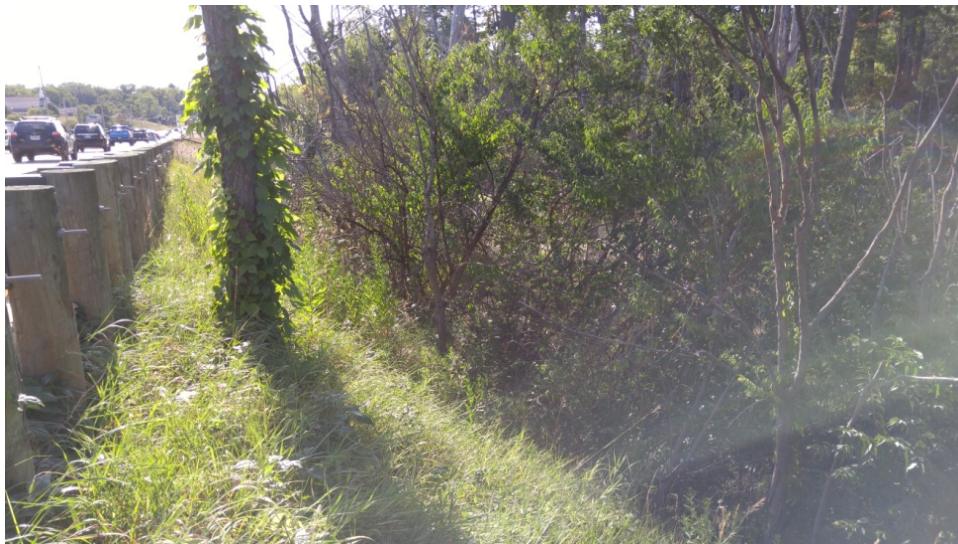
Photograph 5: Embankment at historical landslide near Sta 166+00

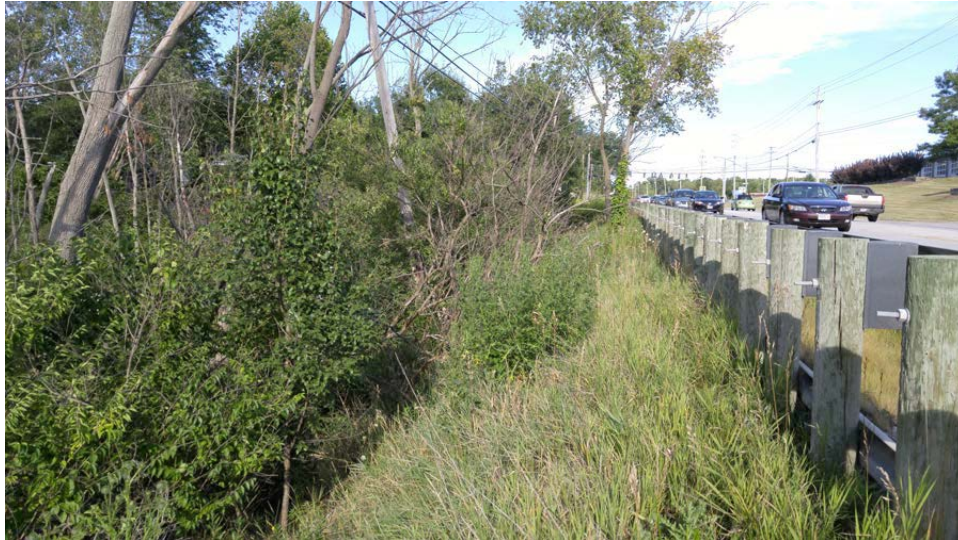
Photograph 6: Guardrail at historical landslide near Sta 166+00

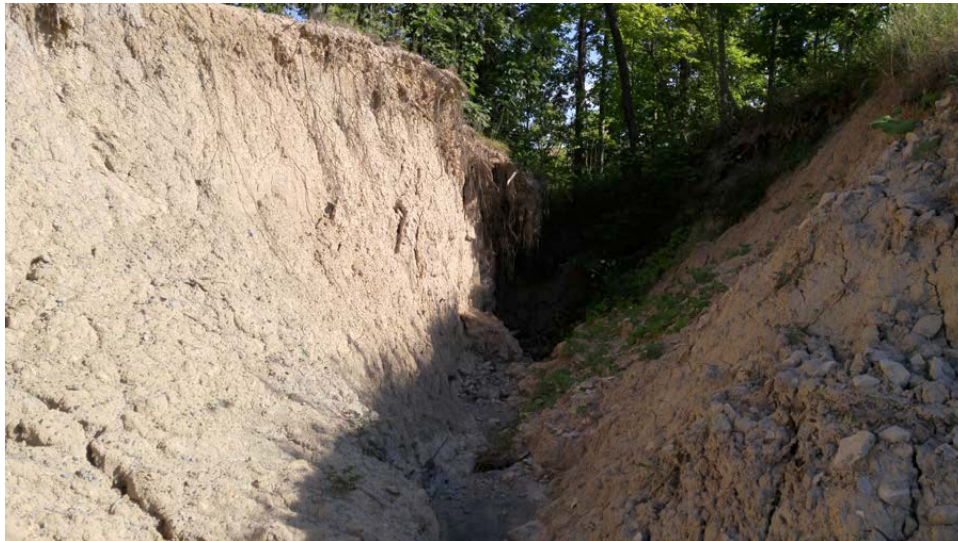
Photograph 7: Eroded channel at historical landslide near Sta 166+00

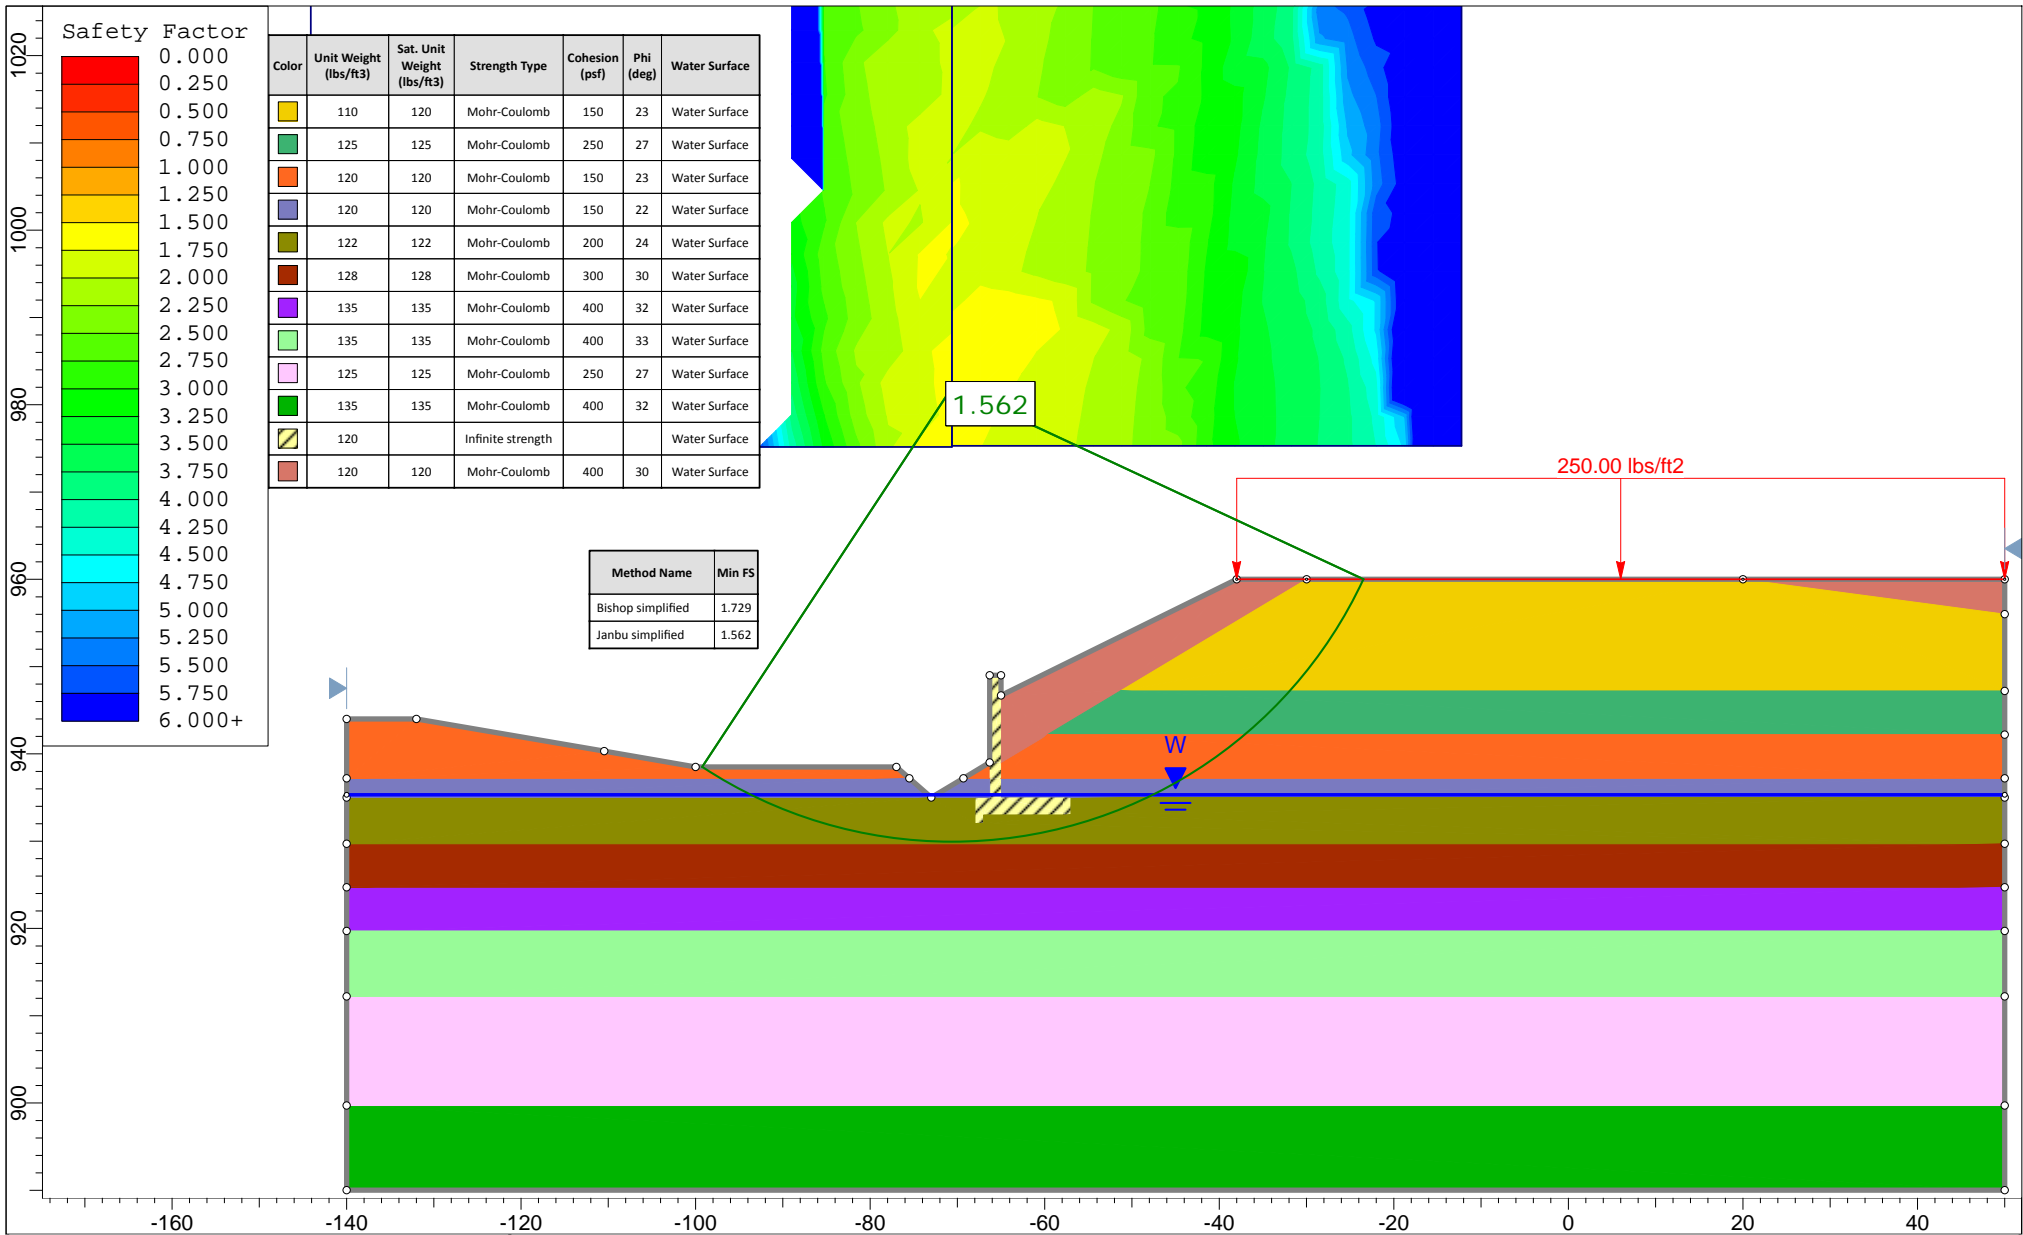
Project			Landslide at MED-18 Sta 127		
	Analysis Description			Circular_Effective Stress Analysis		
	Drawn By	ZM	Scale	1:264	Company	National Engineering & Architectural Services, Inc
	Date	1/26/2017, 4:13:49 PM		File Name	Sta127_Circular_Effective_1ft_withHeadwall_B_014-1.slim

Based on our slope stability analysis for the Station 127+00 section, the minimum slope stability safety factor is about 1.33 (0.75 resistance factor), which equals the desired value of 1.33. The results of the analyses are summarized in Table 11. Based on the results of the analyses, it is our opinion that the subsurface conditions encountered at this location are generally satisfactory and the site can be considered to be stable at existing condition and post construction condition. The graphical output of the slope stability program (cross-sectional model, calculated safety factor, and critical failure plane) is presented in Appendix C.

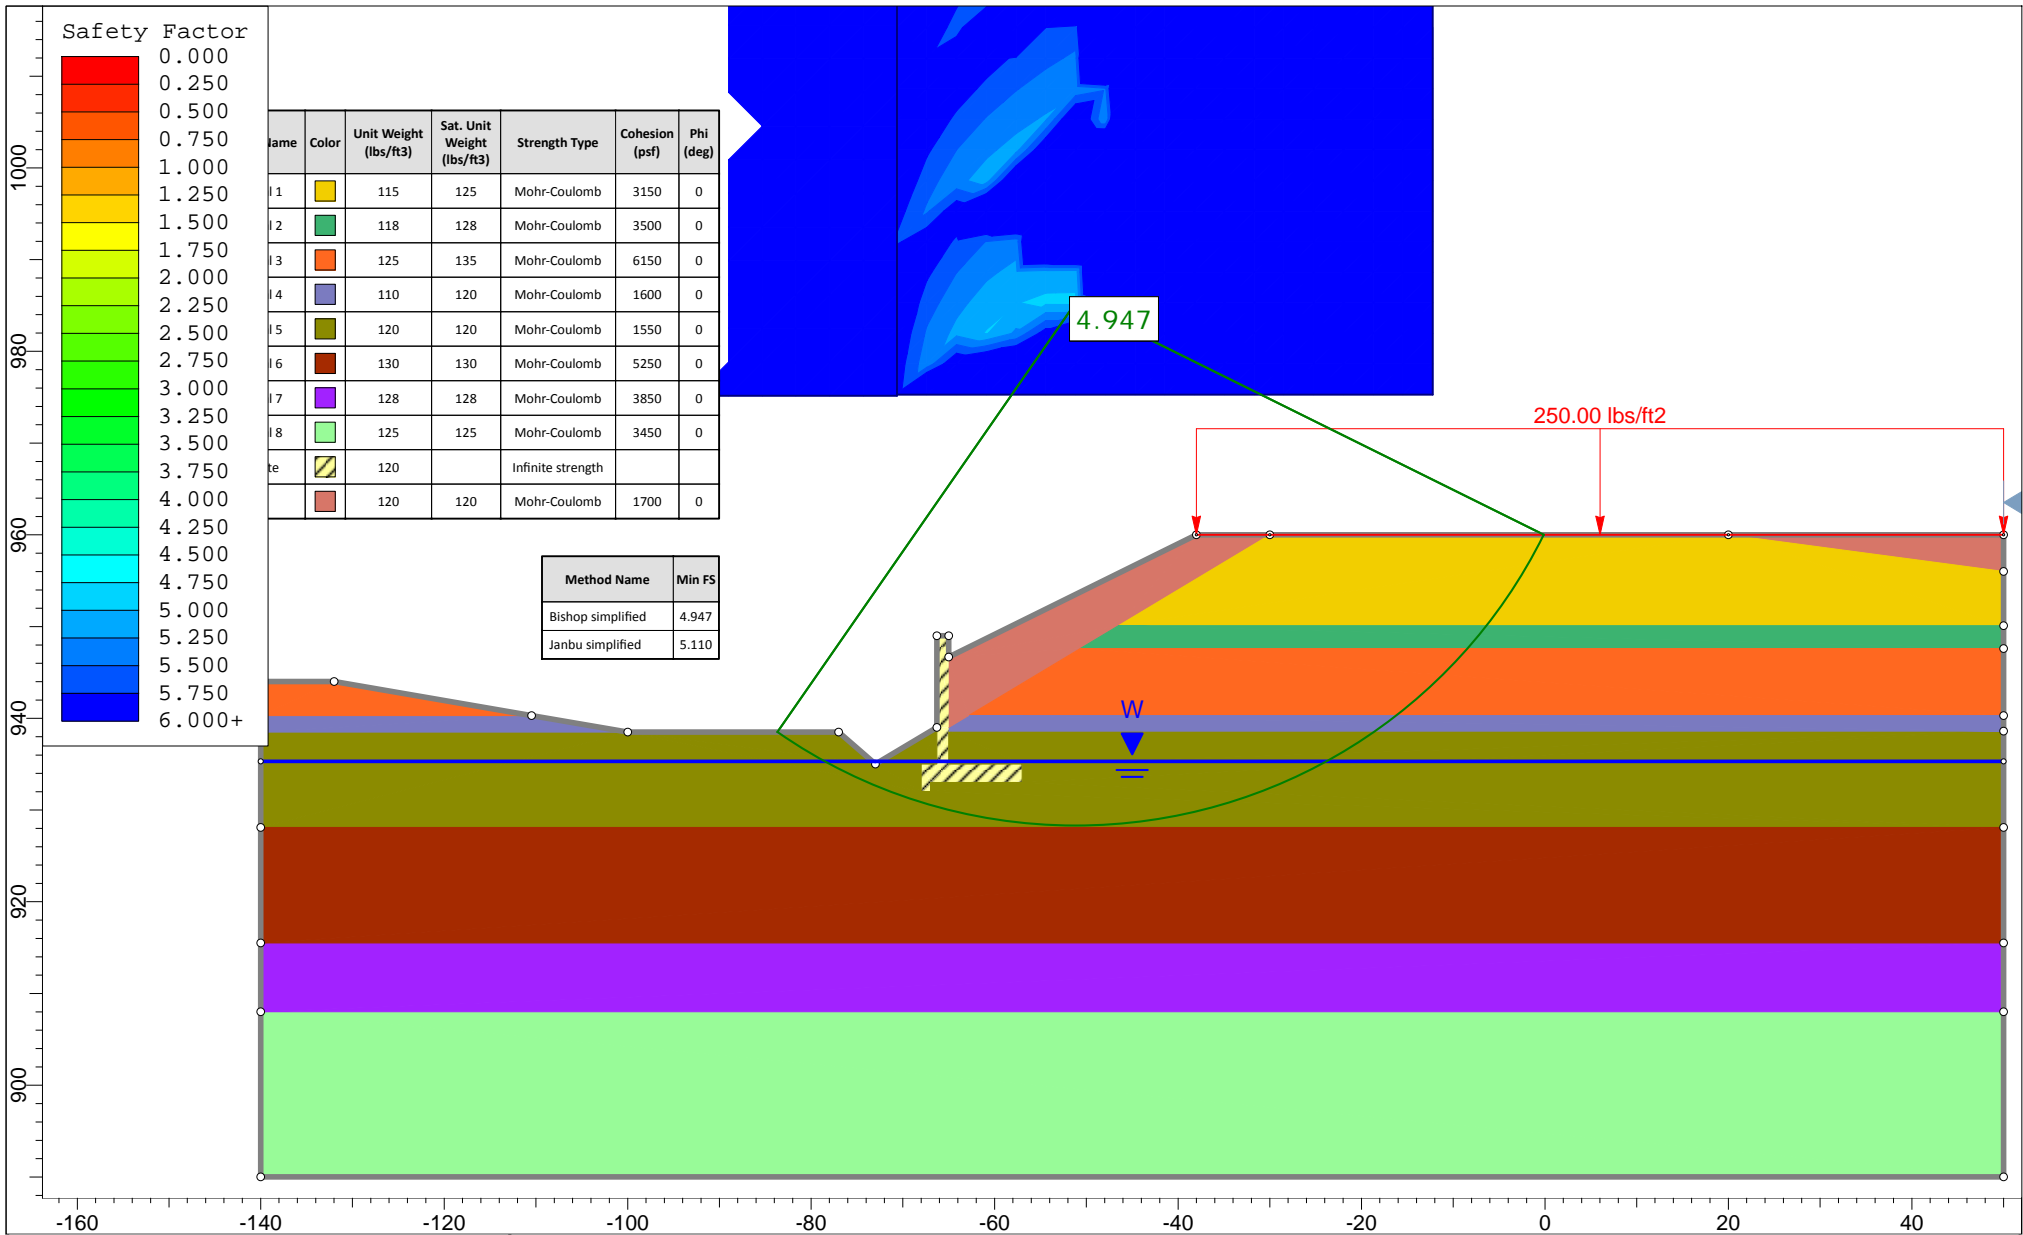
Project			Landslide at MED-18 Sta 127		
	Analysis Description			Circular_Total Stress Analysis		
	Drawn By	ZM	Scale	1:251	Company	National Engineering & Architectural Services, Inc
	Date	1/26/2017, 4:13:49 PM		File Name	Sta127_Circular_Total_1ft_withHeadwall_B_015.slim

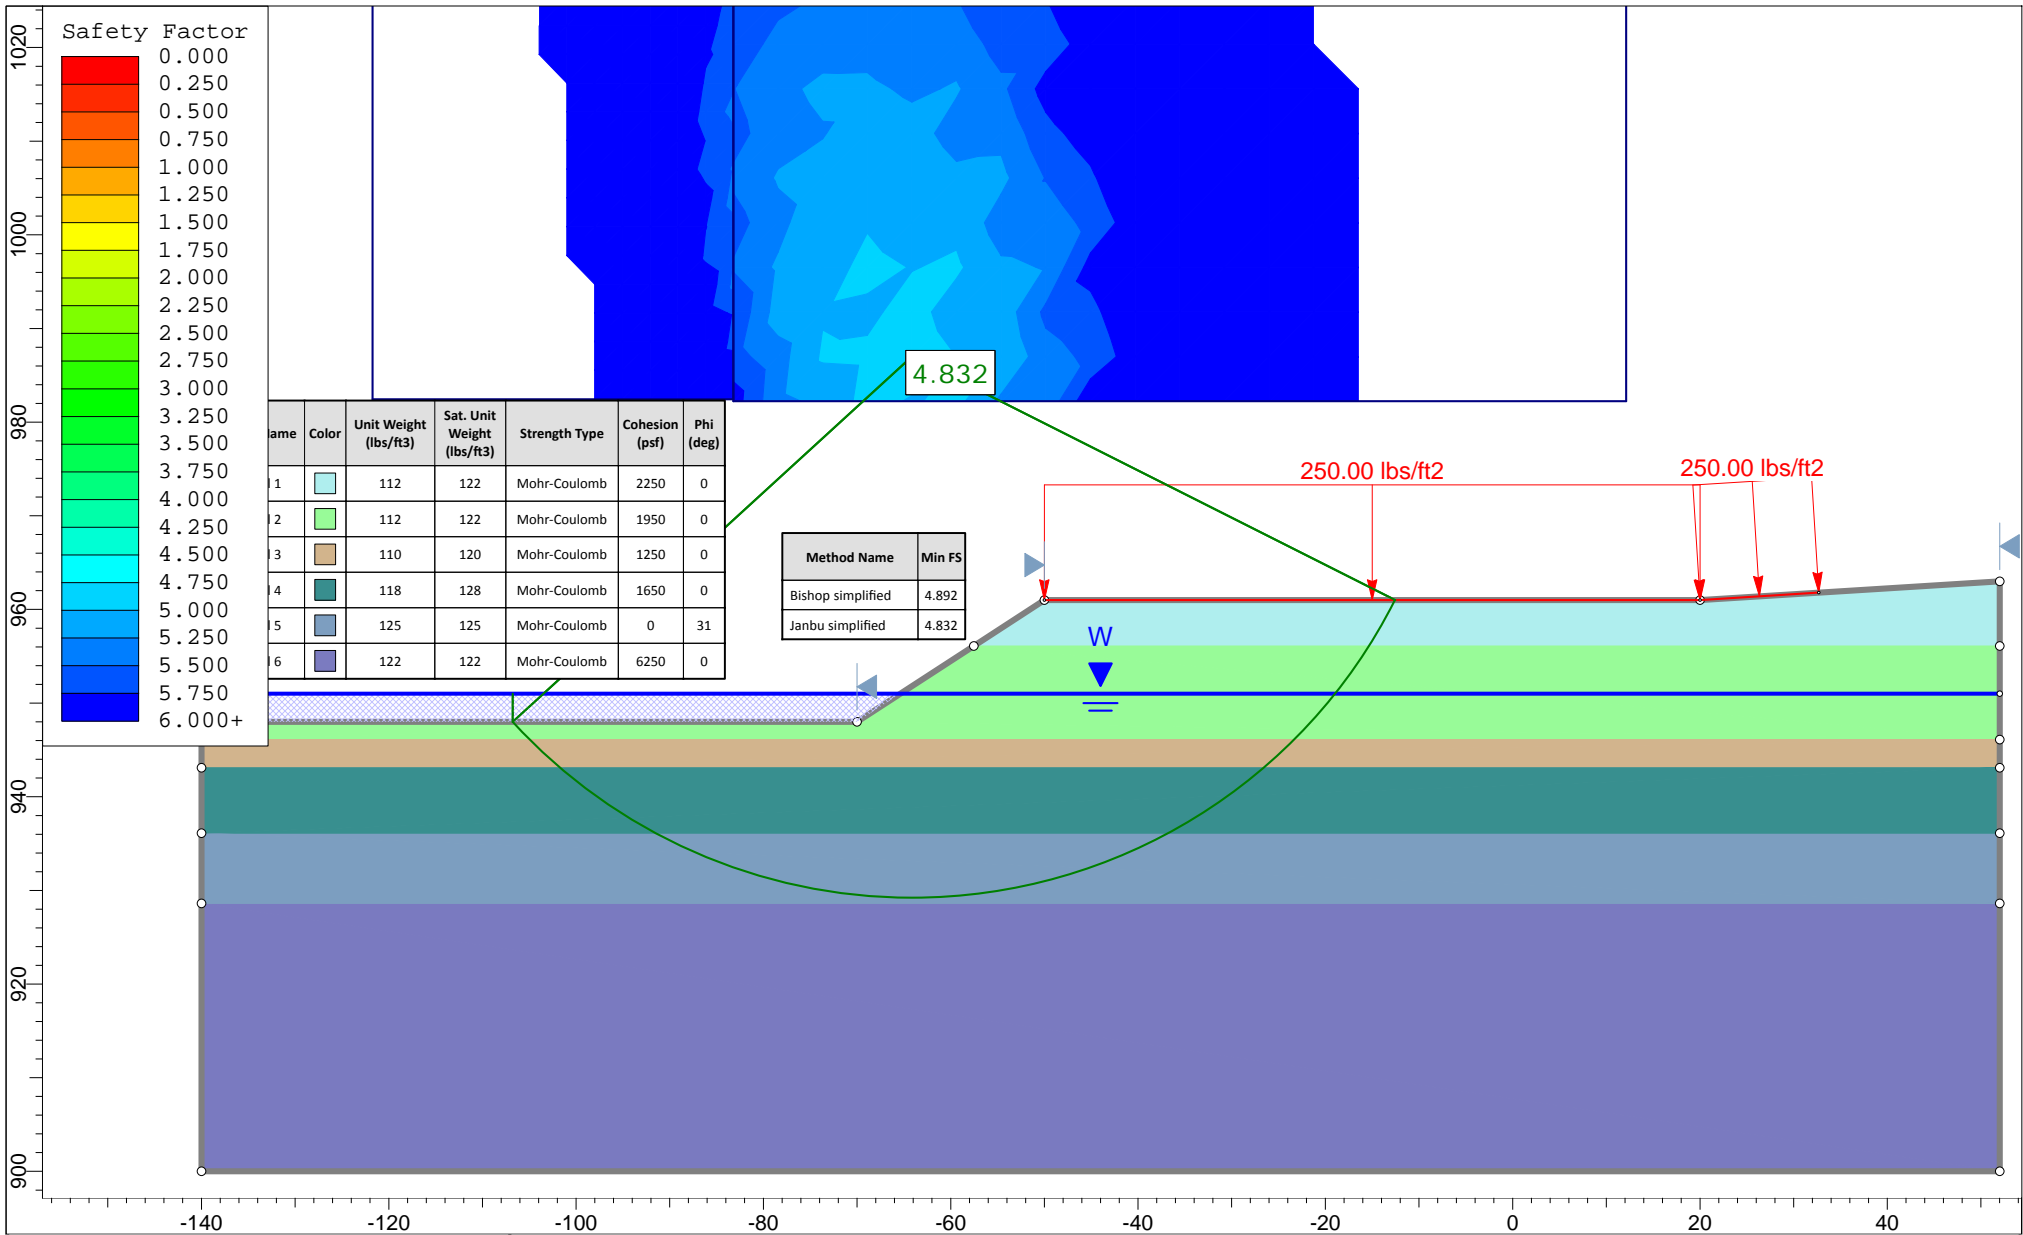
Project			MED-18 Landslide at Sta 166		
	Analysis Description			Circular-Total Stress Analysis		
	Drawn By	ZM	Scale	1:246	Company	National Engineering & Architectural Services, Inc.
	Date	1/26/2017, 11:23:54 AM		File Name	Sta166_Circular_Total_B_027_1.slim

program (cross-sectional model, calculated safety factor, and critical failure plane) is presented in Appendix D.
