**Reference: MOE - CR 81-1.50 Land Slip
Krebs Hill Road
Monroe County, Ohio
GCI Project No. 20-G-24290**

As you authorized on behalf of ADR & Associates, Ltd., Geotechnical Consultants, Inc. (GCI) performed a subsurface exploration and prepared this geotechnical engineering letter report for the referenced slope stabilization along County Road 81 in Monroe County, Ohio. GCI performed a prior study for the MOE – CR 81 – 1.55 slip adjacent to the east end of the site and submitted a report on August 2, 2018. Those repairs were made in 2019 and are performing well. Boring findings from the prior study were used for this report. We present our findings and comments below.

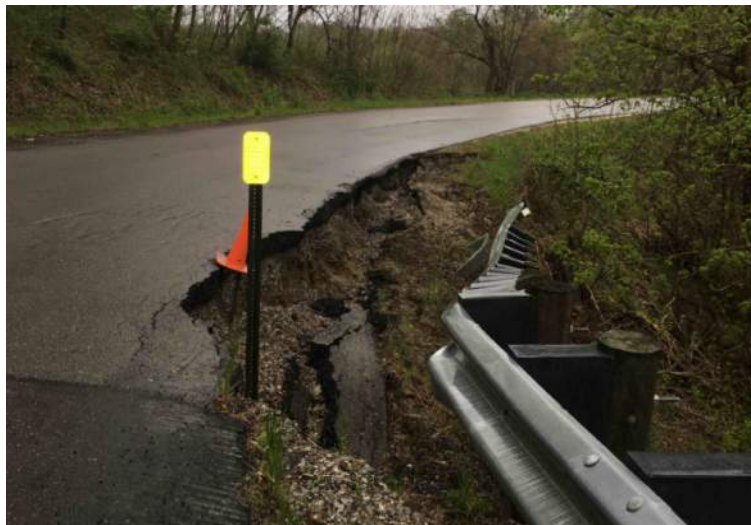
The site is located along County Road 81 (Krebs Hill Road) in Monroe County, Ohio. The subject slip is occurring along the north side of the roadway, just west of the prior slip location. We attached a DeLorme street map in the appendix and a photograph below showing the general site location, and the new to old pavement transition delineating the old and new slip locations fairly well.

View of Roadway Embankment Looking West Across the Slip Area

The site is along a curve in the road with the short radius of the curve along the north side of the road and the long radius along the south side of the road. Roadway grades along County Road 81 fall to the west with surface elevations along the centerline near elevation 1,256 feet at the east end of the slip and 1,252 feet at the west end of the slip. Grades rise south of the roadway alignment at an approximate 2H:1V slope or flatter, and fall to the north with grades between 1H:1V and 1.5H:1V near the top of the slope, and flattening out to about 3H:1V beyond the toe of the slip. There is a near vertical drop of several feet along the north edge of the road where the scarp is present in the east half of the slip.

The slip has impacted about 150 to 160 lineal feet of roadway and is occurring in an irregular pattern with the scarp present along the edge of the roadway and cracking extending into both lanes of the road. The north failing embankment has a tree and underlying brush coverage, with many of the trees leaning as a result of the recent slip. The south embankment has a grass and weed coverage with some trees.

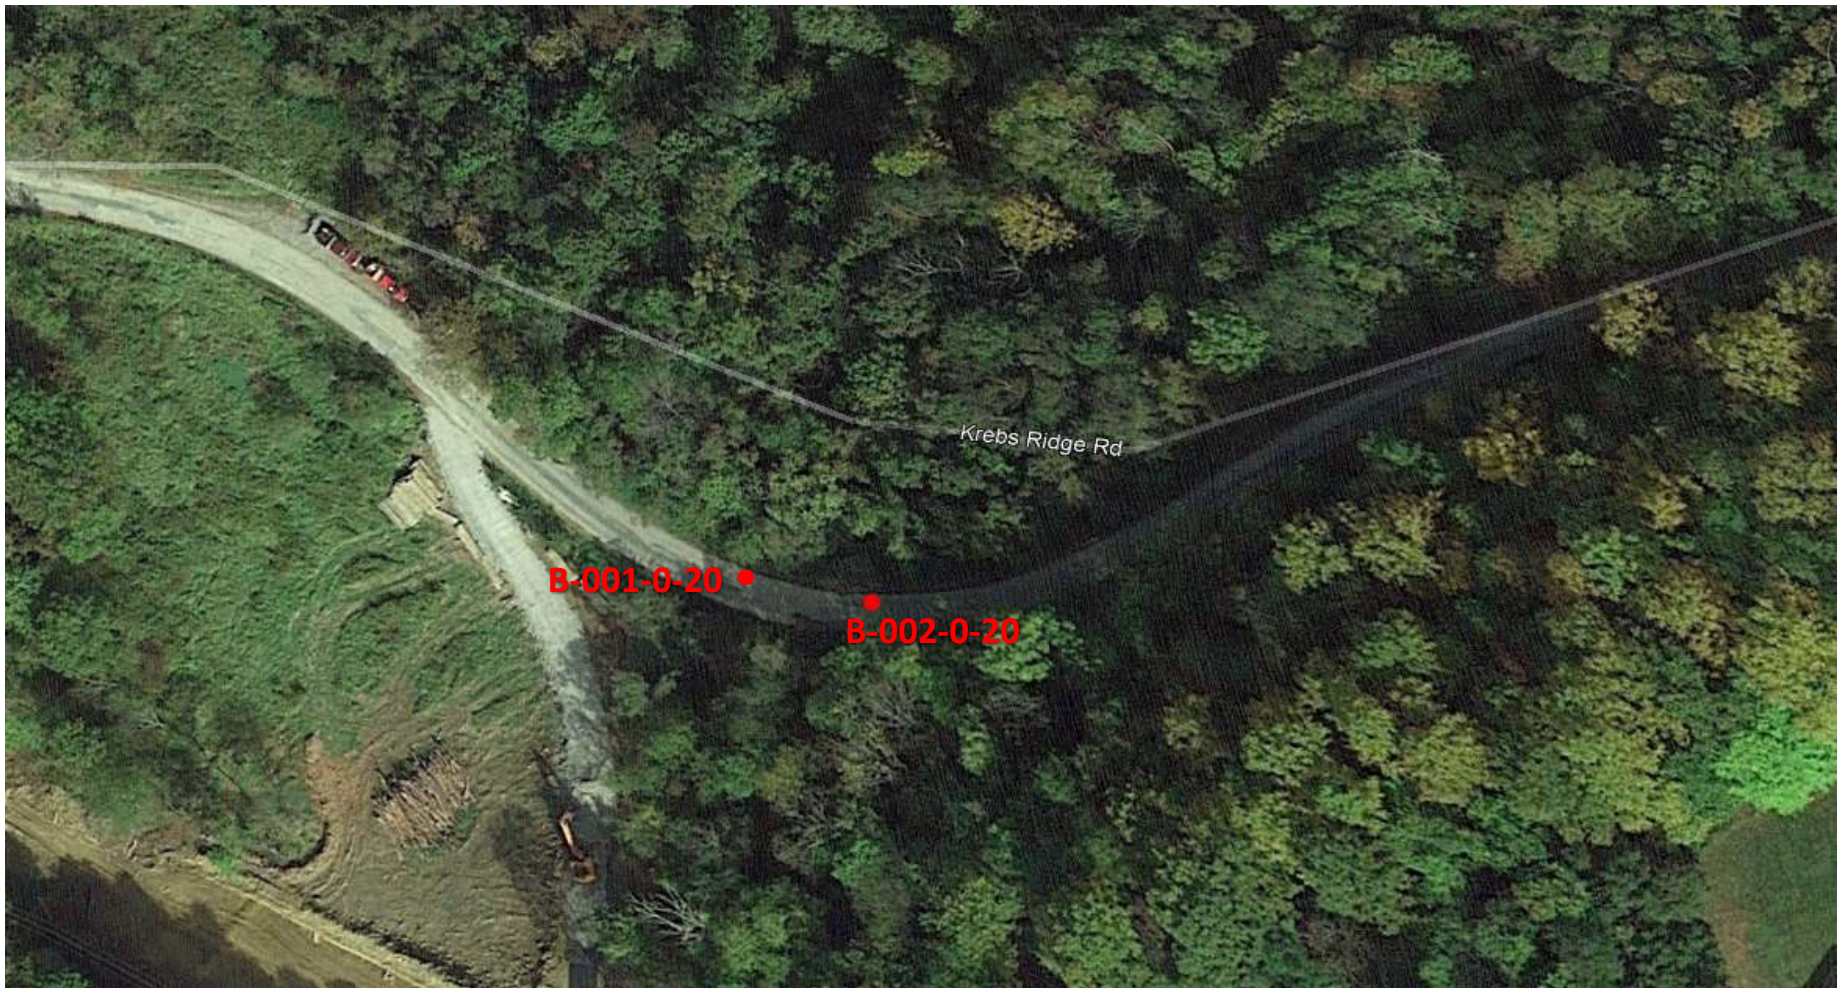
BORING LOCATION PLAN - Aerial	
MOE-CR81-1.50 Slip Repair	
Switzerland Township, Monroe County, Ohio	
Aerial obtained from Google Earth, dated October 2013	
GCI Project No.: 20-G-24290	
Date: 08/10/2020	Drawn By: Jeffrey Holko
Scale: Not to Scale

● Boring Location

We mobilized a truck-mounted rotary drill rig (CME-55 with an automatic sampling hammer) to the site on June 30, 2020 and drilled two (2) standard penetration borings (borings B-001-0-20 and B-002-0-20) within the north lane above where the failure is occurring. Boring B-001-0-20 was performed near the east end and boring B-002-0-20 was performed near the west end of the slip. The attached plan shows the approximate boring locations and we attach copies of the boring logs in the appendix, including Boring B-1 that was performed for the CR 81 – 1.55 slip project on August 15, 2018. We describe our findings below; refer to the attached boring logs for more detailed information.
